EROSION CONTROL INSPECTION CHECKLIST

**GARDEN STREET RESIDENCES
NEW ROCHELLE, NY 10901
SESI CONSULTING ENGINEERS PROJECT # 10491**

Date: 01/06/2020

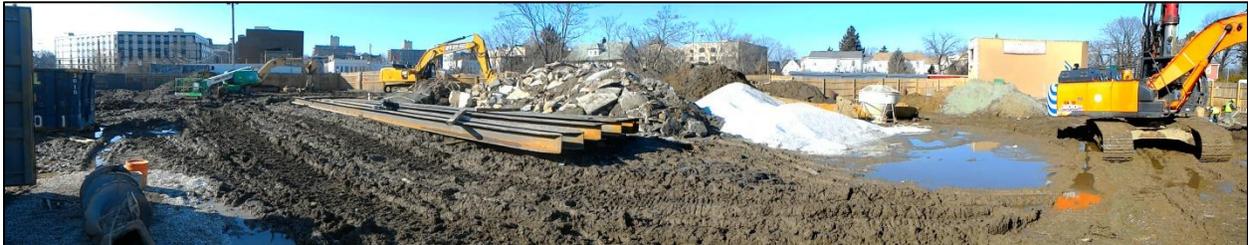
Photo 8: Panoramic View of the site.

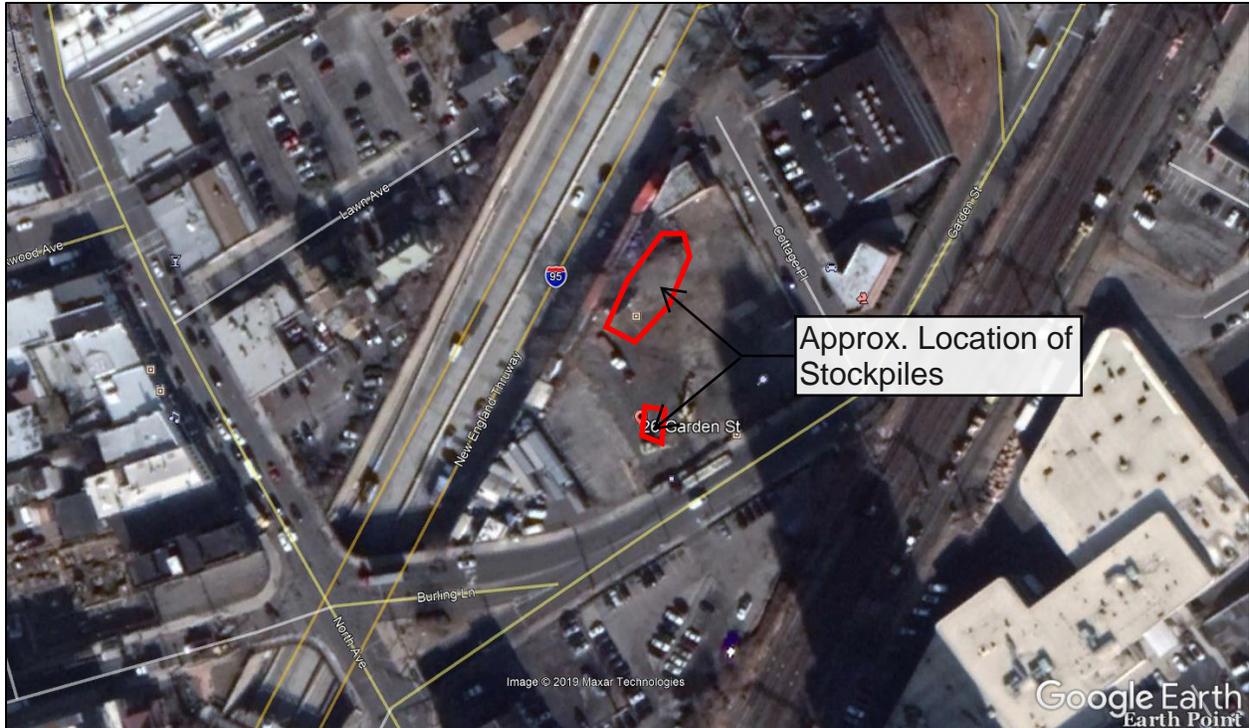
Photo 4: Observed Stockpile on-site; If left inactive for 14 days, a silt fence is recommended to be placed around its edges to prevent sediment erosion.
