PHASE I
ENVIRONMENTAL SITE ASSESSMENT UPDATE REPORT
FIRST PRIZE CENTER
EXCHANGE STREET
CITY OF ALBANY/TOWN OF COLONIE
ALBANY COUNTY, NEW YORK

JULY 30, 1990

C. T. MALE ASSOCIATES, P.C.
50 Century Hill Drive
P.O. Box 727
Latham, New York 12110
(518)785-0976
CTMA Project No.: 90.3039

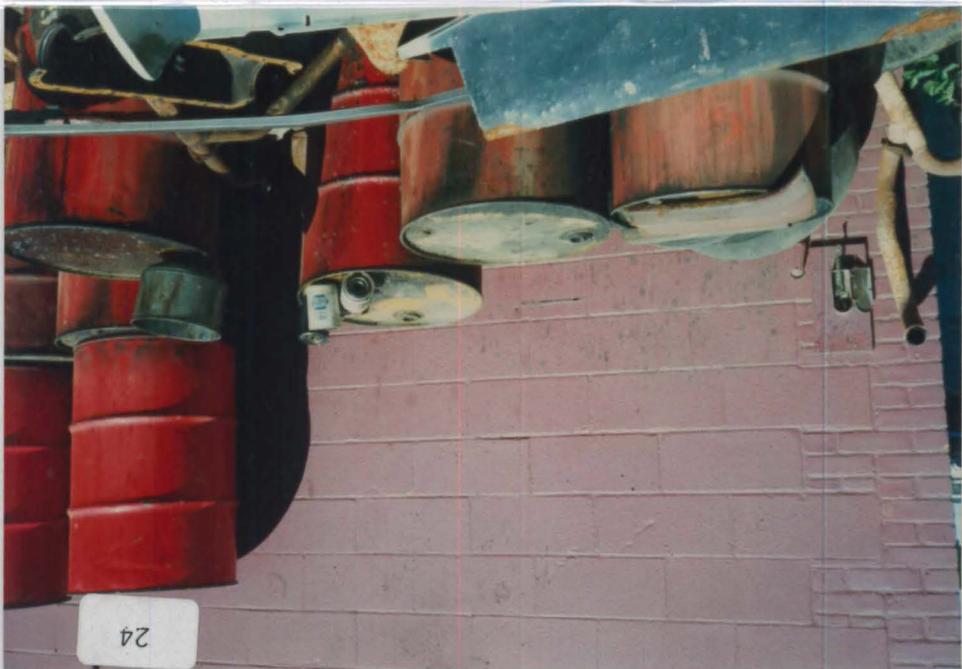
- 22 - 24 Drum storage area (used by John's Truck Repair) at southwest corner of Goodyear building.
- 25 - 28 Four above ground storage tanks on south side of Goodyear building (Photo 28 shows staining on ground between 3 of these tanks).

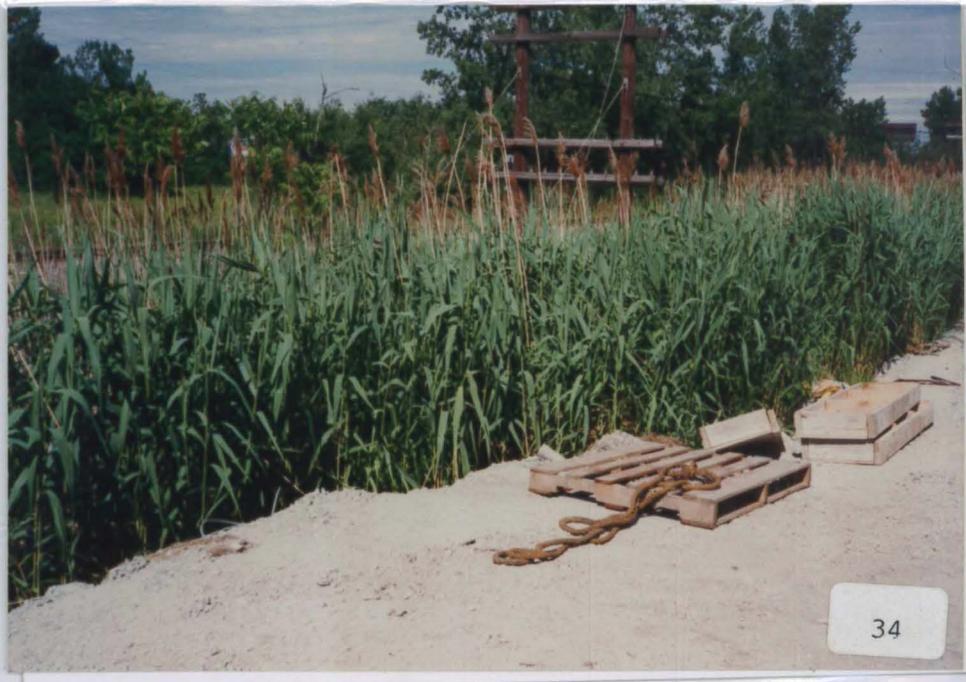
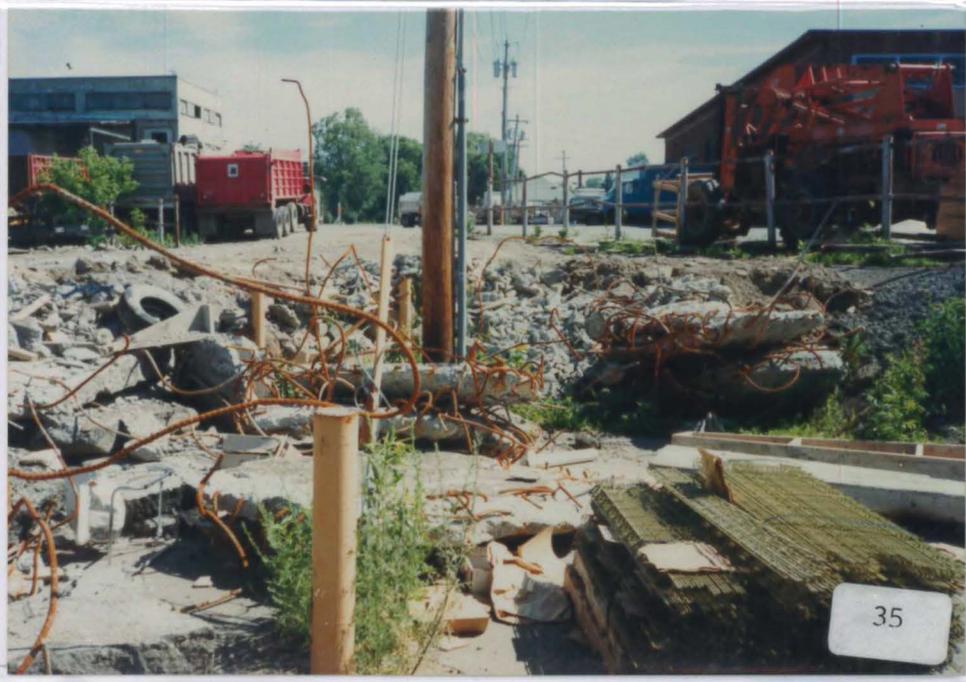
- 33 - 34 Filled area on southwest corner of site.
- 35 - 36 Filled area along south side of Hogpen building foundation.
- 37 - 40 Fill piles along West Side Road, and west of main site building. Photos 39 and 49 show one of these fill piles with oil contaminated soil, an abandoned above ground storage tank, and C & D debris waste materials.

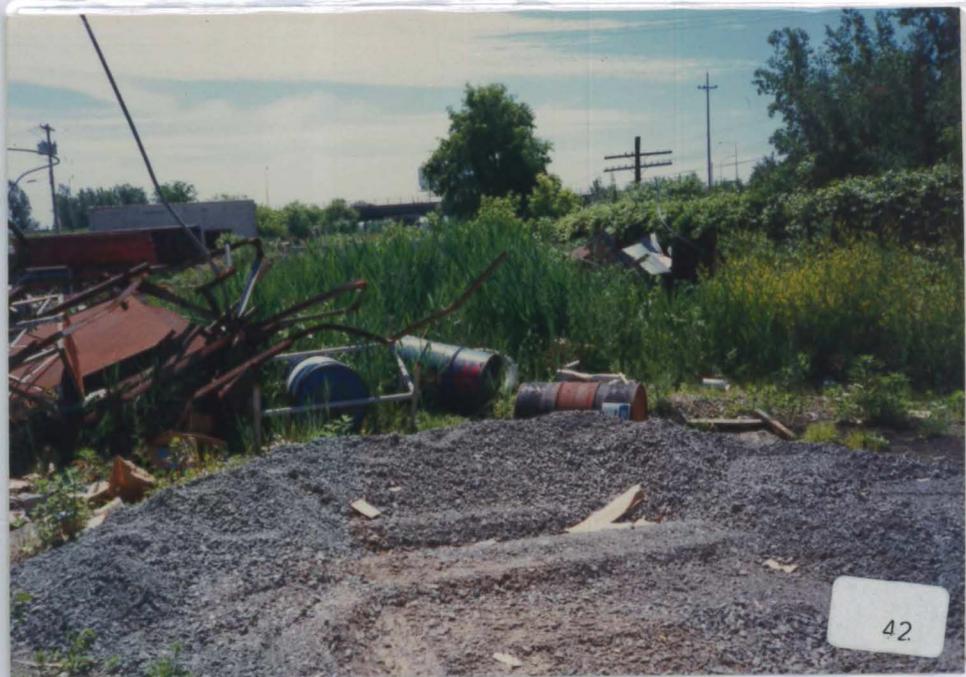
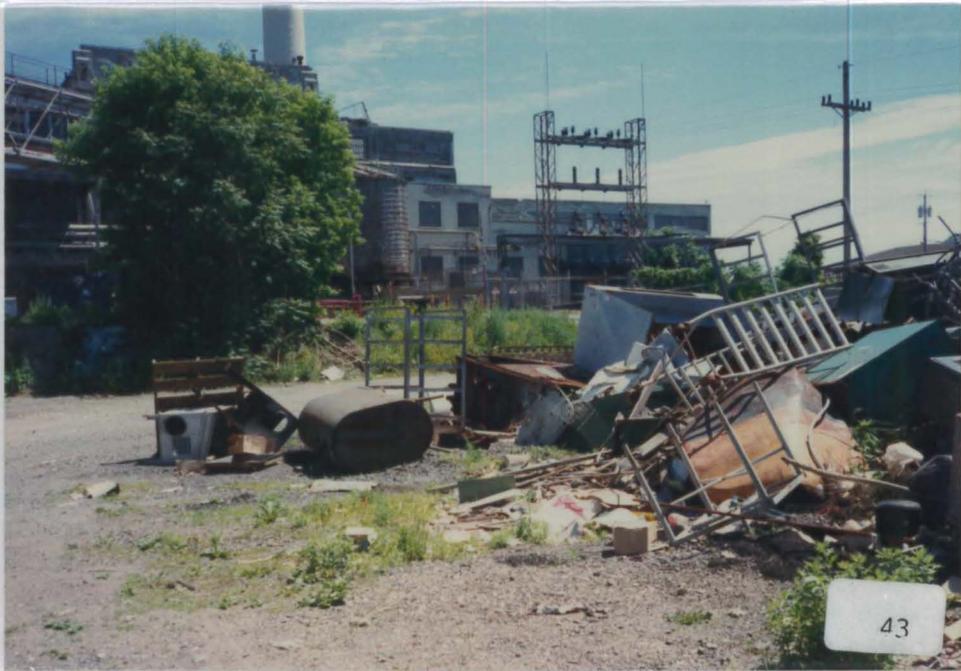
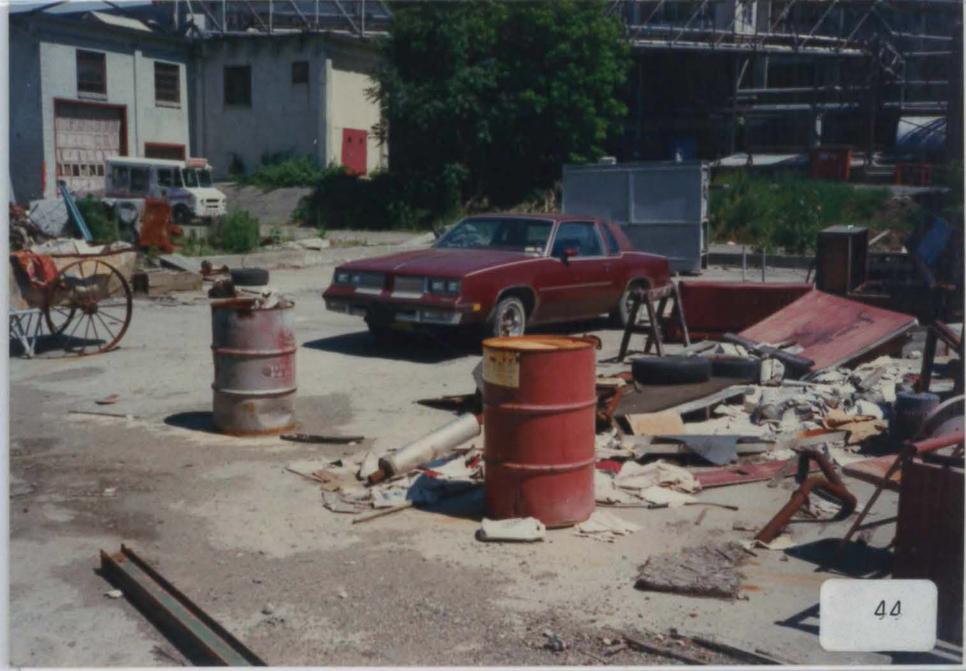
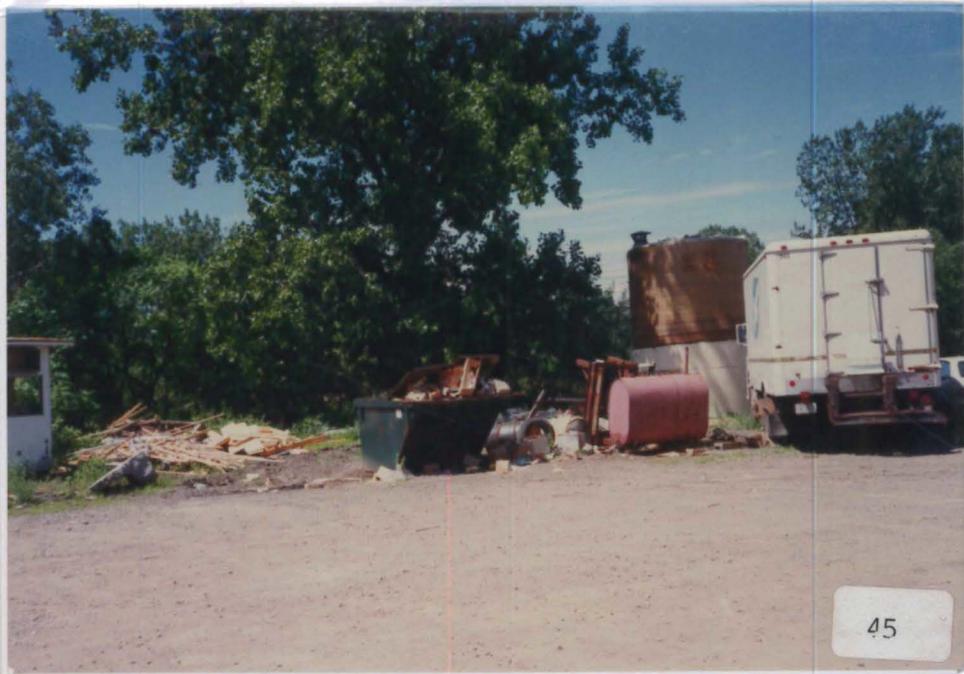
- 41 - 44 Metal debris, drums, abandoned storage tanks and junk automobiles stored on foundation of former Hogpen building.
- 45 - 47 Drums and an abandoned tank west of the former wastewater treatment building.

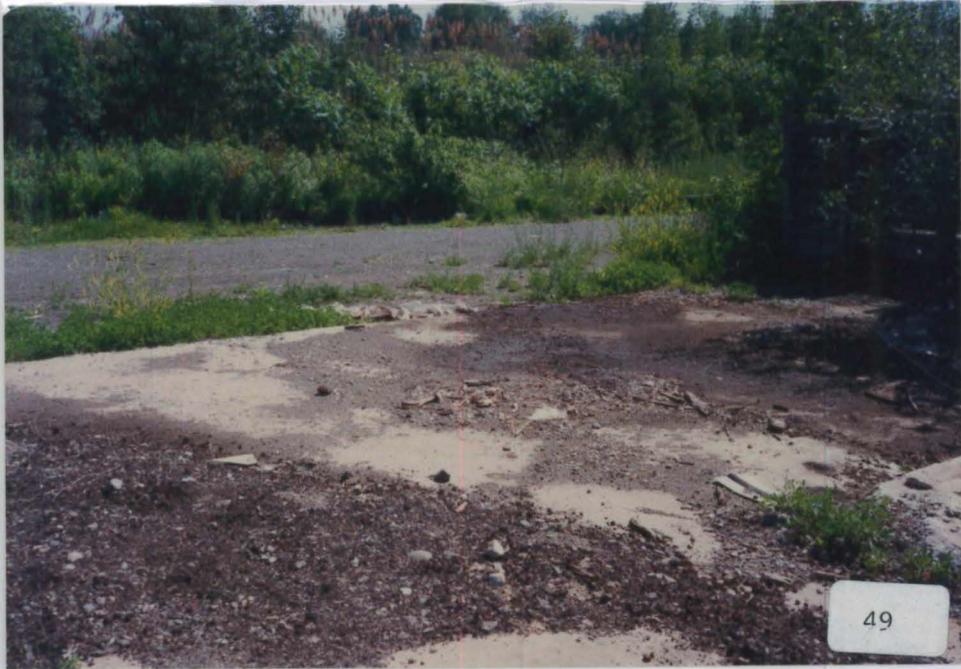
- 48 A pipe with suspect asbestos containing material insulation dumped with scrap metal from former Hogpen building foundation.
- 49 Former incinerator slab in northwest corner from site, where drums were stored by Domermuth Environmental Services for disposal. Oil staining is evident on east side of concrete slab.
