LYONS ENGINEERING, DPC.

2022-2024 PERIODIC REVIEW REPORT

NYSDEC Site Number: C704060

The EJ Victory Building
59 Lester Avenue
Johnson City, New York

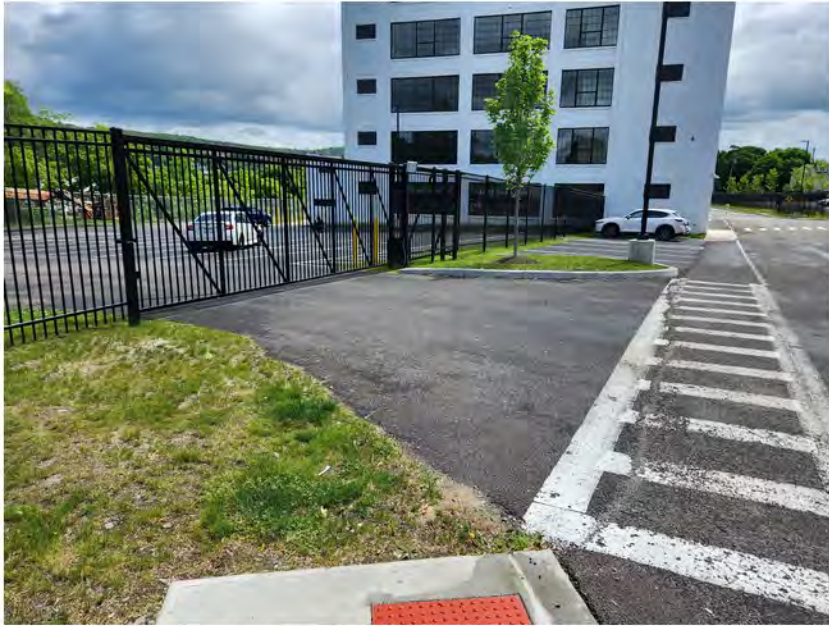
Western end of site, looking east

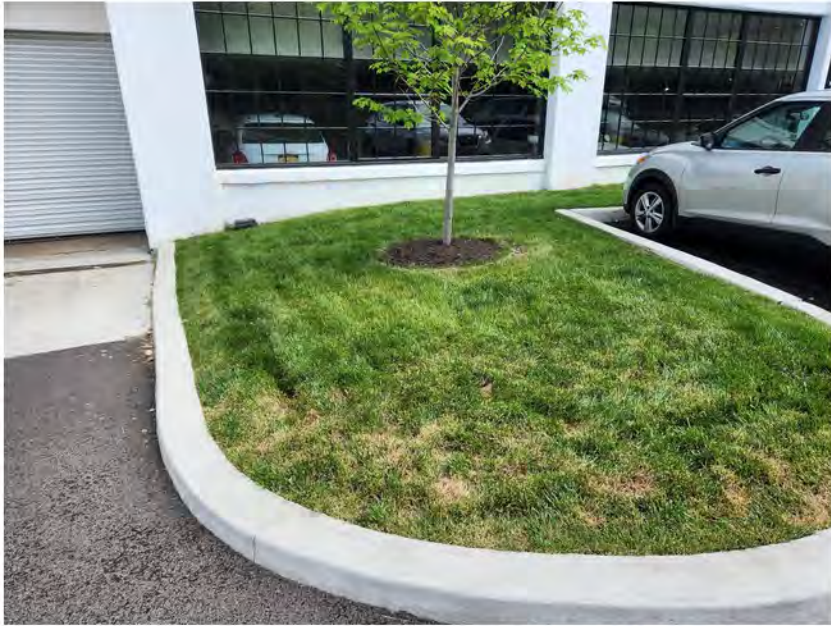
Closeup of lawn in southwestern portion of site, across from Avenue B

Recommendations:
CONSIDER OVERSEEDING THIN AREAS OF LAWN

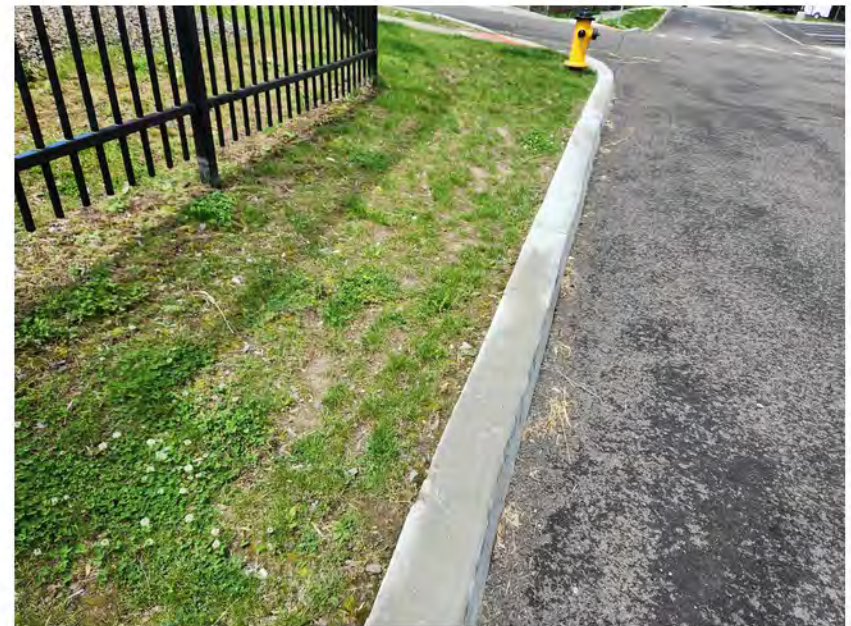
Closeup of lawn at intersection of Helen Drive and Avenue B

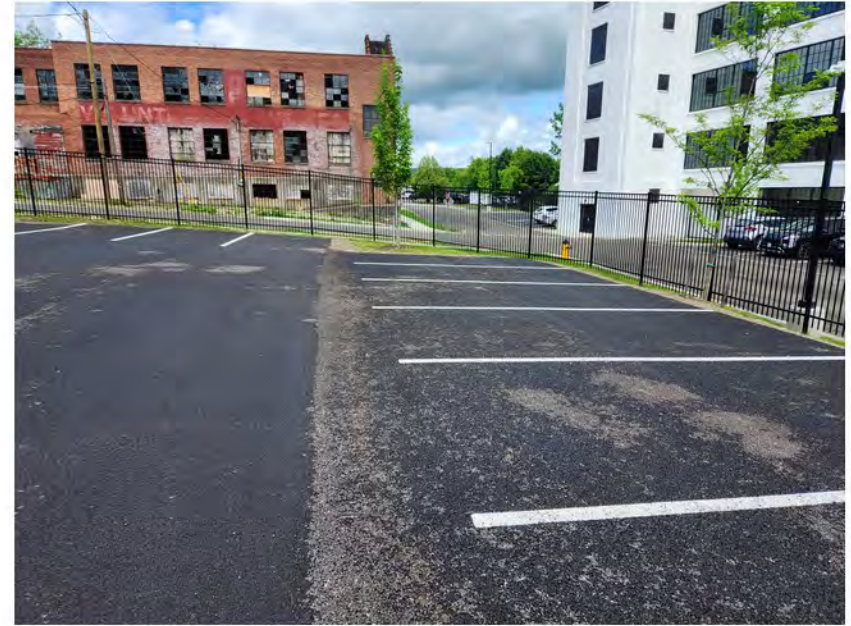
Western end of southwestern parking lot

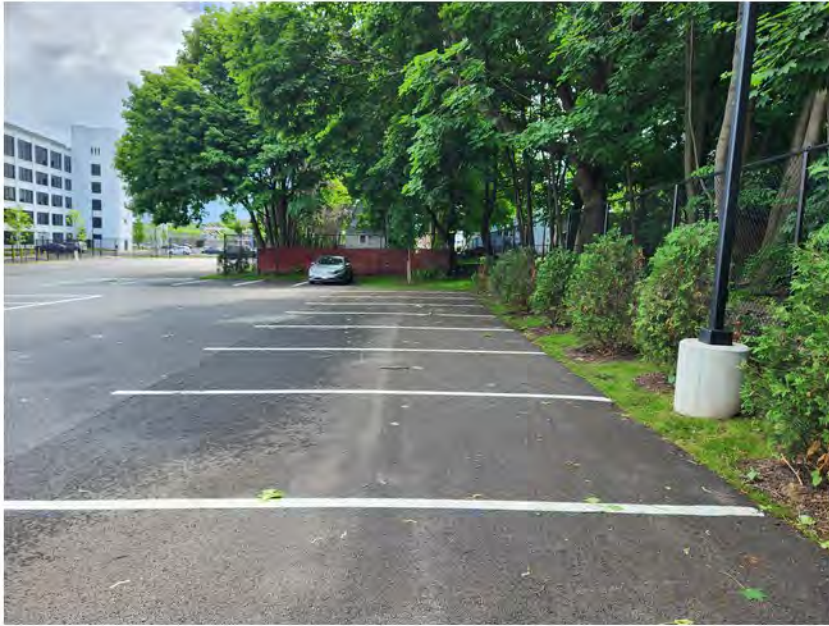
Southern portion of southwestern parking lot, looking east

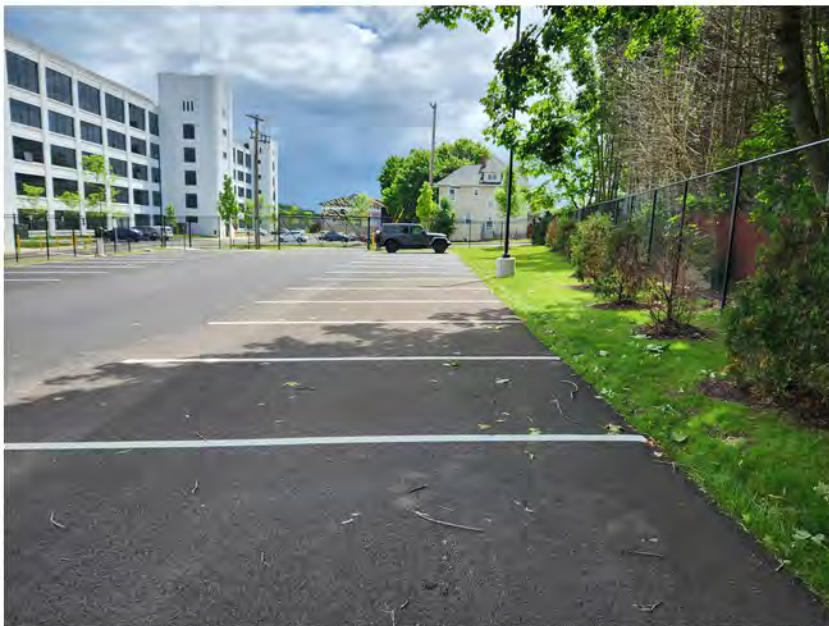
Central and eastern section of southwestern parking lot, looking east

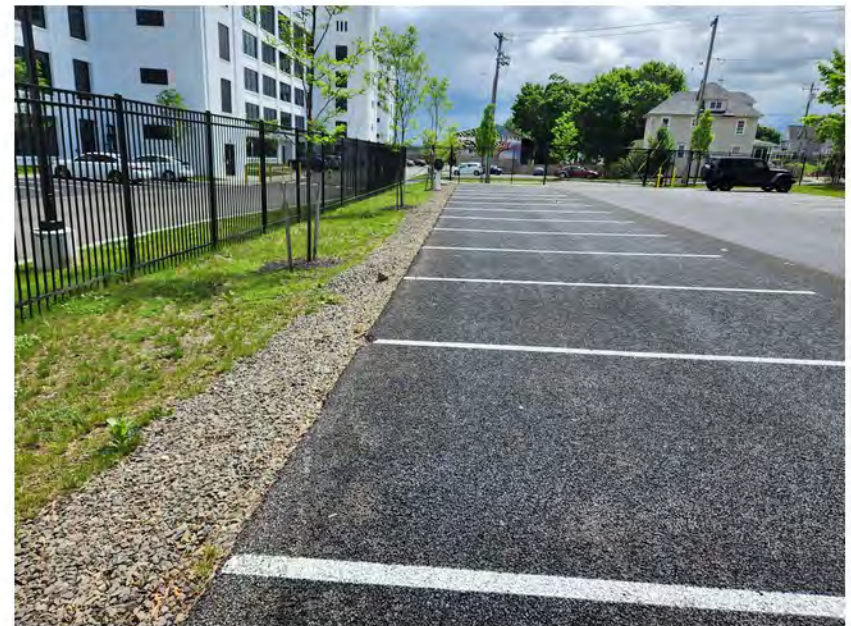
Northern section of southwestern parking lot, looking east

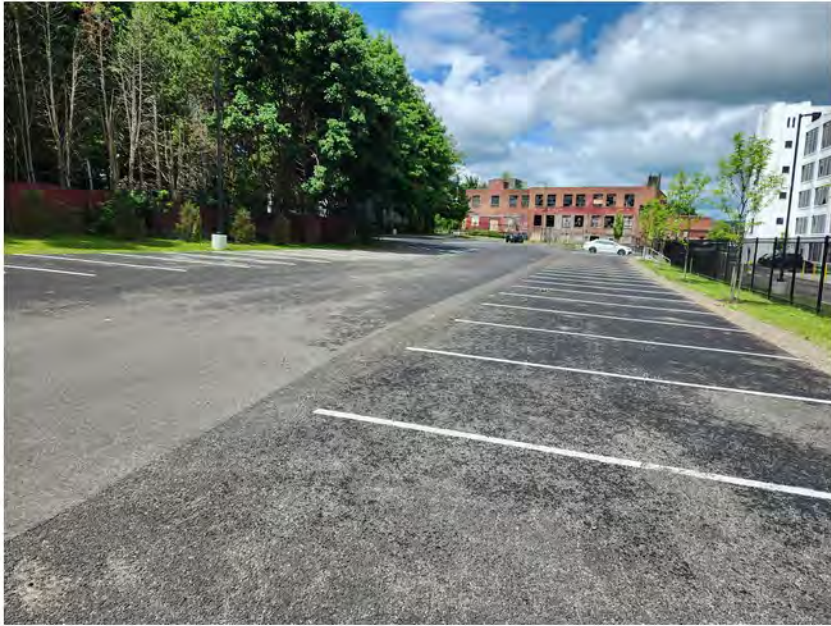
Central and eastern section of southwestern parking lot, looking west

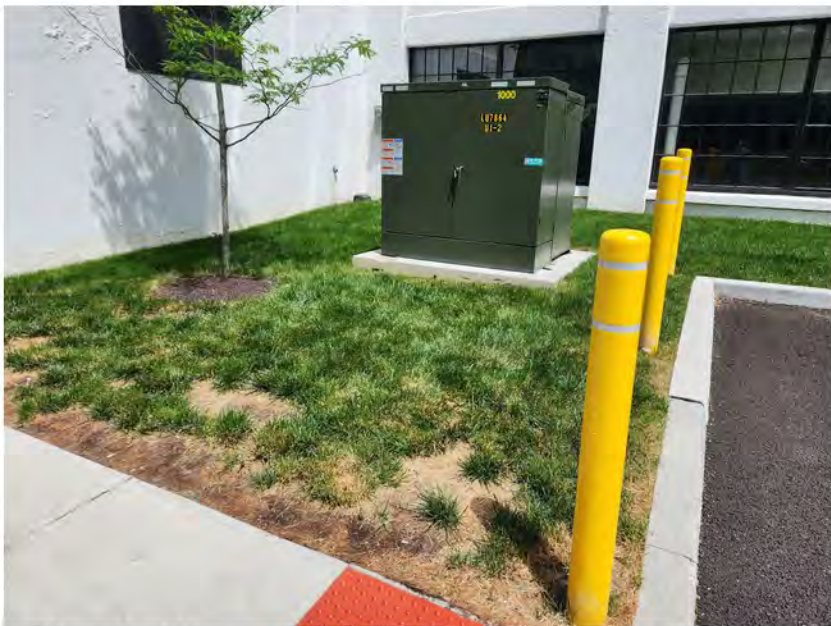
Closeup of lawn area adjacent to parking lot along Helen Drive

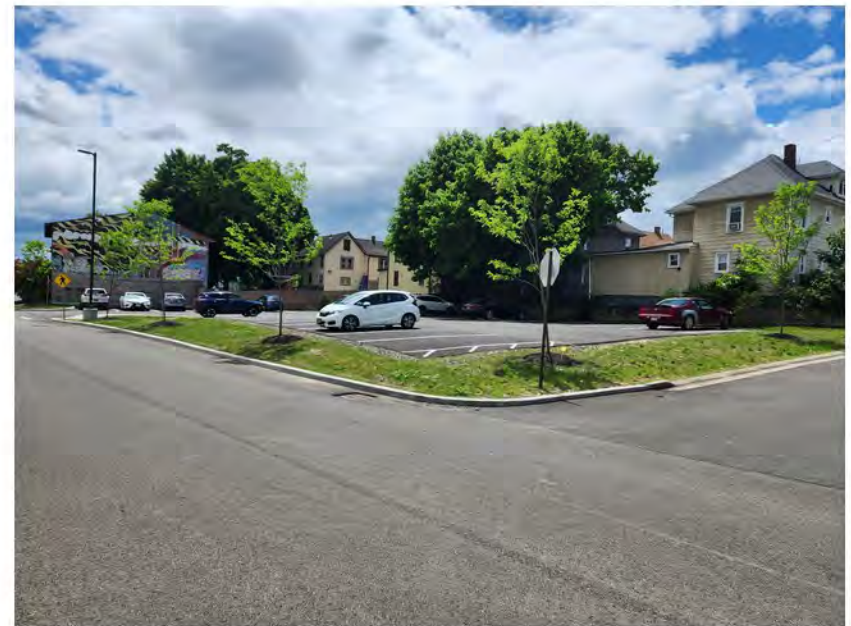
Southeastern parking lot, looking southeast from intersection of Helen Drive and Avenue A

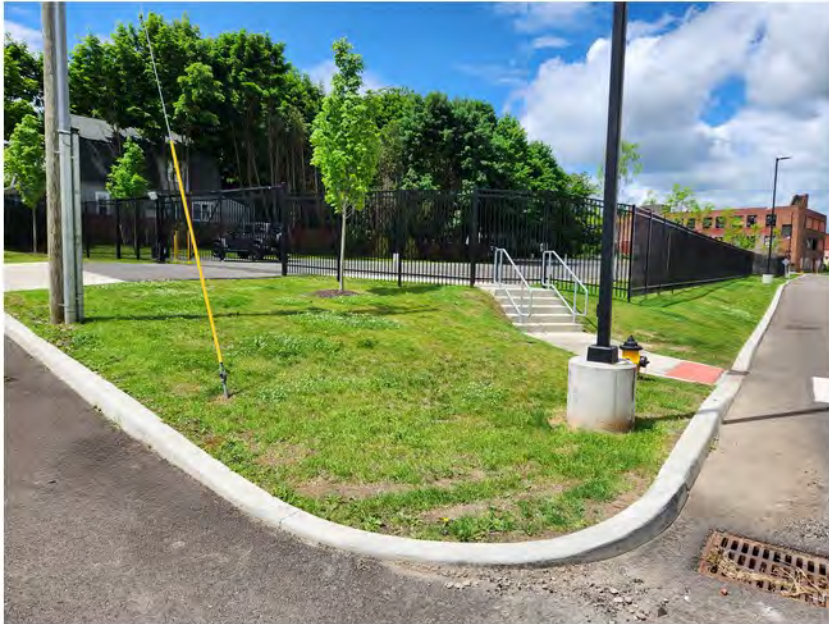
Closeup of lawn area at intersection of Helen Drive and Avenue A

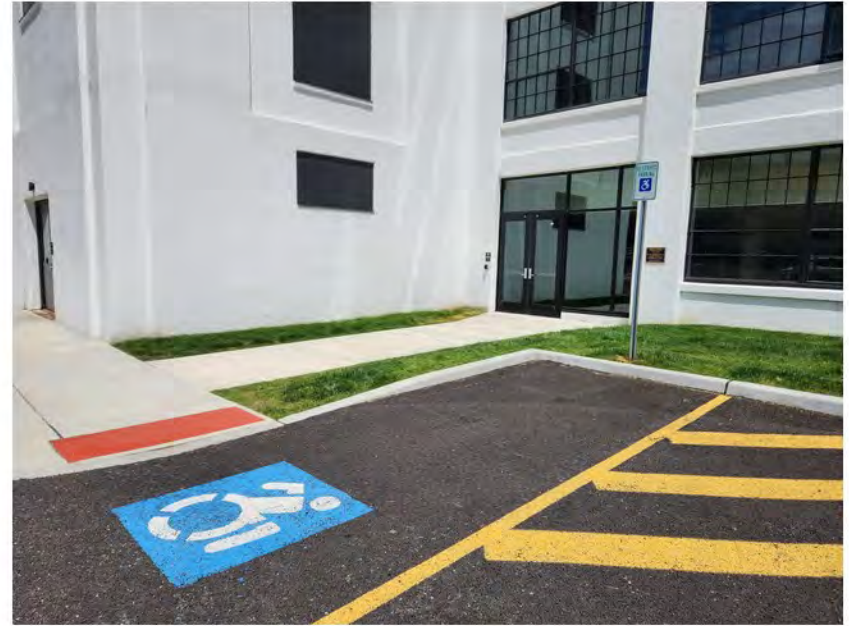
Stairwell entrance along Helen Drive

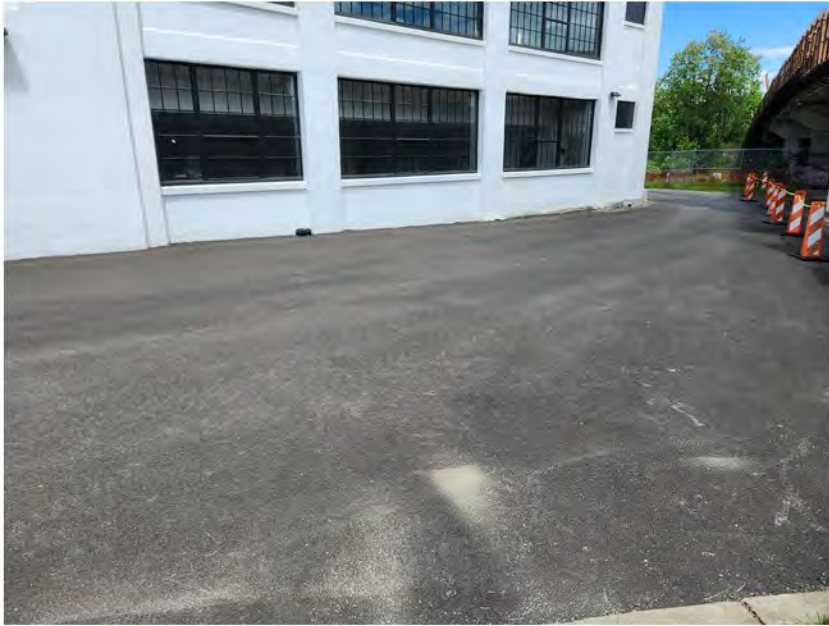
Eastern driveway, looking north

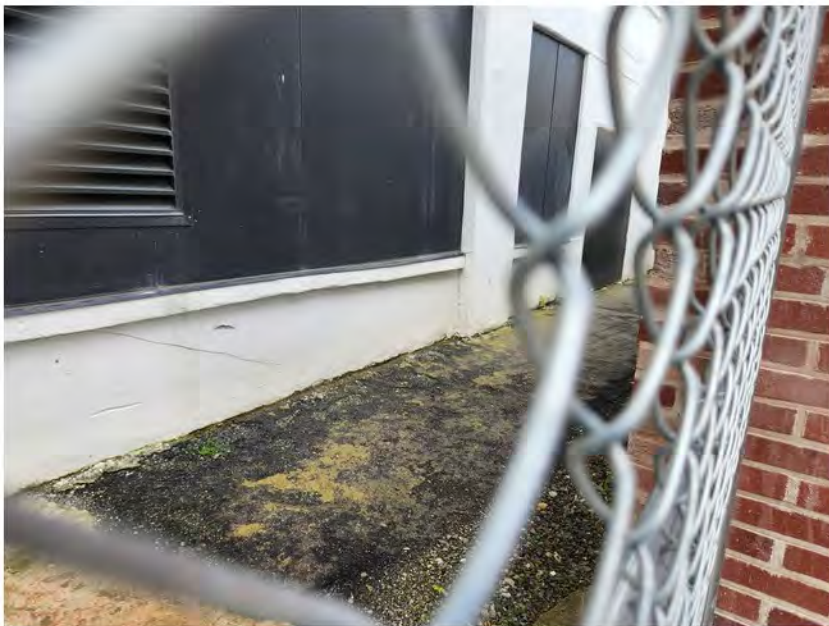
"Courtyard" between main building and annex

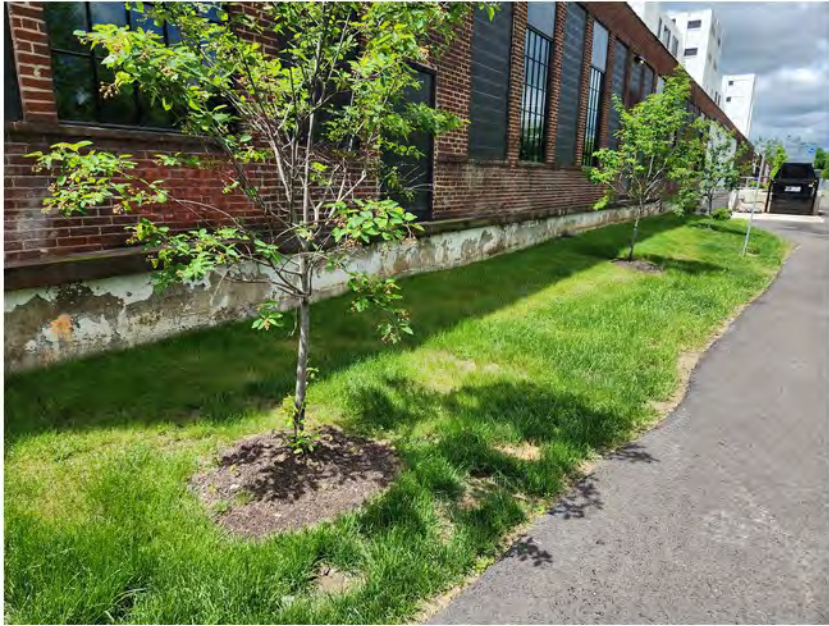
Closeup of eastern lawn area along Avenue C, looking west

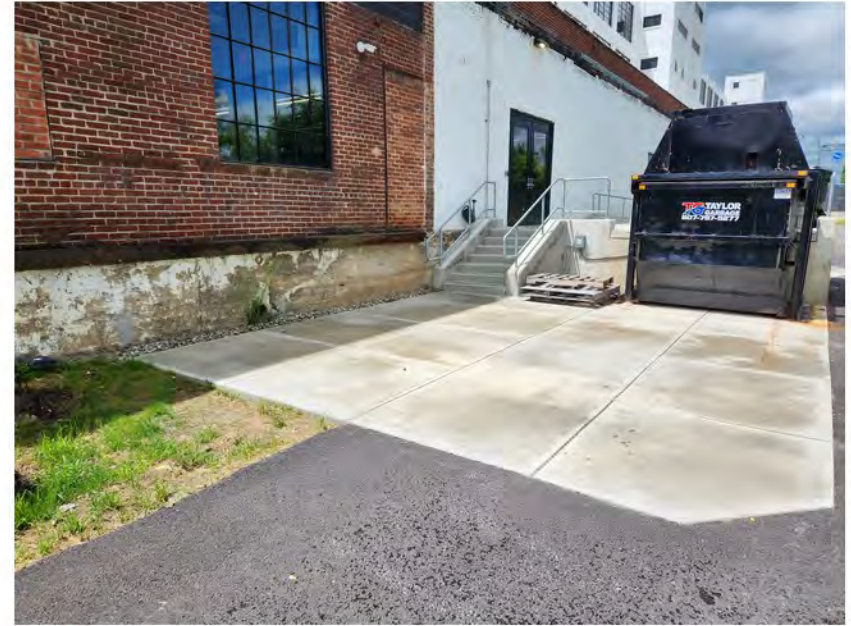
Loading dock area

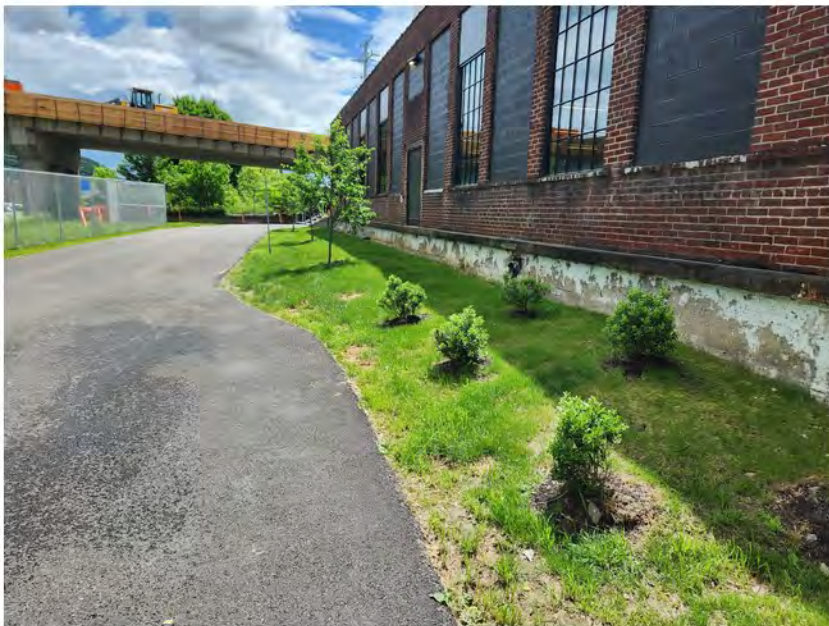
Eastern lawn area along Avenue C, looking east

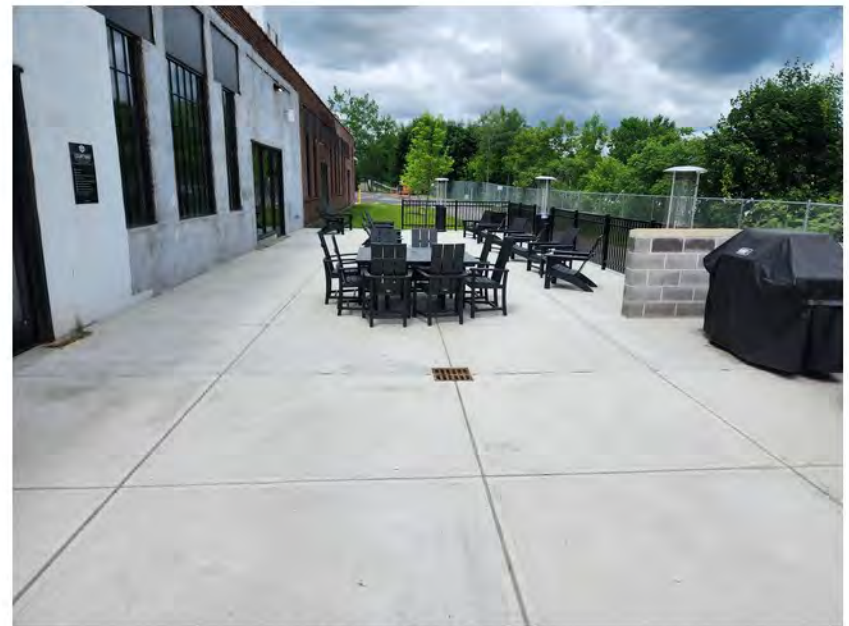
Patio off of lounge

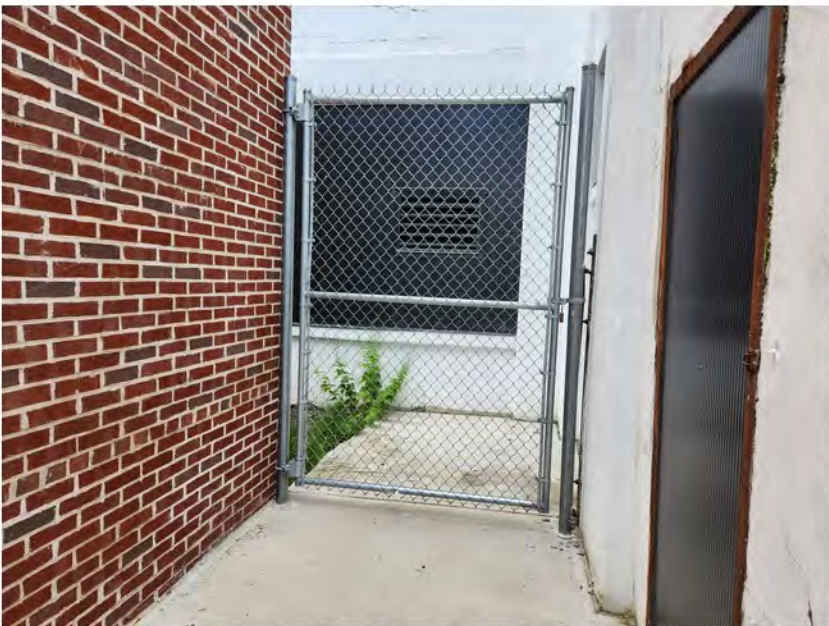
No tenant access to "courtyard" between main building and annex

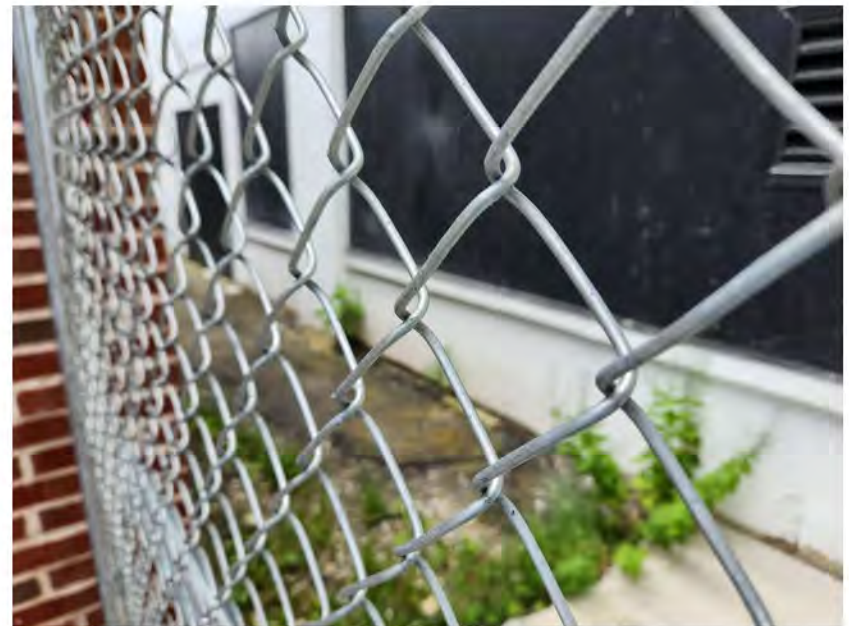
"Courtyard" between main building and annex
