LYONS ENGINEERING, DPC.

2024-2025 PERIODIC REVIEW REPORT

NYSDEC Site Number: C704060

The EJ Victory Building
59 Lester Avenue
Johnson City, New York

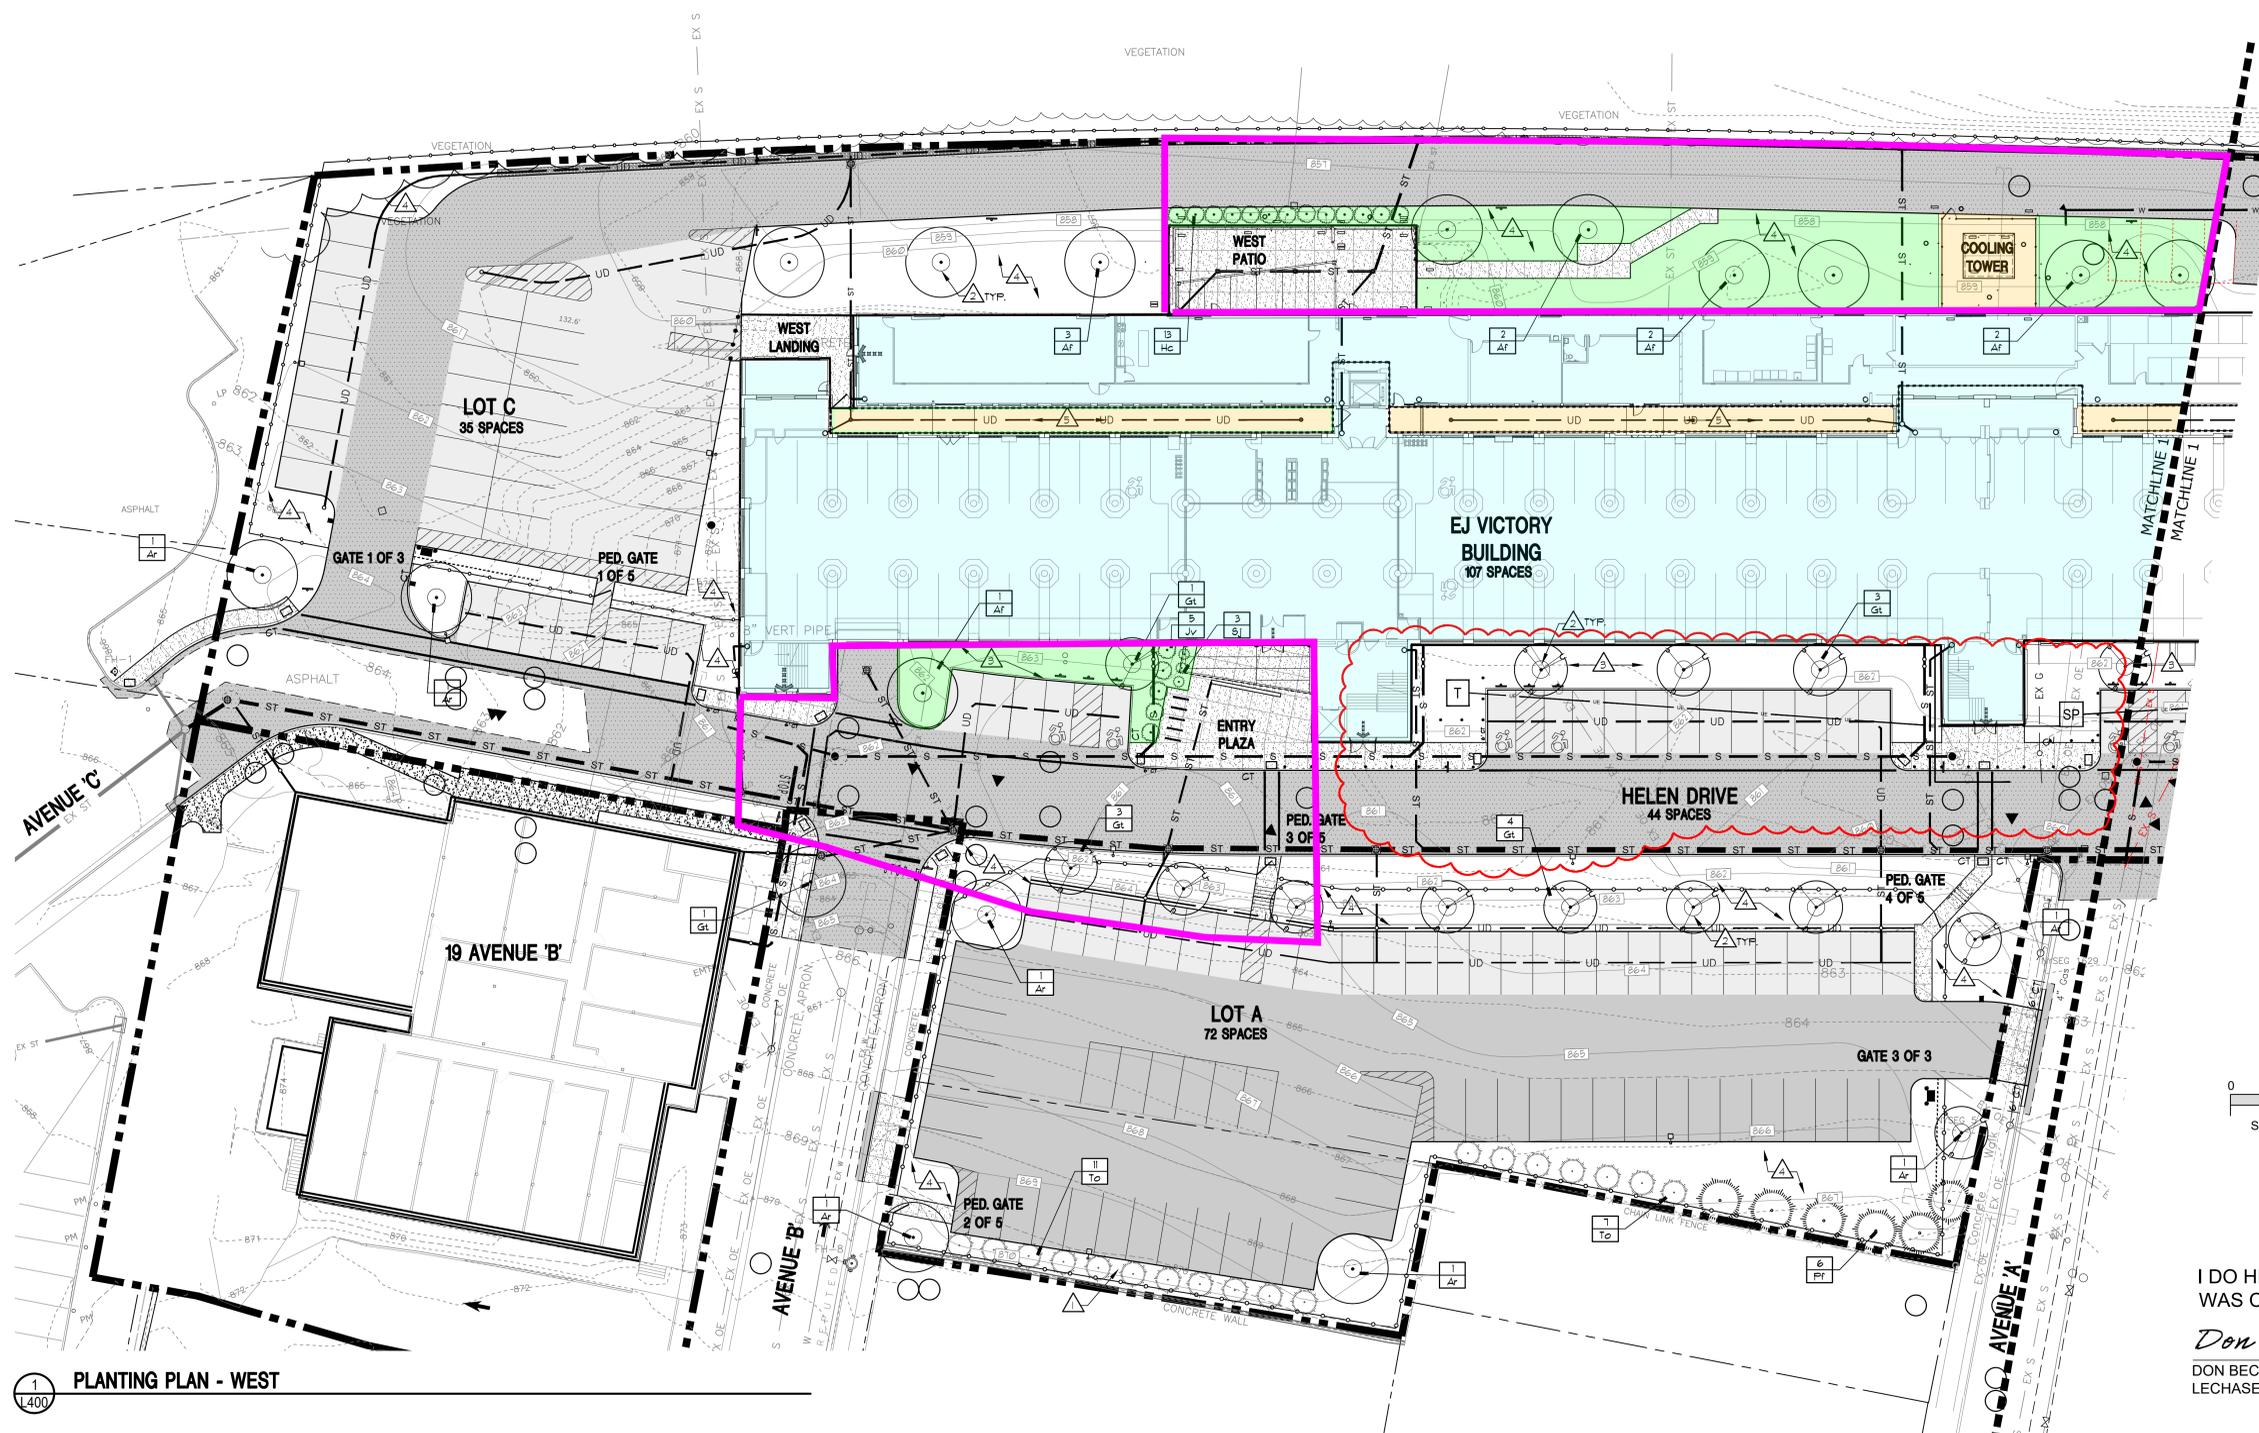
SHEET NUMBER
FIGURE 2A

- Portions of the site were excavated for installation of new underground utilities, building addition foundations, and to accommodate installation of a cover system (see Figure 2). A vast majority of excavated soils were reused onsite in order to implement the remedy. Soils that were excavated and disposed off-site were limited to two areas of discrete contamination:

Exposure to remaining contamination at the site is prevented by a cover system placed over the site. This cover system is comprised of a minimum of 24 inches of clean soil or impervious surfaces such as asphalt pavement, concrete-covered sidewalks, and concrete building slabs. Figure 2 shows the location of each cover type built at the Site. An Excavation Work Plan, which outlines the procedures required in the event the cover system and/or underlying residual contamination are disturbed, is provided as an Appendix to the Site Management Plan (separate document).

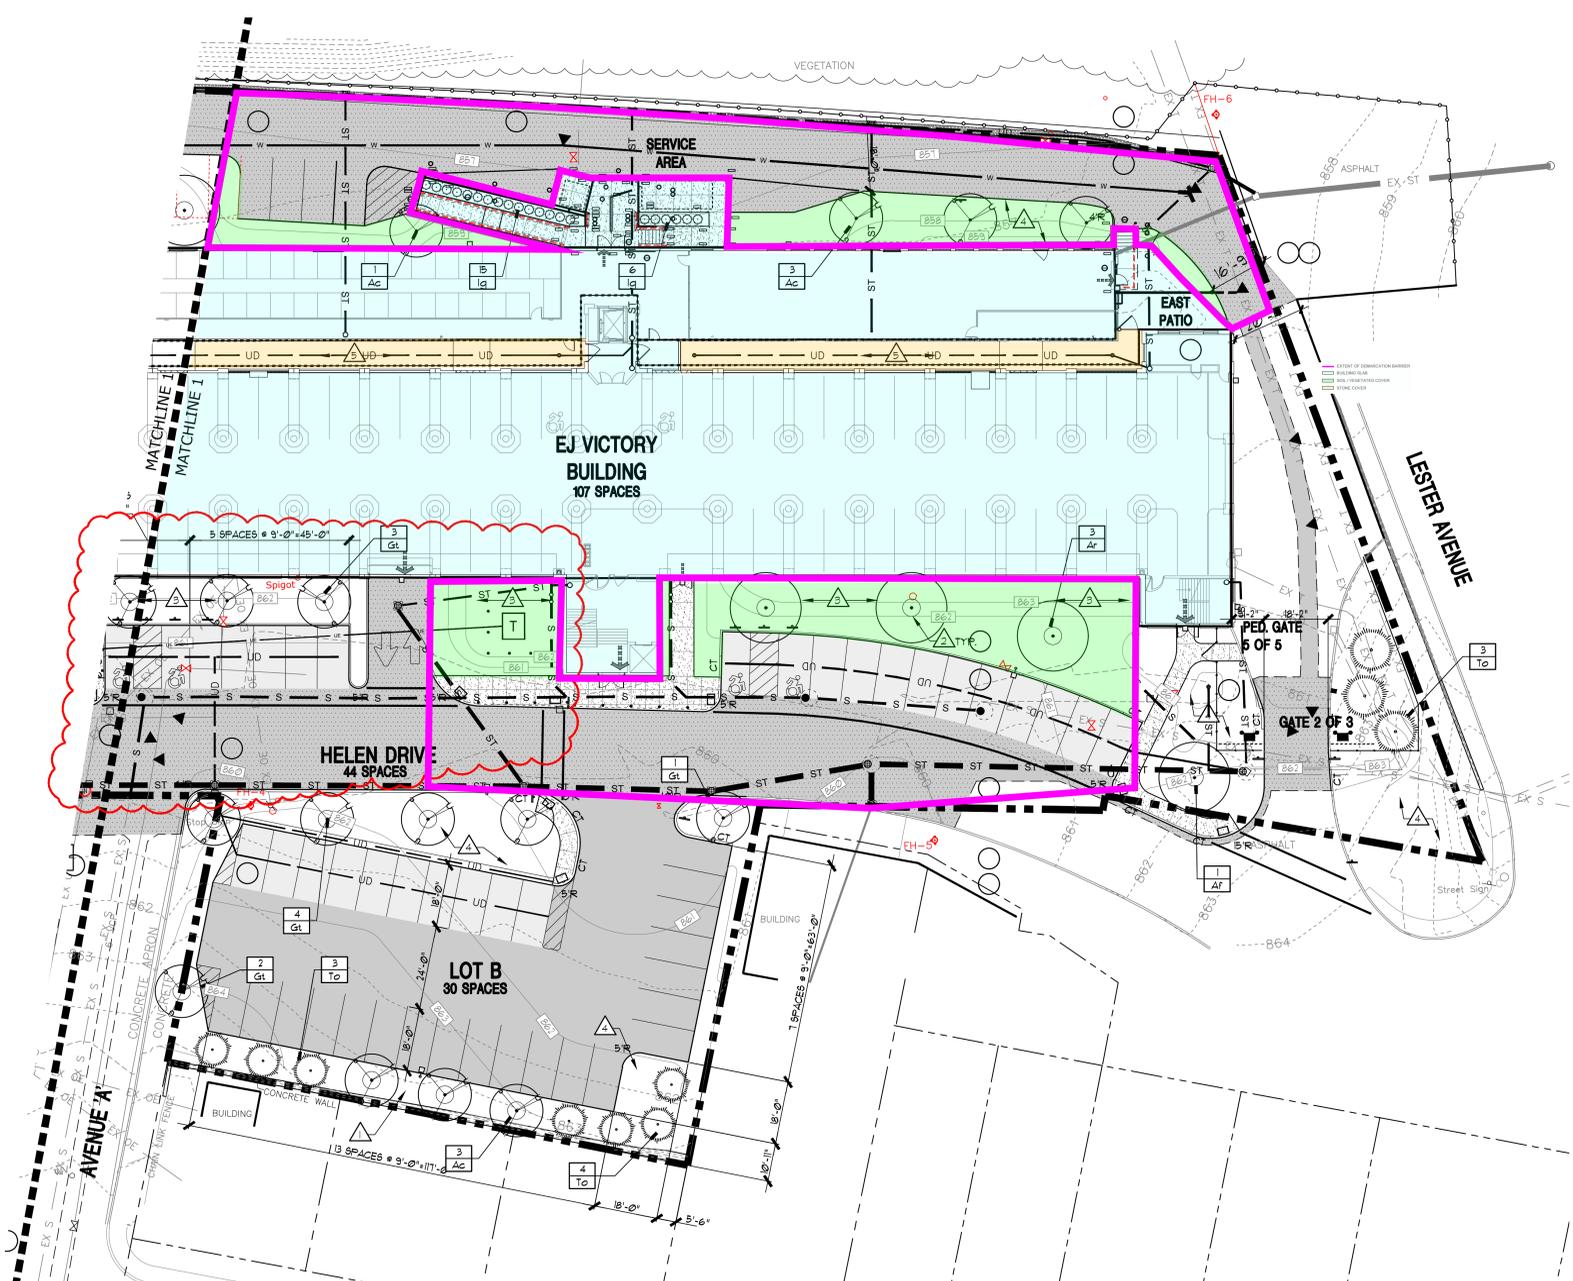
1 PLANTING PLAN - EAST
L401

- A cover system was installed, which was comprised of hardscape (asphalt pavement, concrete-covered sidewalks, and concrete building slabs) or a minimum of 2-feet of clean soil (in landscaped areas), placed over a demarcation barrier (see Figures 3 and 4). The soil cover was a minimum of two feet of soil, with the upper six inches of soil of sufficient quality to maintain a vegetative layer. Soil cover material, including any fill material brought to the site, met the Restricted Residential SCOs for cover material as set forth in 6 NYCRR Part 375-6.7(d).
