Site Investigation  
Salvation Army Site  
Syracuse, New York

**SITE INVESTIGATION  
SALVATION ARMY SITE  
BURT STREET  
SYRACUSE, NEW YORK**

Prepared for  
SYRACUSE HOUSING AUTHORITY  
516 Burt Street  
Syracuse, New York 13202

Project No. N2014.0

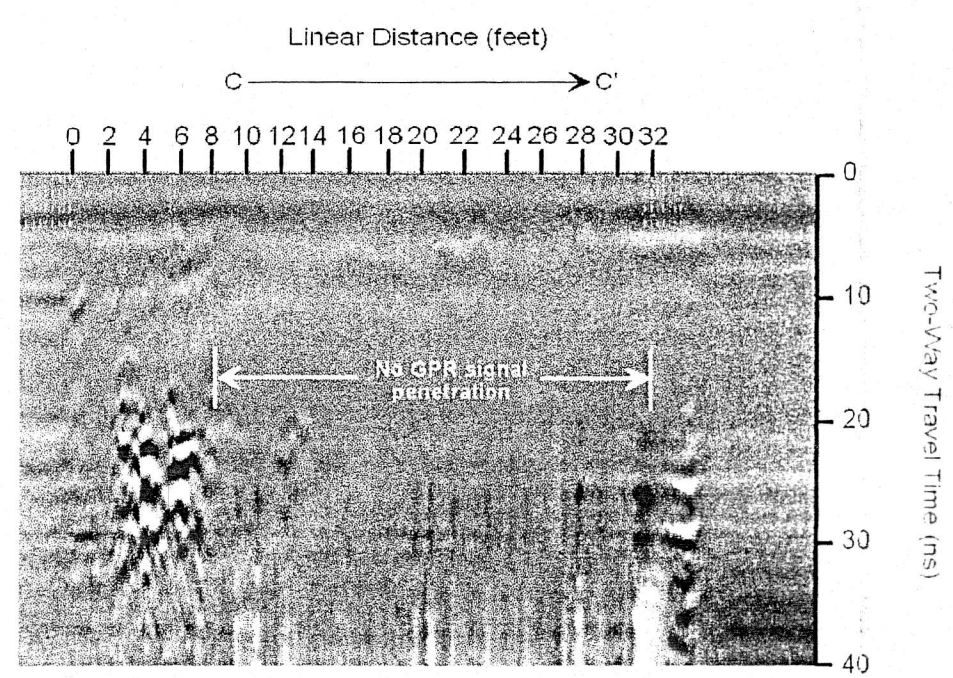
Anomaly AN 6 GPR Profile

The TW-6 scanning results within all accessible areas indicated the presence of seven metallic anomalies (labeled AN1 through AN7, Figure 2). The descriptions and possible sources of each anomaly are included in Table 1. Selected GPR images are included in Figure 2, and each represents a single pass across the TW-6 anomaly. GPR penetration at this site was very poor, resulting in reliance upon the TW-6 results for target delineation. At the client's request, selected examples of GPR data with poor signal penetration were recorded as representative site samples (AN2, AN5, AN6).

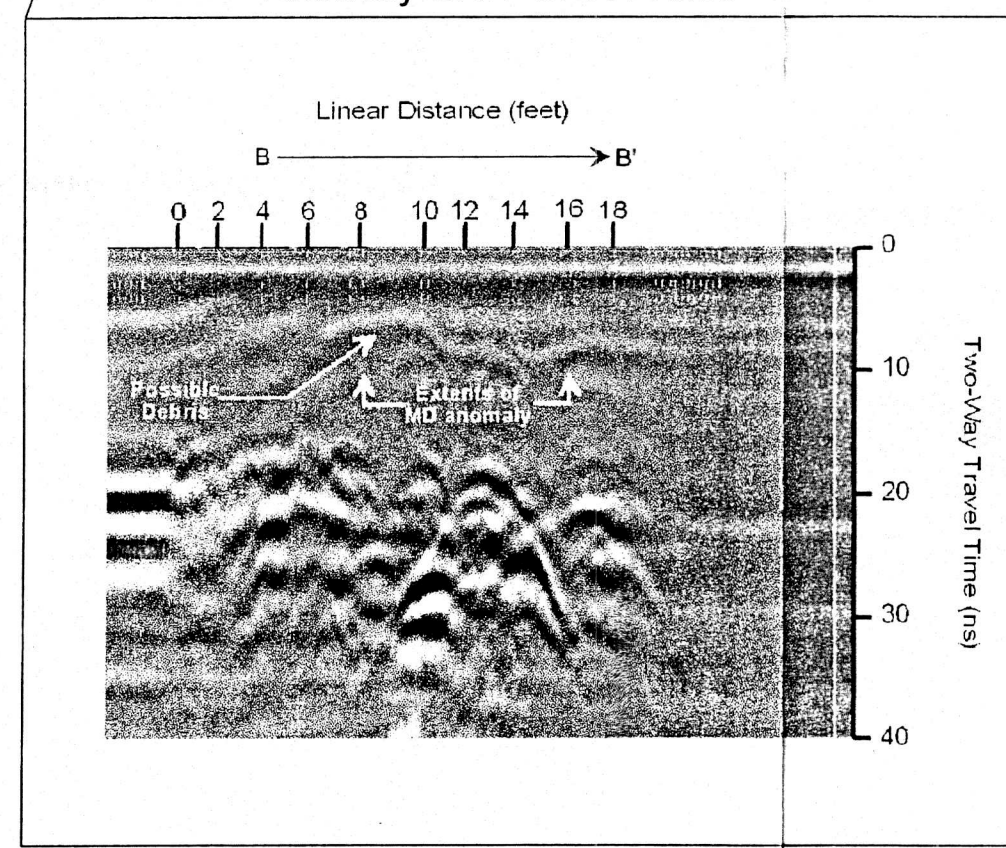
Anomaly SA 1 GPR Profile

The TW-6 scanning results indicated the presence of six metallic anomalies (labeled SA1 through SA6, Figure 1). The descriptions and possible sources of each anomaly are included in Table 1. Selected GPR scan cross sections are included in Figure 1, and represent one or two passes (in orthogonal directions) across the TW-6 anomalies. GPR scanning of the anomalies for which two cross sections are displayed revealed a definable object that could be delineated. Note that in some cases, a record is not shown if GPR imaging revealed no discernable object, in which case the source was most likely near-surface scattered metallic debris. In general, GPR penetration was good across this site, with an average depth of investigation of approximately 7 to 8 feet below ground surface.
