**SITE INVESTIGATION
SALVATION ARMY SITE
BURT STREET
SYRACUSE, NEW YORK**

Prepared for
SYRACUSE HOUSING AUTHORITY
516 Burt Street
Syracuse, New York 13202

Prepared by
S&W Redevelopment
of North America, LLC
430 East Genesee Street
Syracuse, New York 13202

January 2004

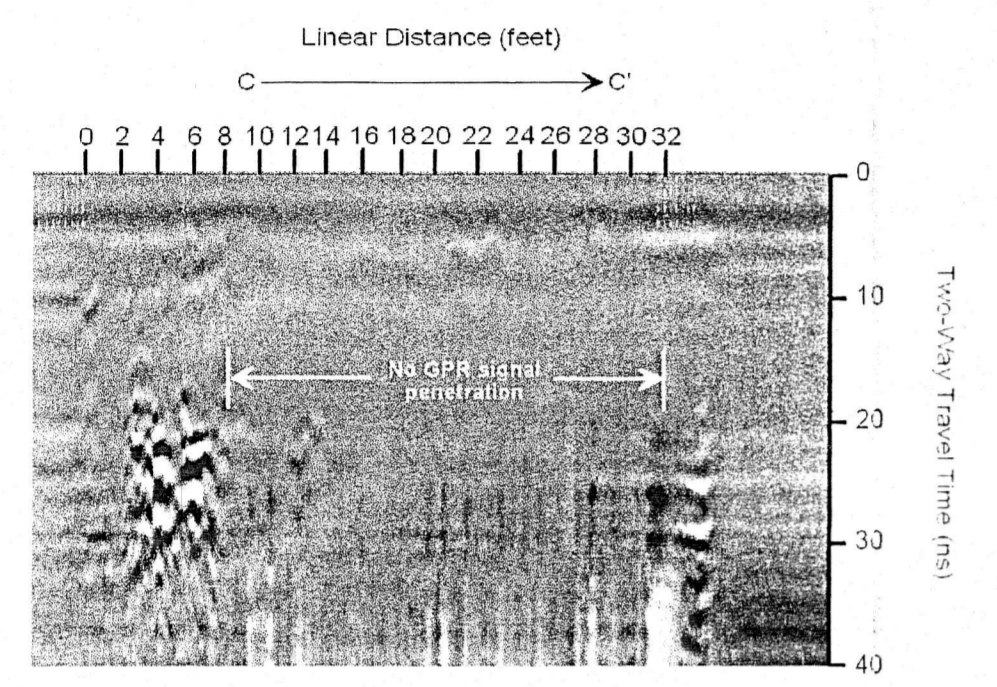
Anomaly AN 6 GPR Profile

The TW-6 scanning results within all accessible areas indicated the presence of seven metallic anomalies (labeled AN1 through AN7, Figure 2). The descriptions and possible sources of each anomaly are included in Table 1. Selected GPR images are included in Figure 2, and each represents a single pass across the TW-6 anomaly. GPR penetration at this site was very poor, resulting in reliance upon the TW-6 results for target delineation. At the client's request, selected examples of GPR data with poor signal penetration were recorded as representative site samples (AN2, AN5, AN6).

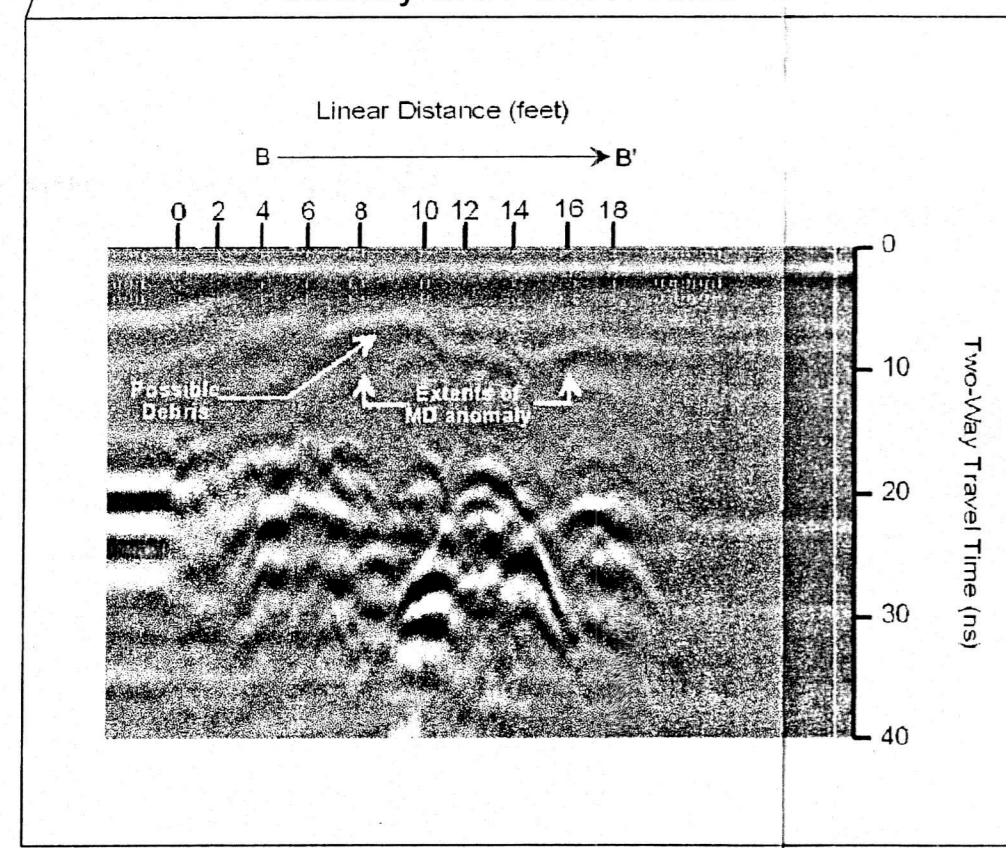
Anomaly SA 1 GPR Profile

The TW-6 scanning results indicated the presence of six metallic anomalies (labeled SA1 through SA6, Figure 1). The descriptions and possible sources of each anomaly are included in Table 1. Selected GPR scan cross sections are included in Figure 1, and represent one or two passes (in orthogonal directions) across the TW-6 anomalies. GPR scanning of the anomalies for which two cross sections are displayed revealed a definable object that could be delineated. Note that in some cases, a record is not shown if GPR imaging revealed no discernable object, in which case the source was most likely near-surface scattered metallic debris. In general, GPR penetration was good across this site, with an average depth of investigation of approximately 7 to 8 feet below ground surface.
