### Inline Camera Sewer Inspections

# SUBSURFACE UTILITY ENGINEERING PROJECT COMPLETION REPORT

DATE: 1/24/2020, **Revised 1/31/2020**

PROJECT NAME: Football Field Complex, Elmira, NY

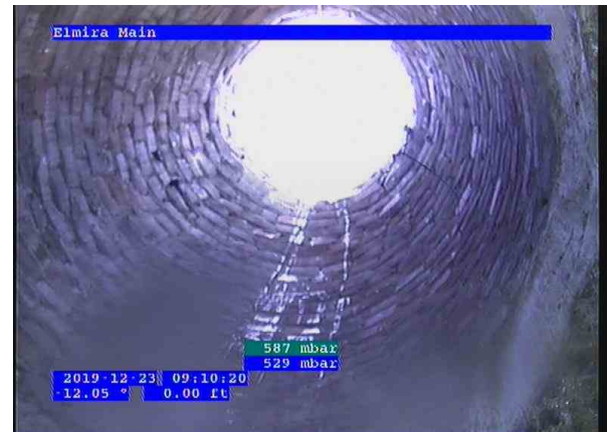
CB-15 to  
Unkonwn\_3cf30b0b-8d8b-452e-a24c-83e6d7f293b5\_2019122  
3\_092006\_603.jpg, 00:00:00, 0.00ft  
Manhole / CB-15

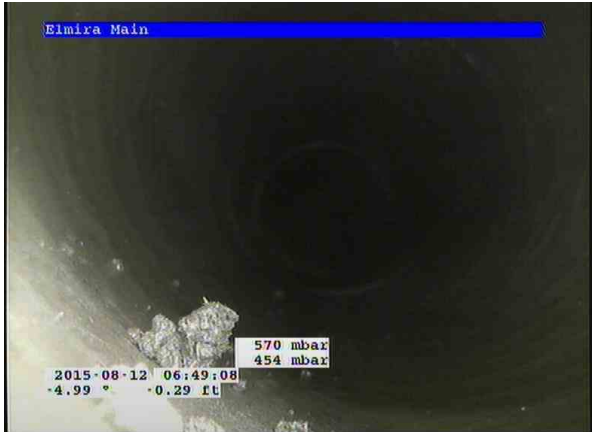
CB8 to  
North\_97eaddb5-a8ee-4576-afc3-a85df4c91e90\_20191227\_0  
94618\_343.jpg, 00:00:00, 0.00ft  
Water Level, 0% of the vertical dimension

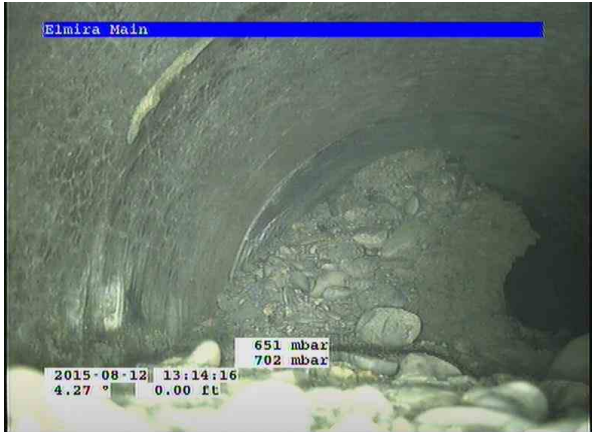
tp7  
cb1\_56d957b5-ba58-48d2-b845-136309cccee3\_20191227\_16  
1128\_719.jpg, 00:00:00, 0.00ft  
Water Level, 5% of the vertical dimension

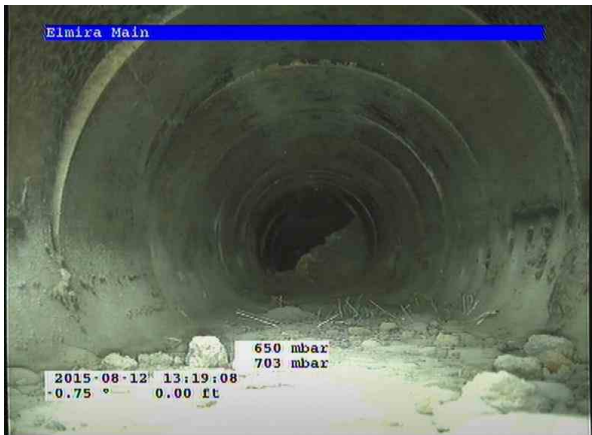
tp7 to  
cb24\_a07c943c-e1e1-4788-af60-040d92f24c70\_20191227\_16  
1620\_470.jpg, 00:00:02, 0.00ft  
Water Level, 0% of the vertical dimension

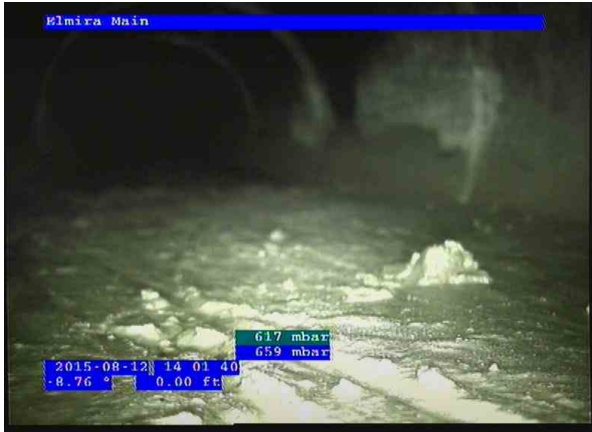
CB1 to  
North\_754a49ee-e302-4f03-8986-7e39a3b71a7d\_20191227\_170751\_718.jpg, 00:00:00, 0.00ft  
Water Level, 0% of the vertical dimension

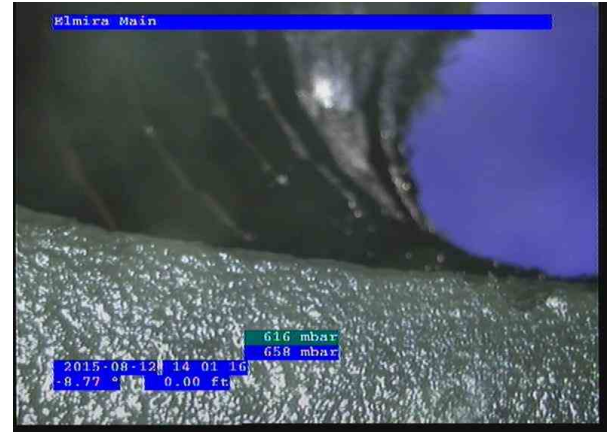
CB1 to  
North\_345adc86-a8bd-4351-ae98-2526a00ef8ff\_20191227\_170727\_418.jpg, 00:10:55, 0.00ft  
Catch Basin / CB1 Start

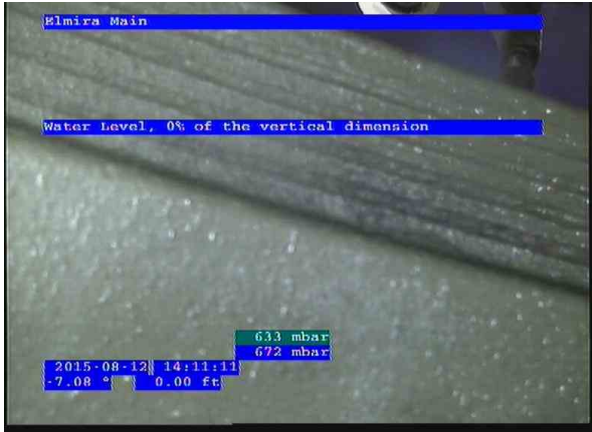
cb1 to  
tp9\_9712d94e-9adf-486d-9be5-b40a8b7d2ddf\_20191227\_171  
723\_142.jpg, 00:00:00, 0.00ft  
Water Level, 0% of the vertical dimension

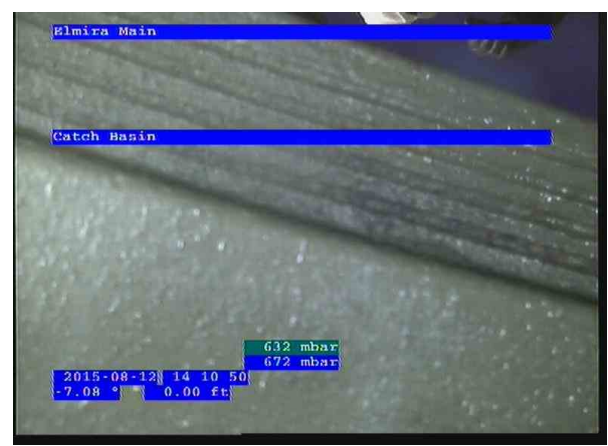
cb1 to  
tp9\_647c9d1f-2173-492c-83b0-9b538801edf7\_20191227\_171  
701\_818.jpg, 00:01:37, 0.00ft  
Catch Basin / CB-01 Start

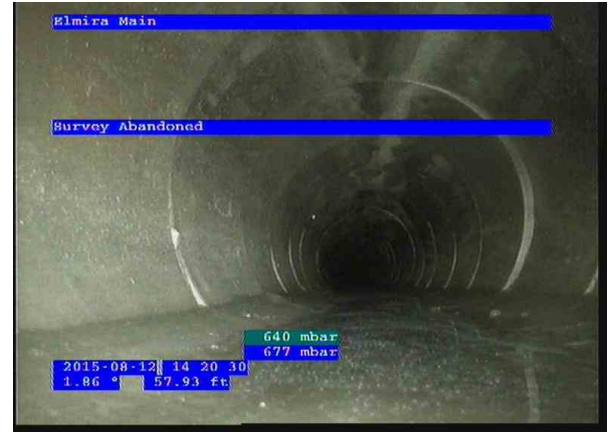
cb1 to  
tp9\_1195476c-1920-4552-8019-c3f8c9076436\_20191227\_17  
2641\_971.jpg, 00:07:53, 57.93ft  
Survey Abandoned / DSF

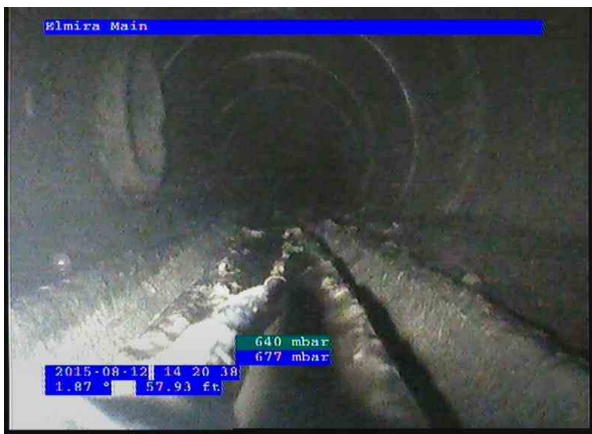
cb1 to  
tp9\_c13cbdee-9df2-43af-9046-c2f05aa83cf0\_20191227\_1726  
49\_644.jpg, 00:07:53, 57.93ft  
Survey Abandoned / DSF

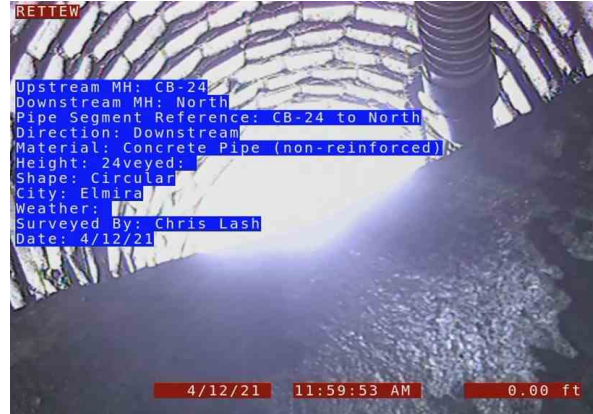
2, 00:00:00, 0.00ft  
Manhole / CB-24

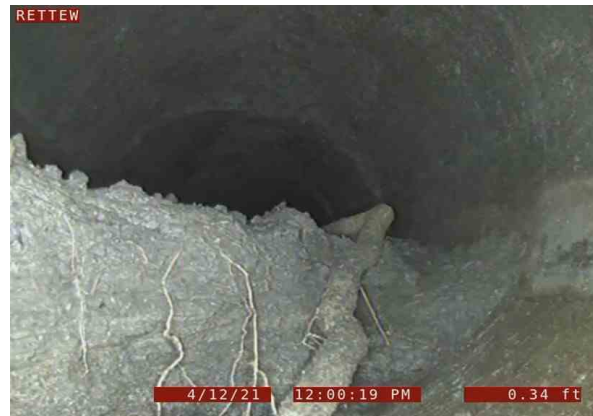
4, 00:00:30, 0.30ft  
Deposits Ingress Gravel, 40% of cross sectional area from 5 o'clock to 9 o'clock

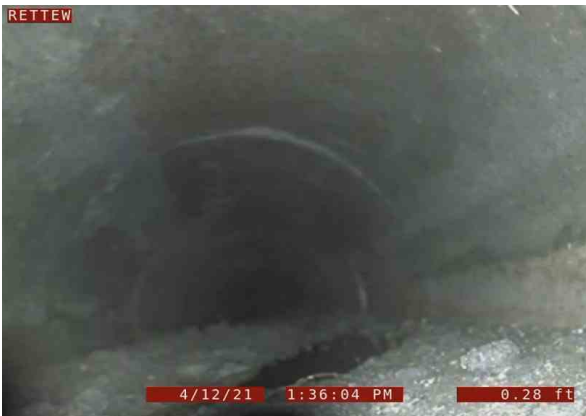
| 1:50 | Distance | Code | Observation | Grade | |
|---|---|---|---|---|---|
| | 0.30 | DNGV | Deposits Ingress Gravel, 50% of cross sectional area from 3 o'clock to 9 o'clock | | M5 |

3, 00:00:35, 0.30ft  
Deposits Ingress Gravel, 50% of cross sectional area from 3 o'clock to 9 o'clock

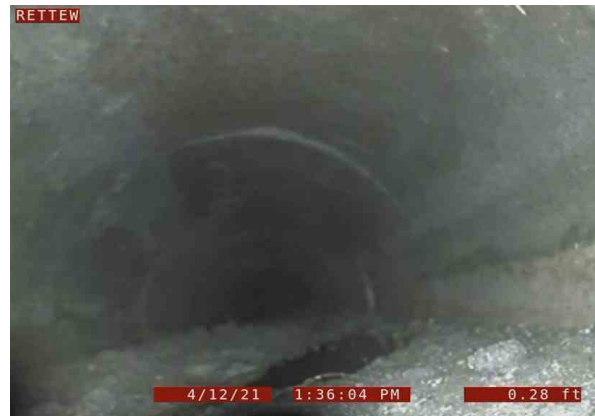
4, 00:00:38, 0.30ft  
Survey Abandoned / DNGZ

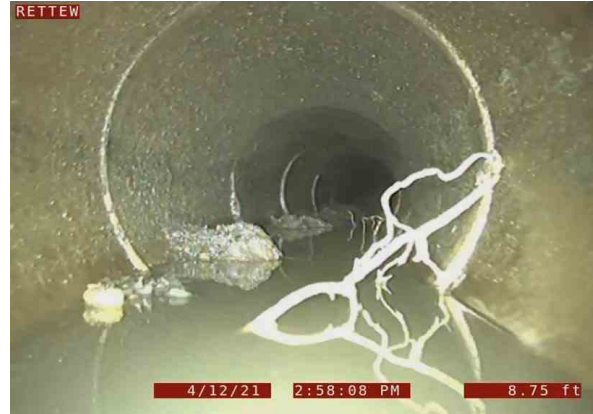
2, 00:00:23, 8.75ft  
Roots Tap Joint at 3 o'clock, 5% of cross sectional area, within 8 inch

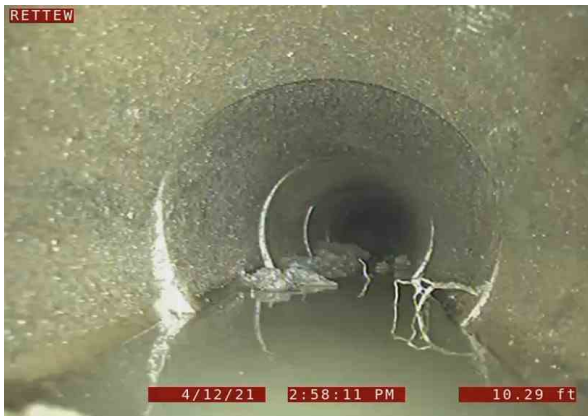
3, 00:00:47, 10.00ft  
Deposits Ingress Fine, 25% of cross sectional area from 6 o'clock to 9 o'clock, Start

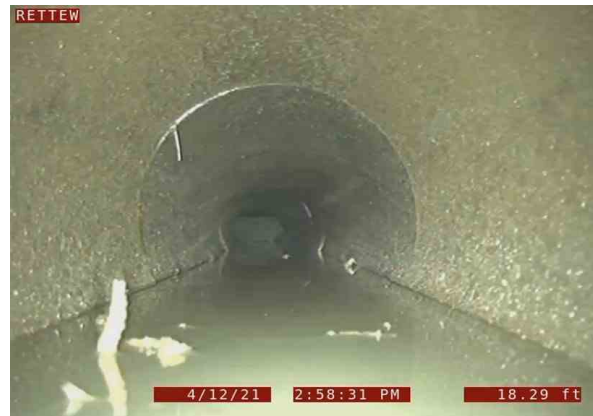
4, 00:00:47, 18.00ft  
Deposits Ingress Fine, 25% of cross sectional area from 6 o'clock to 9 o'clock, Finish

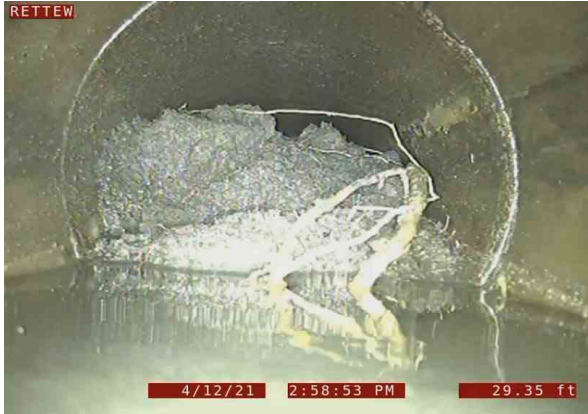
5, 00:01:08, 30.00ft  
 Deposits Ingress Fine, 90% of cross sectional area from 12 o'clock to 12 o'clock

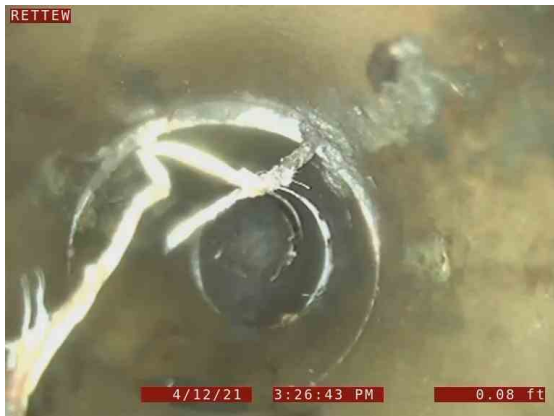
| 1:50 | Distance | Code | Observation | Grade | | | |
|---|---|---|---|---|---|---|---|
| | 0.00 | RTB | Roots Tap Barrell at 12 o'clock, 10% of cross sectional area | M3 | | | |

3, 00:00:18, 0.00ft  
Roots Tap Barrell at 12 o'clock, 10% of cross sectional area

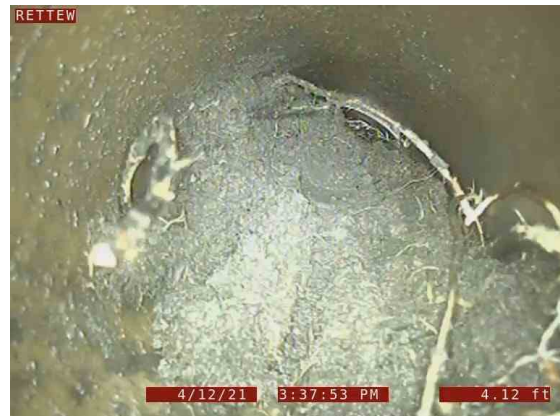
4, 00:03:32, 4.12ft  
Deposits Ingress Fine, 100% of cross sectional area from 12 o'clock to 12 o'clock

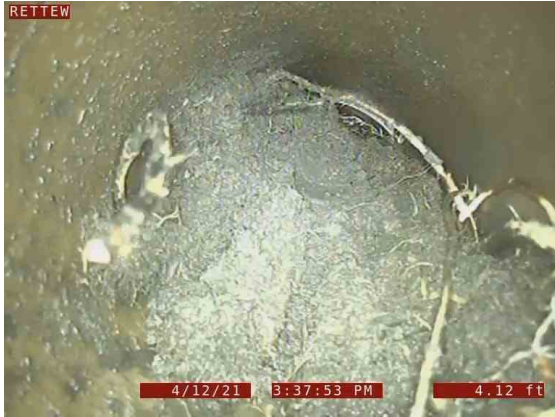
5, 00:03:32, 4.12ft  
Roots Medium Barrell from 12 o'clock to 12 o'clock, 20% lost

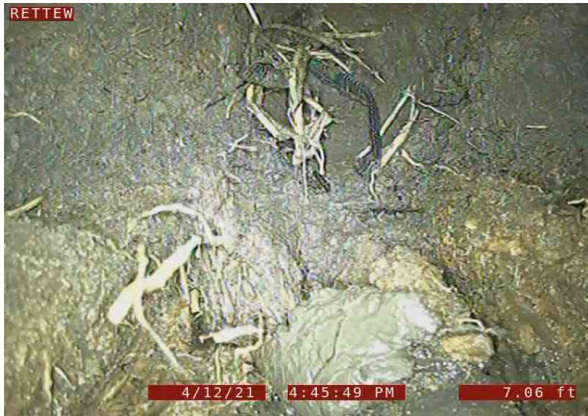
3, 00:00:34, 7.00ft  
Obstacles Other, 100% of cross sectional area from 12 o'clock to 12 o'clock / Soil and Roots

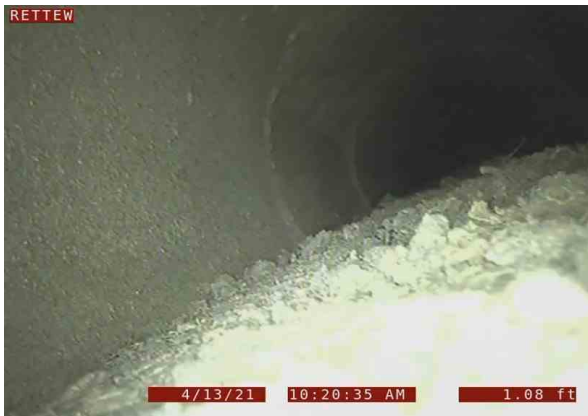
3, 00:00:18, 1.00ft  
Deposits Settled Fine, 50% of cross sectional area from 3 o'clock to 9 o'clock, within 8 inch, Start

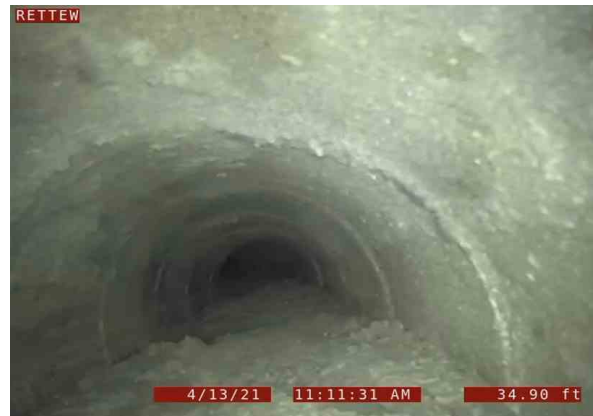
4, 00:00:18, 34.00ft  
Deposits Settled Fine, 50% of cross sectional area from 3 o'clock to 9 o'clock, within 8 inch, Finish

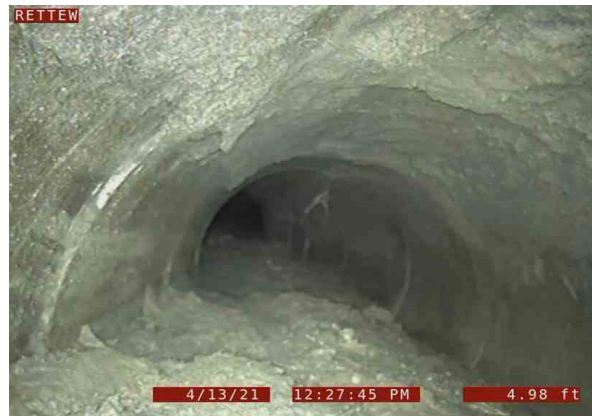
4, 00:12:58, 4.98ft  
Deposits Settled Fine, 50% of cross sectional area from 3 o'clock to 9 o'clock, Finish

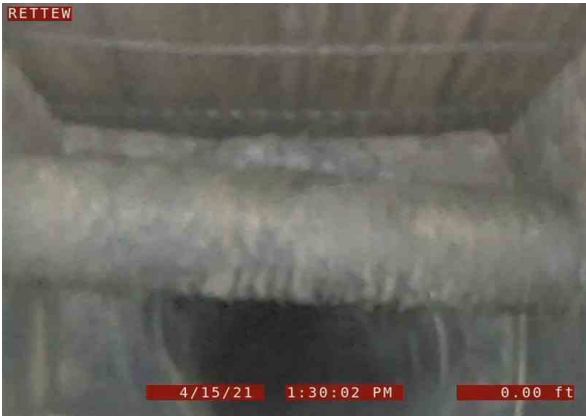
3, 00:00:00, 0.00ft  
General Observation / Cross Bore in Manhole Chamber

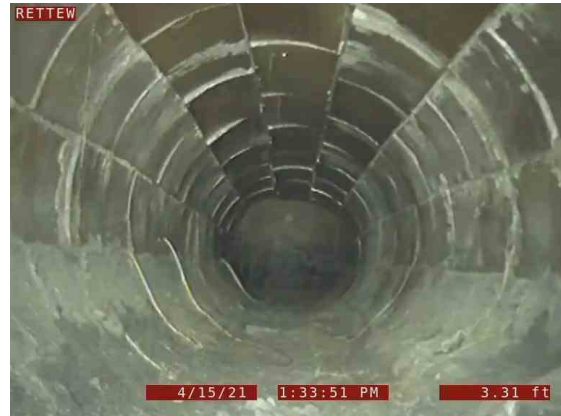
4, 00:01:31, 0.00ft  
Roots Medium Barrell from 4 o'clock to 10 o'clock, 5% lost, Start

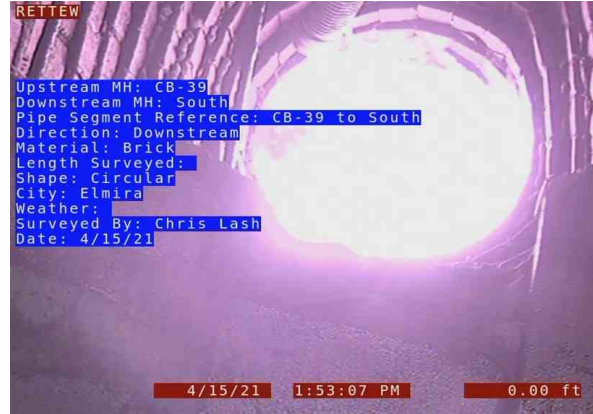
2, 00:00:00, 0.00ft  
Manhole / CB-39

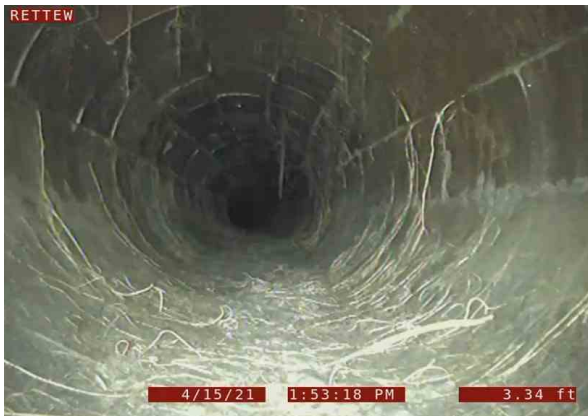
3, 00:00:13, 0.00ft  
Roots Medium Barrell from 3 o'clock to 9 o'clock, 5% lost, Start

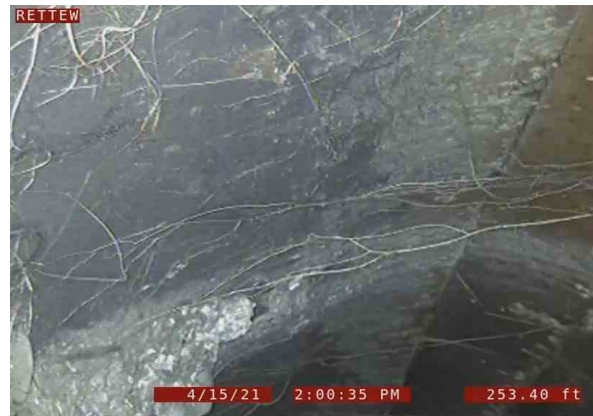
4, 00:07:21, 253.00ft  
Hole at 10 o'clock

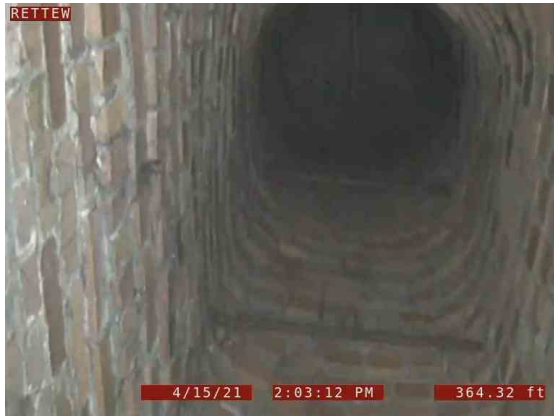
7, 00:00:13, 364.00ft  
General Observation / MH-40 (Buried)

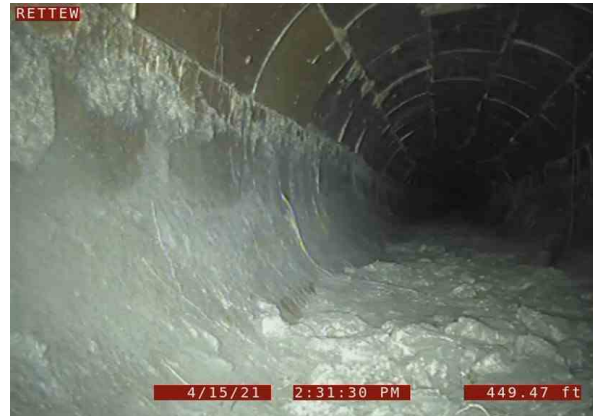
8, 00:01:06, 449.47ft  
Survey Abandoned / DSF

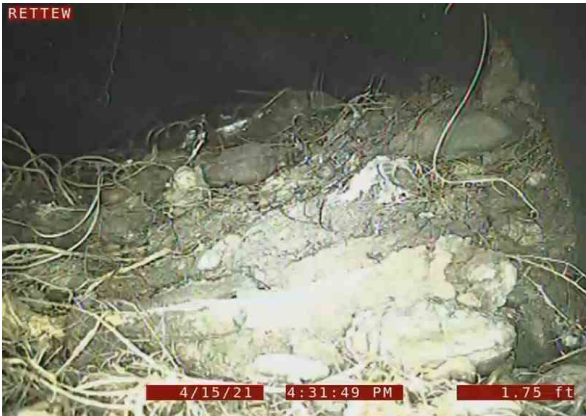
3, 00:00:26, 1.81ft  
Deposits Ingress Gravel, 80% of cross sectional area from 12 o'clock to 12 o'clock

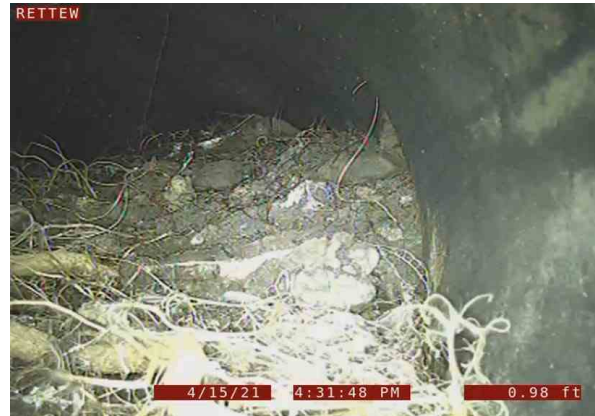
4, 00:00:11, 1.82ft  
Survey Abandoned / DNGV

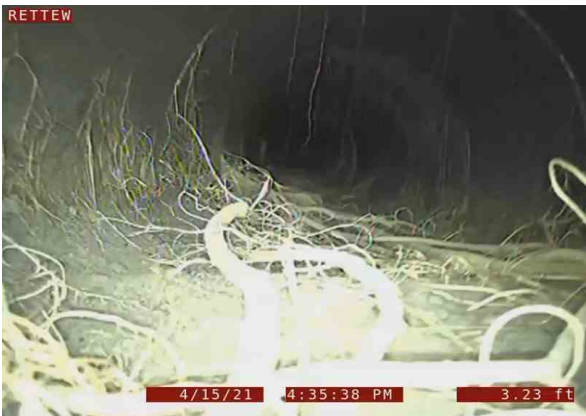
3, 00:00:21, 0.00ft  
Roots Tap Barrell from 4 o'clock to 8 o'clock, 15% of cross sectional area, Start

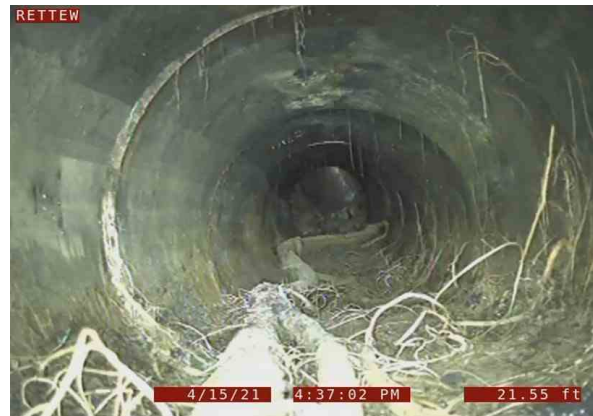
4, 00:01:44, 21.00ft  
Roots Tap Barrell from 4 o'clock to 8 o'clock, 15% of cross sectional area, Finish

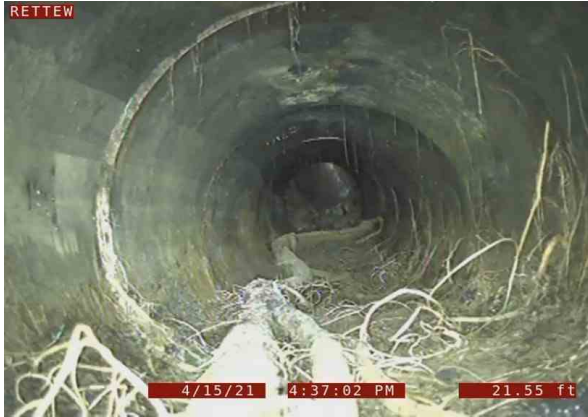
5, 00:01:44, 21.50ft  
Obstacles Other, 15% of cross sectional area from 4 o'clock to 8 o'clock / RTB

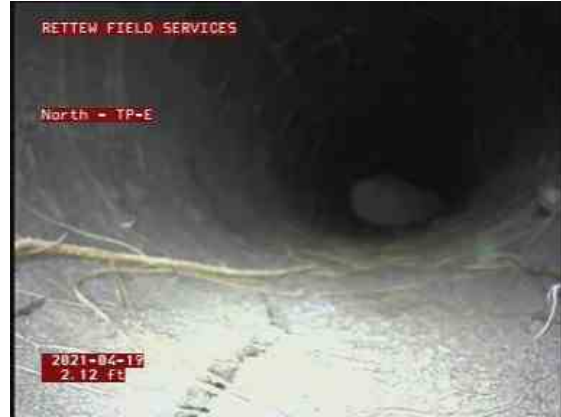
2, 00:00:00, 0.00ft  
Special Chamber / TP-E

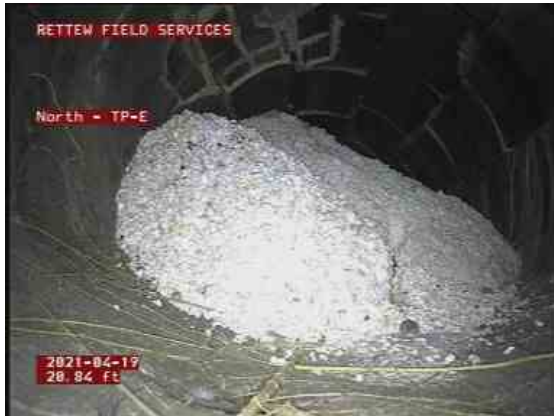
| 1:263 | Distance | Code | Observation | Grade | | | |
|---|---|---|---|---|---|---|---|
| | 21.00 | DSF | Deposits Settled Fine, 50% of cross sectional area from 3 o'clock to 9 o'clock / Grout, Bentonite Clay | M5 | | | |

3, 00:00:55, 21.00ft  
Deposits Settled Fine, 50% of cross sectional area from 3 o'clock to 9 o'clock / Grout, Bentonite Clay

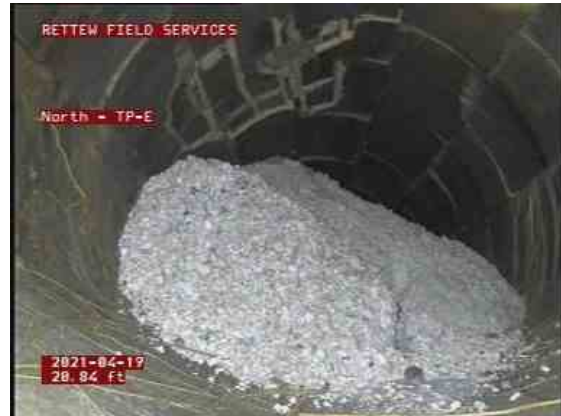
4, 00:00:55, 21.00ft  
Survey Abandoned / DSF

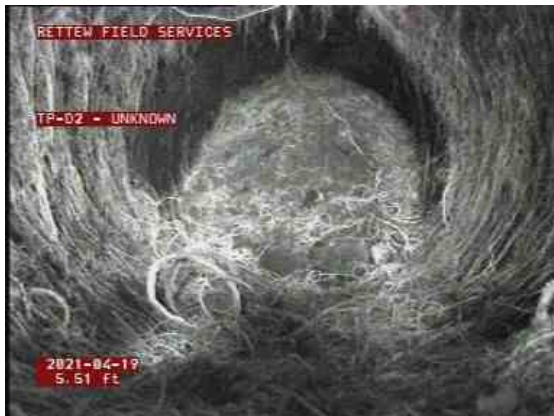
3, 00:00:12, 5.50ft  
Obstacles Other, 100% of cross sectional area from 12 o'clock to 12 o'clock / RBB

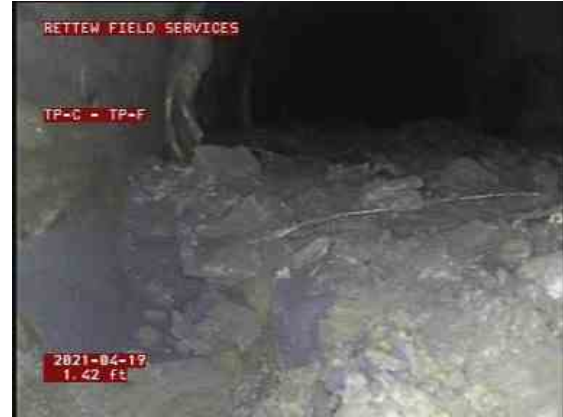
2, 00:00:22, 0.00ft  
Deposits Settled Fine, 30% of cross sectional area from 3 o'clock to 9 o'clock, Start

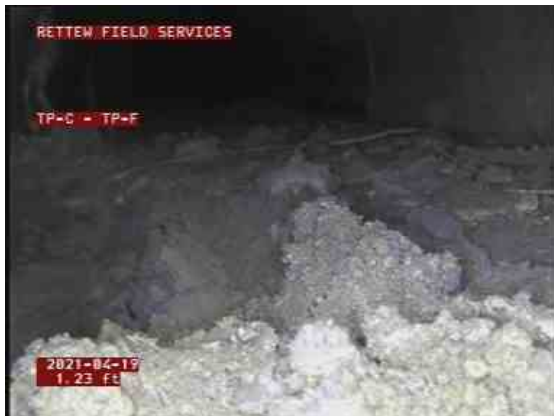
3, 00:00:22, 5.00ft  
Roots Tap Joint at 9 o'clock, 25% of cross sectional area, within 8 inch

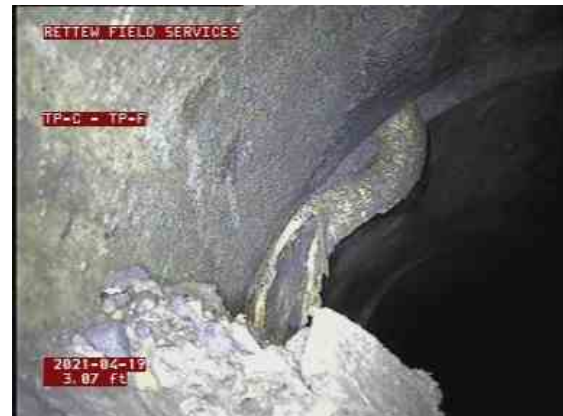
4, 00:00:22, 5.00ft  
Roots Tap Joint at 9 o'clock, 25% of cross sectional area, within 8 inch

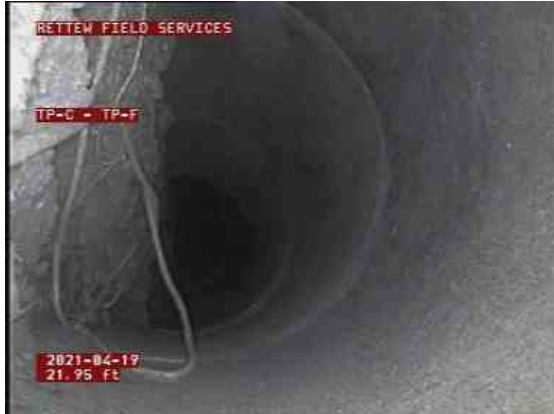
5, 00:05:15, 21.00ft  
Deposits Settled Fine, 30% of cross sectional area from 3 o'clock to 9 o'clock, Finish

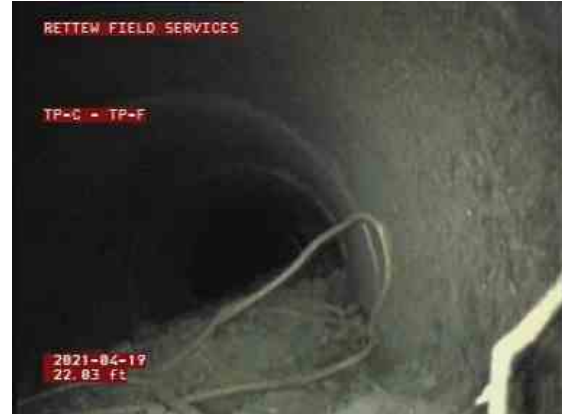
6, 00:05:15, 21.00ft  
Obstacles Other, 30% of cross sectional area from 4 o'clock to 8 o'clock / DSF

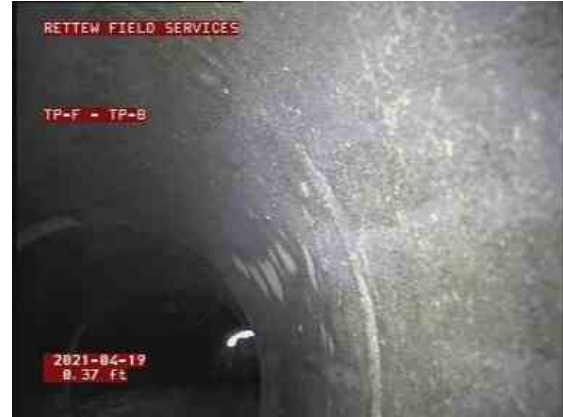
2, 00:00:31, 0.50ft  
Deposits Settled Fine, 40% of cross sectional area from 4 o'clock to 8 o'clock

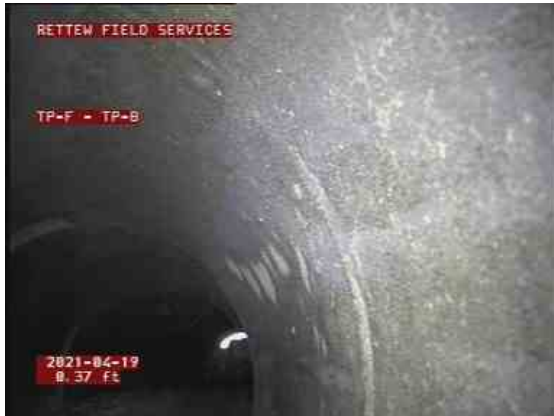
3, 00:00:31, 0.50ft  
Survey Abandoned / DSF

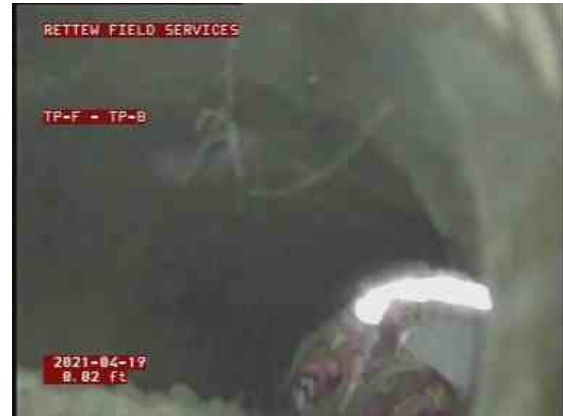
4, 00:00:31, 0.50ft  
Survey Abandoned / DSF
