**Appendix I**  
**STORM WATER SEWER VIDEO SURVEY RESULTS**

## Inspection Report / Inspection: 1

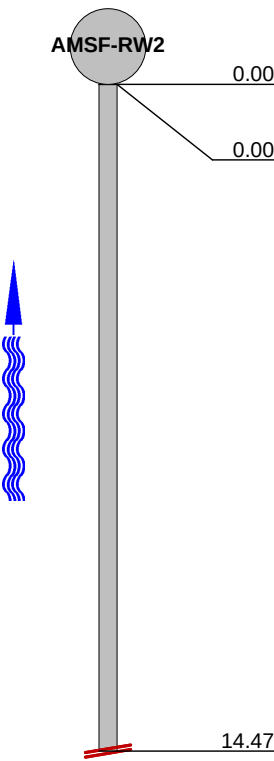
| 1:50 | Position | Code | Observation | Photo | Grade | | |
|---|---|---|---|---|---|---|---|
| | AMSF-RW2 | MWL | Water Level, 5 %of cross sectional area | | | | |
| | | AMH | Downstream Manhole, Survey Begins / AMSF-RW2 to Loading Dock CB | | | | |
| | | MSA | Survey Abandoned / Cannot proceed through bend. | | | | |

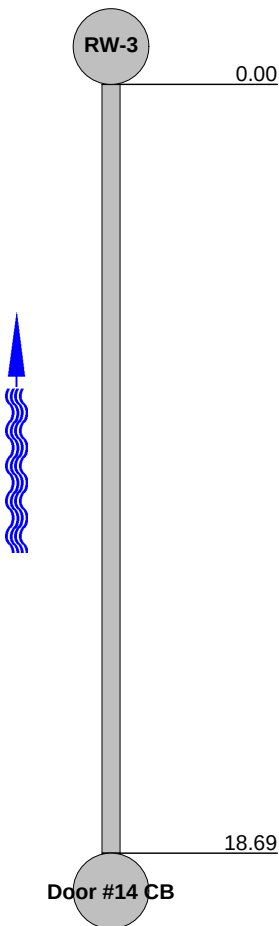
| 1:56 | Position | Code | Observation | Photo | Grade | | |
|---|---|---|---|---|---|---|---|
| | | AMH | Downstream Manhole, Survey Begins / RW-3 to Door #14 CB | | | | |
| | | AMH | Upstream Manhole, Survey Ends / Door # 14 Catch Basin | | | | |

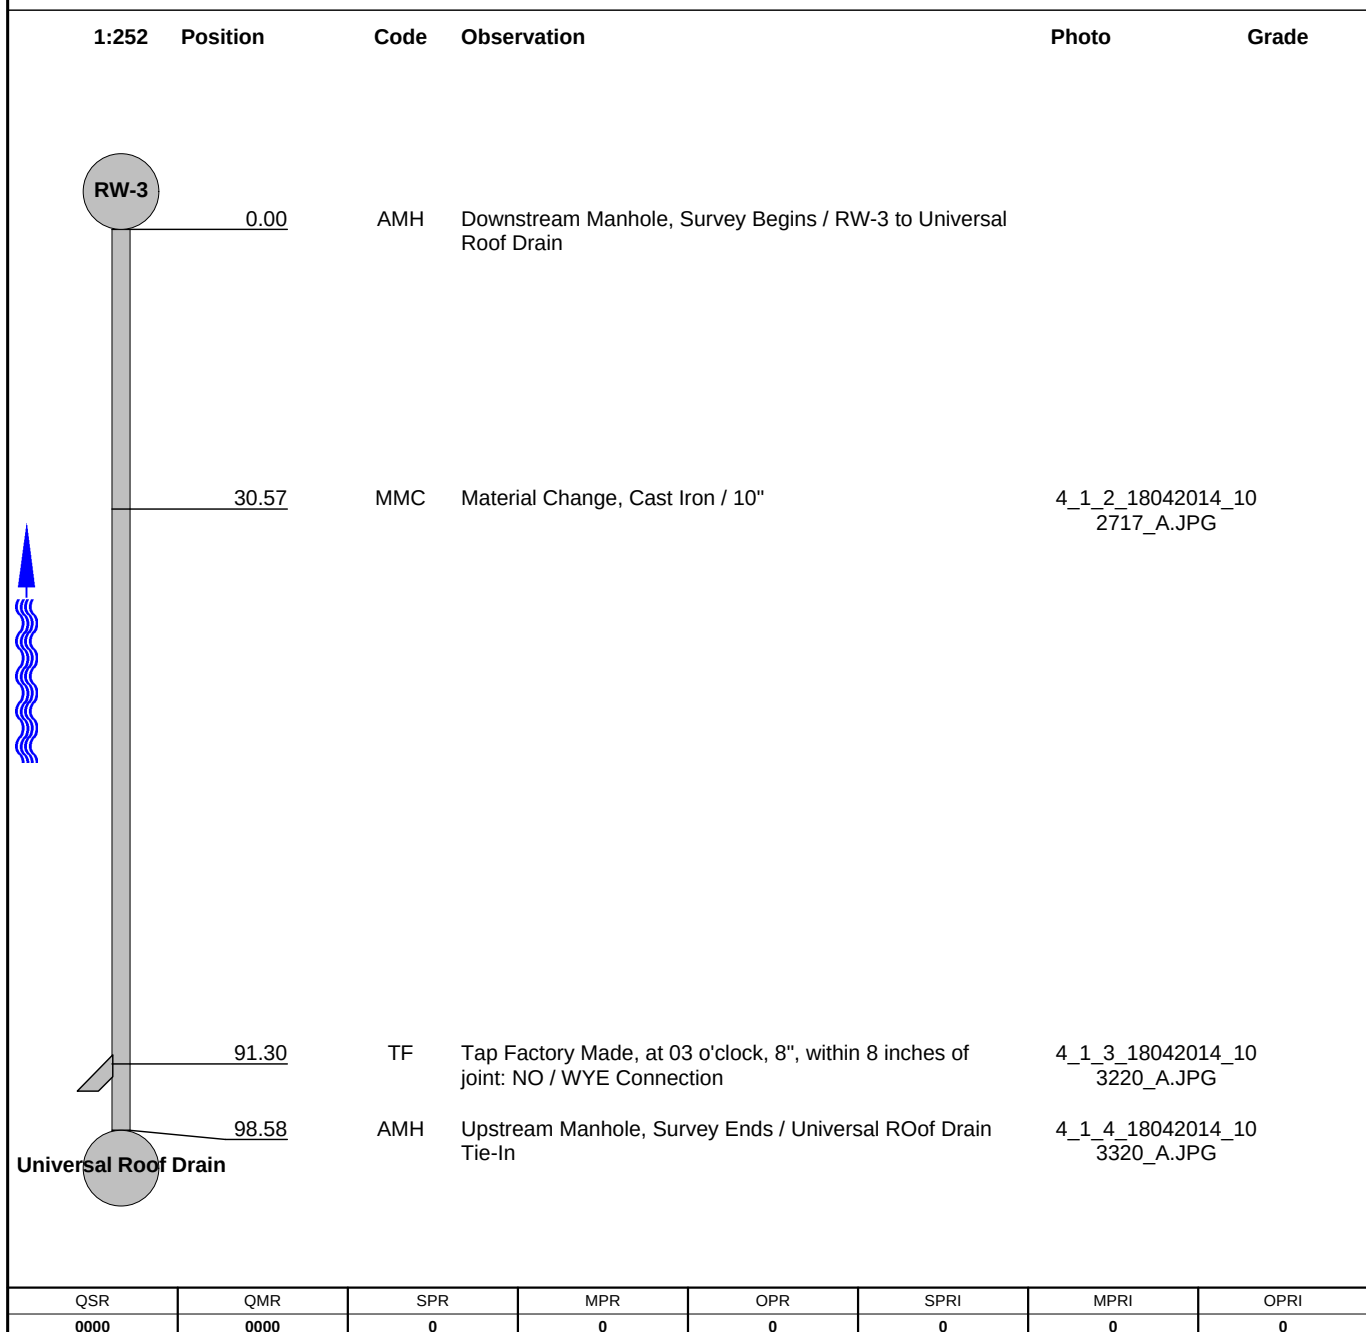
| 1:252 | Position | Code | Observation | Photo | Grade | | |
|---|---|---|---|---|---|---|---|
| | 0.00 | AMH | Downstream Manhole, Survey Begins / RW-3 to Universal Roof Drain | | | | |
| | 30.57 | MMC | Material Change, Cast Iron / 10" | 4_1_2_18042014_10<br>2717_A.JPG | | | |
| | 91.30 | TF | Tap Factory Made, at 03 o'clock, 8", within 8 inches of joint: NO / WYE Connection | 4_1_3_18042014_10<br>3220_A.JPG | | | |

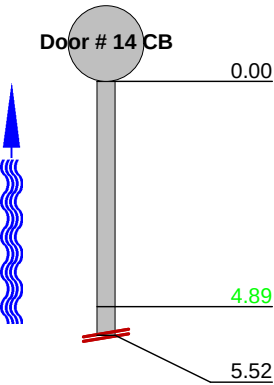
| 1:50 | Position | Code | Observation | Photo | Grade | | |
|---|---|---|---|---|---|---|---|
| | 0.00 | AMH | Downstream Manhole, Survey Begins / Door # 14 CB to unknown NE | | | | |
| | 4.89 | JAM | Joint Angular Medium / 45 Degree Bend | 6_1_2_18042014_11_2244_A.JPG | S 1 | | |
