Appendix J
PROJECT PHOTOGRAPHS

Appendix J
Remedial Investigation Report
Former Alliance Metal Stamping and Fabrication Facility

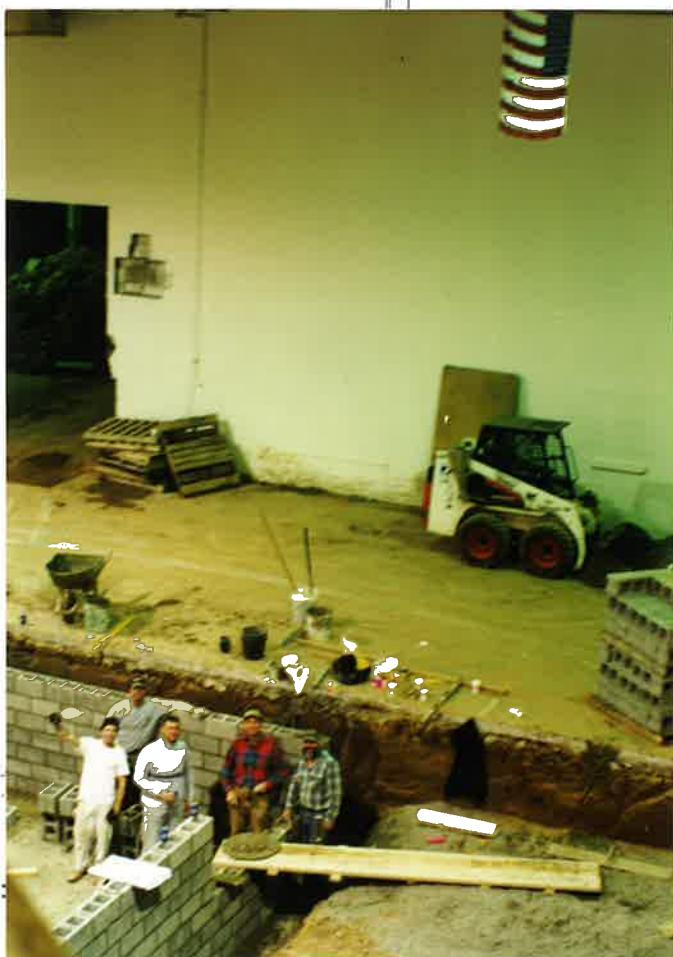
Photo #2

**PHOTOGRAPHS OF THE CONSTRUCTION OF THE TUMBLING RUN AND
GYM PITS IN THE BRIGHT RAVEN GYMNASTICS STUDIO SPACE IN OU-1**
