Periodic Review Report: November 2016 to October 2017 NYSDEC Site #C828115

Rochester Drug Cooperative Building
320 North Goodman Street
Rochester, New York

LaBella Project No. 211352

November 9, 2017

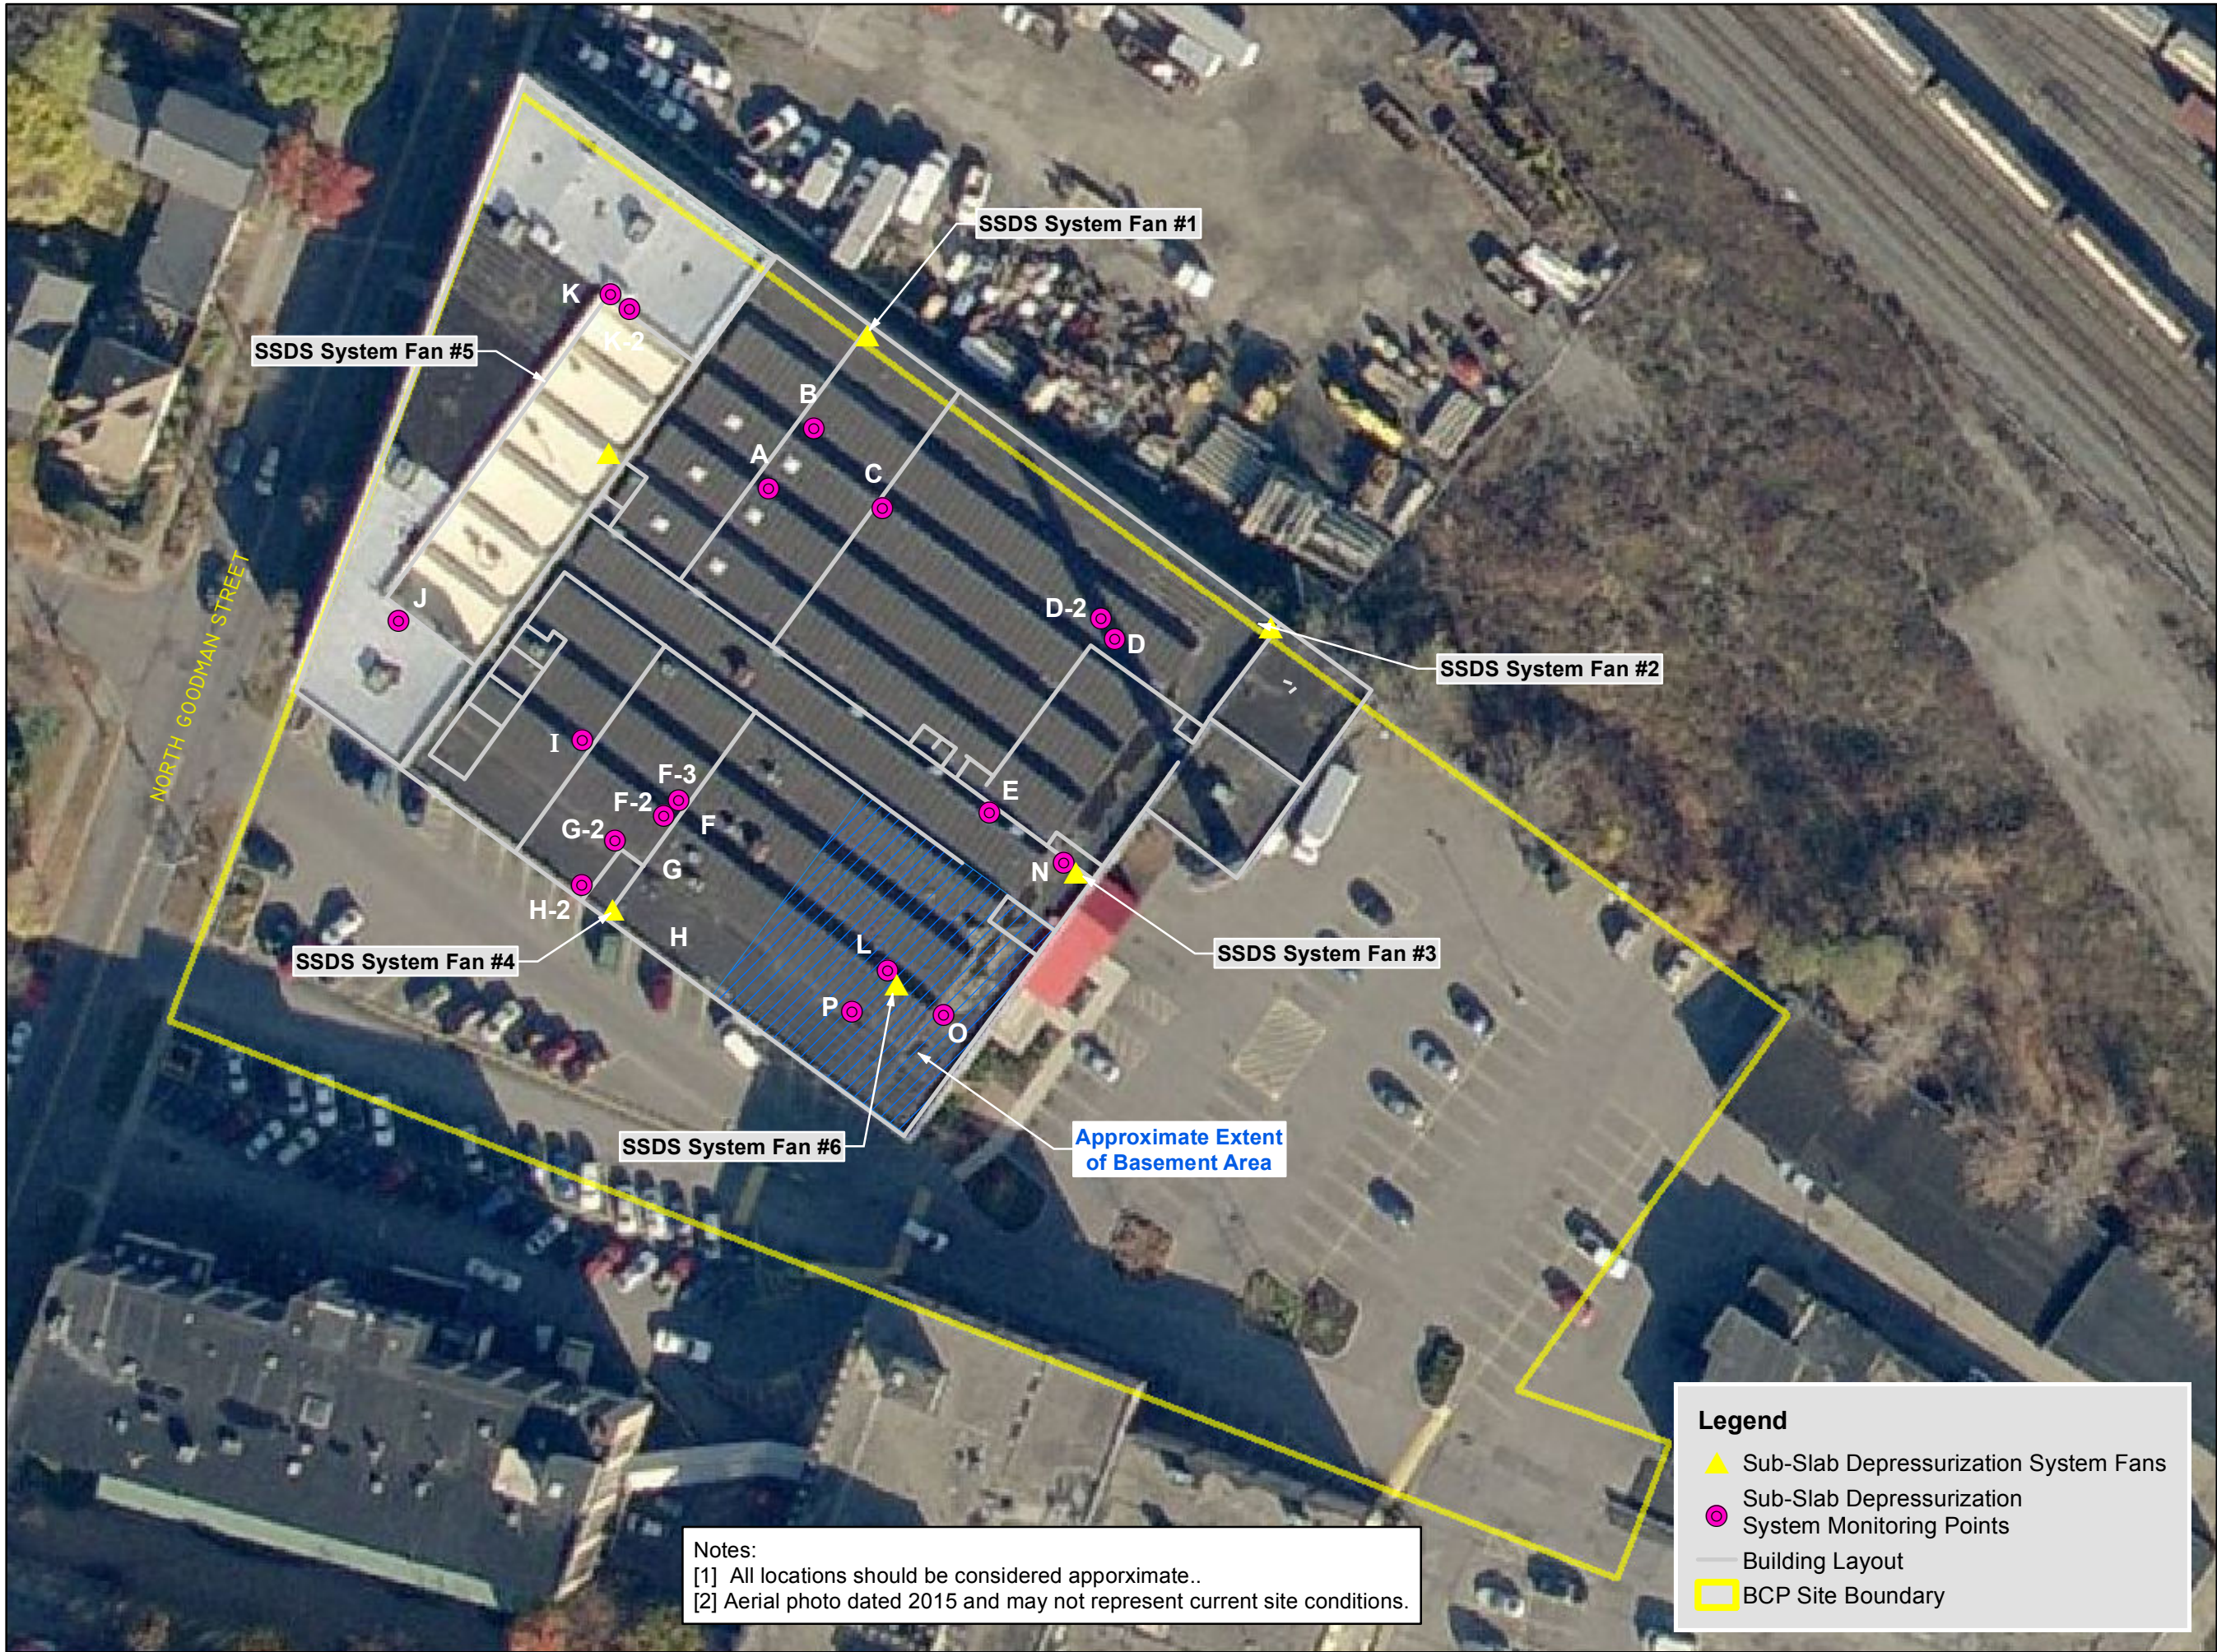
[FIGURE 3]

The sub-slab depressurization system was inspected on October 12, 2017 in order to verify proper operation of the system. There are six fans that operate the SSDS at the locations shown on Figure 3. At each fan location, the following inspections were made:
