# Periodic Review Report

Canandaigua Multi-Brownfield Site  
Lakeshore Drive and Booth Street,  
Canandaigua, New York 14424  
NYSDEC Site No. C835025

LaBella Project No. 2181278

February 11, 2022

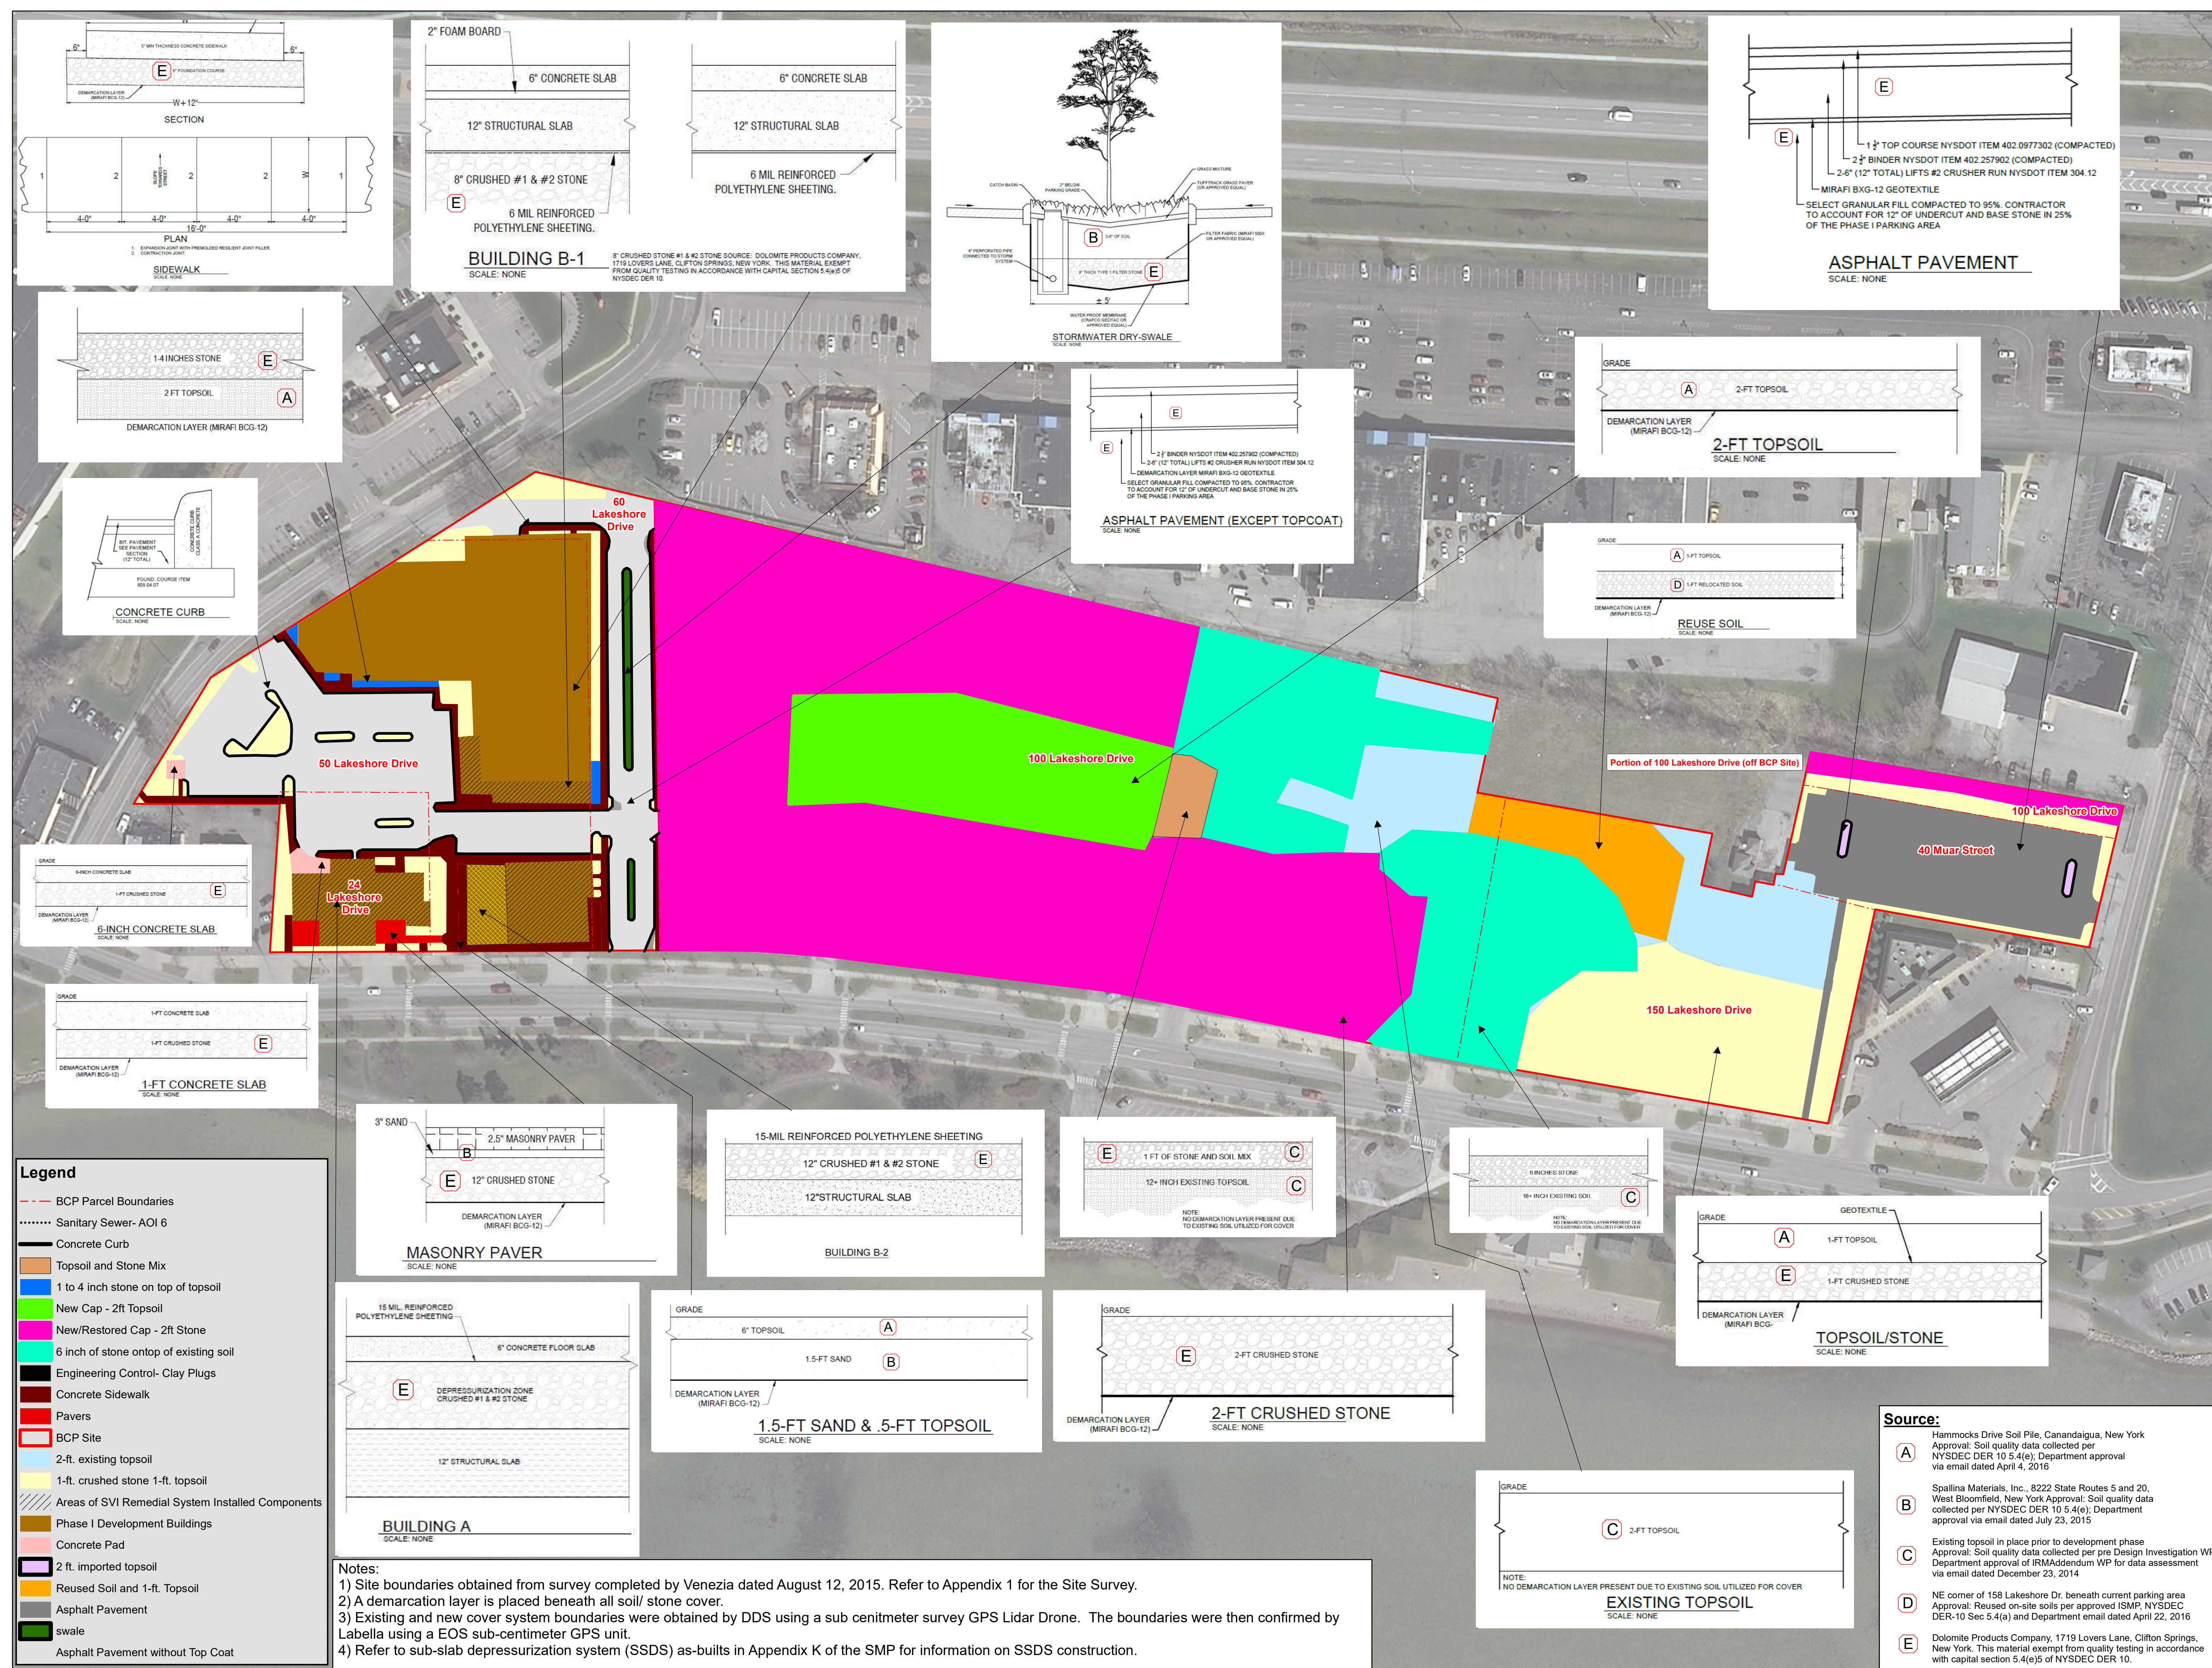
**FIGURE 2**

Exposure to remaining contamination at the site is prevented by a cover system placed over the site. This cover system is comprised of a minimum of 24 inches of clean soil, stone, asphalt pavement, concrete-covered sidewalks, concrete building slabs and stone pavers. Figure 2 presents the location of the final cover system and applicable demarcation layers. A demarcation layer was placed beneath all placed soil/ stone cover (i.e., portions of the Site with existing Site cover do not have a demarcation layer). It is noted the Site cover system was altered temporarily during the construction work within the limits of the Phase II construction area; however, the cover was restored in August and September 2020 and the restored cover areas are illustrated on Figure 2. Details on the cover

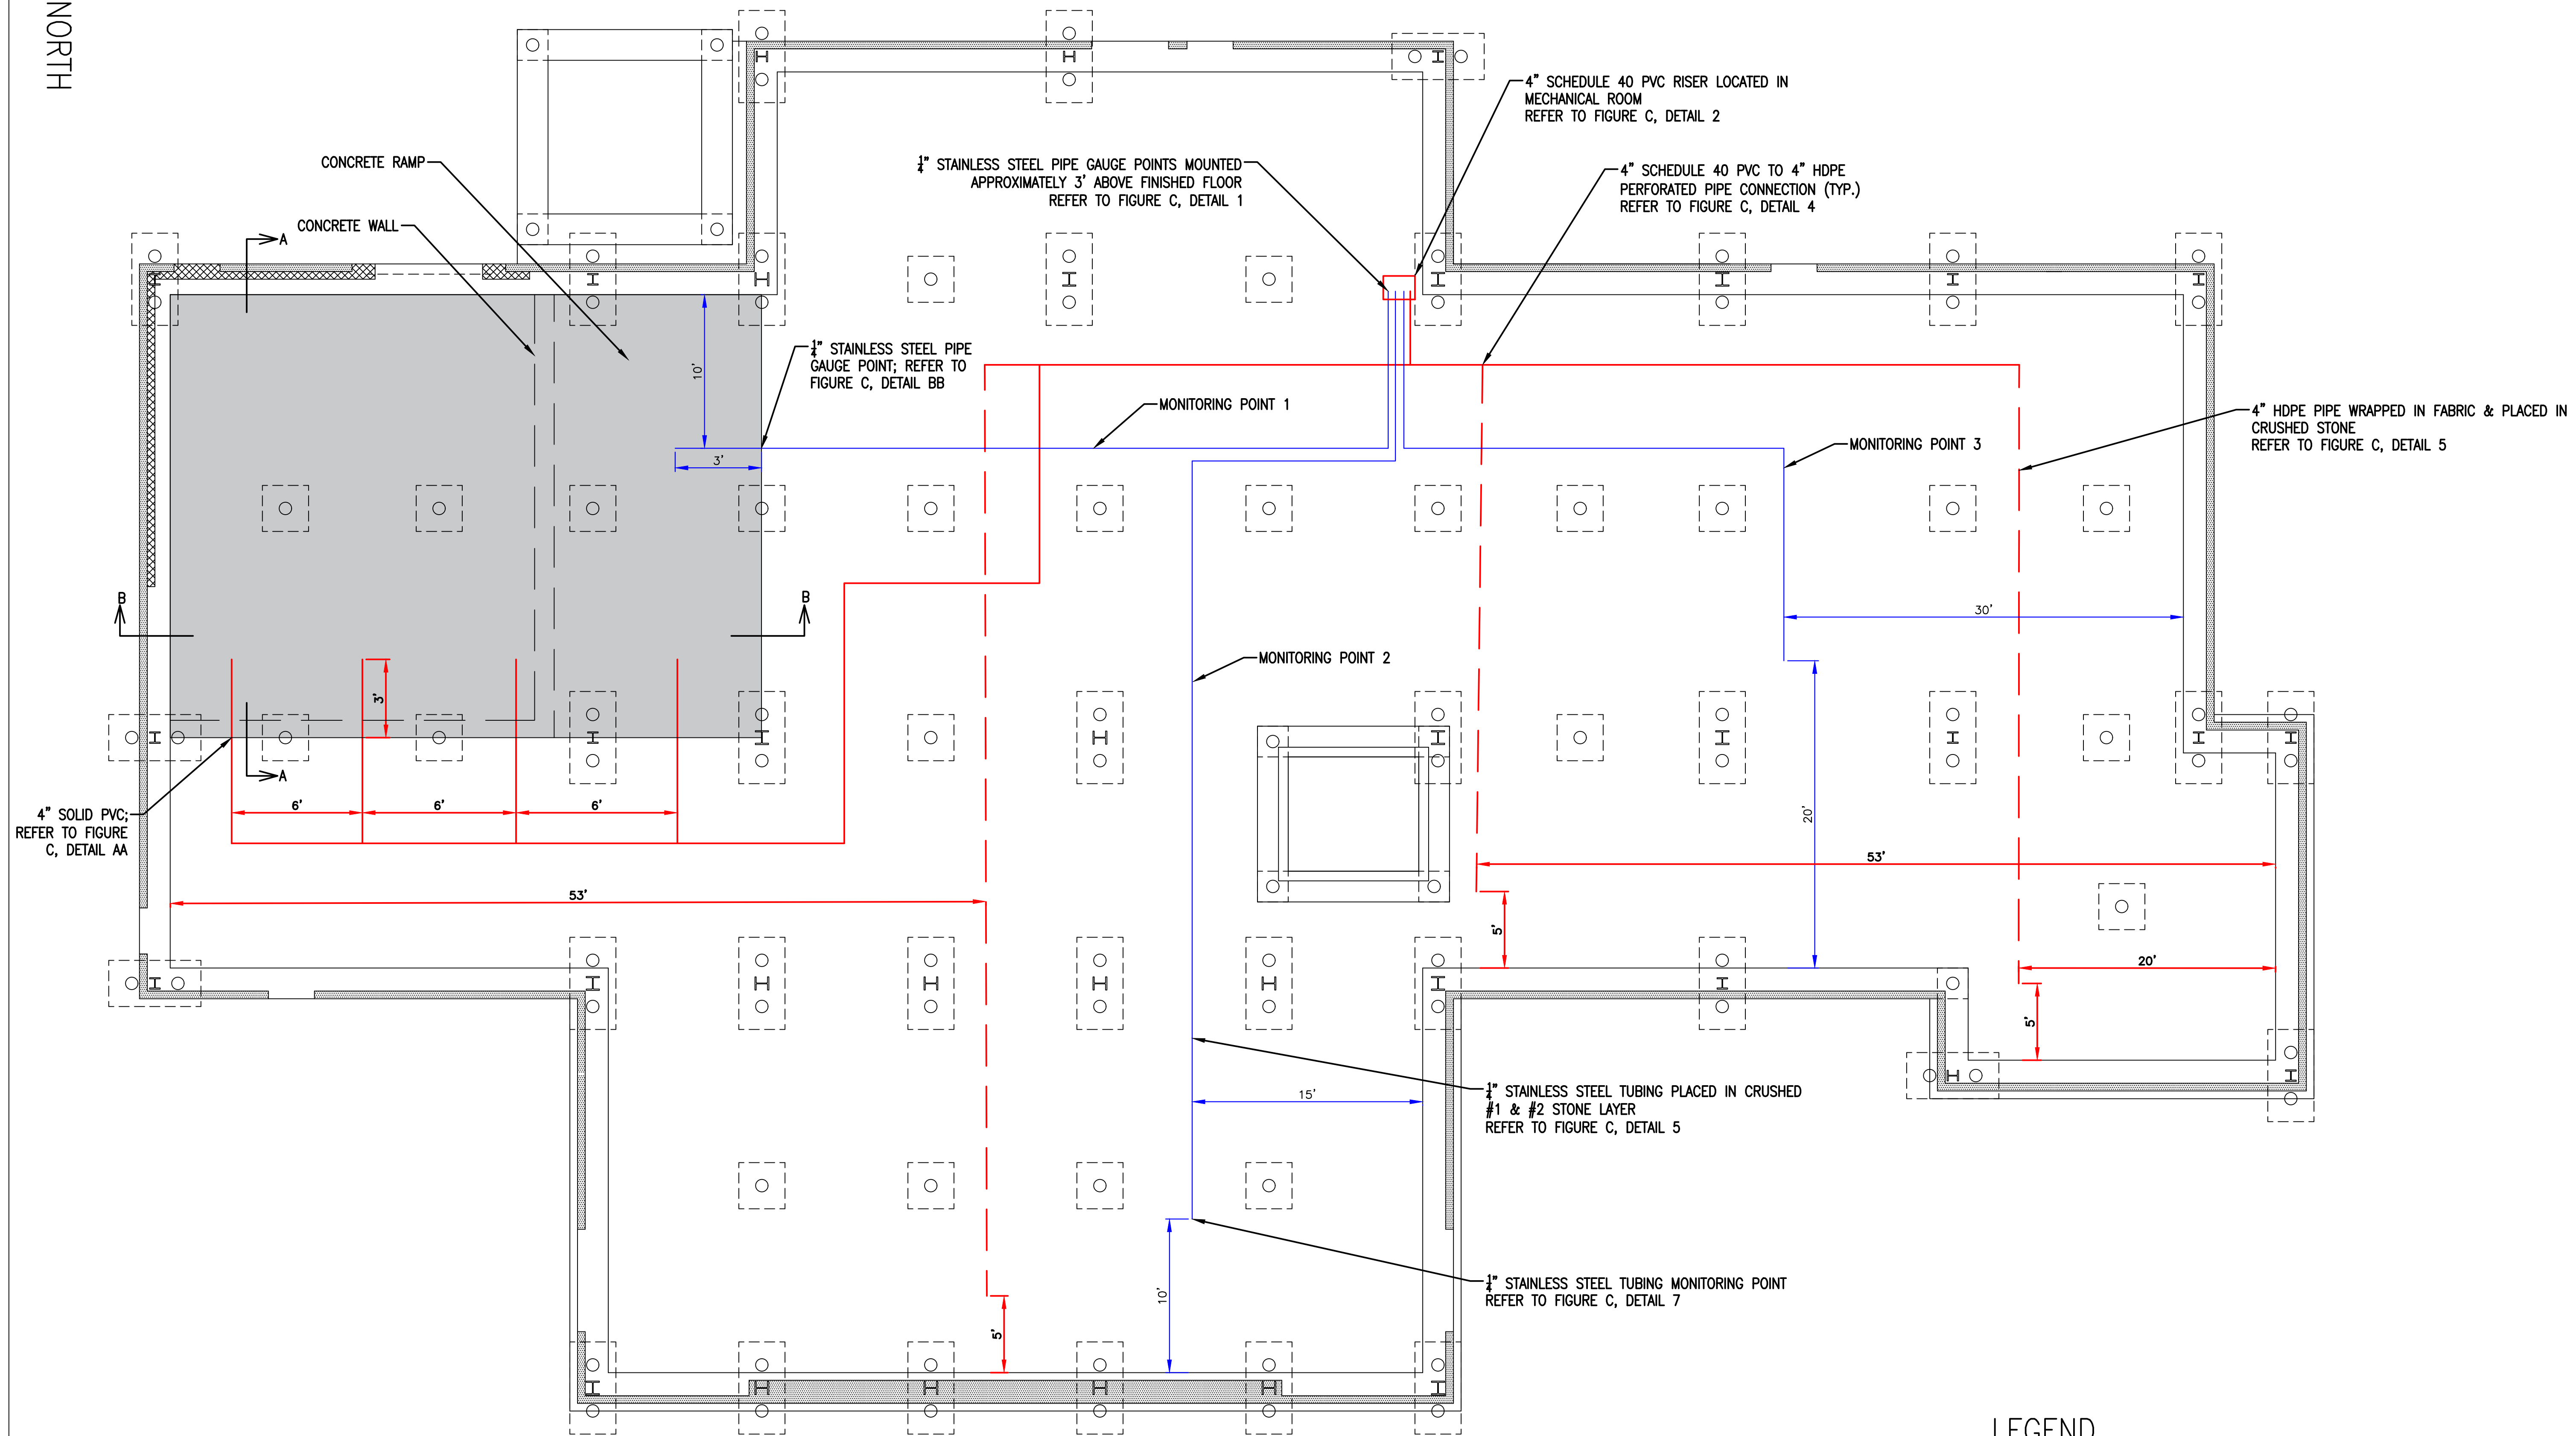
PROJECT/DRAWING NUMBER  
**2181278**  
**FIGURE A**

- Building A:
  - The system was functioning normal, including adequate pressure field extension (PFE) readings on monitoring points and the alarm appeared operational. However, when vacuum was taken away from the alarm the light turned red but did not sound off. The alarm therefore did not meet the requirements and needed to be replaced.

- Building A:
  - The SSDS alarm was removed and replaced with a new fully operational alarm. The rest of the system was functioning normal (including adequate PFE readings on monitoring points).
