# Periodic Review Report

**Reporting Period: June 1, 2023  
to June 1, 2026**

Scott Rotary Seals  
BCP Site No. C905036  
Olean, New York

June 2026

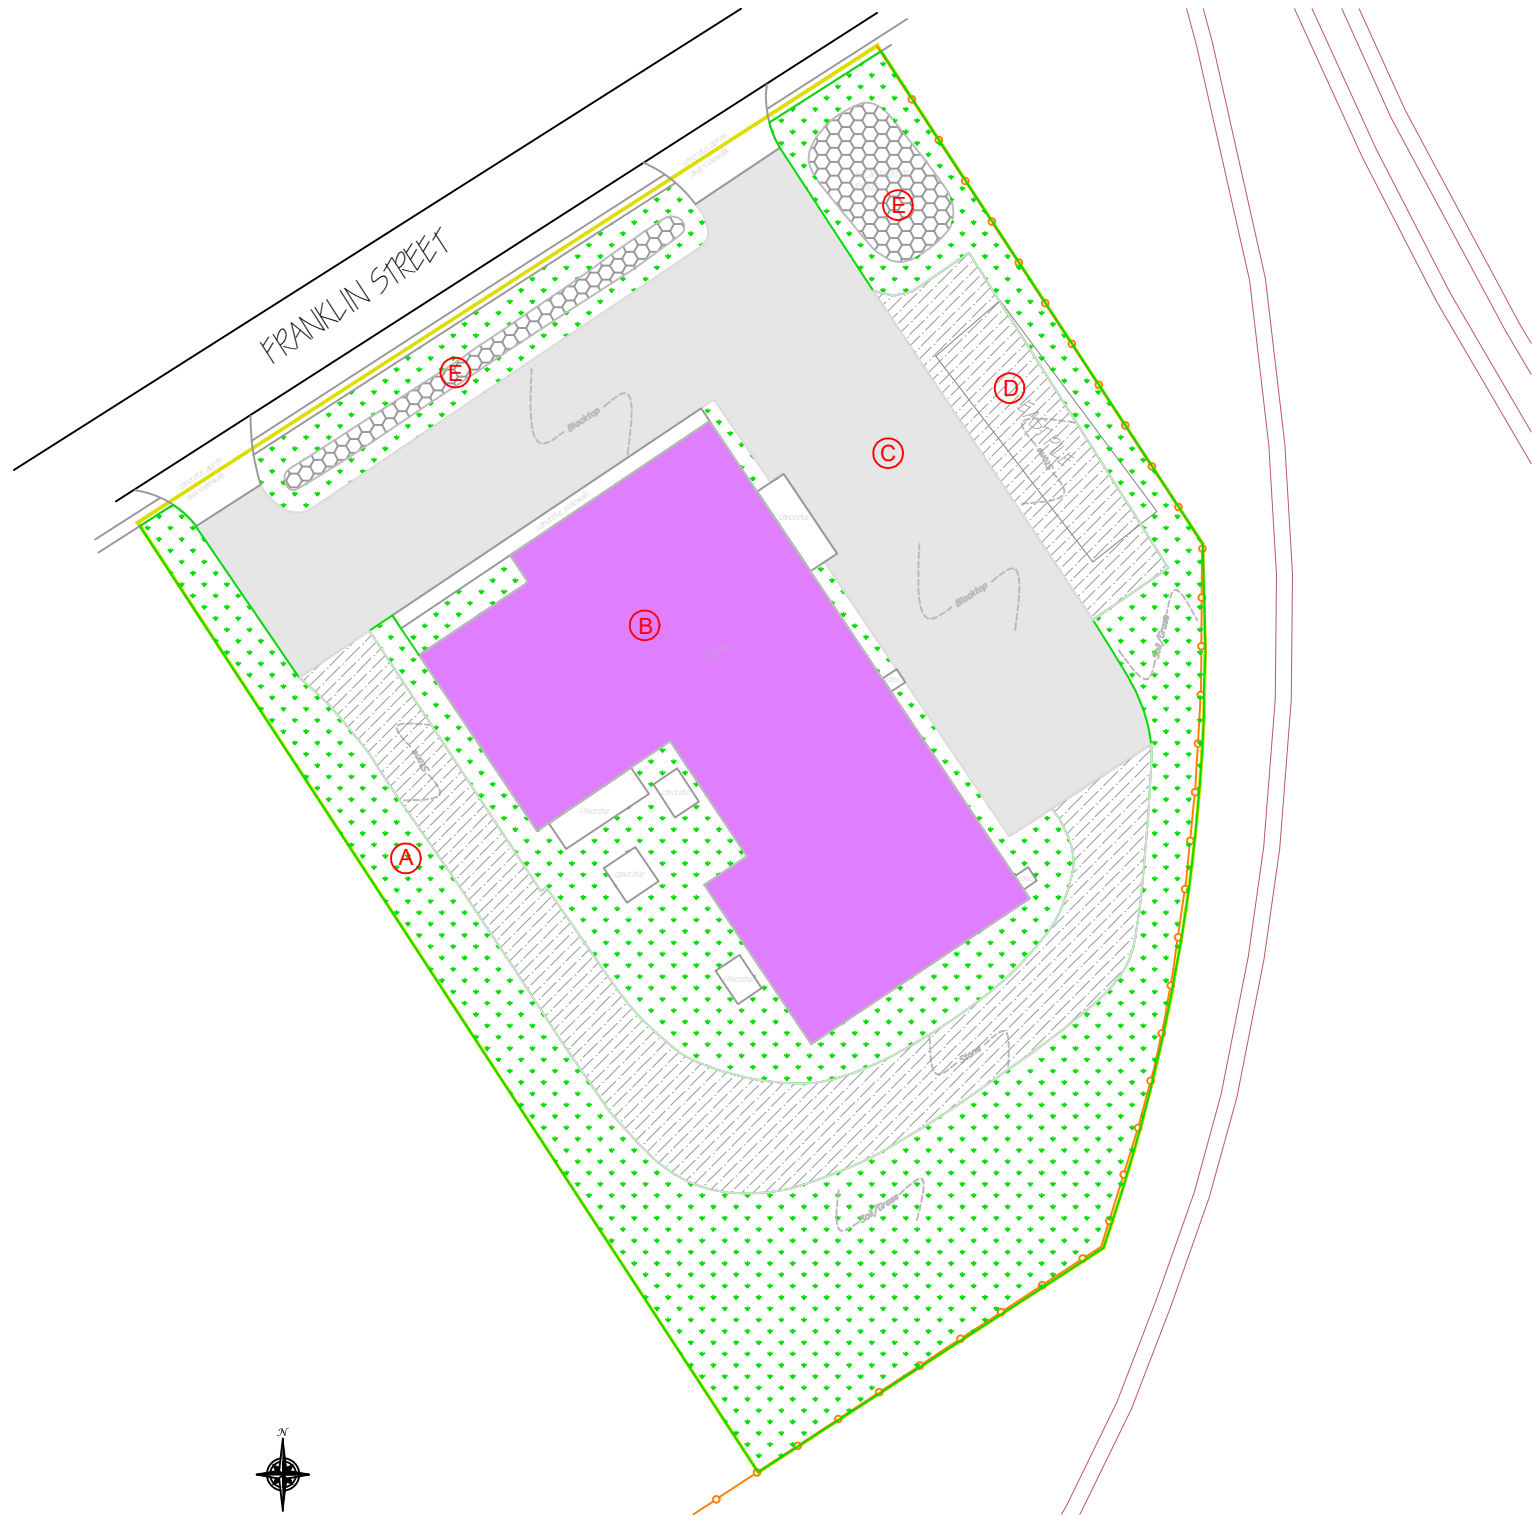
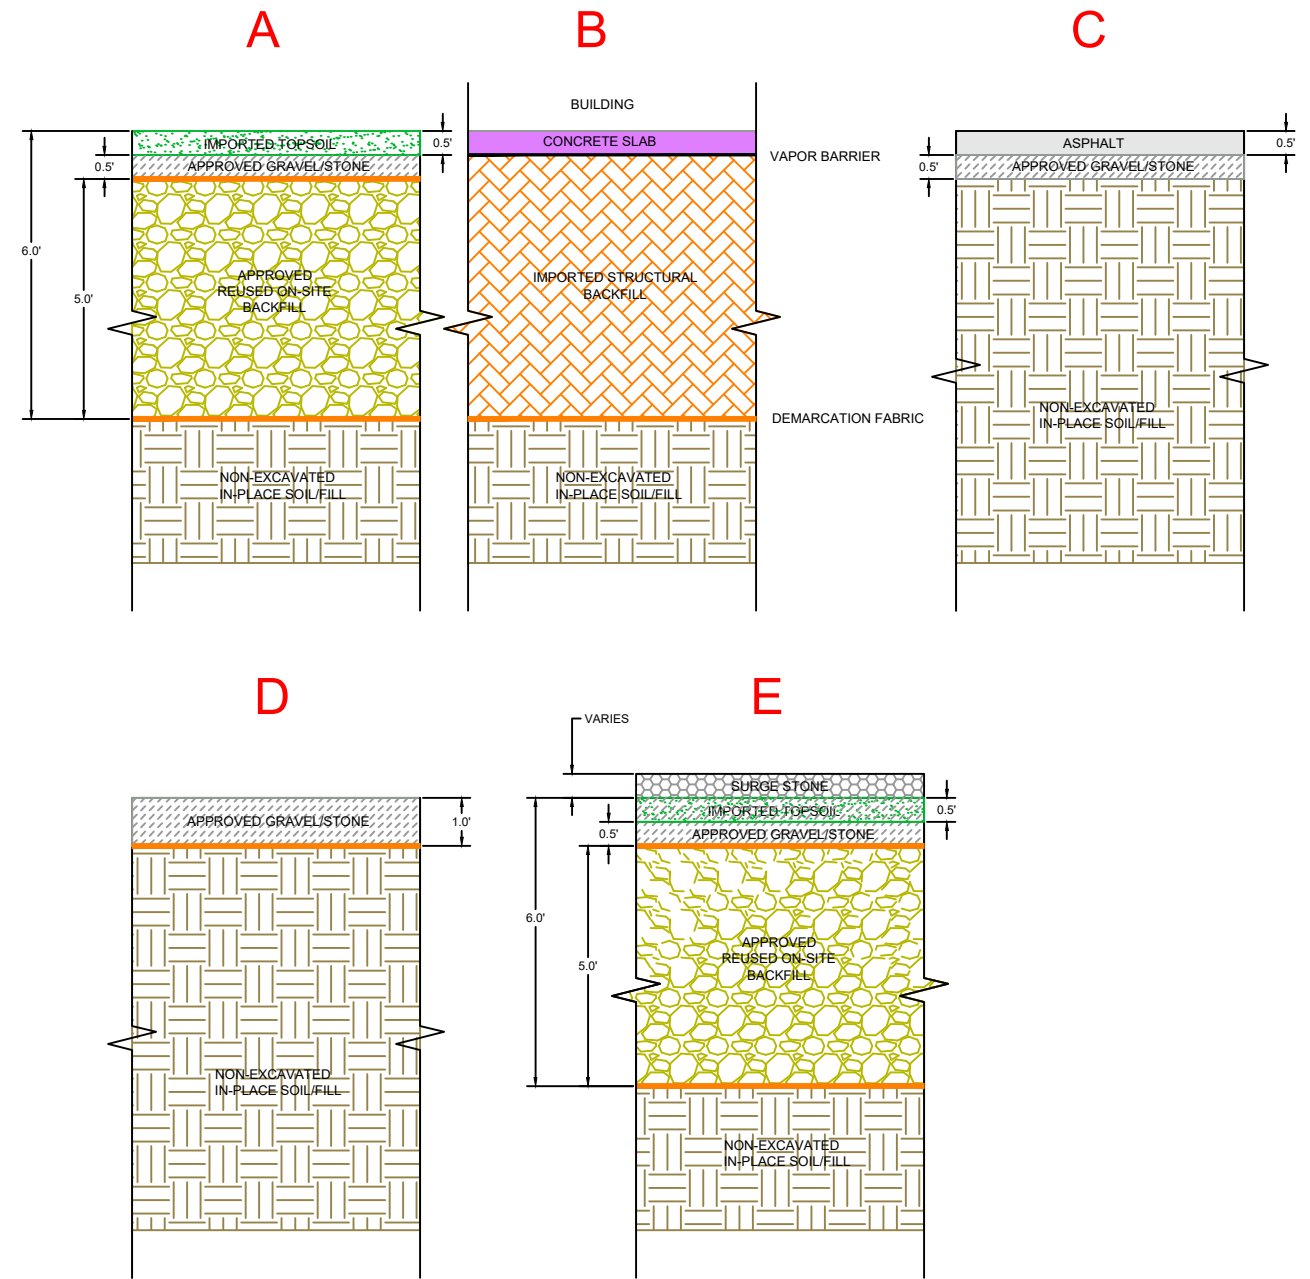
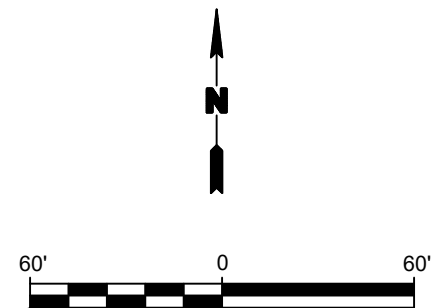
| Title: <b>COVER SYSTEM LAYOUT &amp; DETAILS<br/>(AS-BUILT)</b> | | | |

Appendix A includes the completed Site Management Periodic Review Report Notice – Institutional and Engineering Controls Certification Form. Appendix B includes photographic logs of the Site inspections. Figure 4 shows the cover system layout and details.

- Cover System: The cover system, including building foundations; concrete sidewalks; asphalt and gravel driveways and parking areas; and landscaped vegetated areas are all being maintained in compliance with the SMP.
