**SUPPLEMENTAL REMEDIAL INVESTIGATION  
WORK PLAN**

**211 FRANKLIN STREET  
OLEAN, NEW YORK 14760**

**NYSDEC SITE NUMBER C905038-05-14**

Project No.: 4884S-13

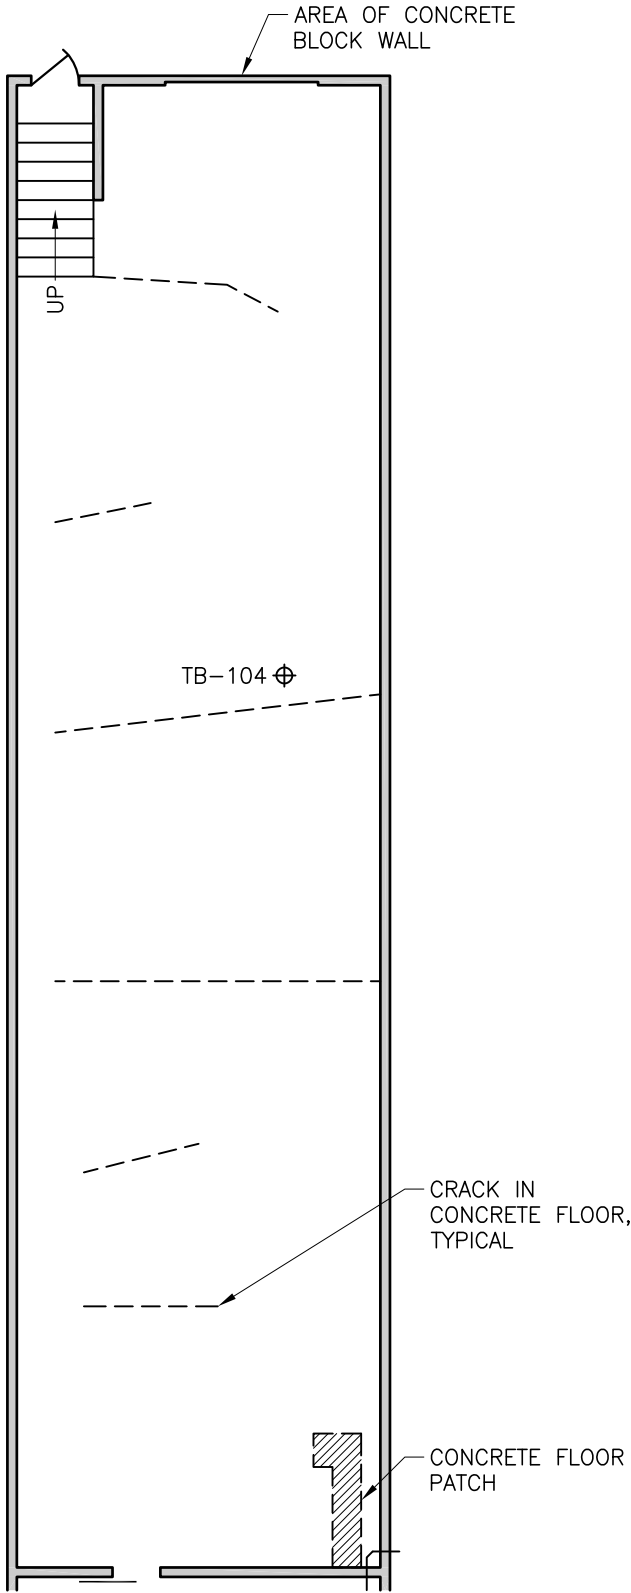
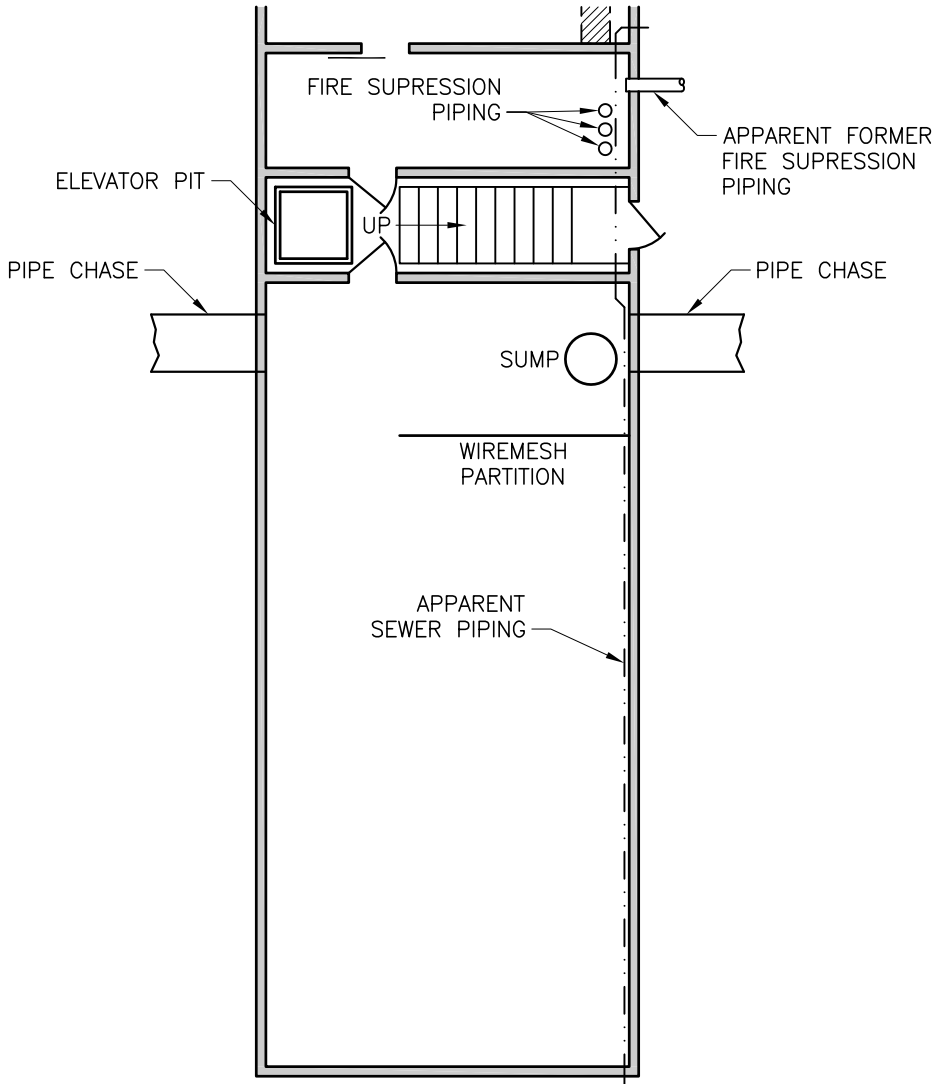
**FIGURE 2**

At the time of the assessment, the basement located beneath the north/central portion of the facility was divided into three rooms (herein designated northern, central and southern). The northern room contained rows of metal framed shelves that were empty of contents at the time of the assessment. The central room contained fire suppression piping and access to a freight elevator. The southern room contained access to a freight elevator, an electrical powered compressor, empty storage cabinets, an oven, a sump and sump-pump, and metal framed shelves that were empty of contents. A sketch of this basement is provided in Figure 2.

The floors in each room of the basement were constructed of poured concrete. Cracks in the concrete floor were observed trending generally southwest-northeast in the northern room, ranging from several feet long to the entire width of the room (i.e., approximately 19 feet). The cracks were less than approximately ½ inch wide and 1/8 inch deep. An L-shaped concrete patch was observed in the floor near the southern corner of the northern room. Intermittent areas of faded, purple-black staining and areas of apparent dry resin were also observed on the floor in the northern room. Cracking and staining were not observed on the concrete floors in the central and southern rooms. However, these floors were painted/sealed. [Note: On July 1, 2014, a test boring, designated TB-104 (refer to Figure 2) was advanced in the northern room of the basement, to a depth of approximately 5 feet below the floor surface, and a fill sample from this location was tested by an analytical laboratory. Field evidence of impact was not observed during drilling. The laboratory test results indicated the presence of volatile organic compounds (VOCs) semi-volatile organic compounds (SVOCs) and metals at concentrations below SCGs.]

The walls of the basement were constructed of poured concrete, except for the wall separating the northern and central rooms (i.e., constructed of plywood and lumber) and a portion of the northern wall of the northern room (i.e., an apparent former loading dock or door, currently filled with a concrete block wall). Foam-board insulation covered most of the wall surface in the northern room, and only the bottom (i.e., approximately 0.5 feet) of the wall surface was visible. The southern wall of the southern room was apparently unconnected (structurally) to the adjacent walls, and appeared to have been constructed at a later date. SolEpoxy facility personnel reported that this wall had been constructed in order to fill in the portion of the basement located further to the south (i.e., the area designated filled basement on Figure 1) prior to installing utility conduits below the ground floor. A system of horizontal pipes, constructed of PVC and transitioning to steel piping, was observed attached to the northeastern wall of the basement, starting at the southern wall of the southern room and exiting the basement toward the north at the southeast corner of the northern room. Based on the presence of in-line goose-neck traps, the pipe

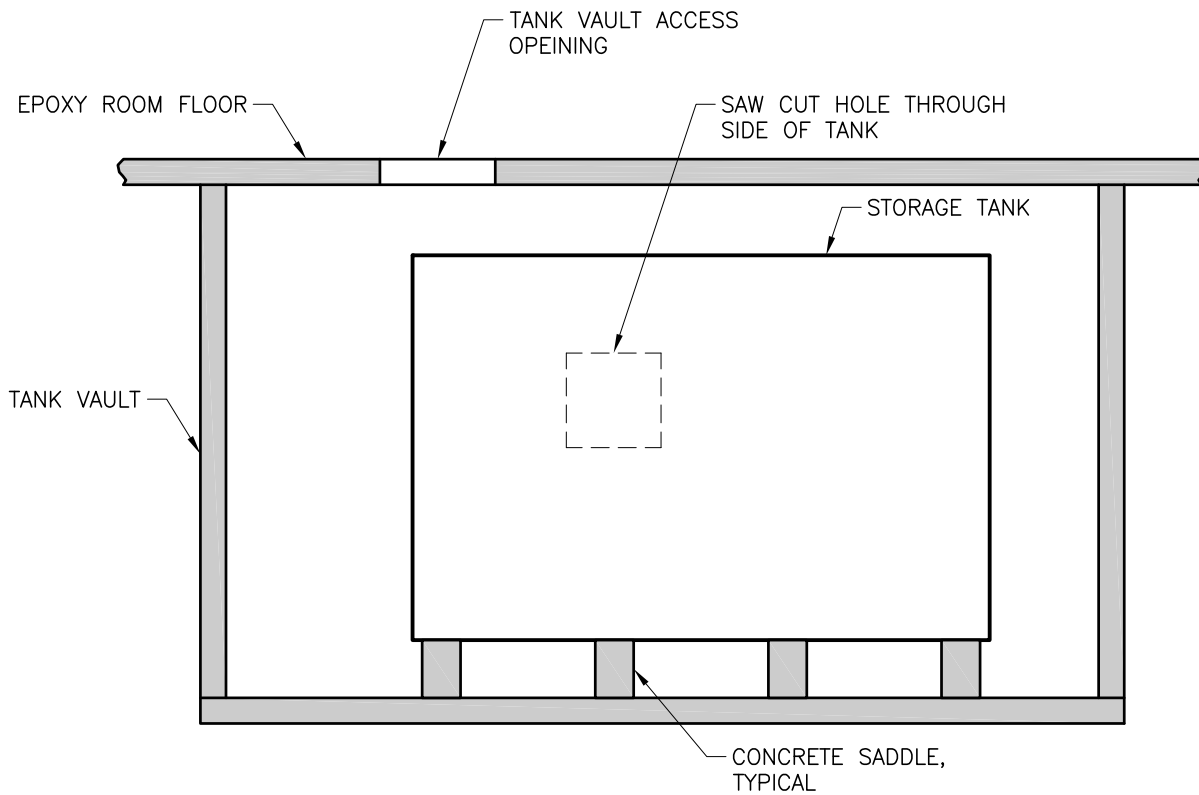
### **EPOXY ROOM TANK VAULT SECTION**

The epoxy room tank vaults (i.e., two adjacent vaults) are located beneath the south-central portion of the building, and they are separated by a concrete block wall. Each vault contains a single-walled, steel, liquid storage tank that was measured to be approximately 10 feet in diameter and approximately 15 feet long. The tanks are suspended approximately 1 foot above the floor on concrete saddles. The tanks were empty of liquids at the time of the site visit, and a square section on the northeast sidewall of each tank had been cut out, rendering the tank un-usable. It was reported by SolEpoxy facility personnel that the epoxy room vault tanks formerly contained castor oil and (epoxy?) resin. However, it is not known what (if any) other materials were formerly stored in these tanks in the past. A plan view sketch of the epoxy room tank vaults is provided as Figure 5 and a cross-sectional sketch is provided as Figure 6.
