2006 Annual Inspection Report

CertainTeed Site (Site # C915185) Buffalo, New York

ENVIRONMENTAL INSPECTION FORM

CertainTeed Site (Portions of Parcels 1 and 2 of Hanna Furnace)

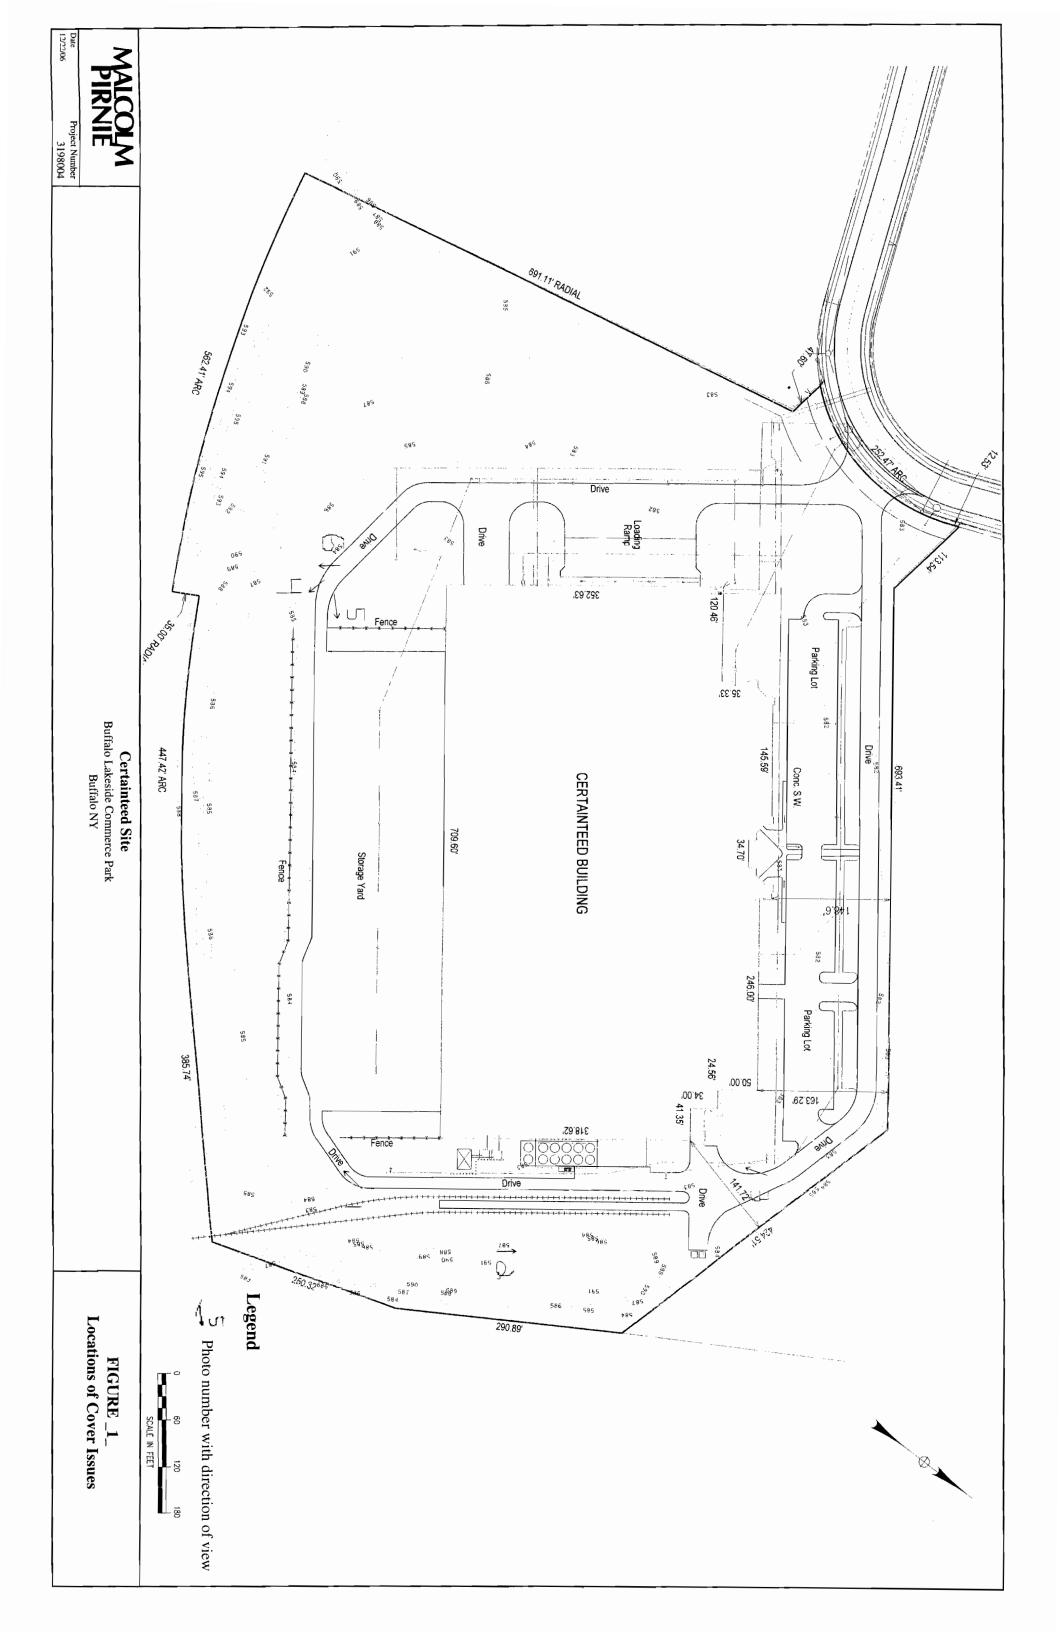
- **Environmental Inspection Form**
- Site Map identifying areas in need of attention
- Photos of areas in need of attention

As you are aware, the establishment of complete grass cover was hampered by the unusually wet growing season in 2006. The site was reseeded using a slit seeder which resulted in significant improvement to the grass cover. However, a few areas of sparse grass cover remain. Also, where trucks cut corners at pavement turns, grass cover is impacted. These areas have been identified and documented on the attached EIF and will be addressed in 2007.

Completion of the grass cover will occur as soon as growing conditions allow next spring.
