Clean Capital/Inovateus Liner Repair QA/QC Report

503 Elk Street
Buffalo, New York 14210
Elk Street Commerce Park
Elk Street Solar
NYSDEC Site No. C915201D

LaBella Project No. 2211232

February 6, 2024

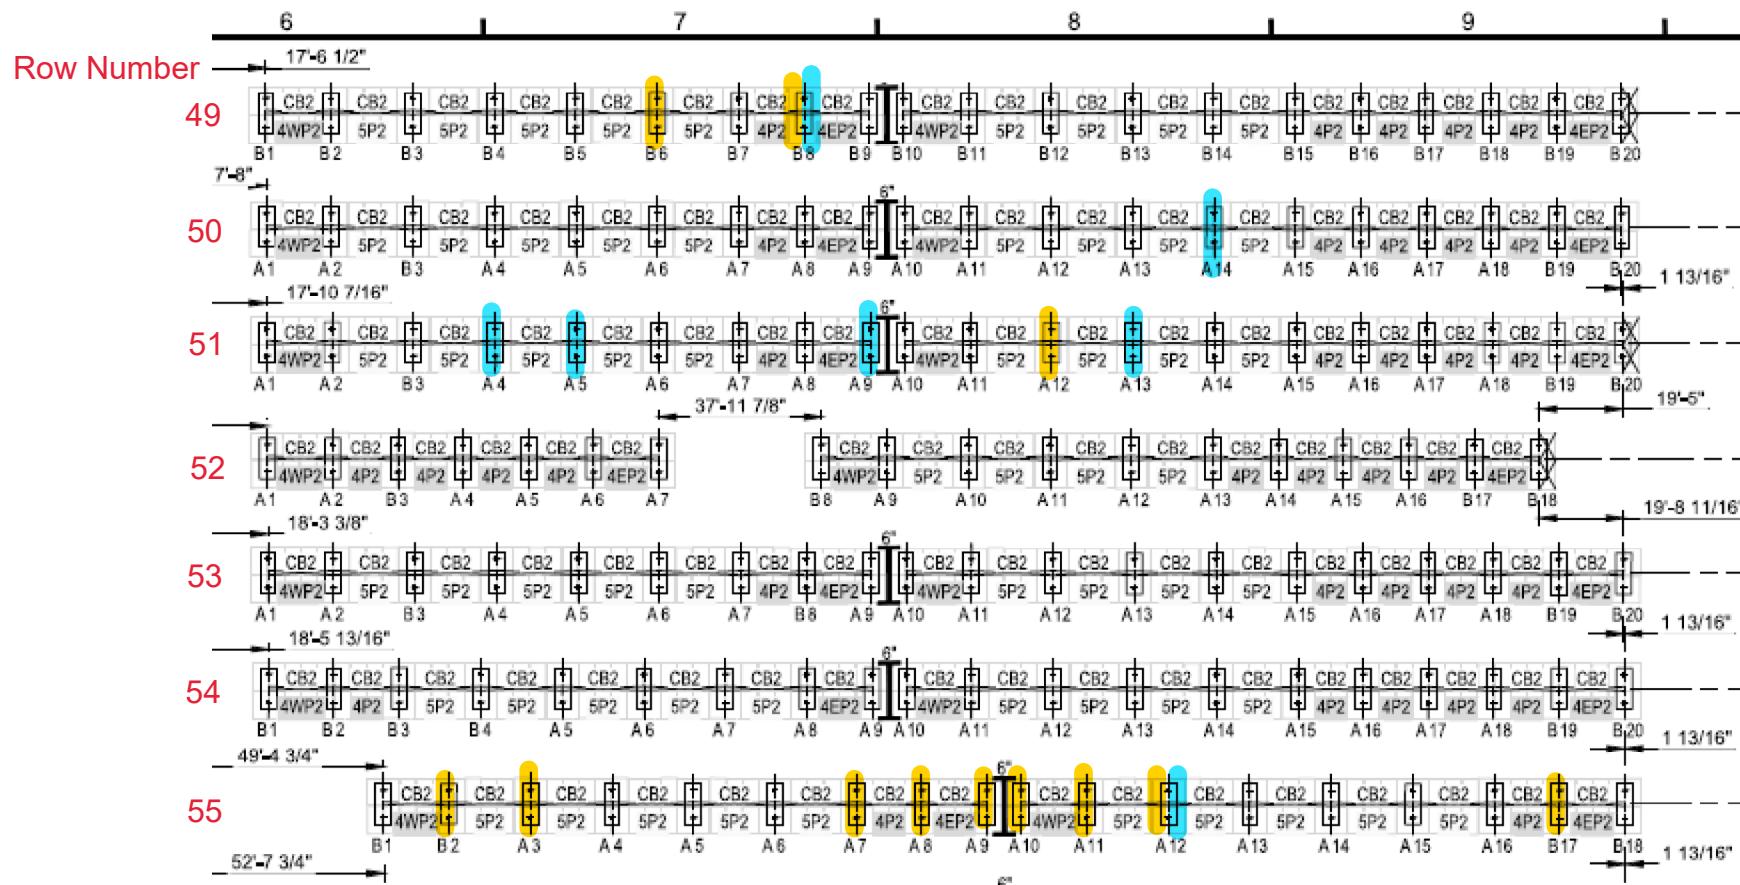
Yellow Highlighted indicates
a hole in geomembrane

Blue highlight indicates a divet/dimple or a
potential defect at the location
