Subject:
Period Review Report
Cobey, Inc. Site, BCP Site #C915202
Buffalo, New York

Periodic Review Report

Cobey, Inc. Site
Buffalo, New York
BCP Site #C915202

ENVIRONMENTAL INSPECTION FORM

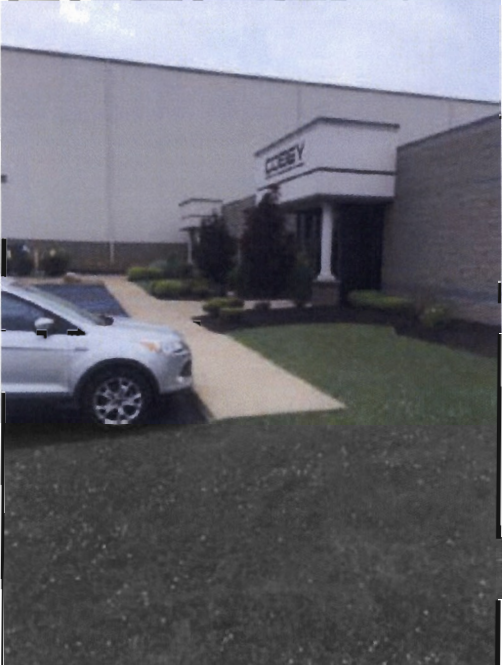
Project: Cobey, Inc. Site – Tri-Annual Site Cover System Inspection		Location: Buffalo, New York	Project No. 06245001.0001
Photo No. 001	Date: 07-14-14

Direction Photo Taken: Southwest			
Description: Main entrance with landscaping.

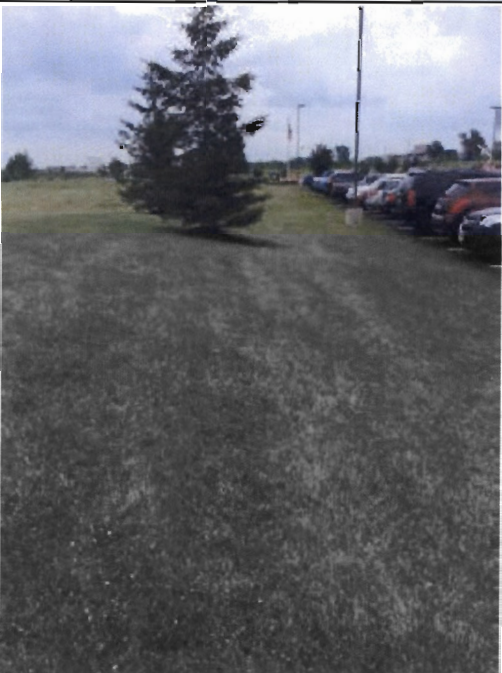
Project: Cobey, Inc. Site – Tri-Annual Site Cover System Inspection		Location: Buffalo, New York	Project No. 06245001.0001
Photo No. 002	Date: 07-14-14

Direction Photo Taken: East			
Description: Landscaped area to the north of main parking lot.

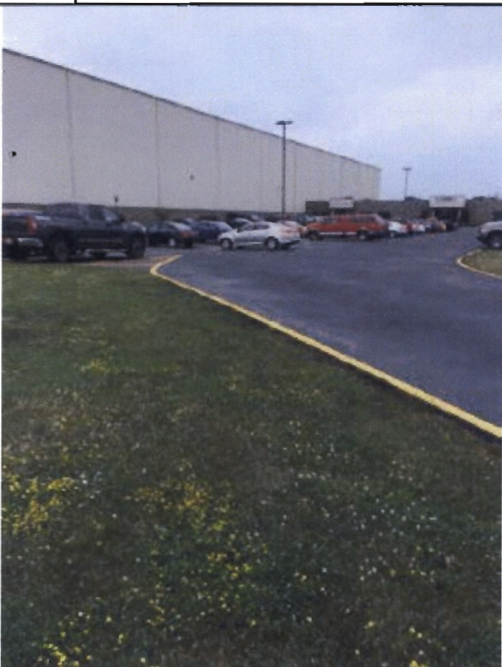
Project: Cobey, Inc. Site – Tri-Annual Site Cover System Inspection		Location: Buffalo, New York	Project No. 06245001.0001
Photo No. 004	Date: 08-26-11

Direction Photo Taken: Southwest			
Description: New asphalt pavement in main parking lot.

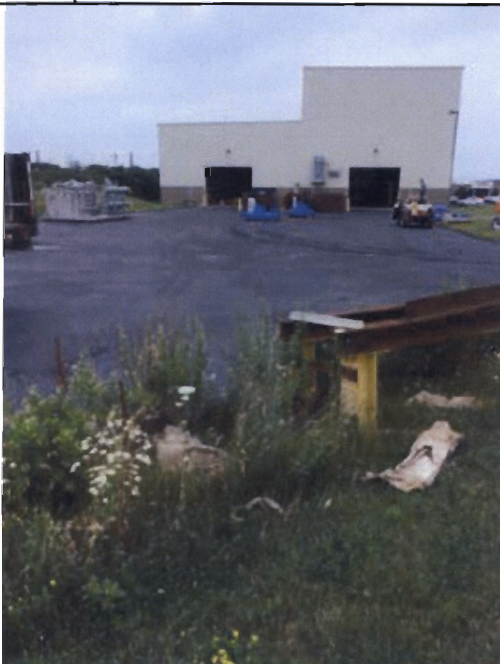
Project: Cobey, Inc. Site – Tri-Annual Site Cover System Inspection		Location: Buffalo, New York	Project No. 06245001.0001
Photo No. 008	Date: 07-14-14

Direction Photo Taken: West			
Description: New asphalt pavement and grass cover at east loading dock.

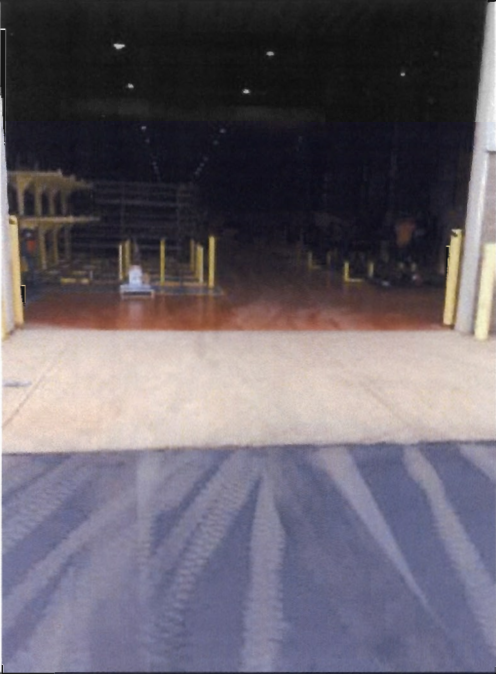
Project: Cobey, Inc. Site – Tri-Annual Site Cover System Inspection		Location: Buffalo, New York	Project No. 06245001.0001
Photo No. 011	Date: 07-14-14

Direction Photo Taken: West			
Description: New asphalt pavement, concrete apron and flooring system at east loading dock.

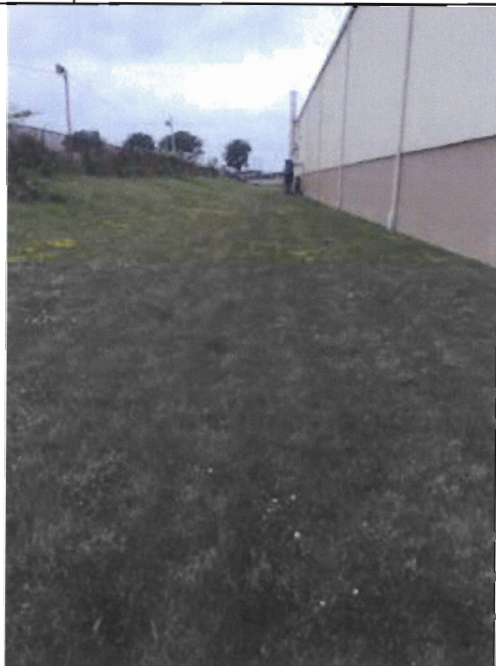
Project: Cobey, Inc. Site – Tri-Annual Site Cover System Inspection		Location: Buffalo, New York	Project No. 06245001.0001
Photo No. 014	Date: 07-14-14

Direction Photo Taken: West			
Description: Grass cover along south edge of the building.

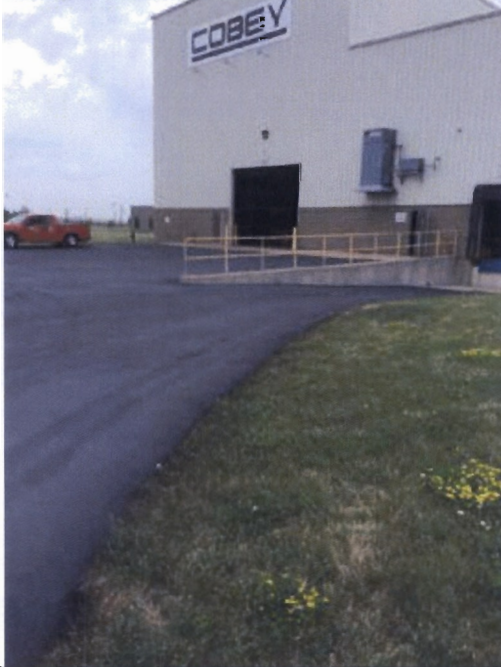
Project: Cobey, Inc. Site – Tri-Annual Site Cover System Inspection		Location: Buffalo, New York	Project No. 06245001.0001
Photo No. 017	Date: 07-14-14

Direction Photo Taken: Northeast			
Description: New asphalt pavement and grass cover at west loading dock.

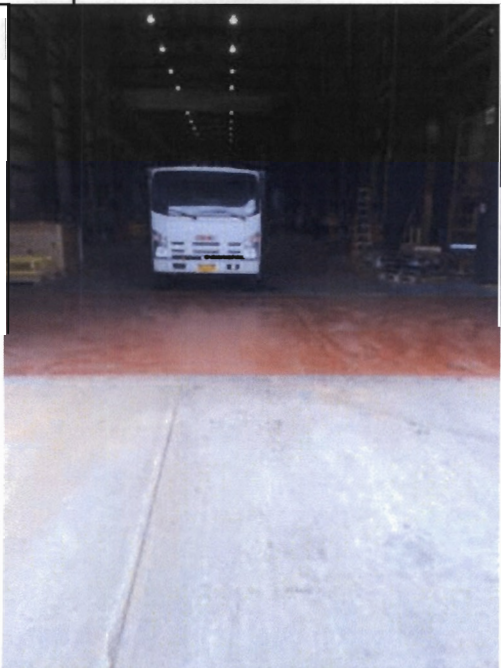
Project: Cobey, Inc. Site – Tri-Annual Site Cover System Inspection		Location: Buffalo, New York	Project No. 06245001.0001
Photo No. 018	Date: 07-14-14

Direction Photo Taken: East			
Description: Concrete apron and flooring system at west loading dock.

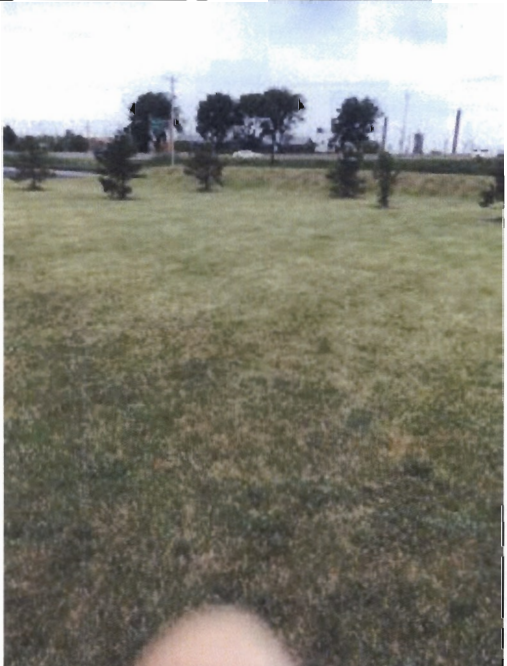
Project: Cobey, Inc. Site – Tri-Annual Site Cover System Inspection		Location: Buffalo, New York	Project No. 06245001.0001
Photo No. 019	Date: 07-14-14

Direction Photo Taken: North			
Description: Landscaped area to the west of the building.

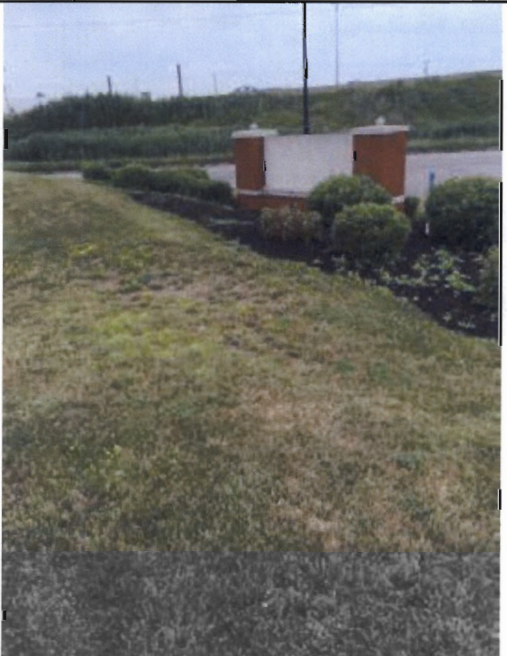
Project: Cobey, Inc. Site – Tri-Annual Site Cover System Inspection		Location: Buffalo, New York	Project No. 06245001.0001
Photo No. 020	Date: 07-14-14

Direction Photo Taken: Southwest			
Description: Landscaped area at corner of Commerce Street and Ship Canal Parkway.

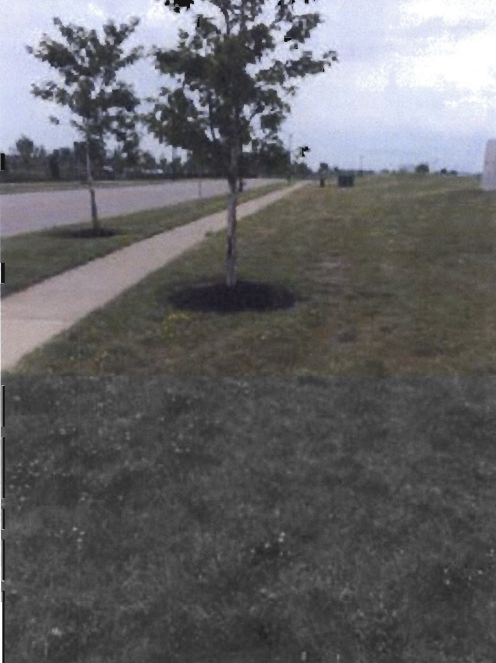
Project: Cobey, Inc. Site – Tri-Annual Site Cover System Inspection		Location: Buffalo, New York	Project No. 06245001.0001
Photo No. 021	Date: 07-14-14

Direction Photo Taken: Northeast			
Description: Sidewalk and landscaped area along north property line.

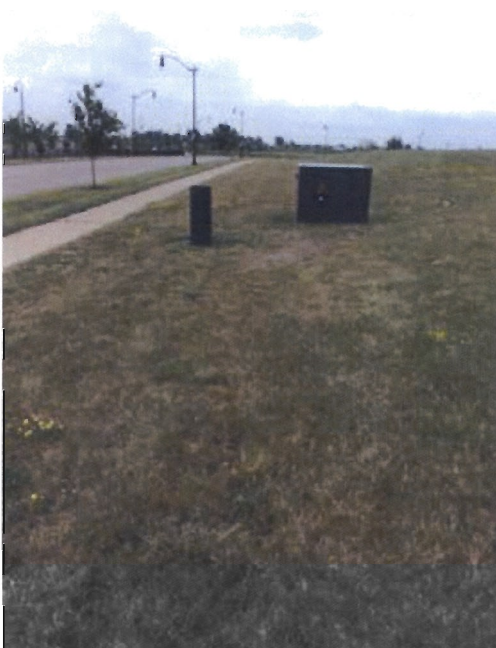
Project: Cobey, Inc. Site – Tri-Annual Site Cover System Inspection		Location: Buffalo, New York	Project No. 06245001.0001
Photo No. 022	Date: 07-14-14

Direction Photo Taken: Northeast			
Description: Sidewalk and grass cover along north property line.

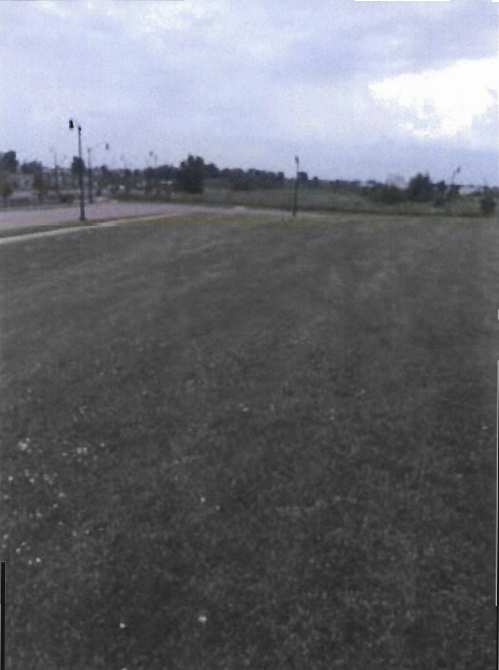
Project: Cobey, Inc. Site – Tri-Annual Site Cover System Inspection		Location: Buffalo, New York	Project No. 06245001.0001
Photo No. 023	Date: 07-14-14

Direction Photo Taken: Northeast			
Description: Grass cover along north property line.

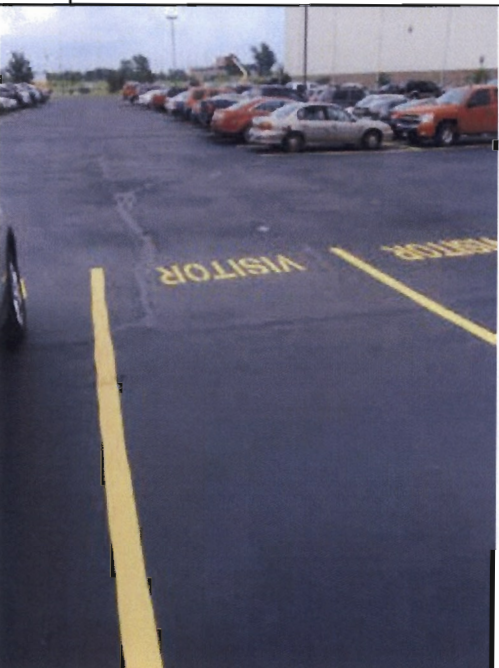
Project: Cobey, Inc. Site – Tri-Annual Site Cover System Inspection		Location: Buffalo, New York	Project No. 06245001.0001
Photo No. 024	Date: 07-14-14

Direction Photo Taken: North			
Description: New asphalt pavement in main parking lot.
