12 February 2018 File No. 129356-003

Subject: Hydro-Air Components, Inc. Property (Former Steelfields Area IV Parcel Site)

Brownfield Cleanup Program (BCP) Site #C915204 Site Management Periodic Review Report &

Institutional Controls/Engineering Controls Certification

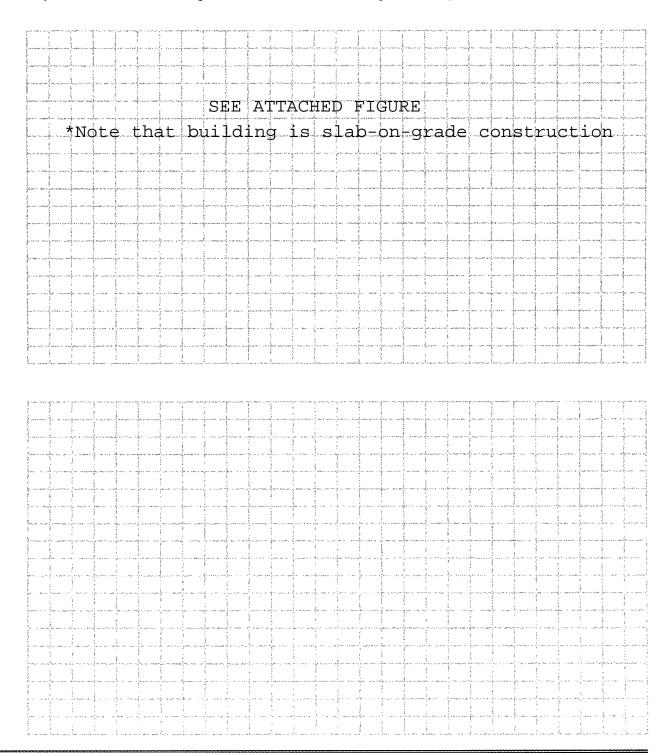
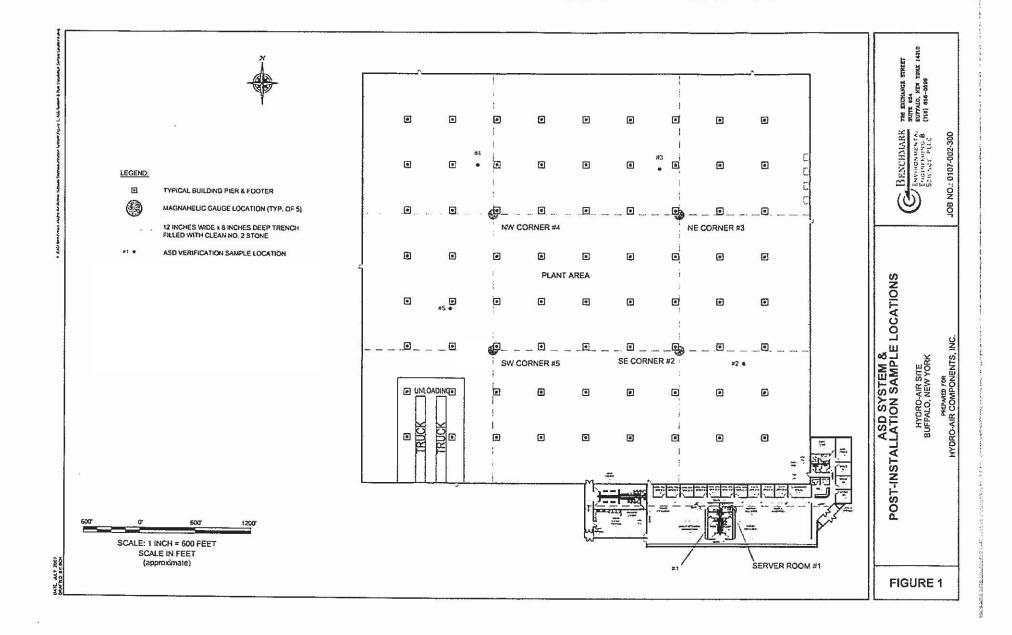
### Floor Plan Sketch:

Draw a plan view sketch of the basement of the building. Indicate Sub-Slab Depressurization system location. Please also note and include, any alterations to the system, locations of visible cracks and/or repairs needed, and changes or alterations to the usage of this space.
