Report No.: 172-016	E&E Project	E&E Project File: NV28.03 Da			ate: Monday, February 20, 2006			
NYSDEC	DR 172 - 016		Temperature: (F)	15	(am)	31	(pm)	
Division of Environr	Division of Environmental Remediation			W	(am)	W	(pm)	
Shenago Steel Mold Site, NYSDEC #9-15-172			Weather:	(am) Ov	ercast			
				(pm) Cle	ear			
Contract # D005660		Arrive at site	0650	(am)				
Buffalo, New York			Leave site:	1547	(pm)			
HEALTH & SAFETY:								
Are there any changes to (If yes, list the deviation un		?	Yes ()	1	No (X)			
Are monitoring results at a	acceptable levels?	Soil Waters Air	Yes () n/	a (̀ X)	No () No () No ()			
OTHER ITEMS:		7 tii	If No, provide comments					
Site Sketch Attached:			Yes () N	o(X)				
Photos Taken:			Yes (X) No ()					
DESCRIPTION OF DAILY	Y WORK PERFORMED:							
excavator, and using it to point were neither excave Hydraulic Oil Spill Area in Horizon loaded out (7 tru	•	ween the track rizon continued pegan demolition as soil from the	s of both excavator lexcavating and lo on of he vault with Hydraulic Oil Spill	rs. The traded ad out soil the Deere Area to P	cks were f from the l 200LC ex ariso Truc	rozen to LNAPL cavator. king for

Report No.: 172-016 E&E Project Fi

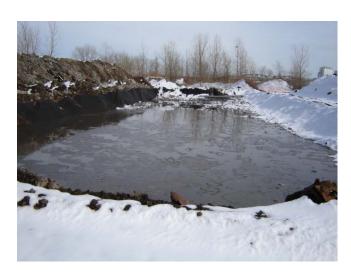
000_064.jpg

Date	Photo ID	Description			
3/06/06	000 058.jpg	View of concrete removal from southwest corner of LNAPL excavation.	SW		
3/06/06	000 059.jpg	View of clay on the floor of LNAPL southwest corner of excavation.	SW		
3/06/06	000 060.jpg	View of remaining soil to be excavated from LNAPL area.	W		
3/03/06	000 061.jpg	View LNAPL Area dewatering discharge to the infiltration basin.	SW		
3/06/06	000 062.jpg	View of excavated west wall of LNAPL area.	N		
3/06/06	000 063.jpg	View of east and north wall of excavated LNAPL area.	N		
3/06/06	000 064.jpg	View of discharged water in infiltration basin.	S

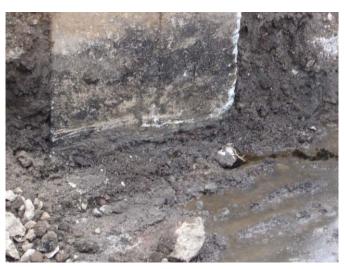
Date	Photo ID	Description	Direction
3/08/06	000 071.jpg	View of non-hazardous soil load out in the TGA.	SE
3/08/06	000 072.jpg	View of excavation around concrete foundations Test Pit # 2 area (TGA).	SE
3/08/06	000 073.jpg	View of oil seep at base of concrete foundation in Test Pit # 2 area (TGA).	SW
3/08/06	000 074.jpg	View of 1-foot excavation in TGA.	NE
3/08/06	000 075.jpg	View of load out to Pariso Trucking.	SE
3/08/06	000 076.jpg	View contractor personal performing mainetance on site access roads.	N

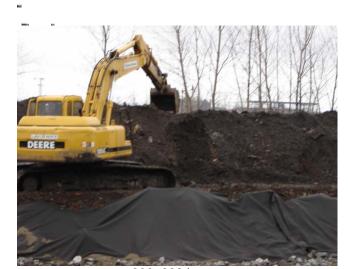
000_088.jpg

Date	Photo ID	Description	Direction
3/10/06	000 084.jpg	View dewatering the sump in the LNAPL excavation prior to backfill	SE
3/10/06	000 085.jpg	View of excavation on the north end of LNAPL area in (TGA).	NW
3/10/06	000 086.jpg	View of the beginning of backfill at the northeast end of the LNAPL area.	NE
3/10/06	000 087.jpg	View of the beginning of backfill on the southeast end of the LNAPL area.	Е
3/10/06	000 088.jpg	View of Horizon excavating soil from infiltration berm for further soil characterization for disposal (Per PCO # 2).	SE
3/10/06	000 089.jpg	View of floor excavation in the infiltration basin for further soil characterization (Per PCO # 2).	N
3/10/06	000 090.jpg	View of Horizon personal collecting infiltration basin floor sample.	N

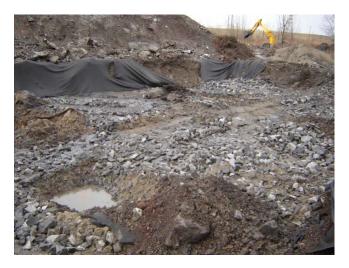
000_096.jpg

Date	Photo ID	Description	Direction
3/13/06	000 091.jpg	View of standing water on the west end in the LNAPL area.	N
3/13/06	000 092.jpg	View of standing water on the east and north end of the LNAPL area.	NW
3/13/06	000 093.jpg	View of Horizon personal assembling discharge pipe from the LNAPL area.	S
3/13/06	000 094.jpg	View of standing water in the TGA LNAPL excavation.	SE
3/13/06	000 095.jpg	View of standing water in the north end of TGA LNAPL excavation.	SE
3/13/06	000 096.jpg	View of three foot excavation north end of the TGA.	N
3/13/06	000 097.jpg	View of infiltration basin floor condition.	W

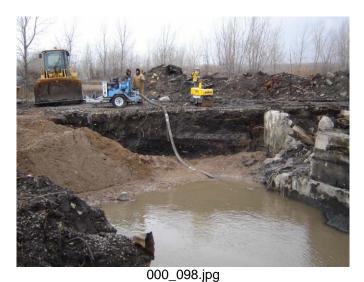
000_099.jpg

Date	Photo ID	Description	Direction
3/14/06	000 098.jpg	View of Horrizon dewatering the LNAPL area.	N
3/14/06	000 099.jpg	View water from LNAPL area discharged to infiltration basin	N
3/14/06	000 100.jpg	View of Horizon excavating to the limit of excavation in TGA LNAPL area.	NE
3/14/06	000 101.jpg	View of remaining stockpiled soil in TGA LNAPL area.	N
