Re: 154 South Ogden Street Site (C915268)  
Buffalo, New York  
Periodic Review Report (December 9, 2014 to January 2, 2016)

# Periodic Review Report

*154 South Ogden Street Site*

*BCP Site No. C915268  
154 South Ogden Street  
Buffalo, New York*

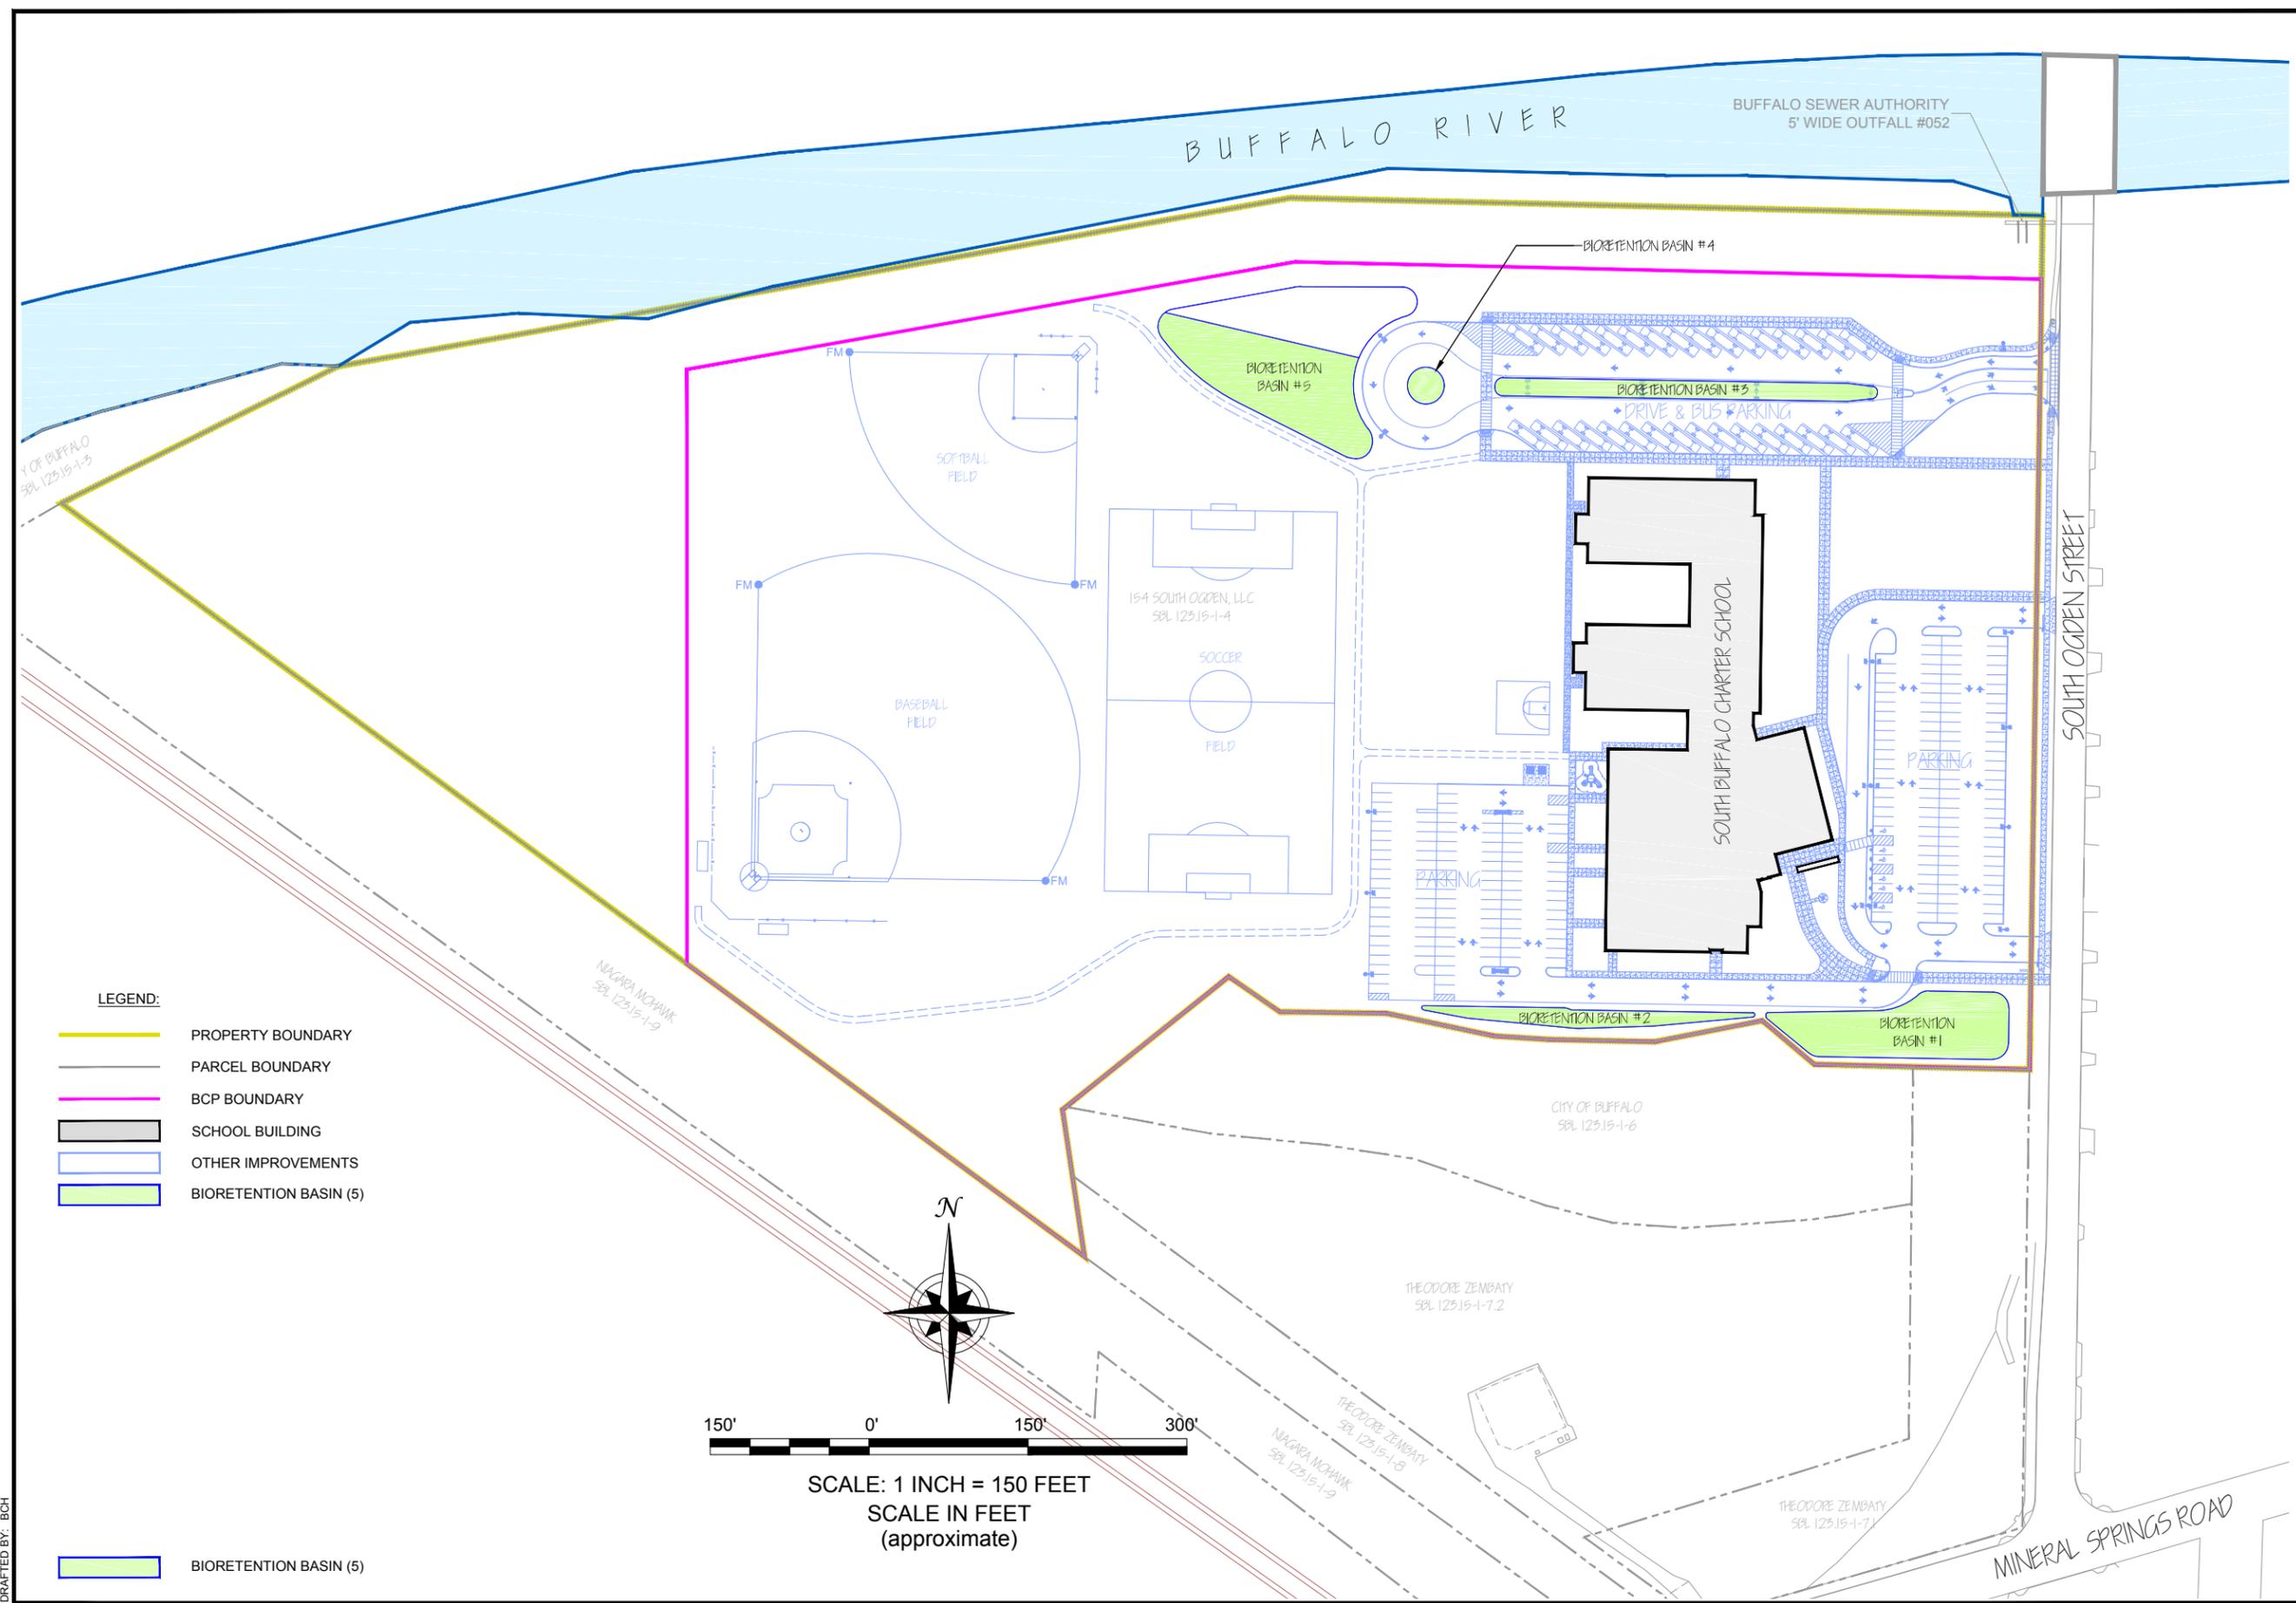
**FIGURE 2**

The site is located in the County of Erie, New York and is identified as a portion of Block 1 and Lot 4 on the City of Buffalo Tax Map # 123.15 per Erie County Tax Map records. The site is situated on an approximately 21-acre area bounded by the Buffalo River to the north; vacant property, a cell tower, and Mineral Spring Road to the south; South Ogden Street to the east; and railroad tracks and power lines to the west (see Figures 1 and 2).
