STOHL ENVIRONMENTAL, LLC

Re: Visual Survey and Bulk Sampling of Suspect Materials/Debris
Kensington Heights Complex

Buffalo Municipal Housing Authority
Limited Asbestos Inspection - Client Defined Areas/Materials
Kensington Heights
Buffalo, New York
Conditions as of September 13, 2011

Buffalo Municipal Housing Authority
Visual Asbestos Inspection for Debris
Kensington Heights
Buffalo, New York
Conditions as of October 5, 2011

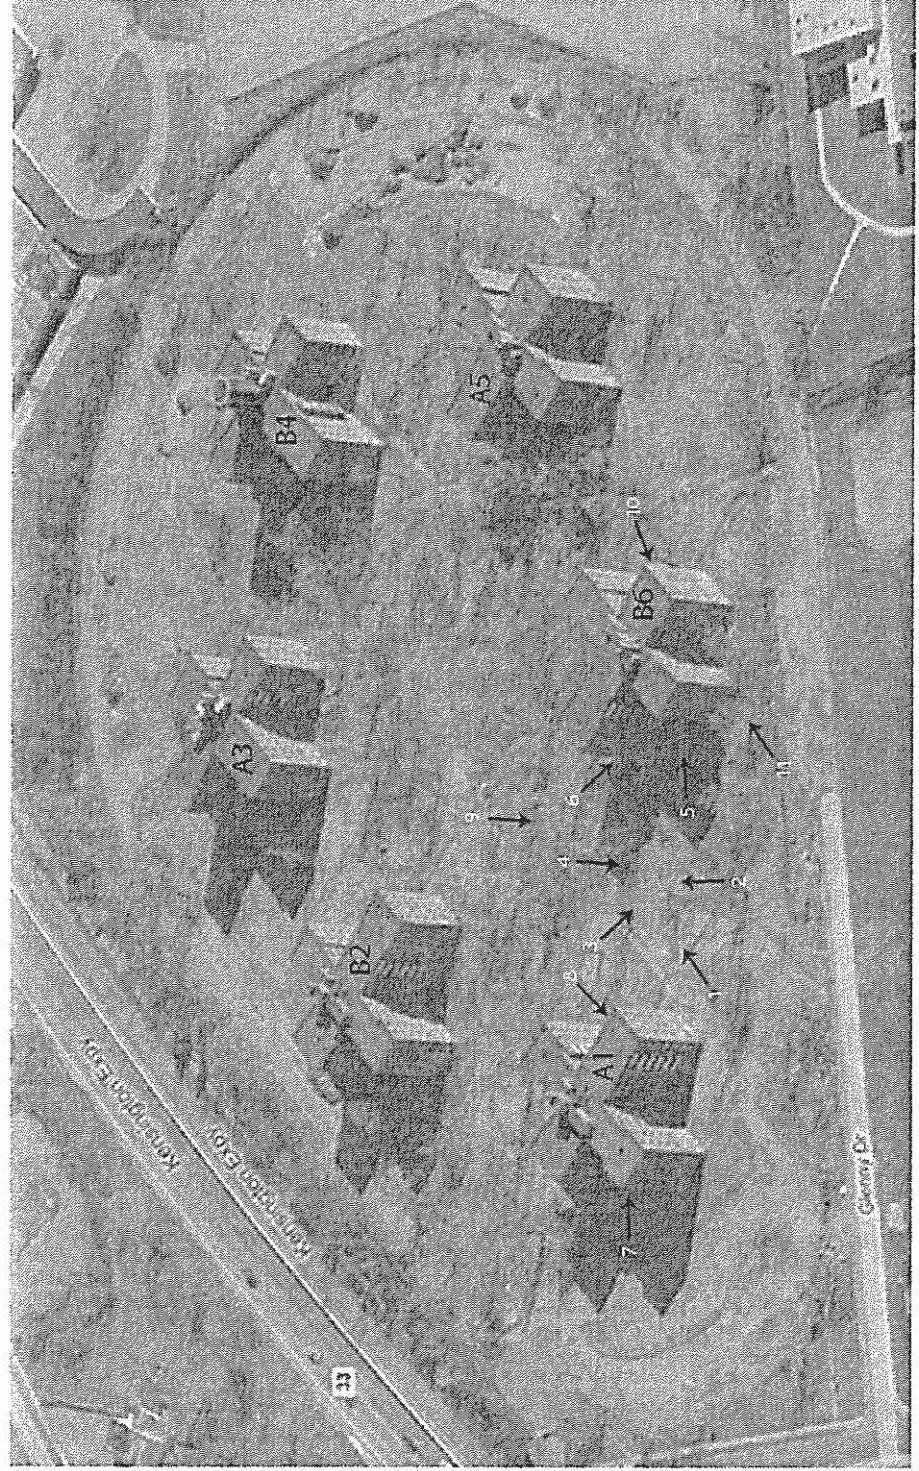
Stohl Env File # 2011-667

Sample #	Description	Location of Sample
1	Transite Debris	In Middle of Buildings A1 and B6
2	Transite Debris	In Middle of Buildings A1 and B6
3	Debris of Brake Shoe	In Middle of Buildings A1 and B6
4	Window Caulk-White	In Middle of Buildings A1 and B6
5	Transite Debris	Western Corner of Building B6
6	Caulk-White/Gray	Northwest Corner of Building A1
7	Transite Debris	Western Corner of Building A1
8	Transite Debris	Eastern Corner of Building A1
9	Transite Debris	Between Buildings B2 and B6
10	Transite Debris	Eastern Corner of Building B6
11	Friable Debris	Southwest of Building B6

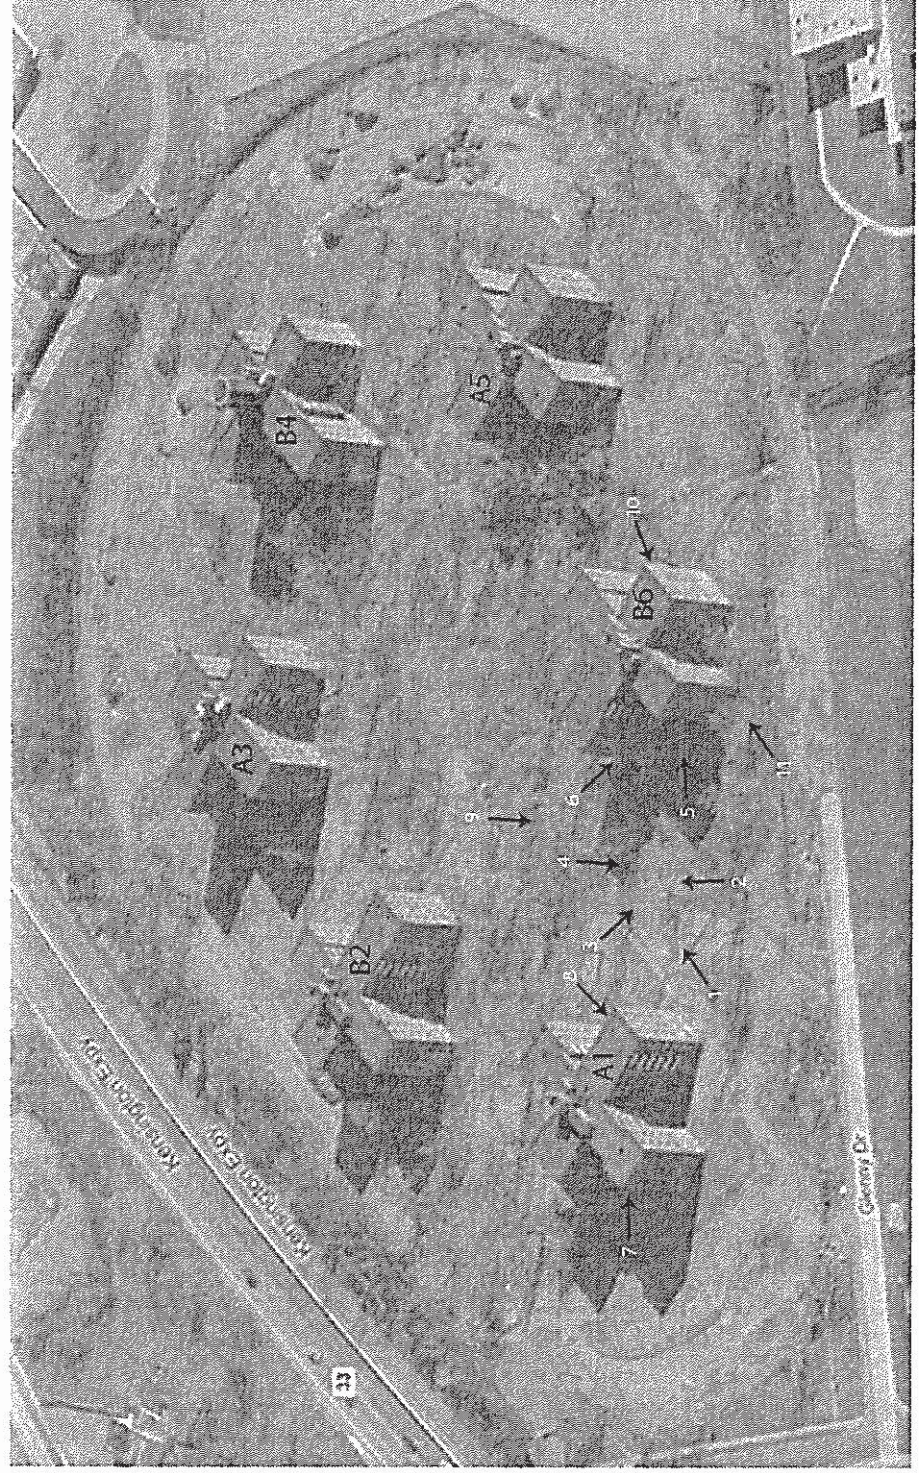
Stohl Env File # 2011-667

Sample #	Description	Location of Sample
1	Transite Debris	In Middle of Buildings A1 and B6
2	Transite Debris	In Middle of Buildings A1 and B6
3	Debris of Brake Shoe	In Middle of Buildings A1 and B6
4	Window Caulk-White	In Middle of Buildings A1 and B6
5	Transite Debris	Western Corner of Building B6
6	Caulk-White/Gray	Northwest Corner of Building A1
7	Transite Debris	Western Corner of Building A1
8	Transite Debris	Eastern Corner of Building A1
9	Transite Debris	Between Buildings B2 and B6
10	Transite Debris	Eastern Corner of Building B6
11	Friable Debris	Southwest of Building B6
