STOHL ENVIRONMENTAL, LLC

Re: Visual Survey and Bulk Sampling of Suspect Materials/Debris
Kensington Heights Complex

Buffalo Municipal Housing Authority
Limited Asbestos Inspection - Client Defined Areas/Materials
Kensington Heights
Buffalo, New York
Conditions as of September 13, 2011

Buffalo Municipal Housing Authority
Visual Asbestos Inspection for Debris
Kensington Heights
Buffalo, New York
Conditions as of October 5, 2011

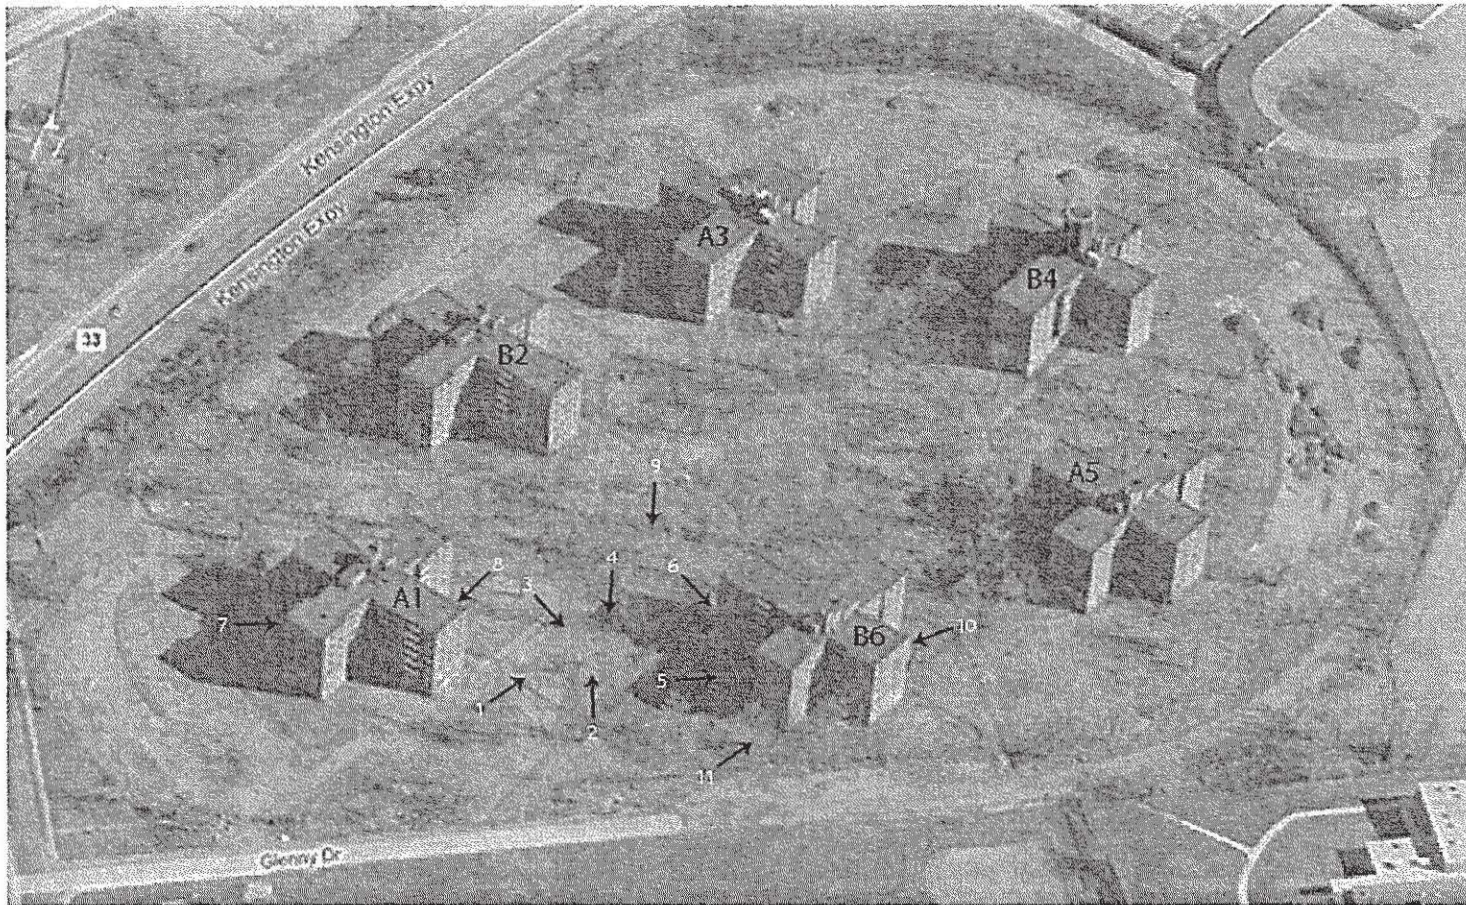
Sample #	Description	Location of Sample
1	Transite Debris	In Middle of Buildings A1 and B6
2	Friable Debris	In Middle of Buildings A1 and B6
3	Debris of Brake Shoe	In Middle of Buildings A1 and B6
4	Window Caulk-White	In Middle of Buildings A1 and B6
5	Transite Debris	Western Corner of Building B6
6	Caulk-White/Gray	Northwest Corner of Building A1
7	Transite Debris	Western Corner of Building A1
8	Transite Debris	Eastern Corner of Building A1
9	Transite Debris	Between Buildings B2 and B6
10	Transite Debris	Eastern Corner of Building B6
11	Friable Debris	Southwest of Building B6
