**HIGHLAND PLAZA
BROWNFIELD SITE # C915293**

**215 to 237 HIGHLAND PARKWAY
TONAWANDA, NEW YORK**

**REMEDIAL INVESTIGATION
FINAL REPORT**

May, 2017

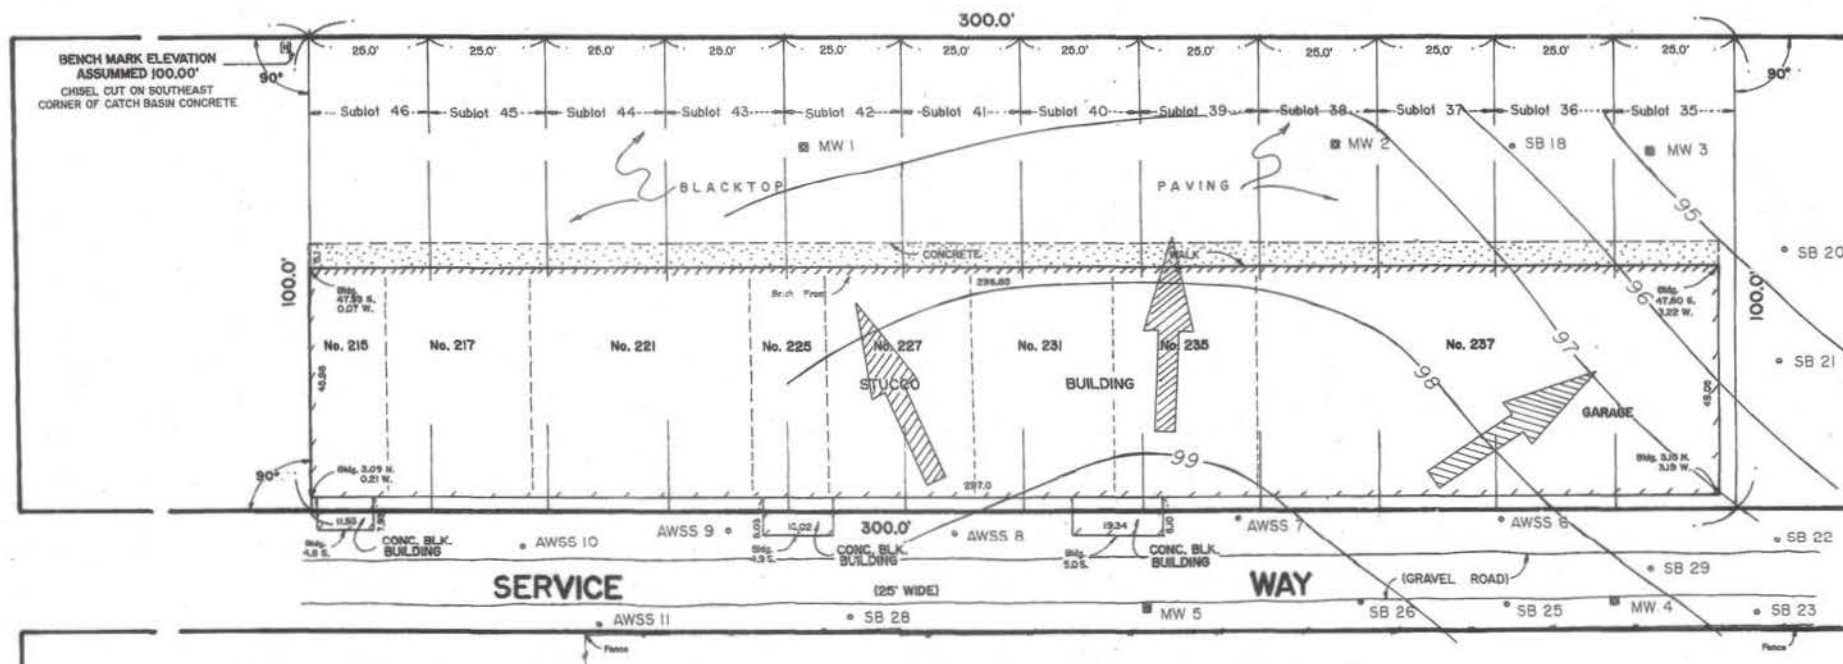
FIGURE 4 : WATER TABLE MAP
HIGHLAND PLAZA
TONAWANDA, NEW YORK

The water level information collected during the initial water level collection event on December 4th, 2015 was used to construct a potentiometric surface map of the water table to determine groundwater flow direction (Figure 4). Groundwater flow direction was determined to be toward the north and east.

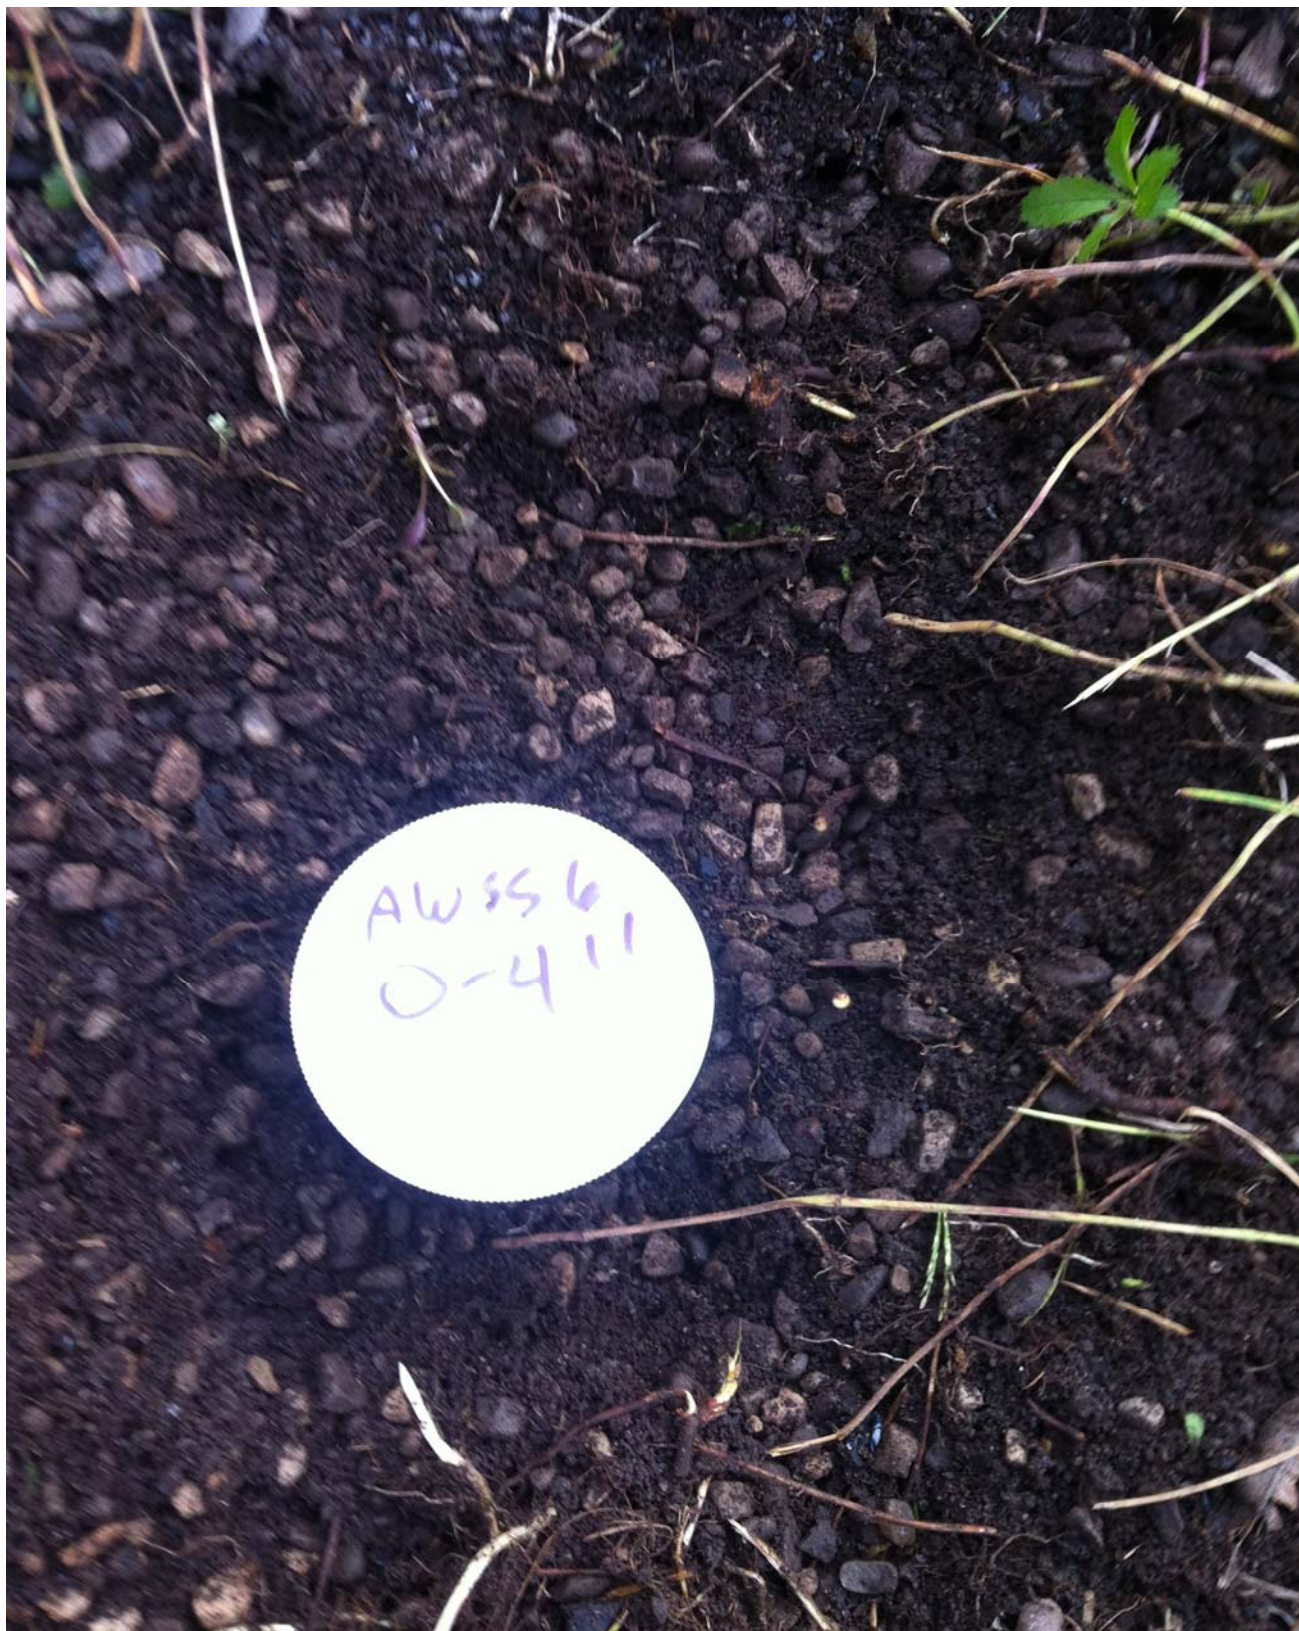
Photo 4. Surface soil sample location AWSS - 6.

Soil borings advanced in the service alley behind the building encountered varying amounts of dark grey to black topsoil (0 to 8 inches) underlain by angular medium grey gravel (crushed stone) and sand. At some locations, crushed stone and sand were present at the surface. These materials were underlain by native silty clay soils (Photos 4 through 9).
