REMEDIAL INVESTIGATION/ALTERNATIVES ANALYSIS REPORT

31 TONAWANDA STREET SITE AND 150 TONAWANDA STREET/FORMER CSX VACANT RAIL PROPERTY BUFFALO, NEW YORK 14207 NYSDEC SITE # C915299

October 2019

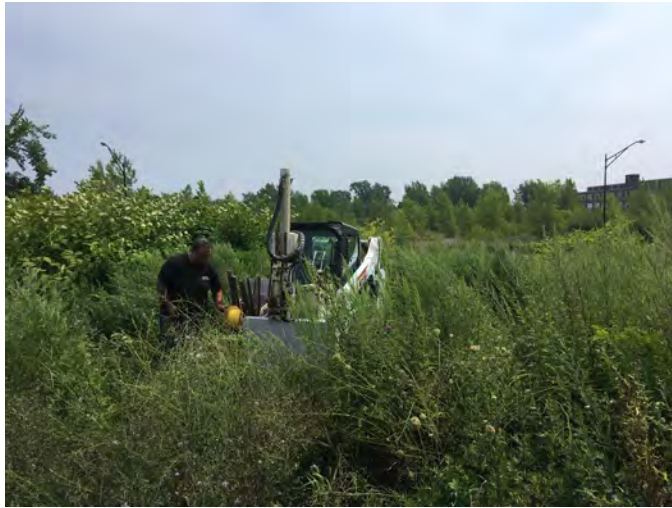
5. BH-3 soil boring location, looking east.

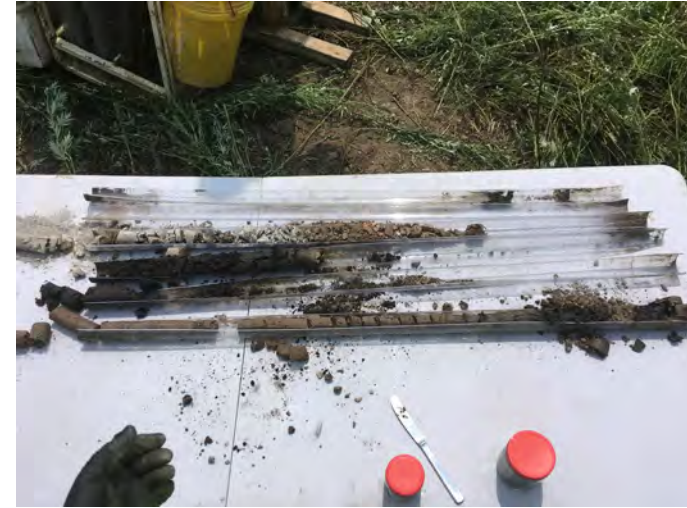
6. BH-3 soil core, 0 – 11' top to bottom, right to left.

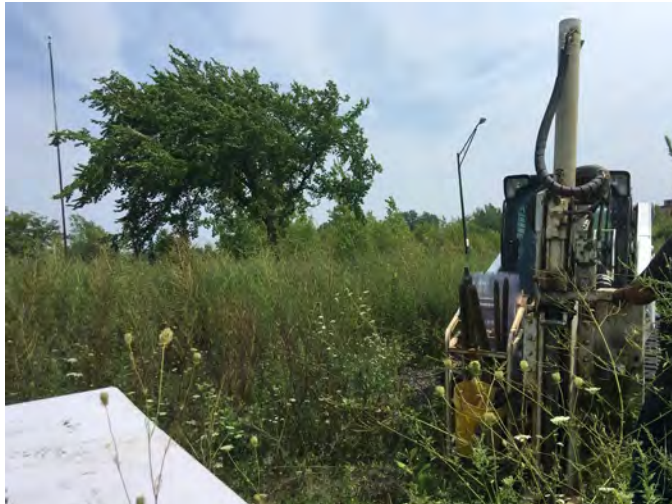
7. BH-4 soil boring location, looking east.

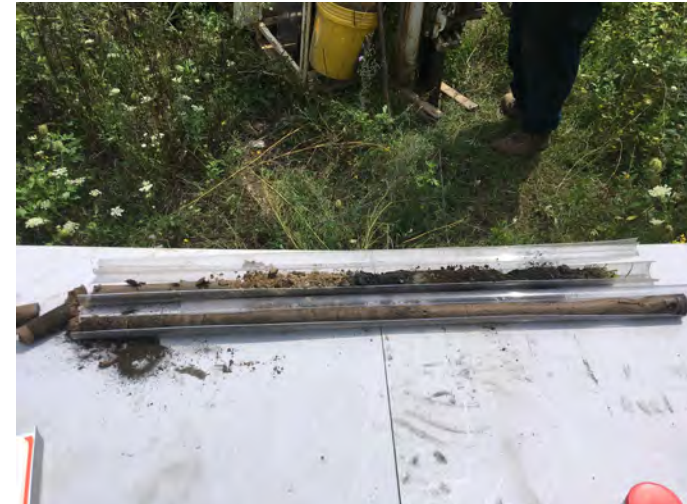
8. BH-4 soil core, 0 – 8' top to bottom, right to left.

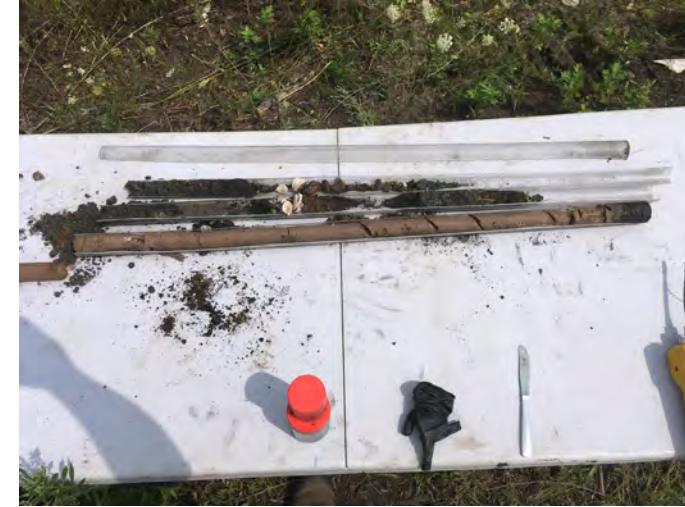
10. BH-5 soil core. 0 – 8'; top to bottom, right to left.

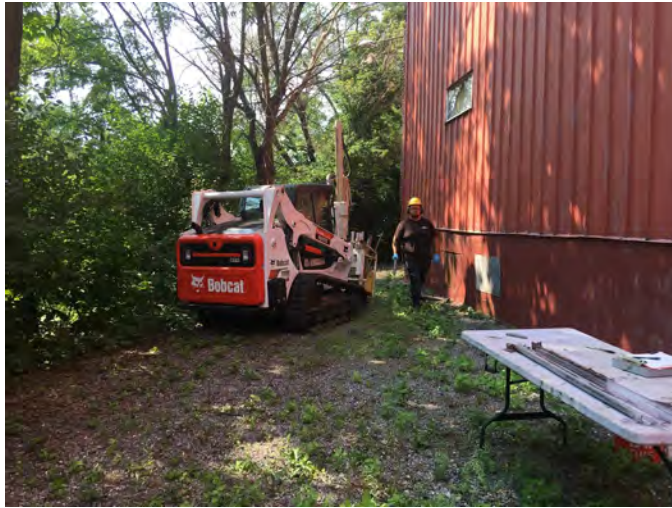
17. BH-2 boring location, looking south.

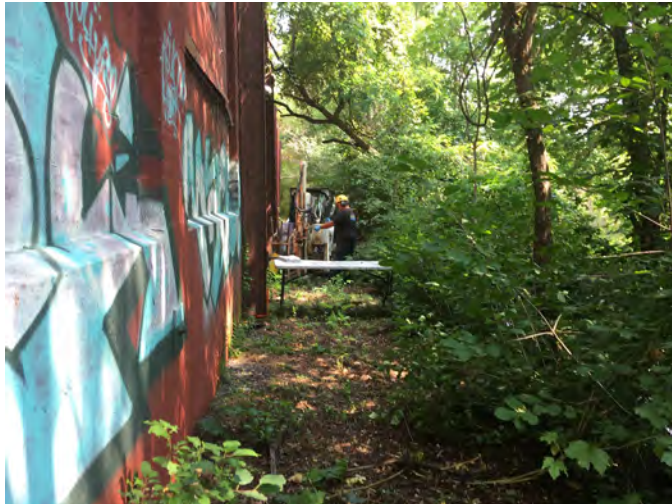
19. BH-1 boring location, looking northeast.

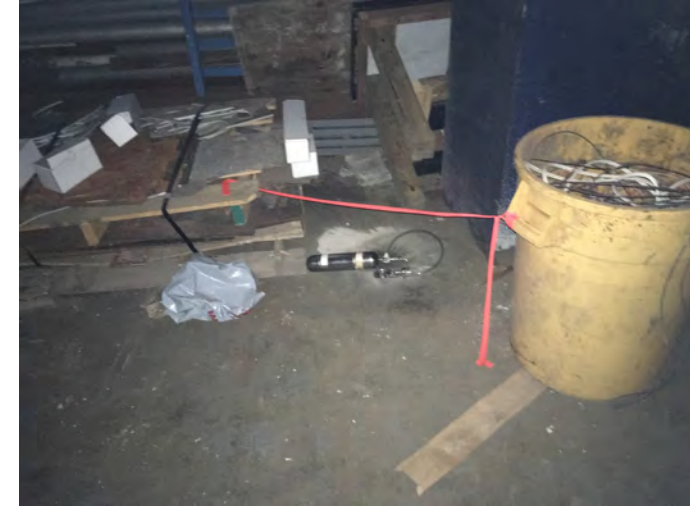
26. SS-02 sample location, middle of high bay slab on grade.

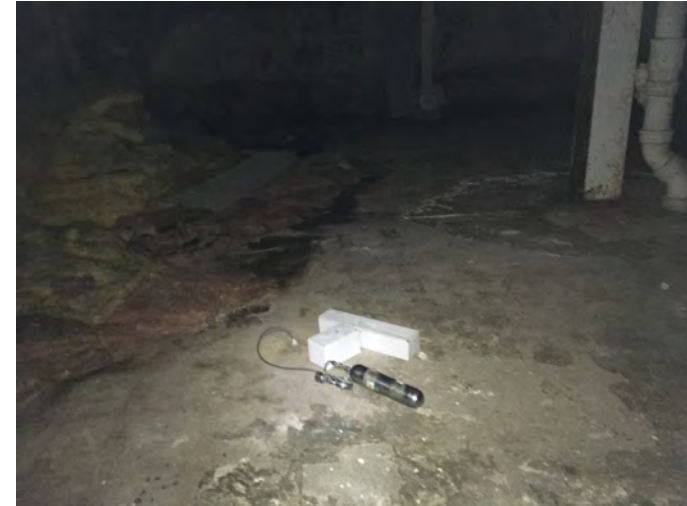
30. SS-04 sample location, northern end of basement.

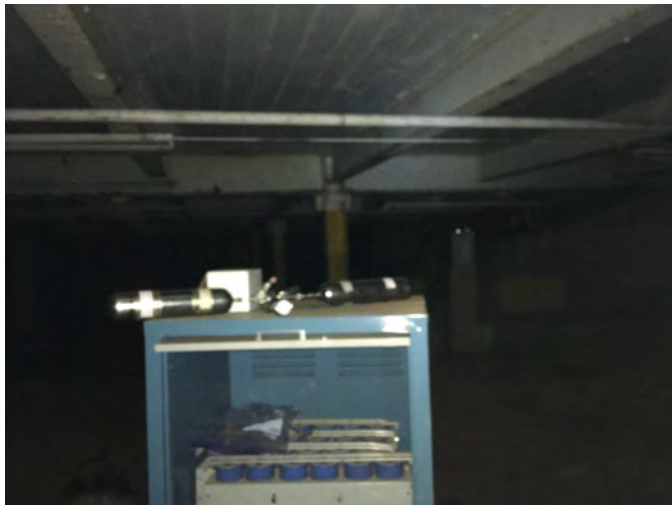
31. IA-04 sample location, northern end of basement.

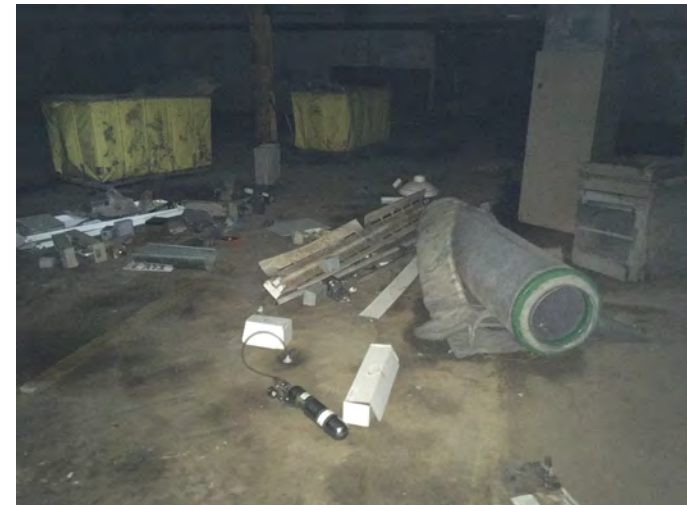
32. SS-05 sample location, middle of basement.

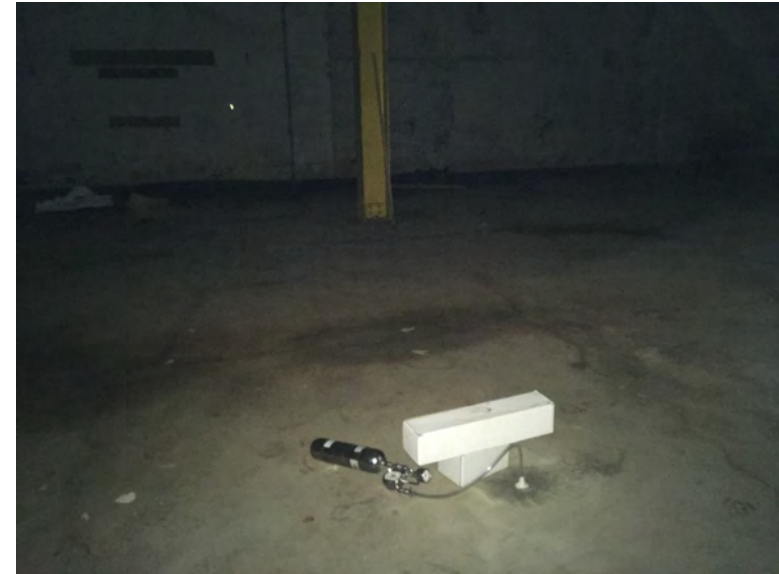
34. SS-06 southern end of basement.

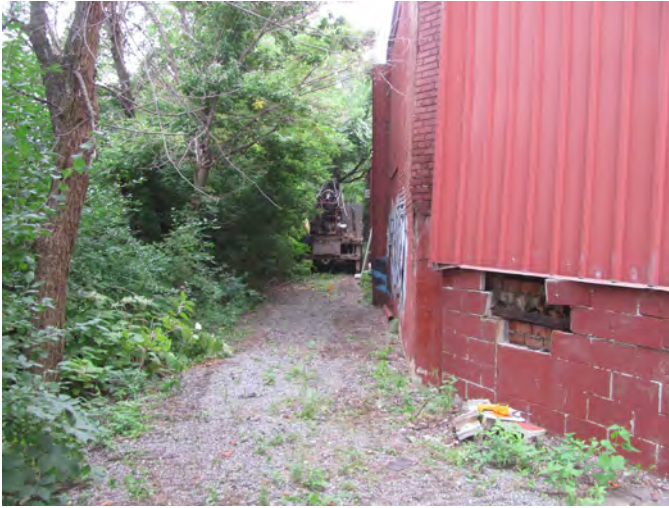
37. 31-MW-3 Well install location, adjacent creek, southeast edge of property.

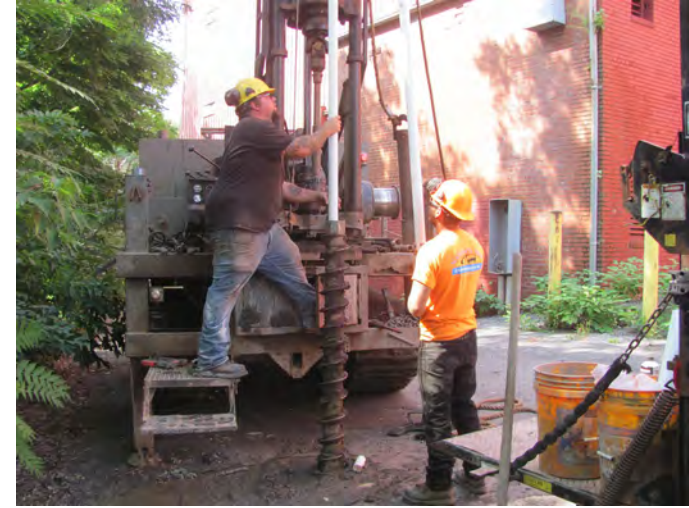
38. 31-MW-4 well installation adjacent creek on east side of property.

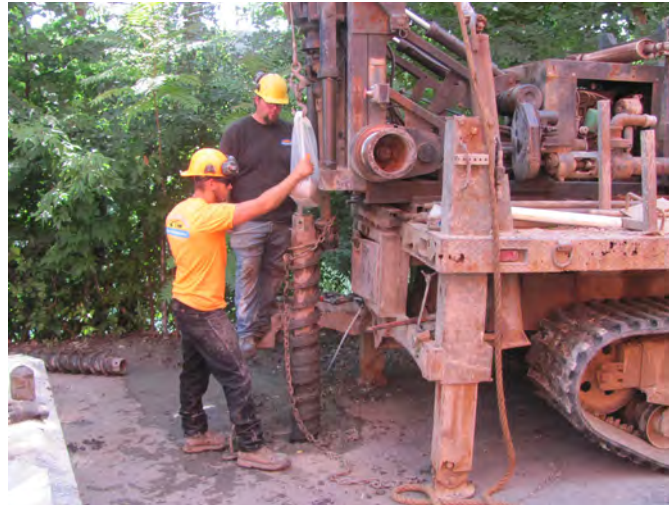
39. 31-MW-4 well installation. No. 0 sand used for filter pack.

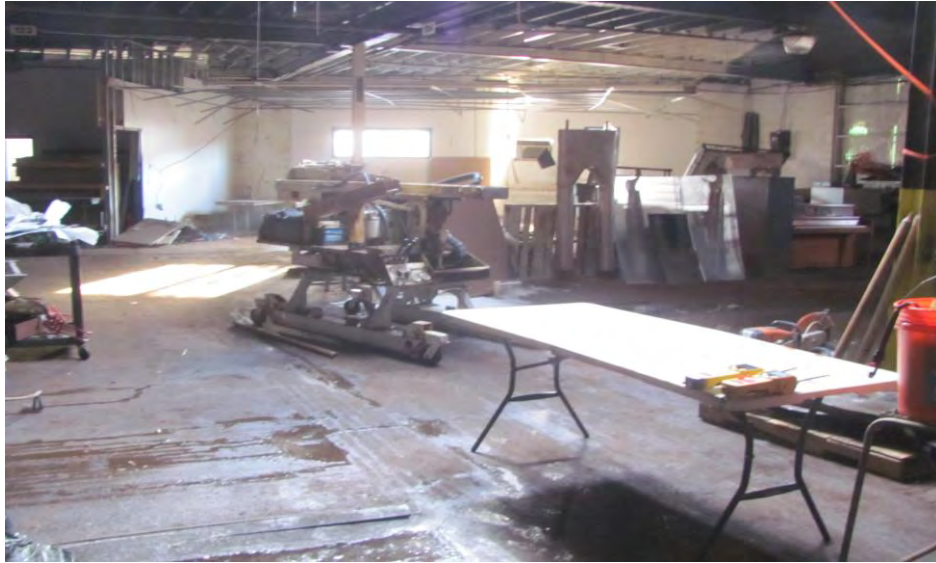
1. Borehole SBH-1 location; from west end facing east

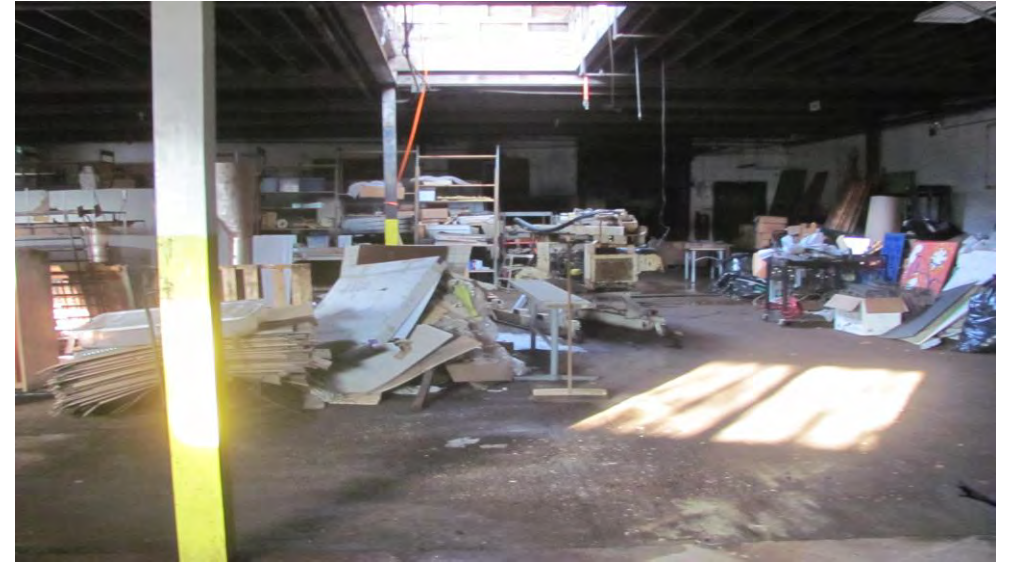
2. View of location of SBH-1 from east facing west

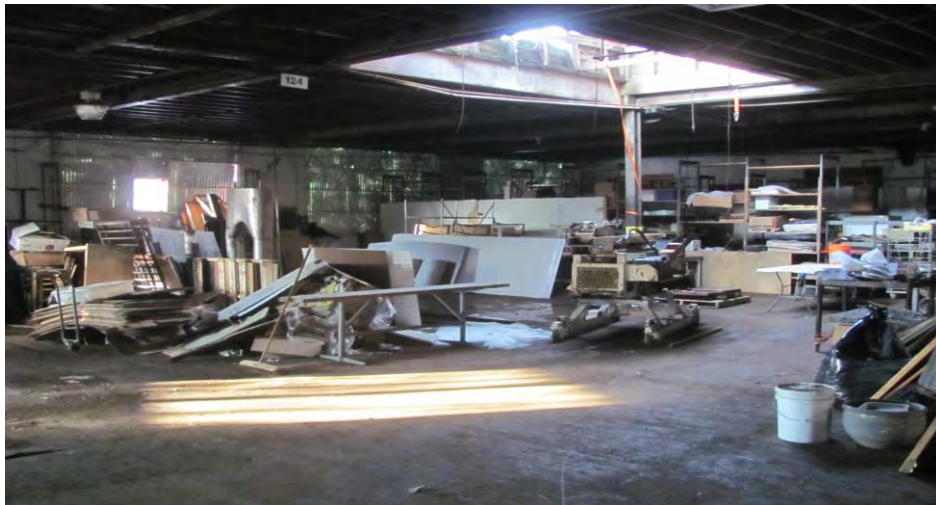
3. Location of SBH-1 from east facing southwest

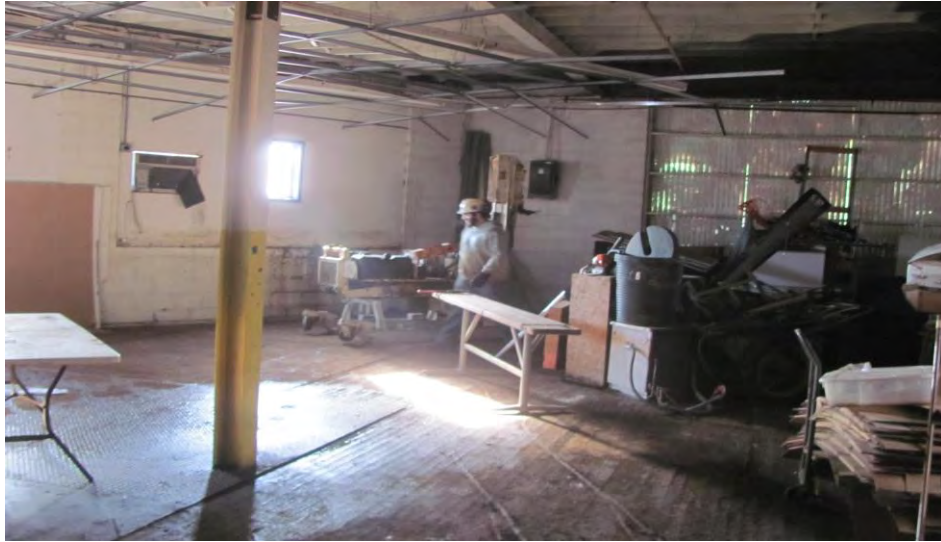
5. Location of SBH-2 facing southeast – in southeast corner of building

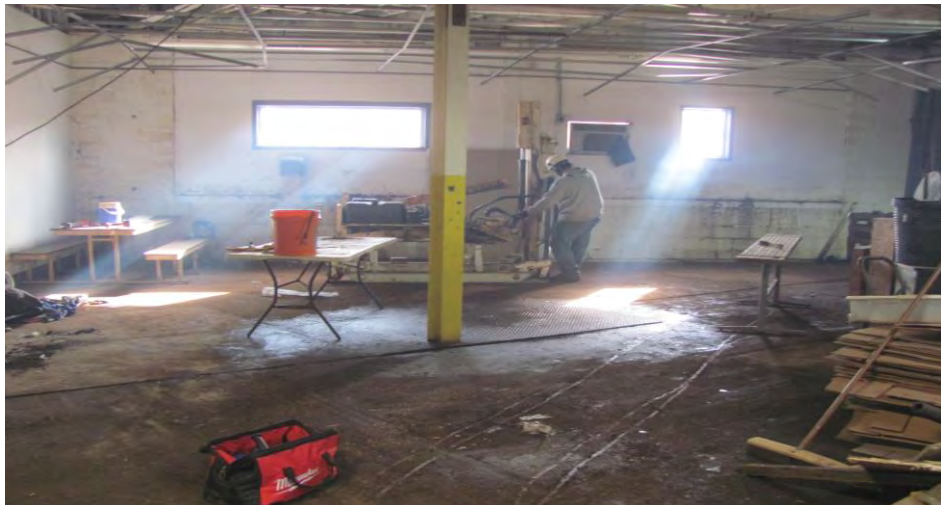
7. Location of SBH-3 from west facing east; location is along wall in southeastern portion of the building

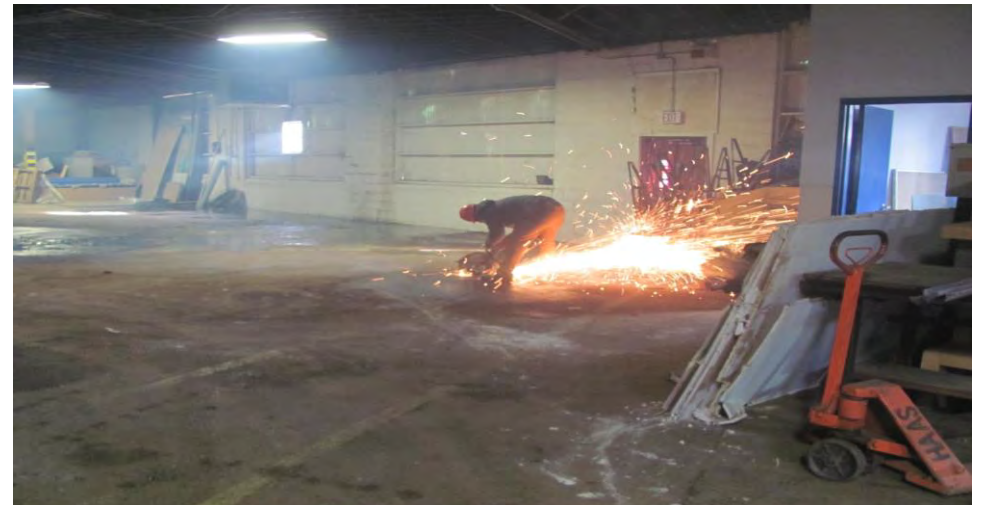
8. View of cutting metal for SBH-5

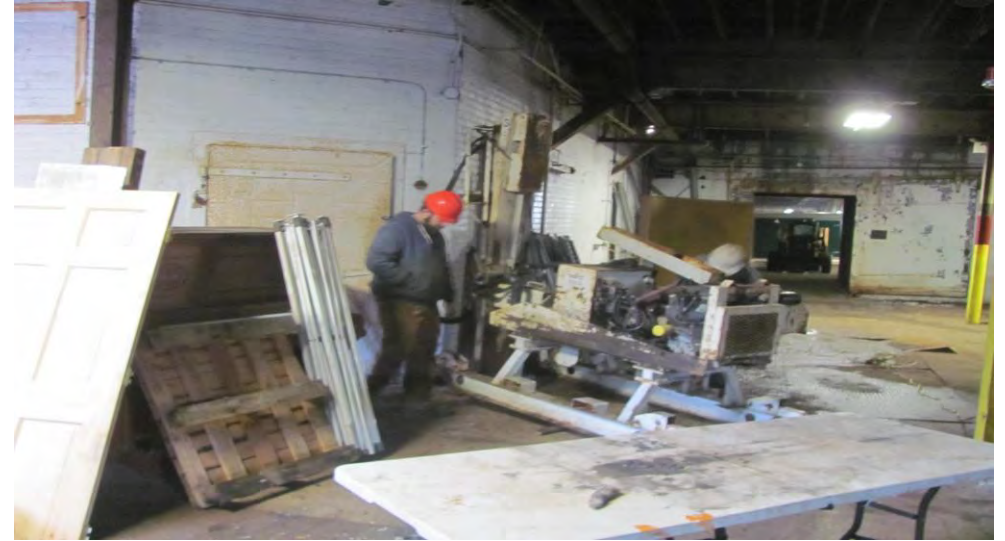
10. Location of SBH-4 facing northwest

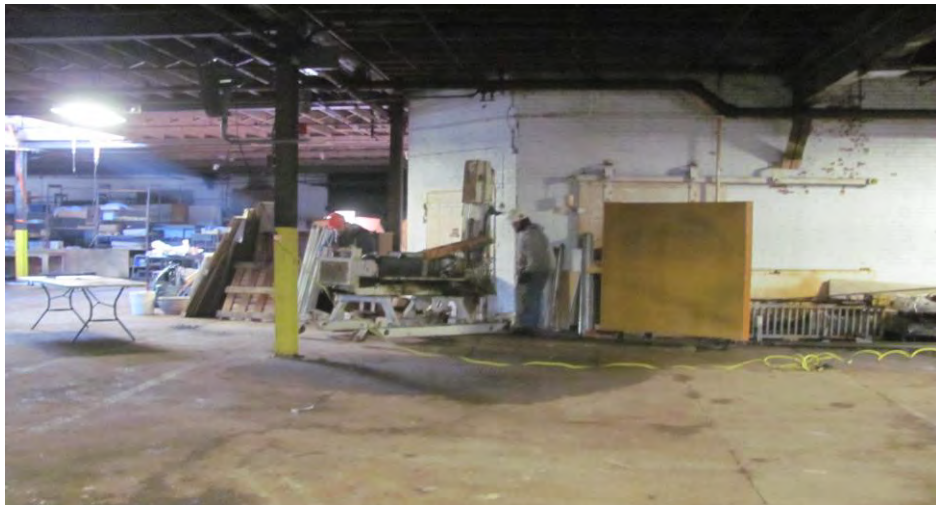
11. Borehole SBH-4 facing west

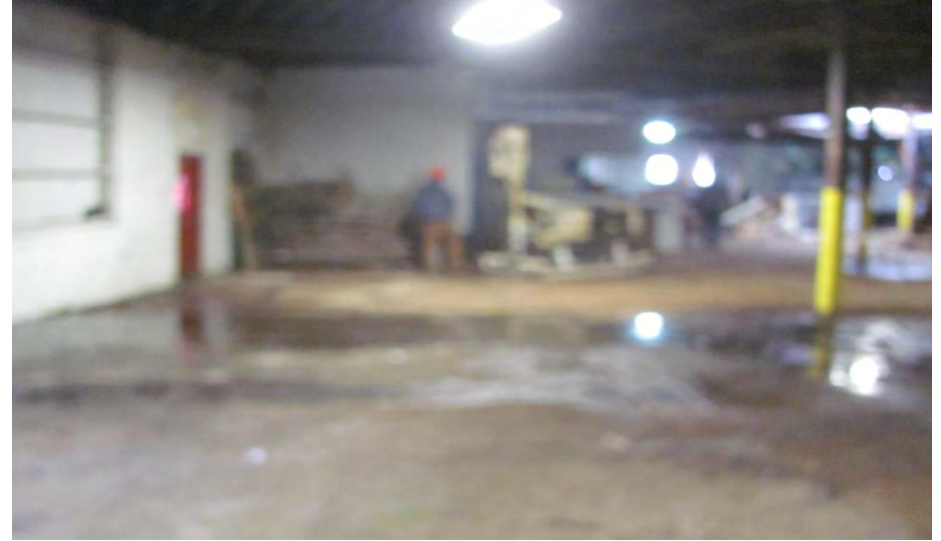
14. Location of SBH-5 facing south

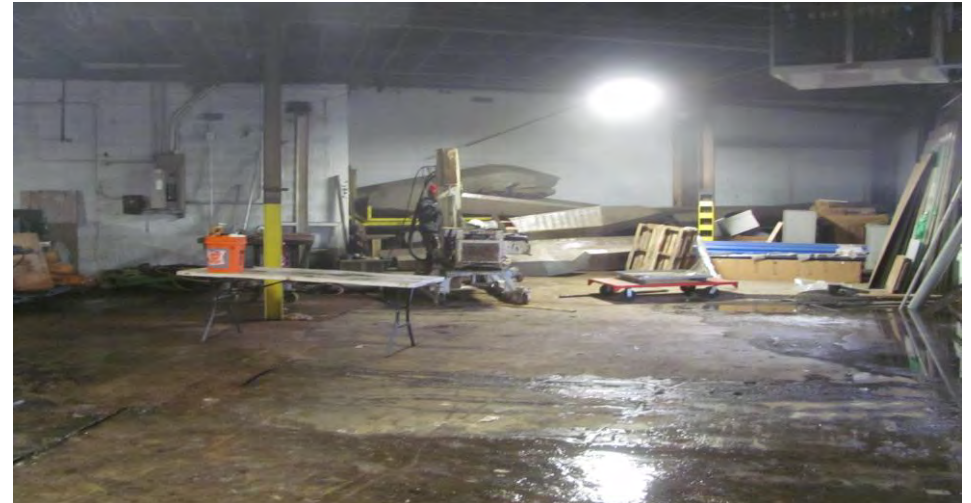
16. Location of Borehole SBH-6 facing north

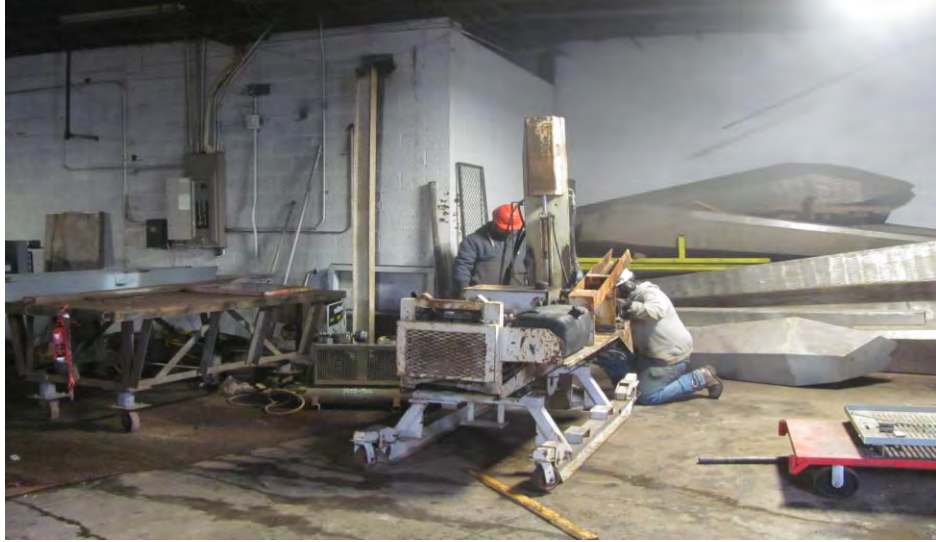
17. Location of SBH-6 facing north

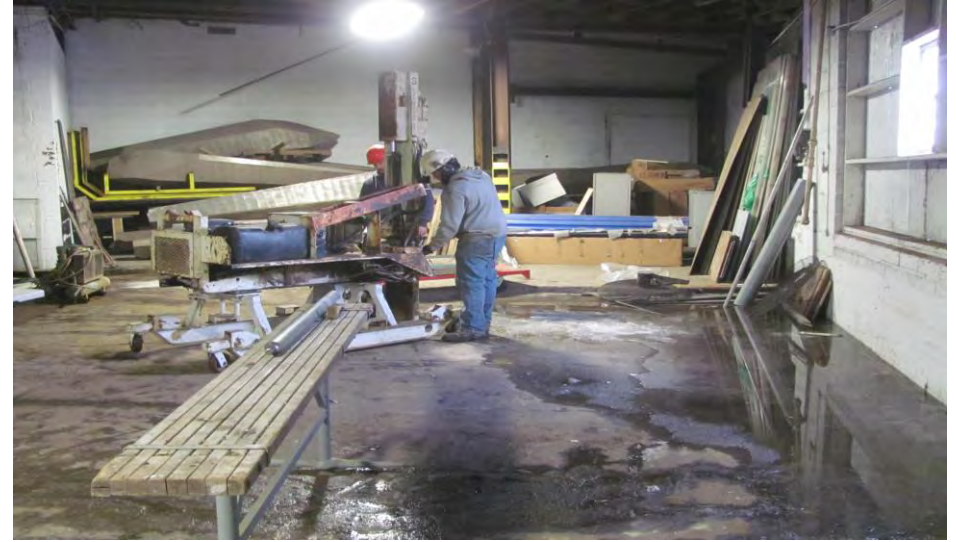
18. Location of SBH-7 facing north

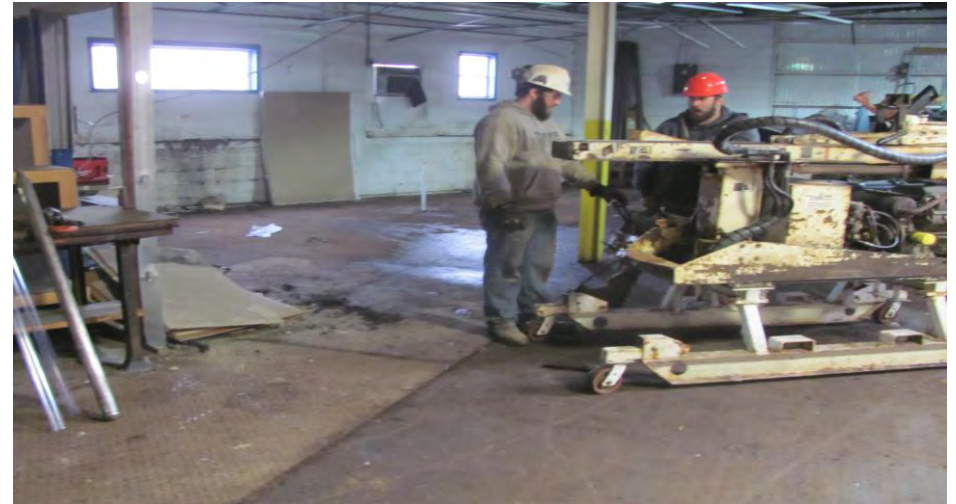
20. Location of Borehole SBH-8 facing southeast

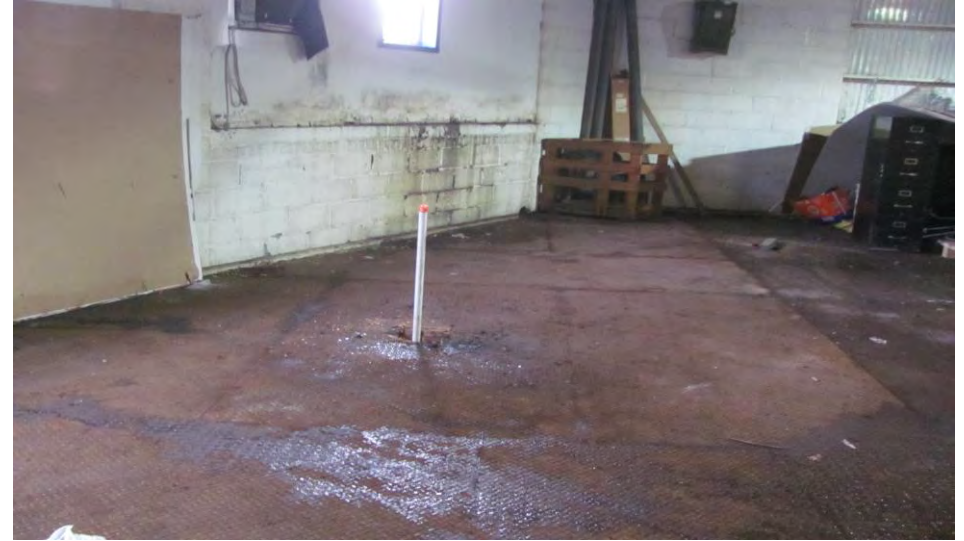
22. Well installed in SBH-3

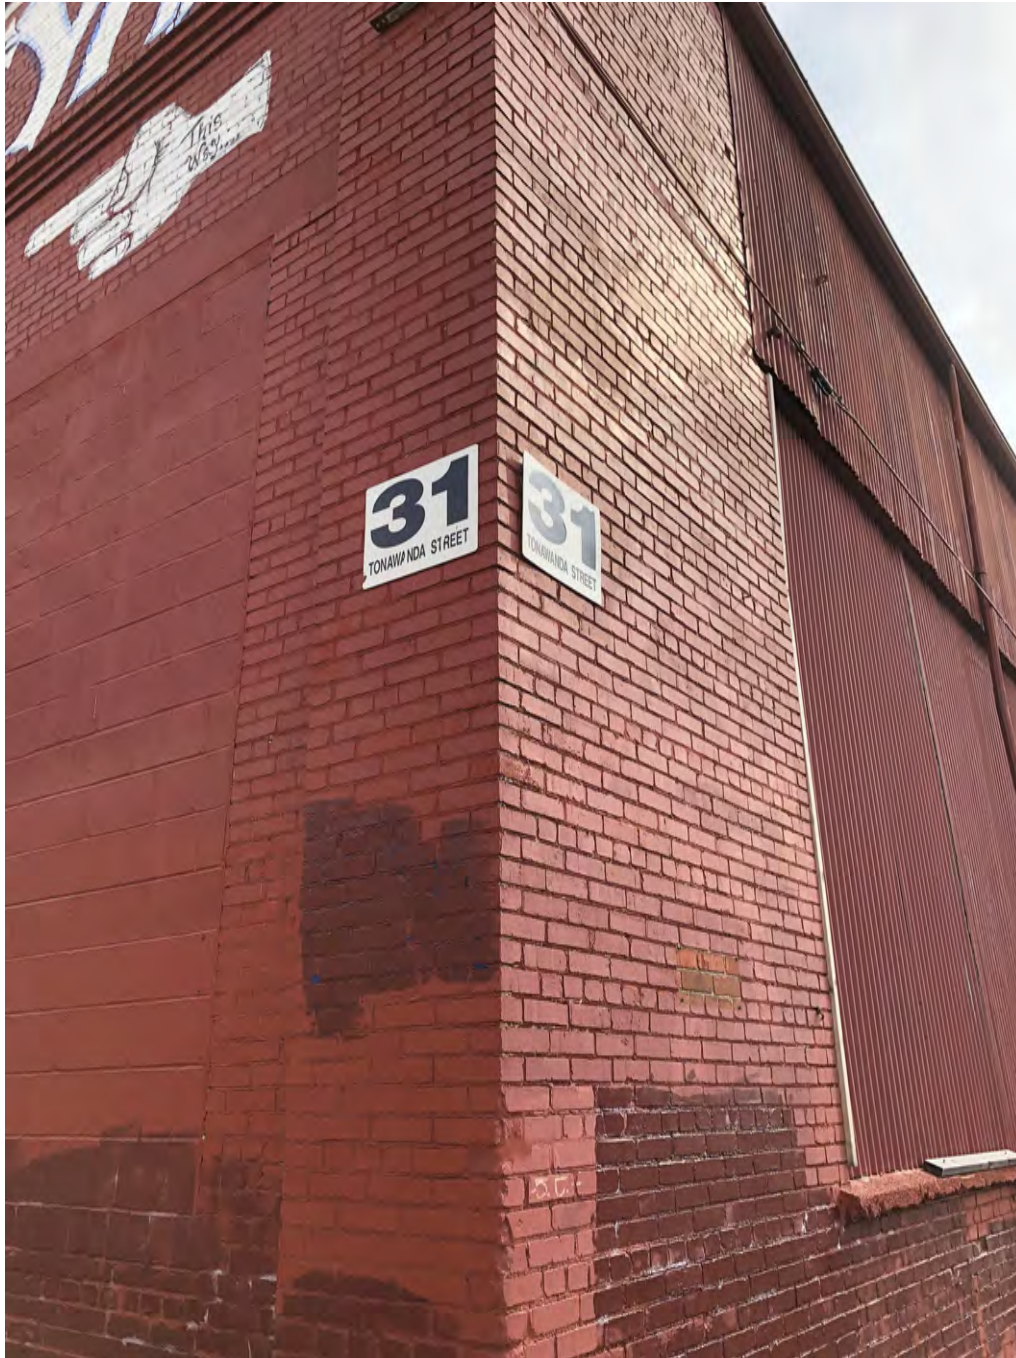
Exterior View of Building

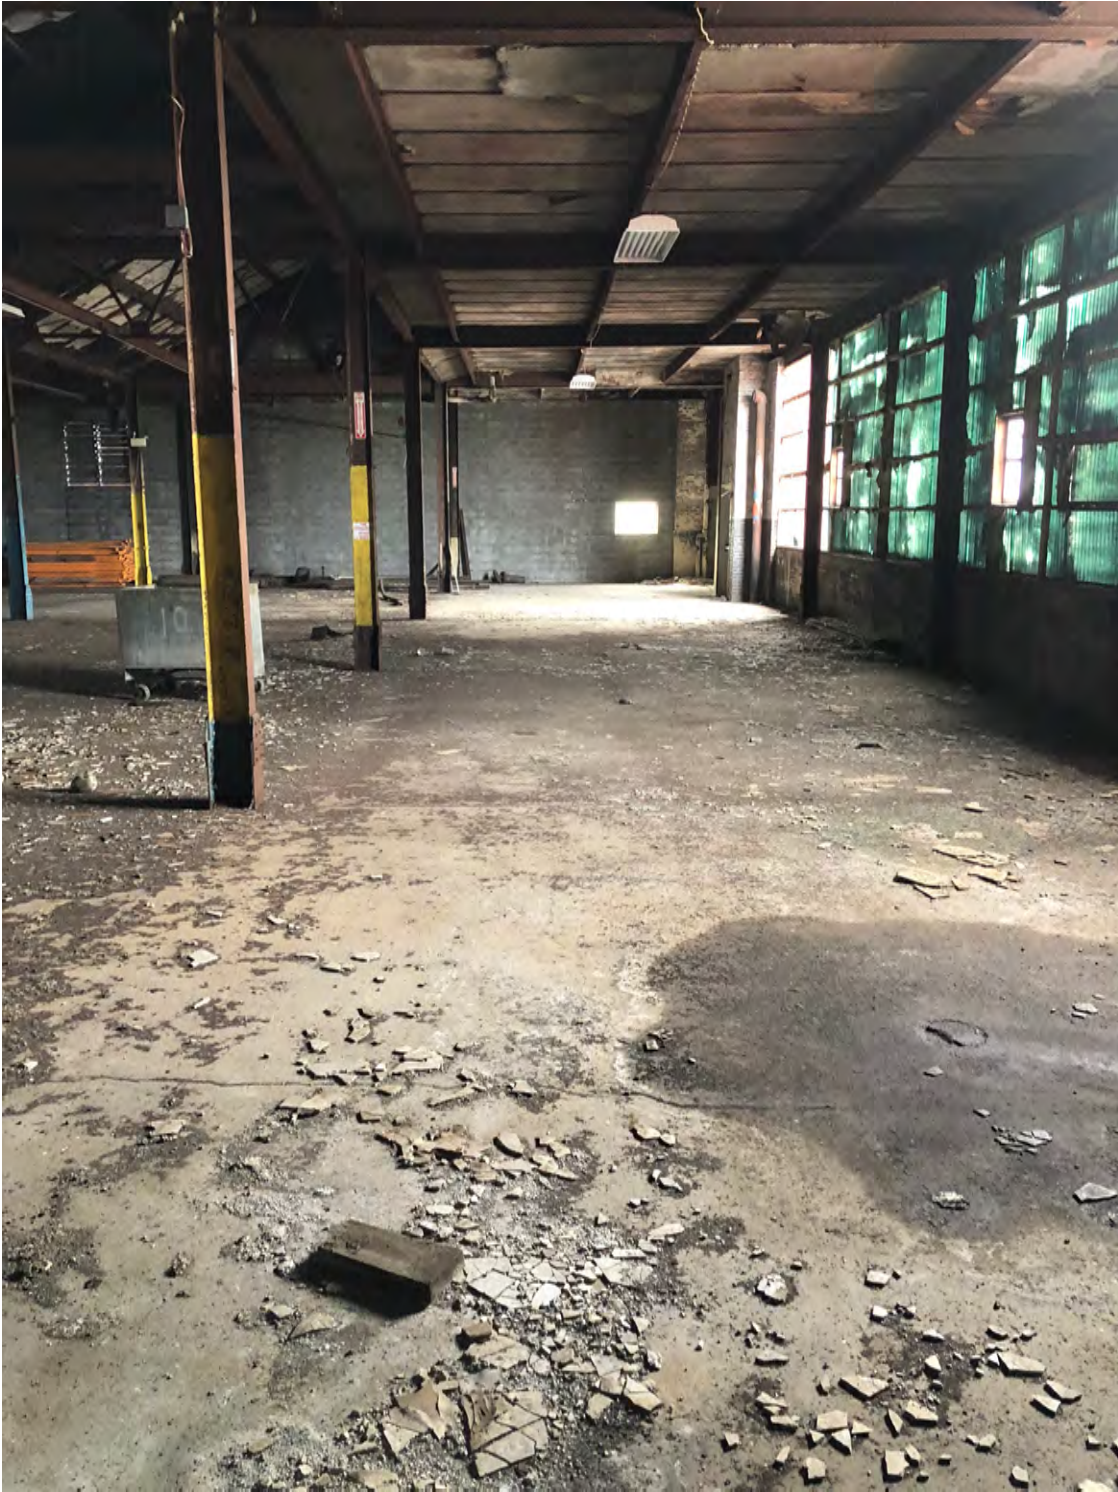
View of Building Interior
