Remedial Investigation Report

**31 Tonawanda Street Off-Site Area
Buffalo, Erie County, New York
Site Number C915299A**

August 2023

New York State Department of Environmental Conservation
Region 9
700 Delaware Avenue
Buffalo, New York 14209

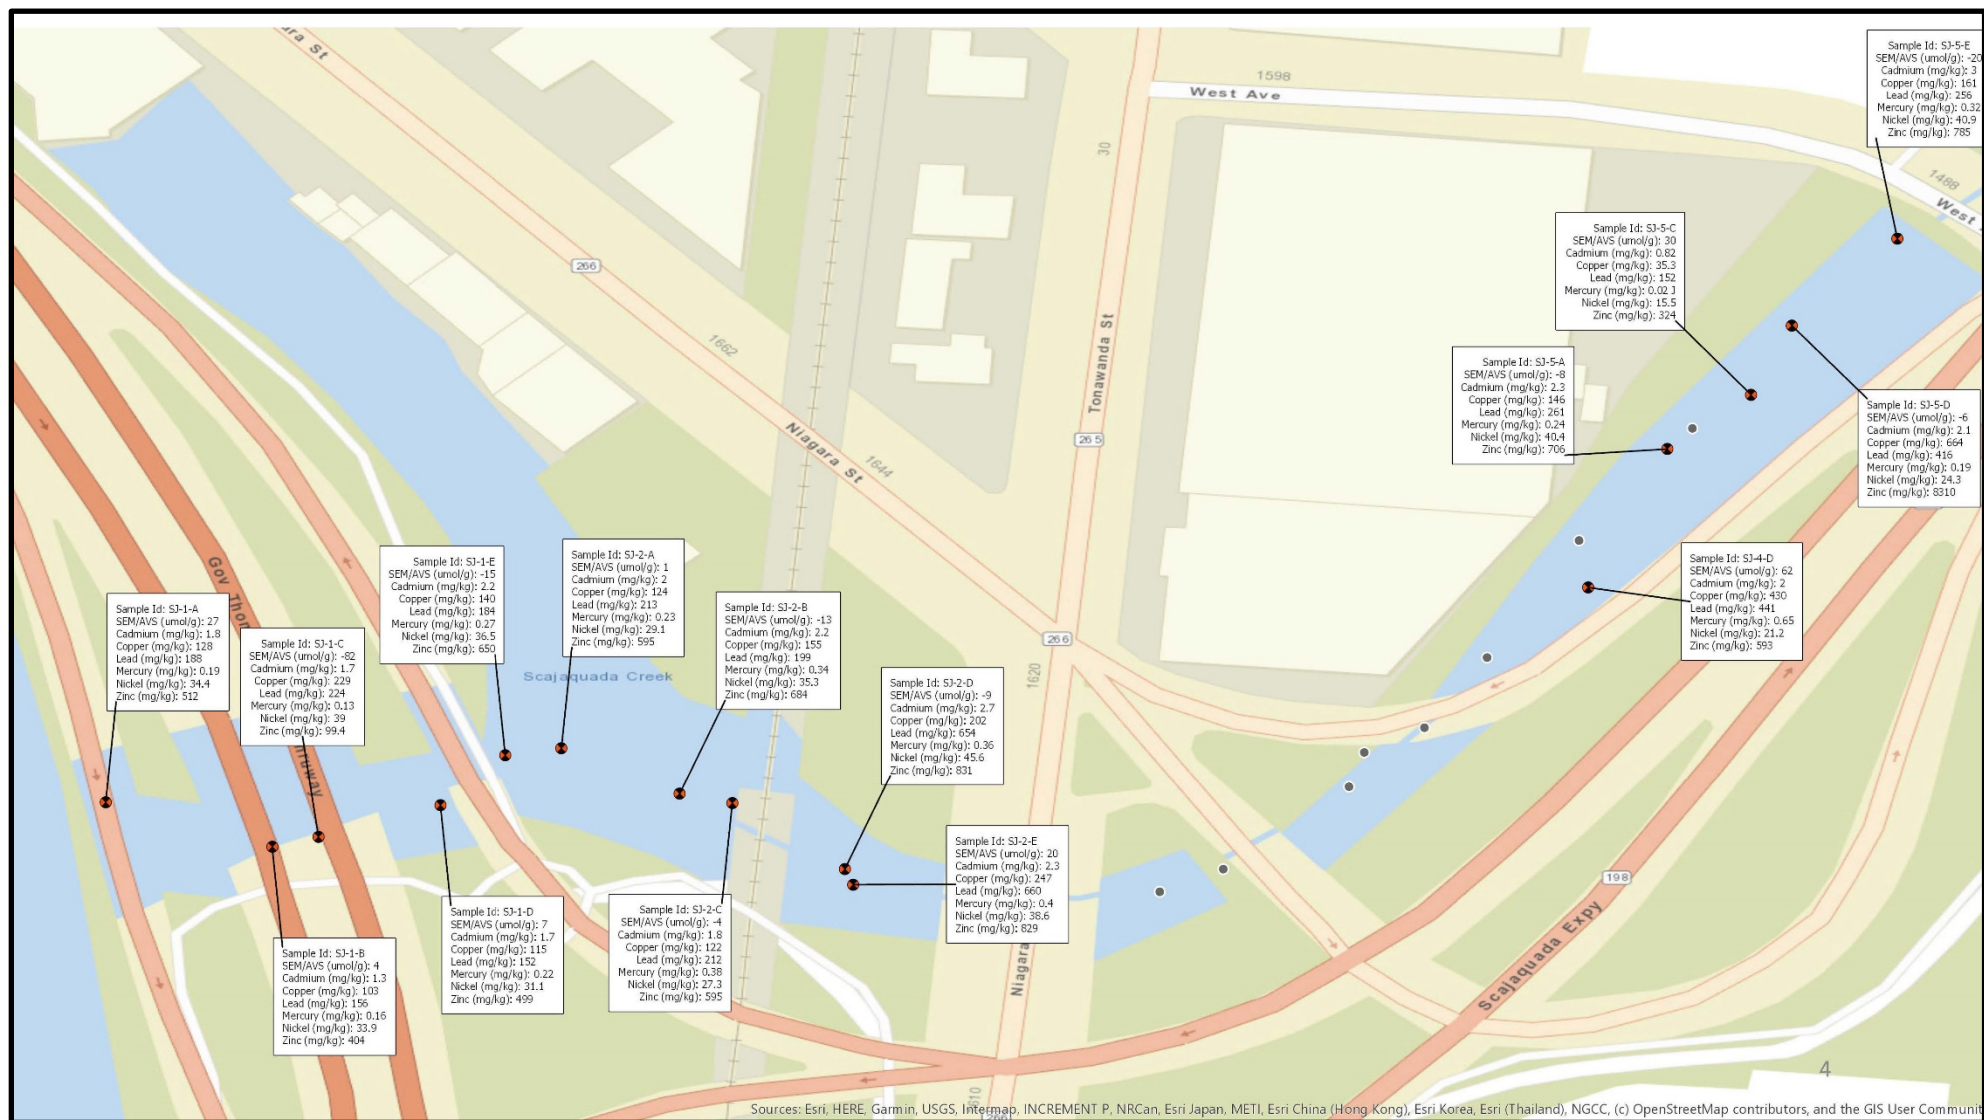
Figure 3-4. 2017 USACE Sediment Sample Location Map with Metals Results.

All twenty (20) sediment samples collected from Scajaquada Creek downstream of West Avenue were analyzed for metals (Tables 6-11 and 6-12). Twenty-three (23) metals were detected in these samples. Of these metals, nine (9) were detected at concentrations that exceeded the NYSDEC sediment guidance values, with eight (8) of these metals being EPA priority pollutant metals. The priority pollutant metals that exceeded the Class B (but not Class C) sediment guidance values included arsenic (4 samples), cadmium (14 samples), chromium (15 samples), copper (9 samples), lead (3 samples), mercury (12 samples), silver (3 samples), and zinc (3 samples). The priority pollutant metals that exceeded the Class C sediment guidance values included cadmium (1 sample), copper (9 samples), lead (17 samples), silver (1 sample), and zinc (14 samples). Concentrations of nickel also exceeded the NYSDEC Class B (14 samples) sediment guidance values (Tables 6-11 and 6-12). The metal results from the sediment samples collected U.S. Army Corp of Engineers in September 2017 are shown on Figure 3-4.

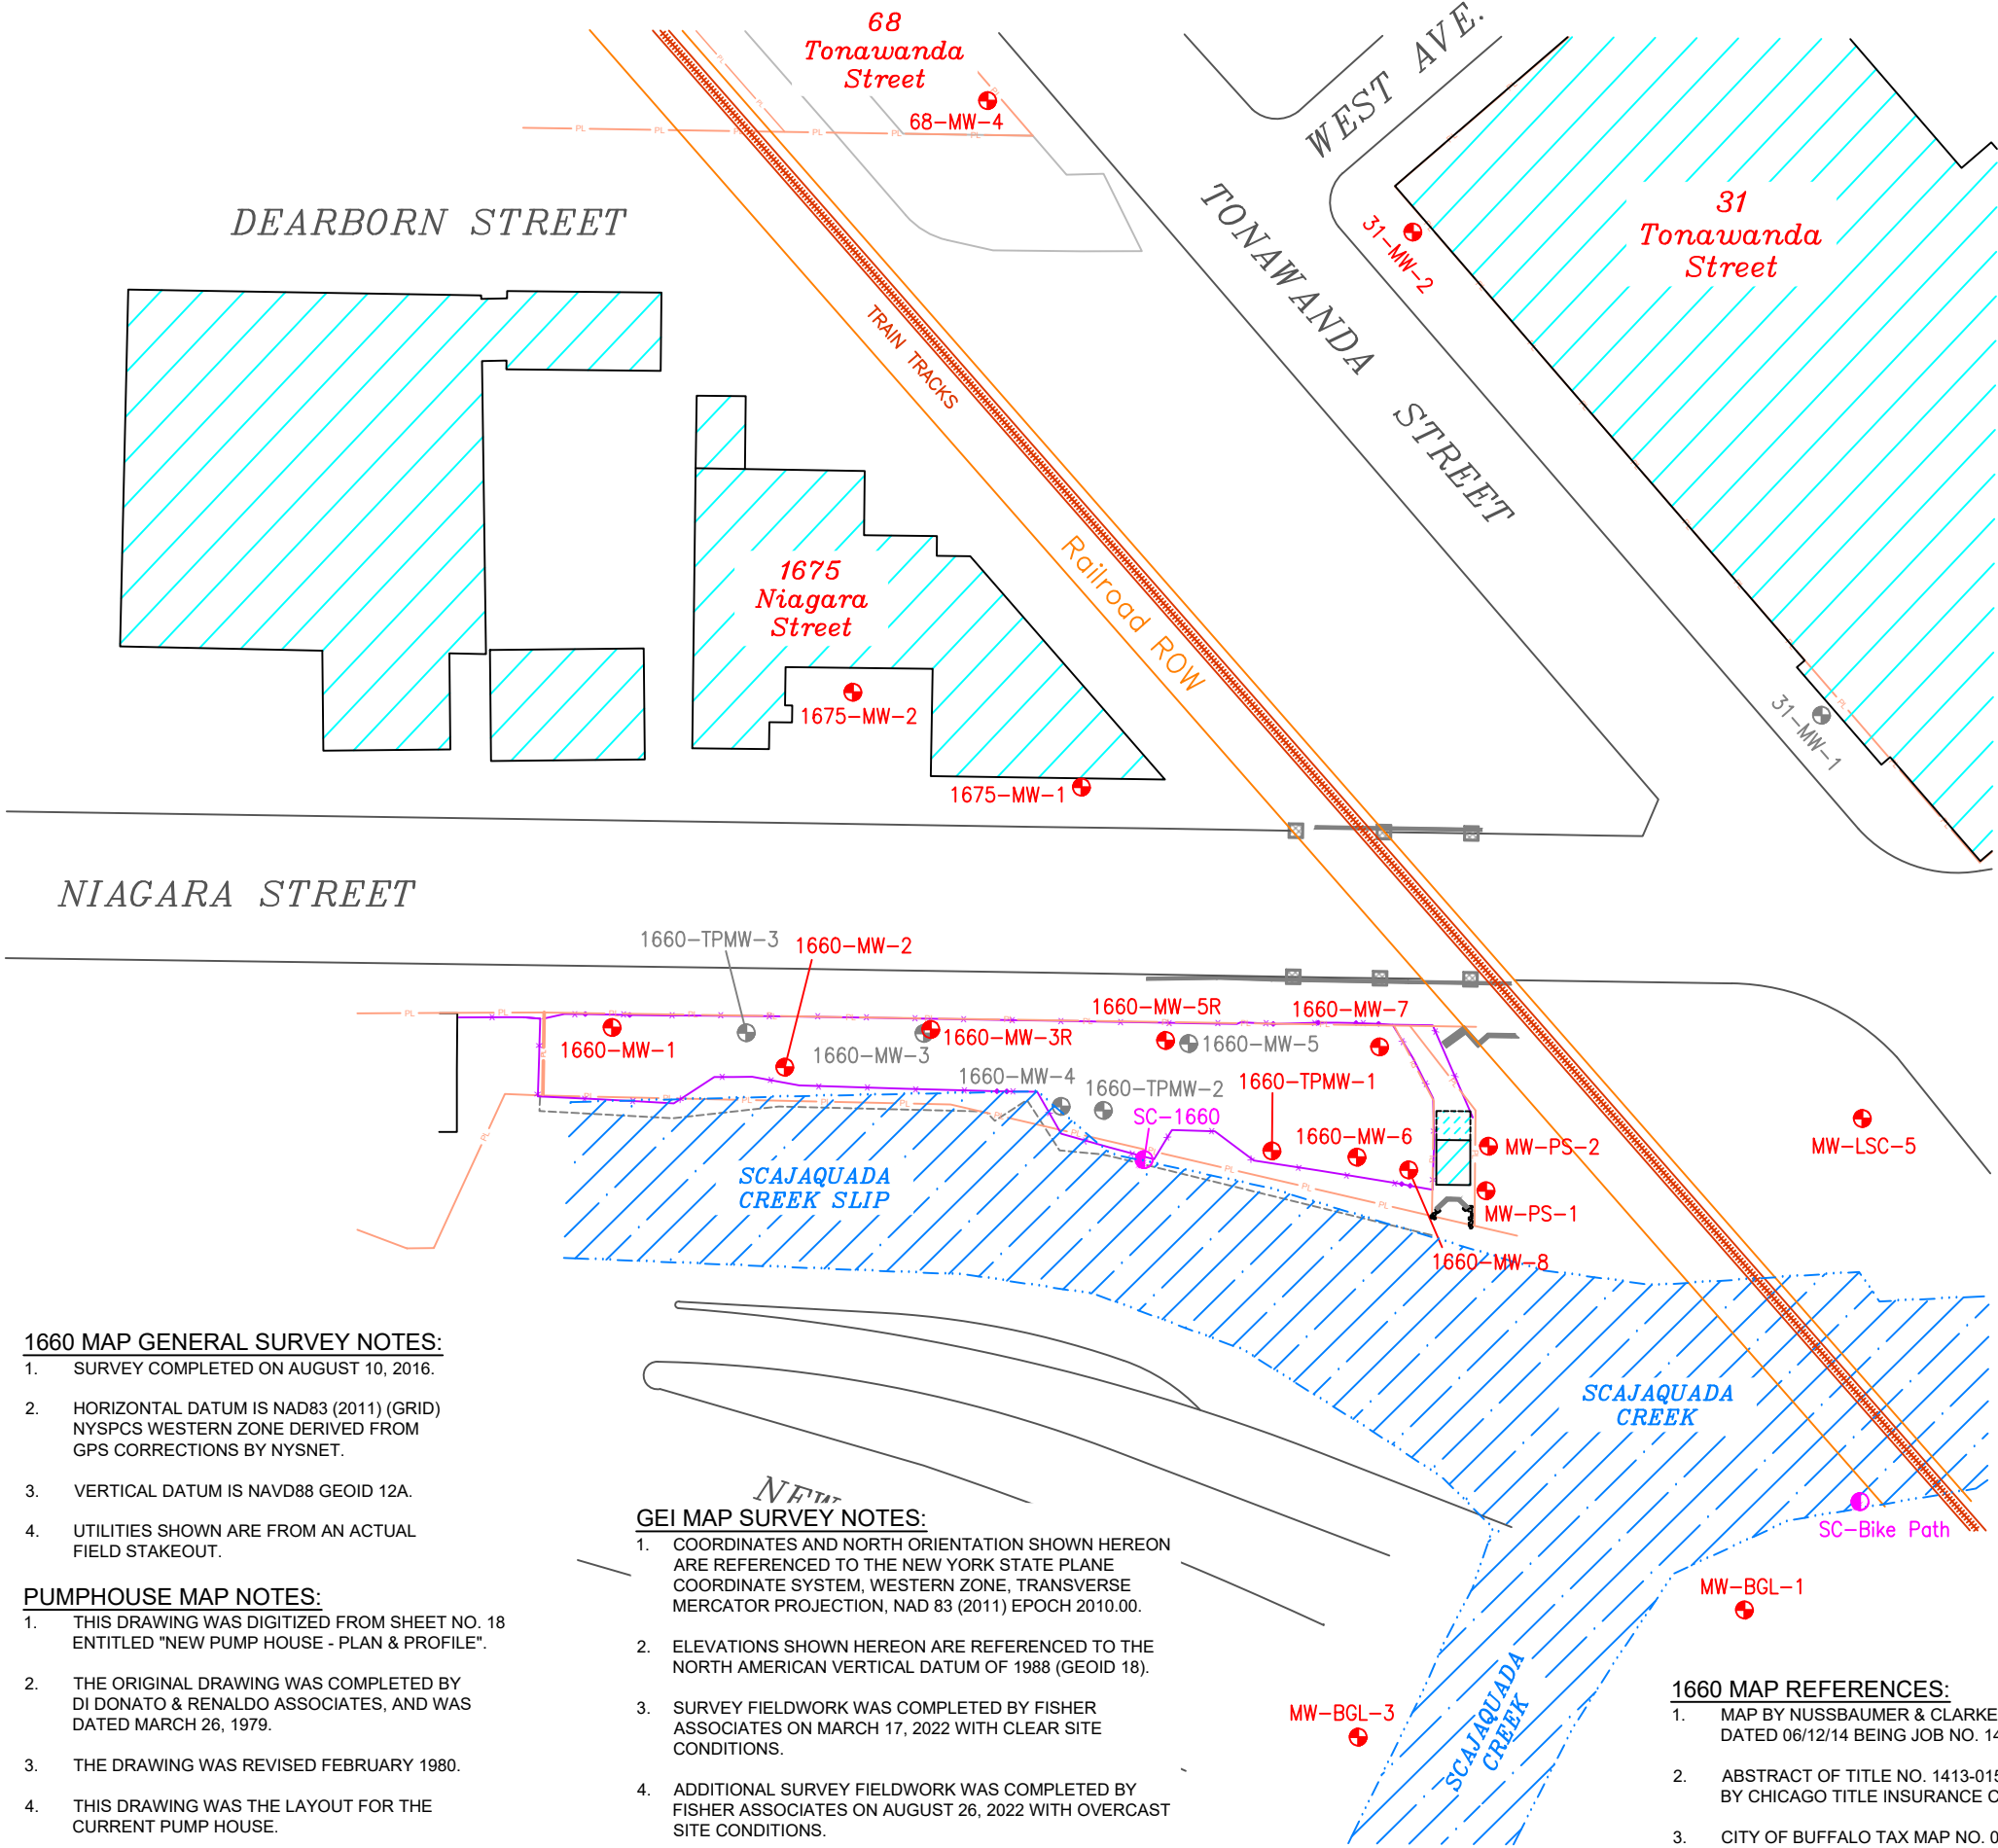
| | CHECK | | | FIGURE 3-10 |

As described in Sections 3.7 and 4.6, three (3) overburden monitoring wells were installed along the bike path during the Remedial Investigation of the 31 Tonawanda Street Off-Site Area. The locations of these wells are shown on Figure 3-10. Groundwater samples collected from these wells were analyzed for TCL volatile organic compounds via USEPA method 8260C, TCL semi-volatile organic compounds via USEPA method 8270D, TCL pesticides via USEPA method 8081B, TCL PCBs via USEPA method 8082A, TAL metals via USEPA method 6010C, and mercury via USEPA method 7470A. The analytical results for these samples are summarized in Table 6-3, while information concerning sample collection and analysis is given in Table 3-2. The lab report for these samples is included in Appendix F.

Three (3) NAPL samples were collected from bike path well MW-100 (Figure 3-10) during

Figure 8-1 shows the locations of utilities near the 57-71 Tonawanda Street BCP Site. The utilities under and along Tonawanda Street pass close to well 57-MW-4 (see **Figure 3-10** for location), suggesting that these utilities could act as migration pathways for contaminated groundwater detected in this well (**Table 6-4**).

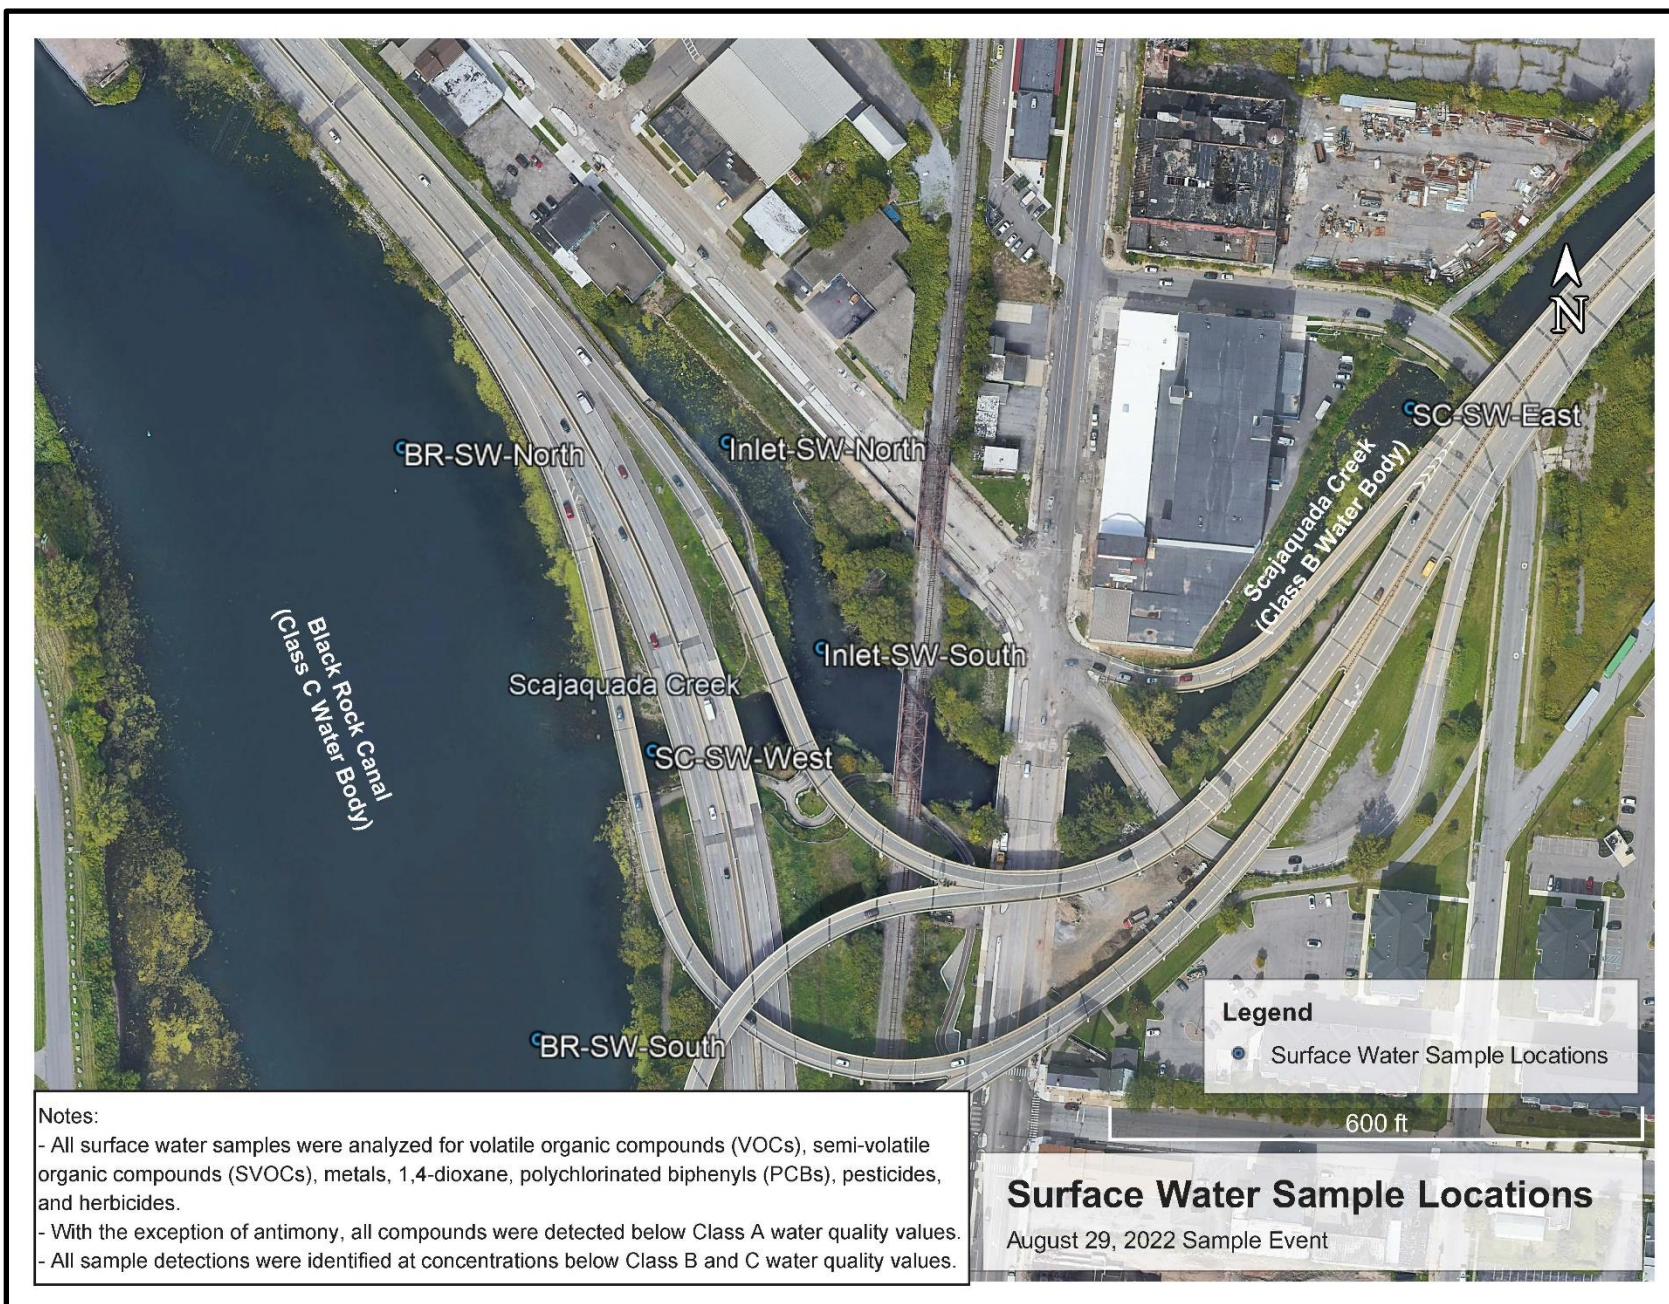
Figure 3-11. Surface Water Sample Location Map for the August 29, 2022 NYSDEC Sampling Event.

The results from six (6) surface water samples collected on August 29, 2022 from the main channel of Scajaquada Creek, the Scajaquada Creek Slip and the Black Rock Canal are summarized in Table 6-14D and were discussed in Section 6.7.2. The approximate locations of these samples are shown on Figure 3-11. Chlorinated VOCs detected in these samples included 1,1-dichloroethane (1 sample) and cis-1,2-dichloroethene (3 samples including a surface water sample collected in January 2020). None of the concentrations detected, however, exceeded NYSDEC surface water standards or guidance values (Table 6-14D).

The results from six (6) surface water samples collected on August 29, 2022 from the main channel of Scajaquada Creek, the Scajaquada Creek Slip and the Black Rock Canal are summarized in **Table 6-14D** and were discussed in Section 6.7.2. The approximate locations of these samples are shown on **Figure 3-11**. Petroleum VOCs were not detected in these samples, indicating that the operation of the pumphouse is not adversely impacting surface water in the Scajaquada Creek Slip with respect to petroleum VOCs.

Table 6-14D and were discussed in Section 6.7.2. The approximate locations of these samples are shown on Figure 3-11. Polycyclic aromatic hydrocarbons were not detected in these samples, indicating that the operation of the pumphouse is not adversely impacting surface water in the Scajaquada Creek Slip with respect to polycyclic aromatic hydrocarbons.
