April 22, 2021

To: Benjamin McPherson (NYSDEC)

From: Todd Waldrop (Inventum)

RE: Surface Water System - Next Steps
Riverview Innovation & Technology Campus, Inc.
Brownfield Cleanup Program Site No. C915353
Town of Tonawanda, New York

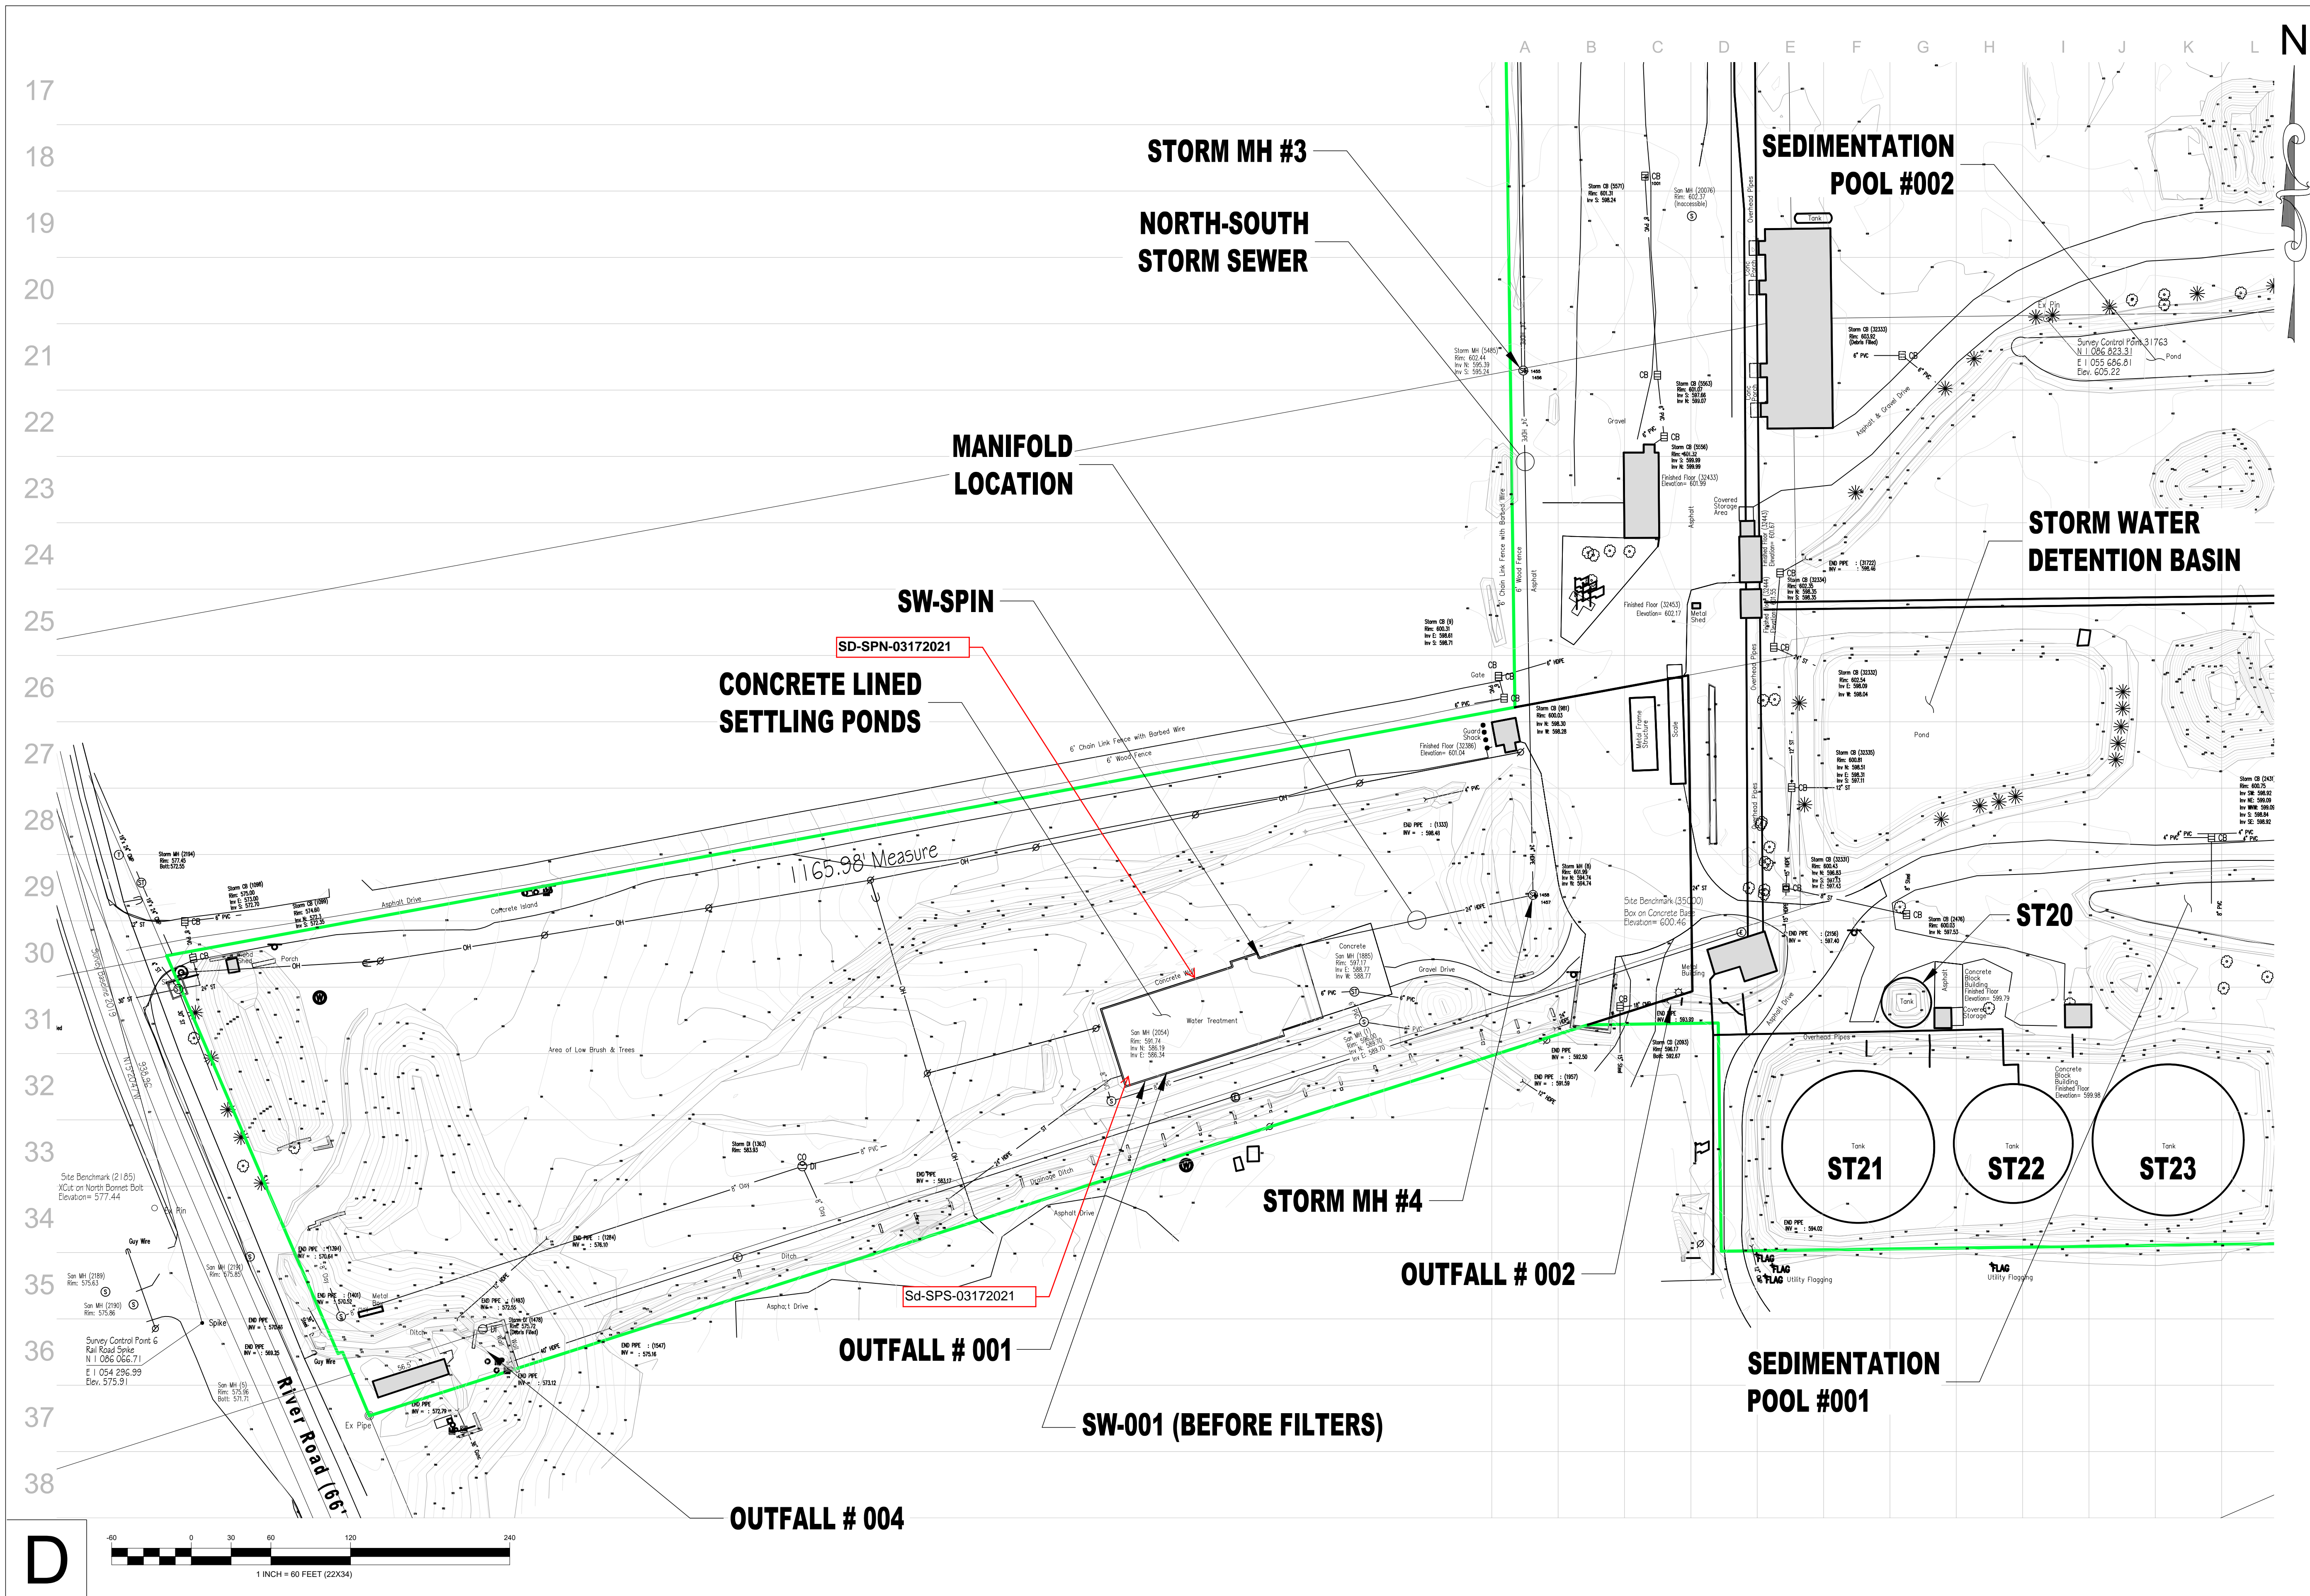
FIGURE 1
 DRAWING NUMBER
SW-002

For source evaluation purposes, eight grab samples of water from the surface water collection system (Figures 1 and 2, and Table 1) were collected on February 24, 2021 coincident with the February SWPPP sample collection. Only the SWPPP sample represents the flow at the discharge, the grab samples are not compliance samples, the samples are not representative of flows from the discharge point.

The grab water data indicate that the concentrations of six compounds (Mercury, Ammonia, Cyanide, Benzene, Naphthalene, and Toluene) within the system would exceed the Action Levels if they were discharged through #001 directly. The concentrations of four of the compounds (Mercury, Benzene, Naphthalene, and Toluene) were effectively treated in the system and the February SWPPP sample indicates compliance with the Action Levels for those compounds. Mercury was in compliance in February, but was not in the January sample. The following were noted in the grab water data (Figures 1 and 2, Table 1):

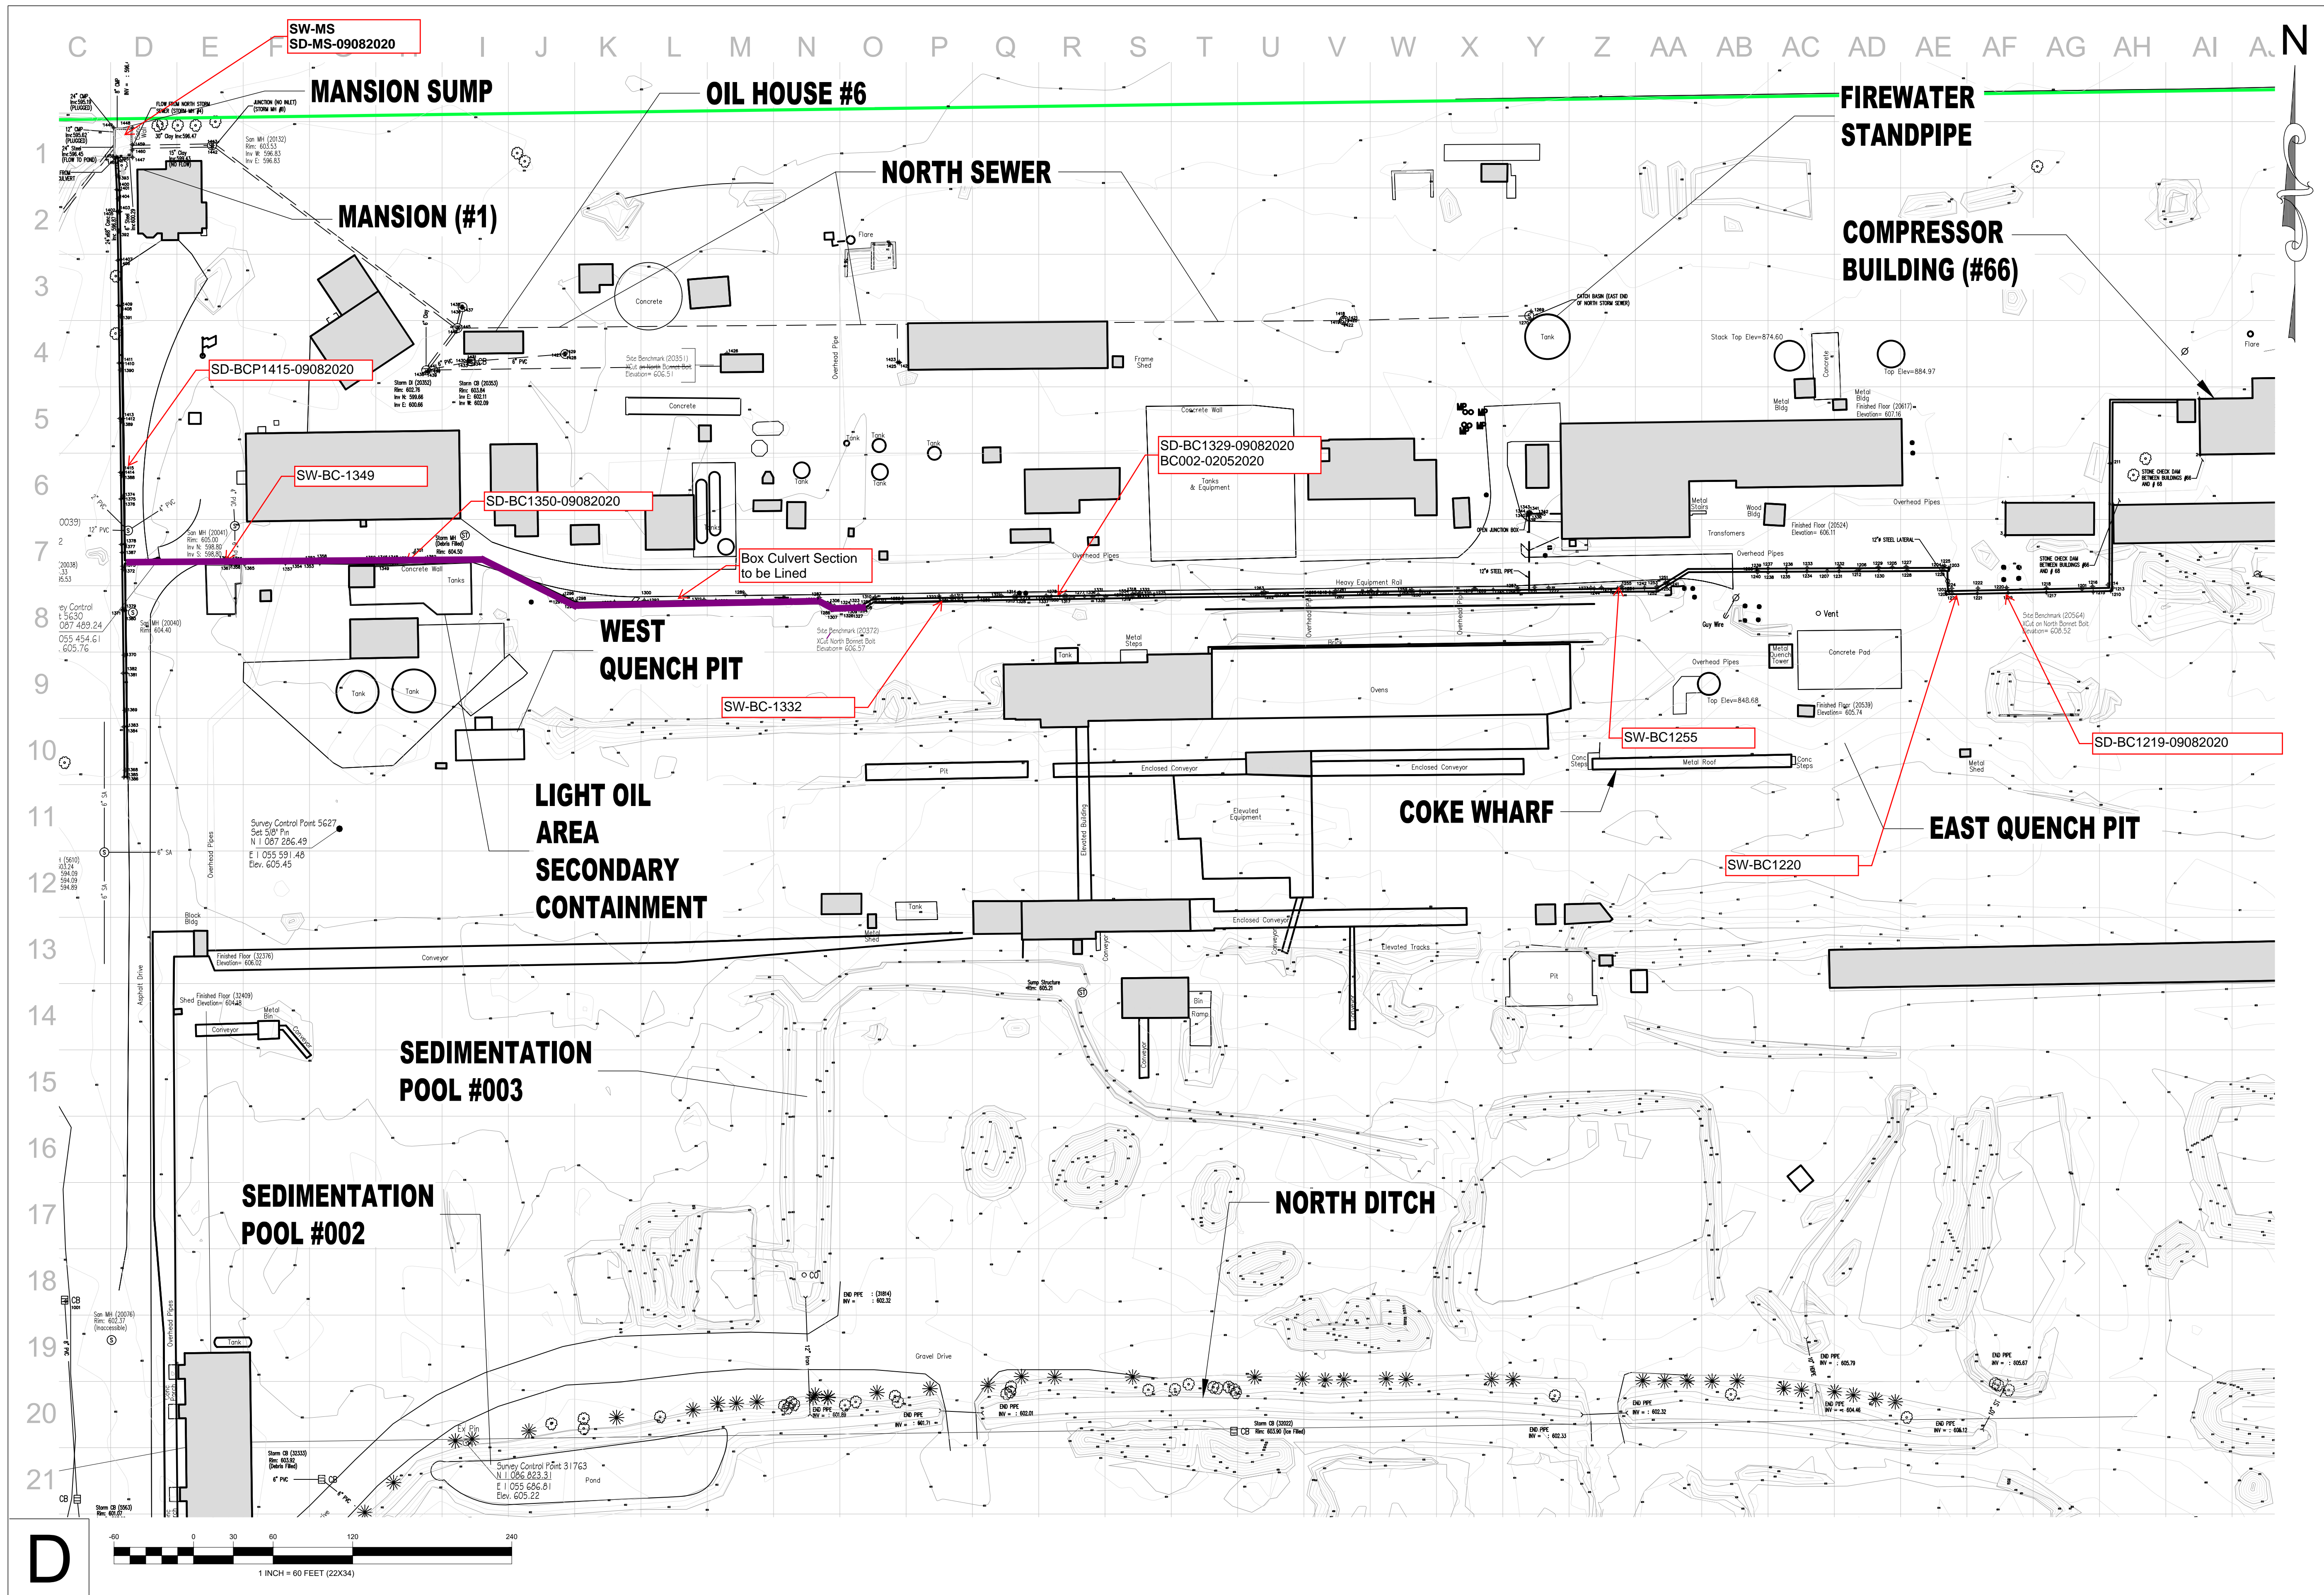
The removal of the sediment from the box culvert allowed sealing of the laterals draining into the system and inspection of the system. The sediment data collected prior to removal is shown in Table 2 (locations are shown on Figures 1 and 2). Following the Box Culvert cleaning, sediment grab samples were collected from the two settling Ponds (SD-SPN-03172021 and SD-SPS-03172021) for the three compounds affecting the SWPPP (Mercury, Ammonia and Cyanide). The sediment sample from the North settling pond was collected along the north side immediately downgradient of the discharge. The sediment sample from the South settling pond was collected in the southwest corner of the pond. The sample locations were based on visual characteristics on the sediment, the north pond sediment was light brown and somewhat organic in nature, the sample from the south pond was black and released a significant amount of gas when disturbed. The data:

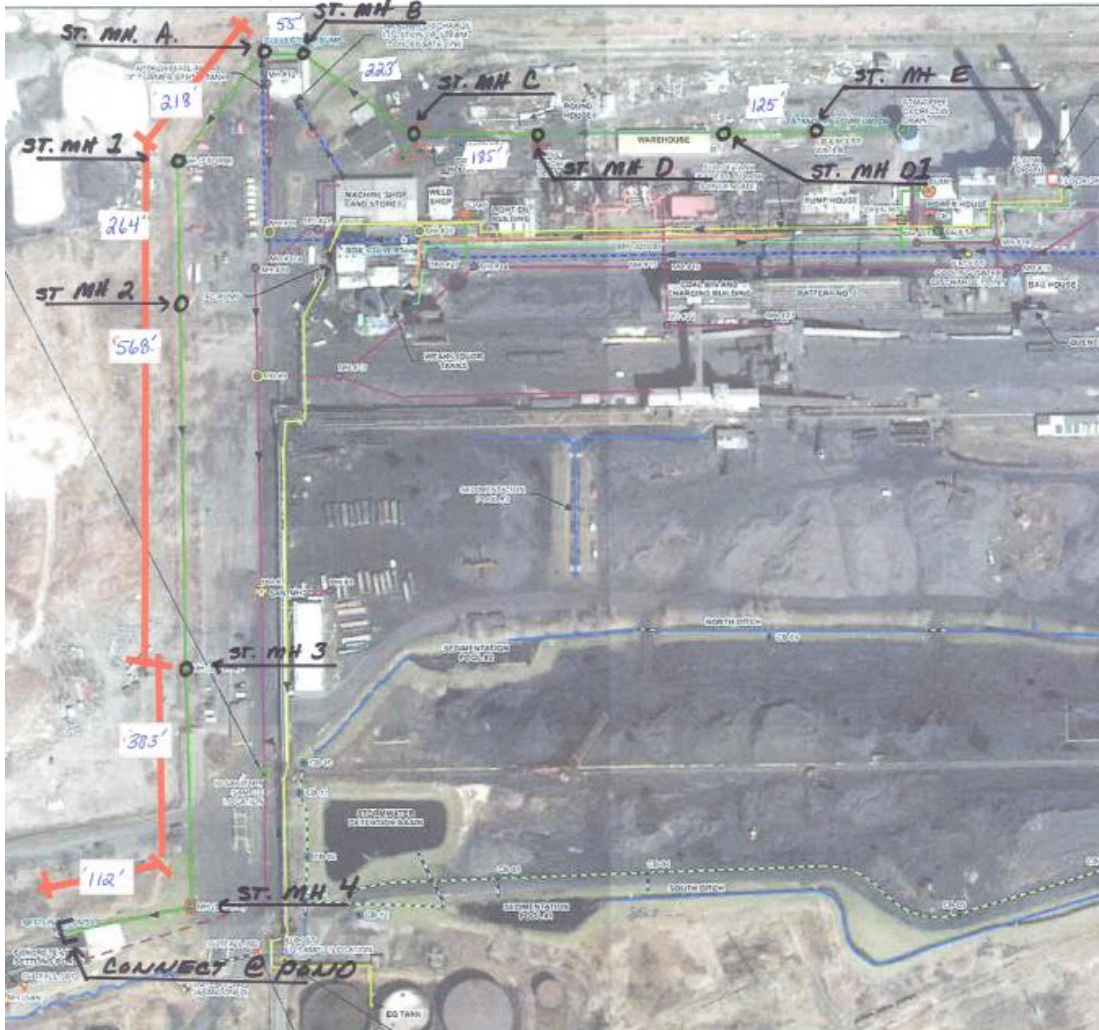
Inspection Sections

- 1 - The red line was added by videographer to indicate the length of sections associated with each video segment.
- 2 – The MH designations are by Kandy.
- 3 - The colors noted from the video are not necessarily true colors as the light from the robot and pipe enclosure can distort the color.
