January 8, 2014  
File No.: 21.0056546.00

Re: Storm Sewer Investigation Report  
BCP Sites # C932138, C932139, C932140  
GM Components Holdings  
200 Upper Mountain Road  
Lockport, NY 14094

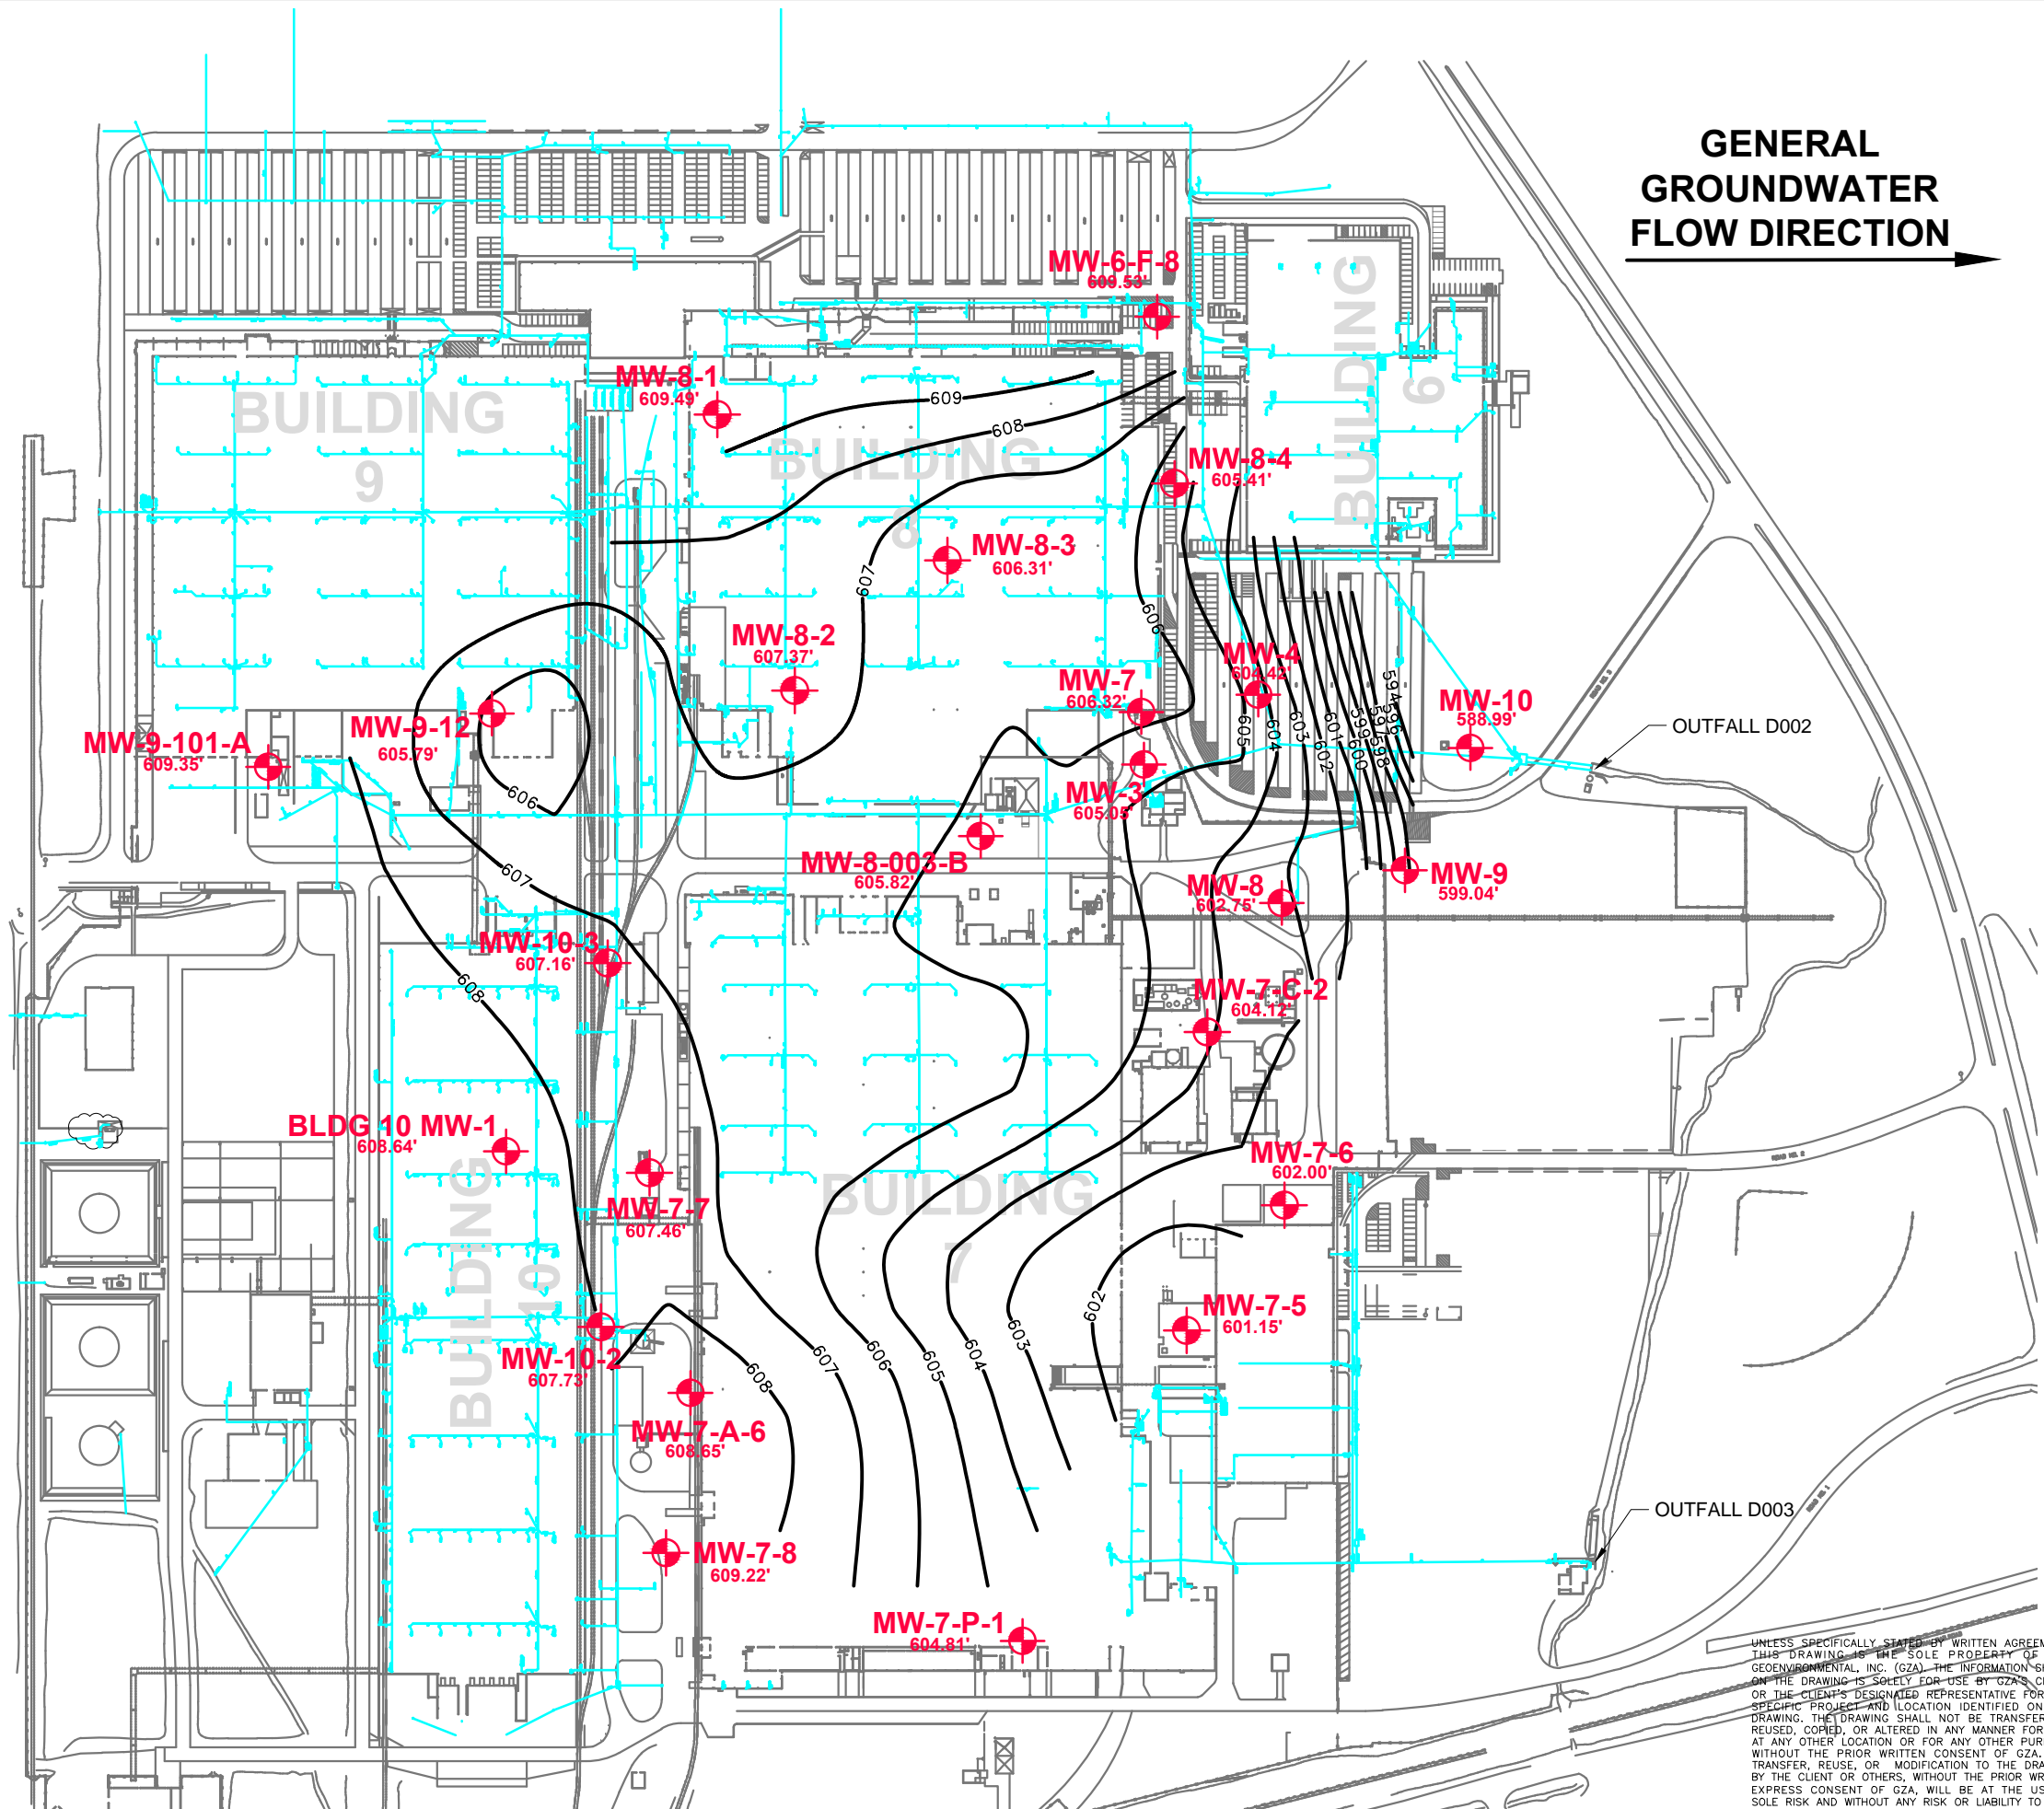
Groundwater elevations were measured at select monitoring wells within the storm sewer sampling area after the first sampling event. The groundwater measurements are depicted as groundwater contours shown on Figure 2. A comparison was done of the groundwater contours and the elevations of the various storm sewer components. The storm sewer component elevations were determined from a drawing provided by GMCH or from measurements collected from select storm sewer components in the field. These elevations are provided on Table 1. The portions of the storm sewer system highlighted in orange on Figure 3 represent portions of the system that are located at or below the groundwater elevation based on the comparison completed.

MH-2: The closest monitoring well to MH-2 is MW-8-003-B located 180 feet northeast and cross-gradient based on the groundwater contours shown on Figure 2. The total COC concentrations at these locations are 24.8 ppb and 2,180 ppb (two orders of magnitude difference) with MW-8-003-B being the higher of the two. MH-2 does not appear to have a similar contaminant profile to other nearby wells.

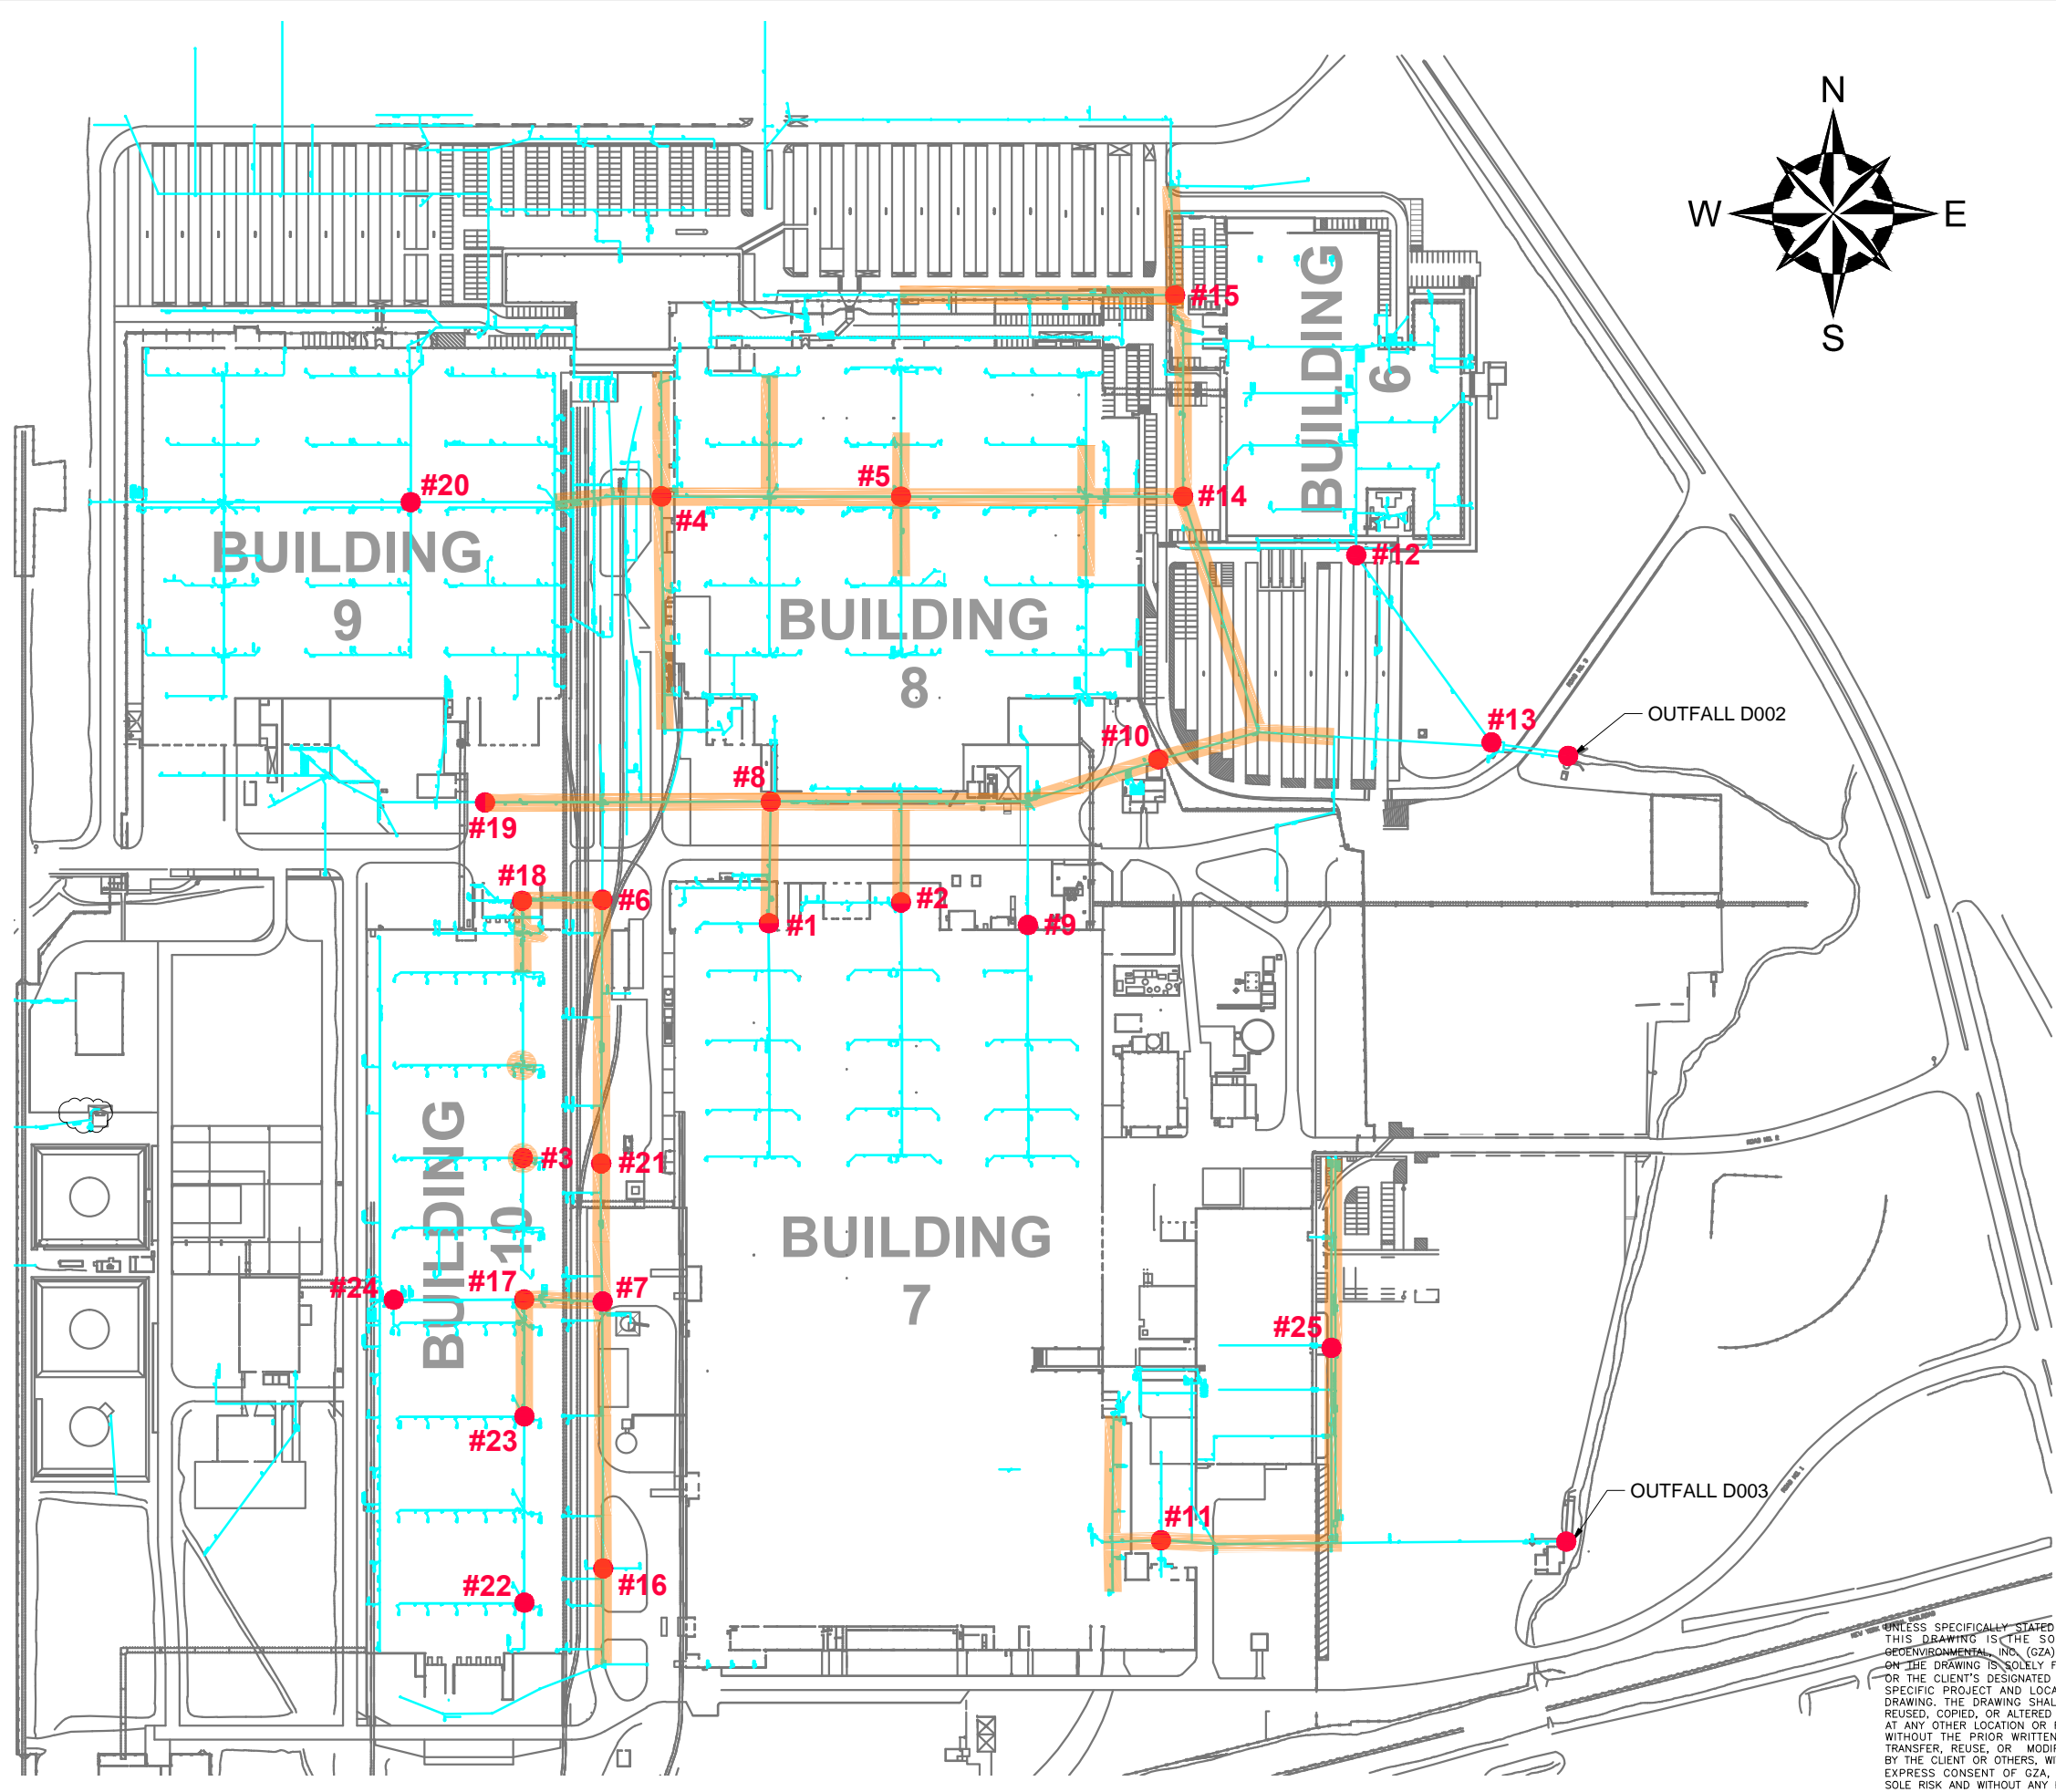
The storm sewer sampling discussed in this report occurred in four (4) events and included 26 different storm sewer structures as shown on Figure 3. [Note that location #7 could not be opened and was not sampled.]. The sampling has been conducted under both low-flow conditions and high-flow conditions.
