From: Mazurkiewicz, Richard [richard.mazurkiewicz@aecom.com]
Sent: Thursday, November 21, 2013 9:54 AM
To: Jim Carter External
Cc: John Signore; Brehm, Kevin
Subject: Draft Remediation Report - Tulip Corp. 3125 Highland Avenue Niagara Falls, NY
Attachments: 13-11-20 DRAFT Tulip Remediation Report.pdf

November 20, 2013

**Subject: Remediation Documentation Report
Tulip Corporation
3125 Highland Avenue
Niagara Falls, New York
AECOM Project 60271770**

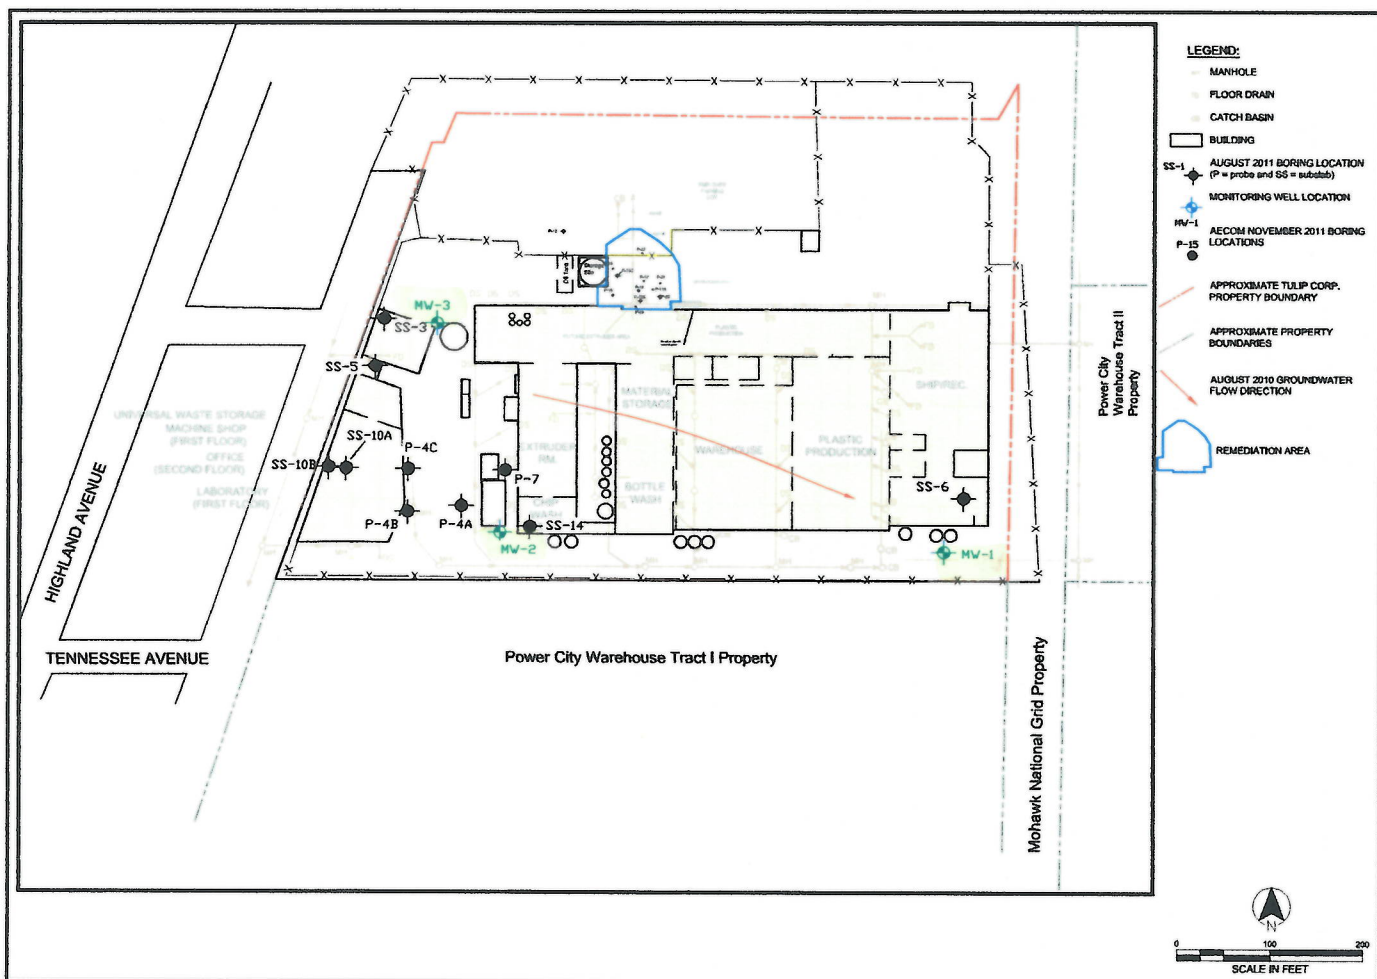
FIGURE 1

On August 15-19, 2011, at the request of Tulip Corporation (Tulip Corp.), AECOM performed Phase II ESA activities at the Site for a potential property transfer. The ESA included advancing three soil probes (P-11A, P-11B, and P-11C) near the north side of the building, in the location of a former coal pile storage area. The probe locations around the former coal pile area and Site features are illustrated on **Figure 1**.
