Re: Corrective Measures Summary Letter
Former Scolite Site
2 Madison Street
Troy, New York
Site No. E442037

Professional Service Industries, Inc. (an Intertek Company) is submitting this Corrective Measures Summary Letter behalf of the City of Troy, New York that documents the repair to an isolated area of the cover system that was damaged in July 2022. A Site Location Map is included as **Figure 1**.

COVER SYSTEM BREACH

CORRECTIVE MEASURES

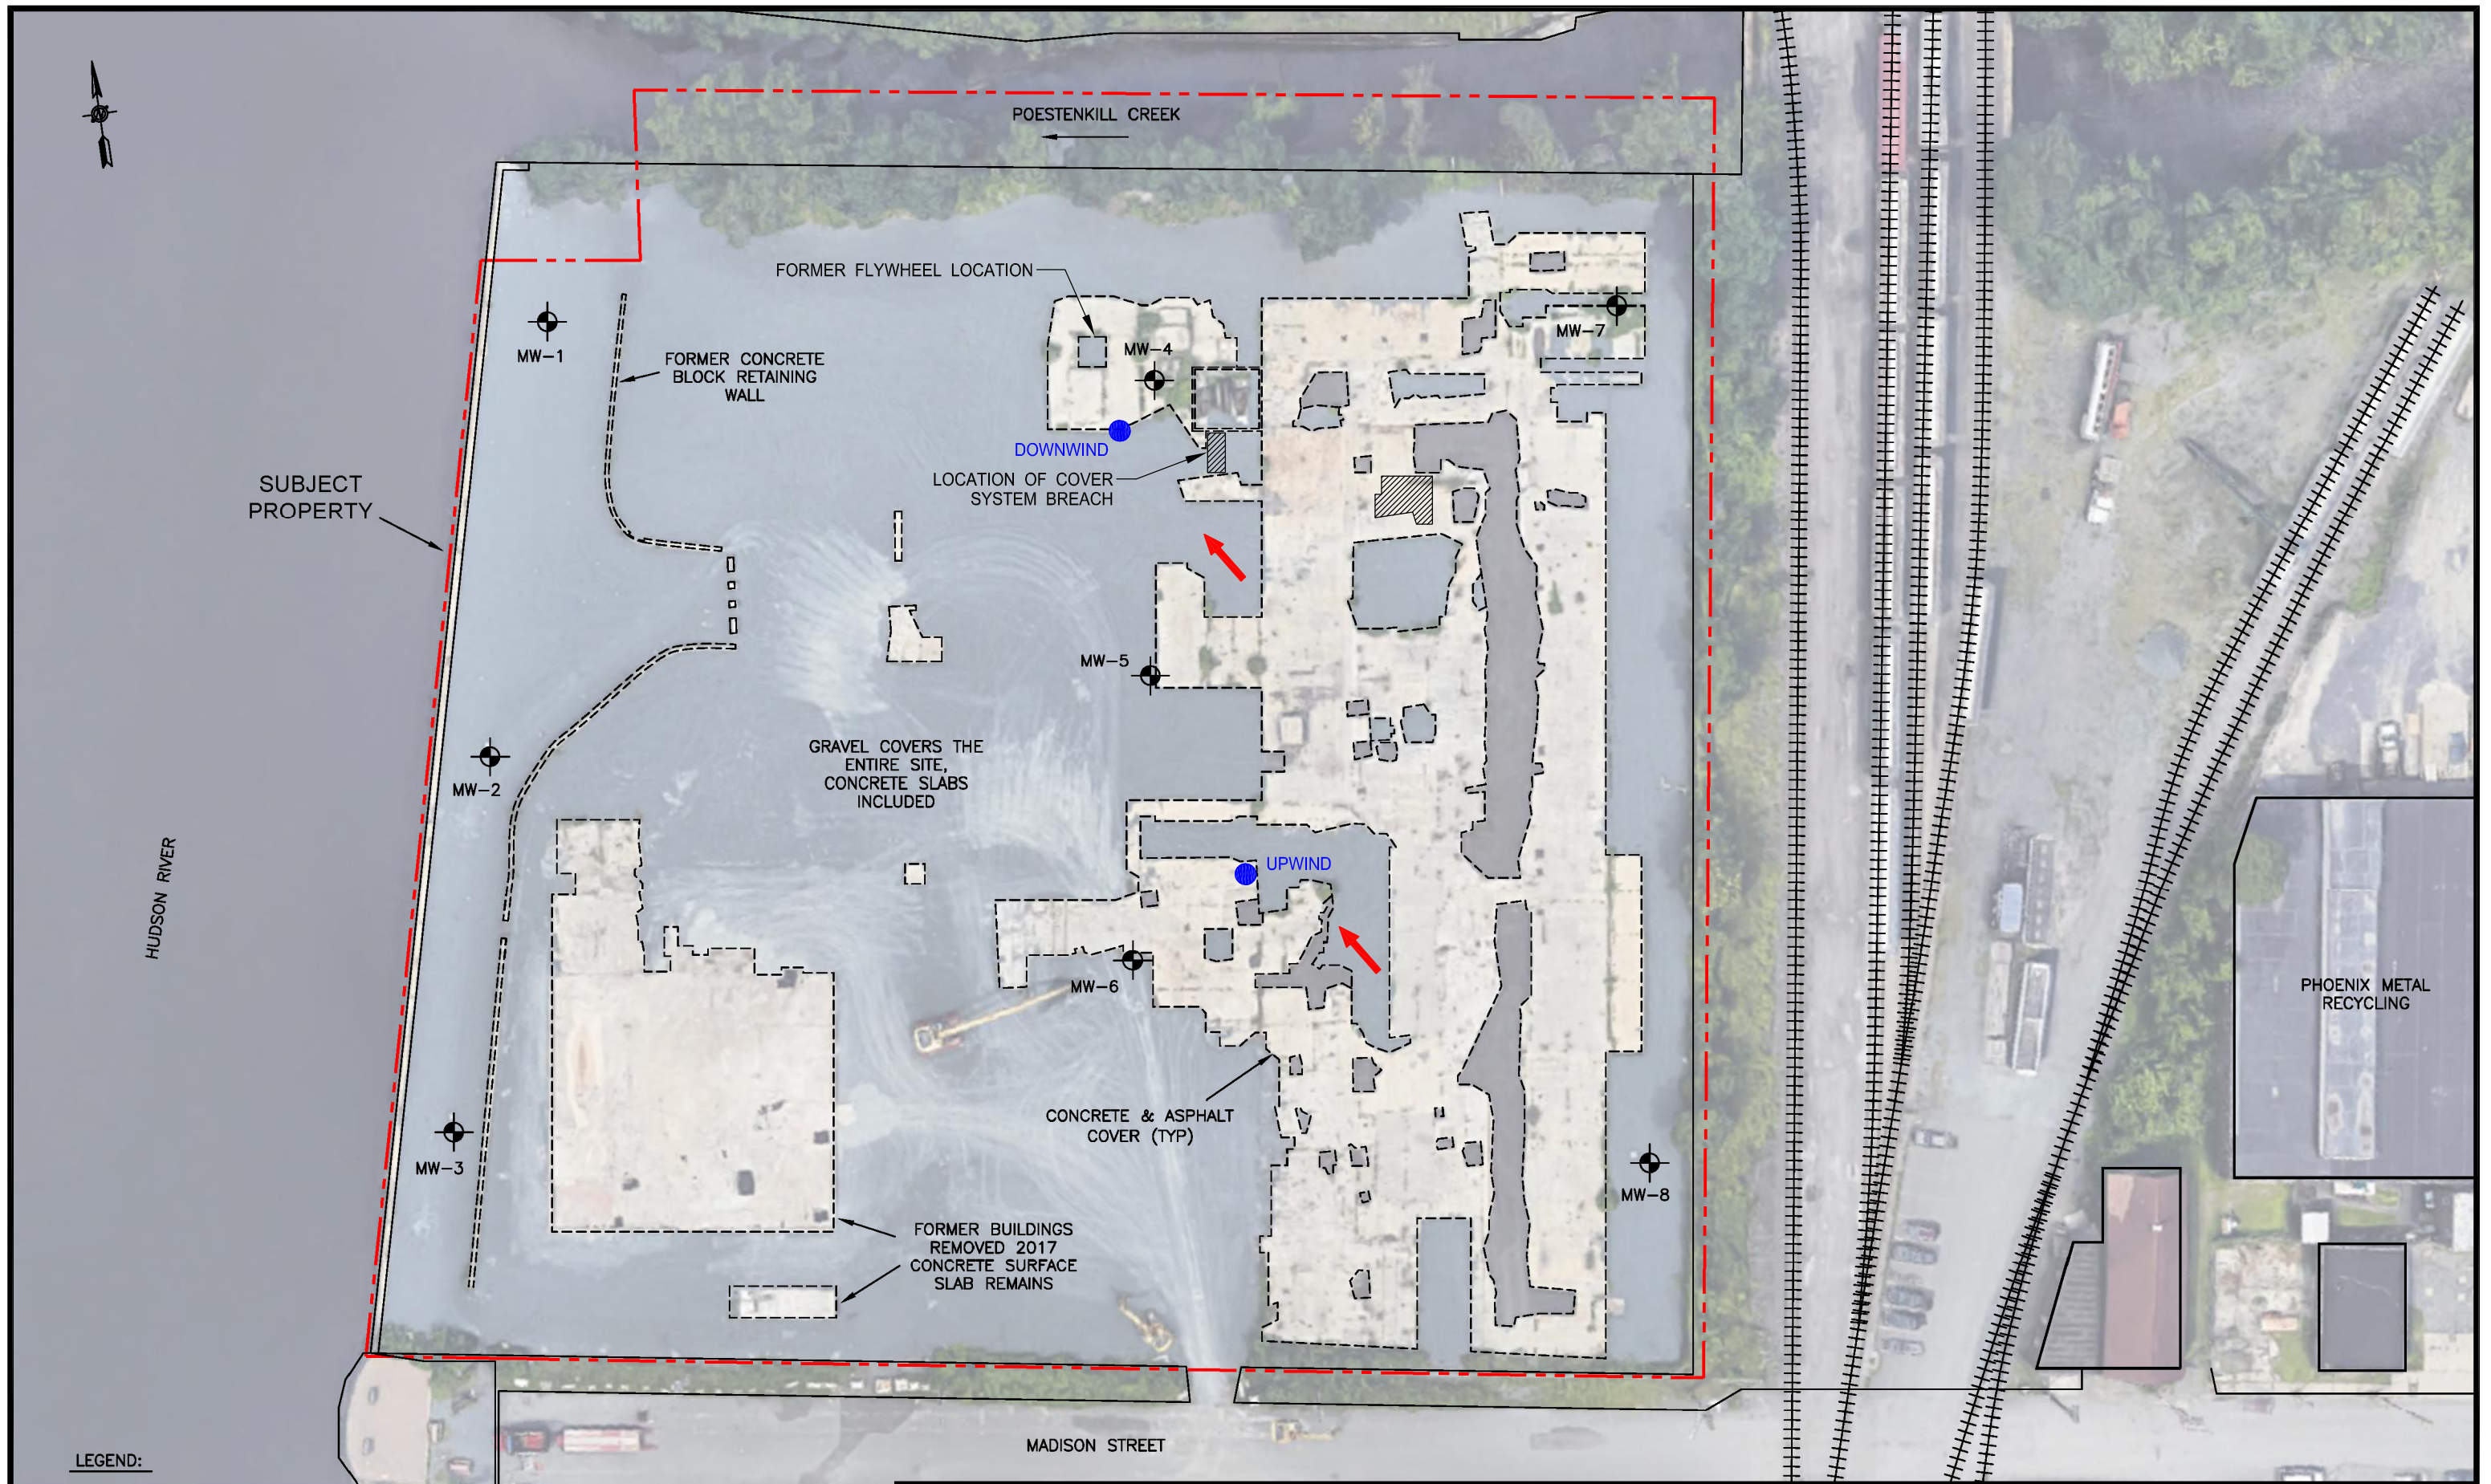
Figure:
2

Breach Repair Area

After the preparation of the main repair area, filter fabric was placed in the excavation area overlapping the existing fabric by 6 feet. Filter fabric was then extended over existing grade by 3 feet prior to the placement of minimum of 12" of No. 2 stone. See attached photos of the breach and flywheel areas.
