February 4, 2025

Re: Nassau Metals, OU-2
Voluntary Cleanup Program Site No. V00159
Corrective Actions Work Plan Addendum, **ASR Project #A22-115**

158 Page Avenue Work to be Performed

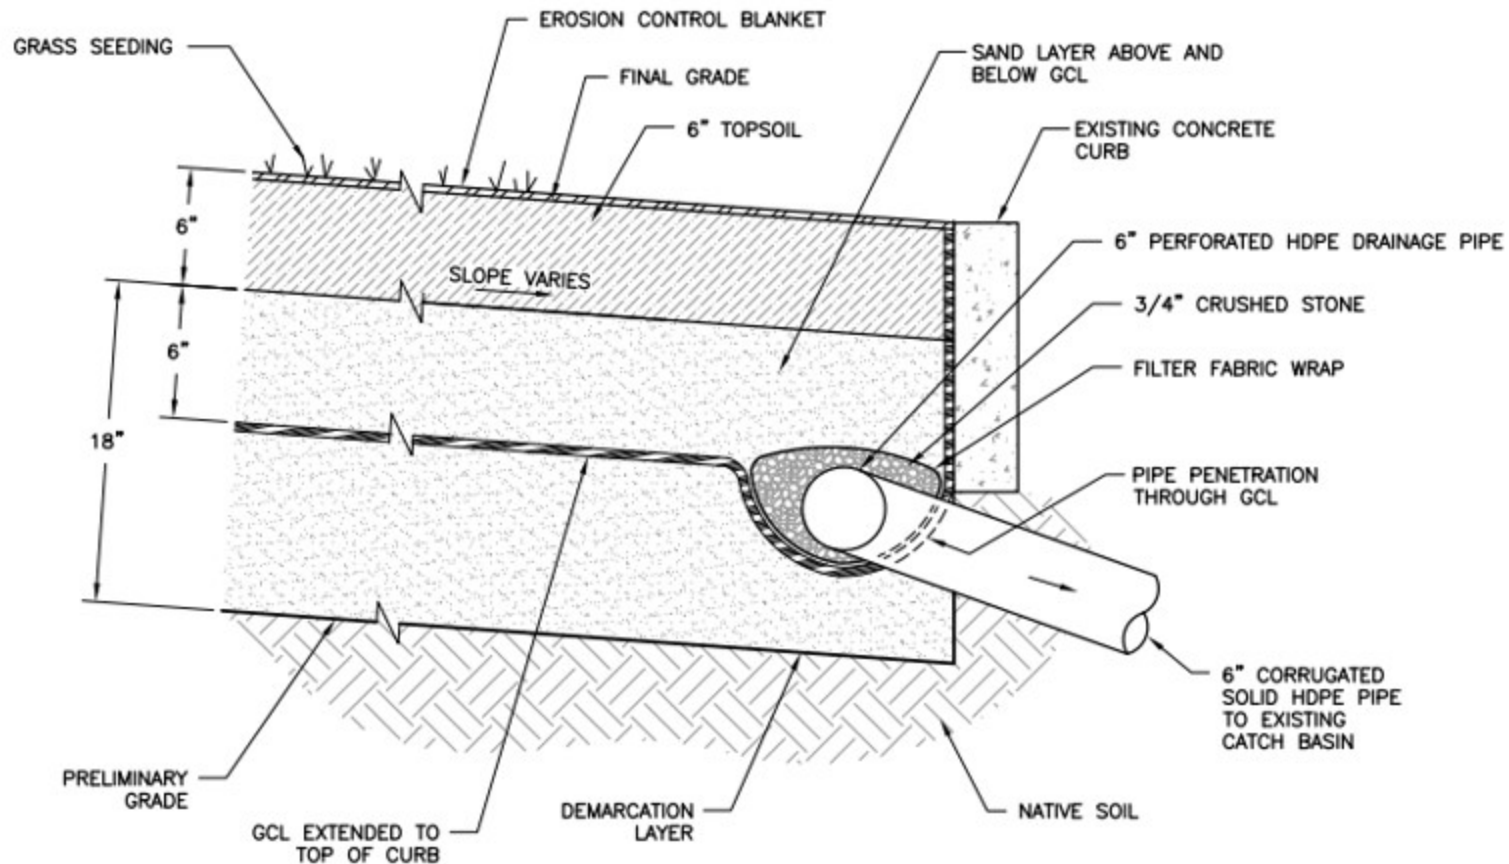
GCL Design Detail

The subsurface investigation determined that the geosynthetic composite layer (“GCL”) capping system east of 158 Page Avenue had been damaged during construction activities. Based on publicly available satellite imagery, this area was disturbed in 2015 during construction of a pedestrian ramp and driveway, and again visibly disturbed in July 2022 during renovations to the building at 158 Page Avenue.

To further investigate this issue, **ASR** proposes to hand excavate the area to determine the lateral extent of the missing GCL; test pits will be hand dug throughout the blue highlighted area on Figure 1 at 10-foot intervals in north/south and east/west cardinal directions. The GCL will be considered “damaged” if the demarcation barrier is not covered by at least 12-inches of material as specified in Appendix I of the Remedial Completion Report for the Site. The corresponding GCL design detail has been appended to this work plan as Attachment 1.

After the extent of the damaged GCL has been delineated, a new GCL cap with a minimum 1-foot thickness will be installed above the existing ground surface. An appropriately designed retaining wall may need to be installed to support the proposed remedy. Any imported material will be sampled as required by the SMP and the NYSDEC notified in advance of any import as required by the SMP.
