David Szymanski - Fencepost Installation Summary

Re: Summary of Materials Encountered
Mineral Springs Fence Replacement

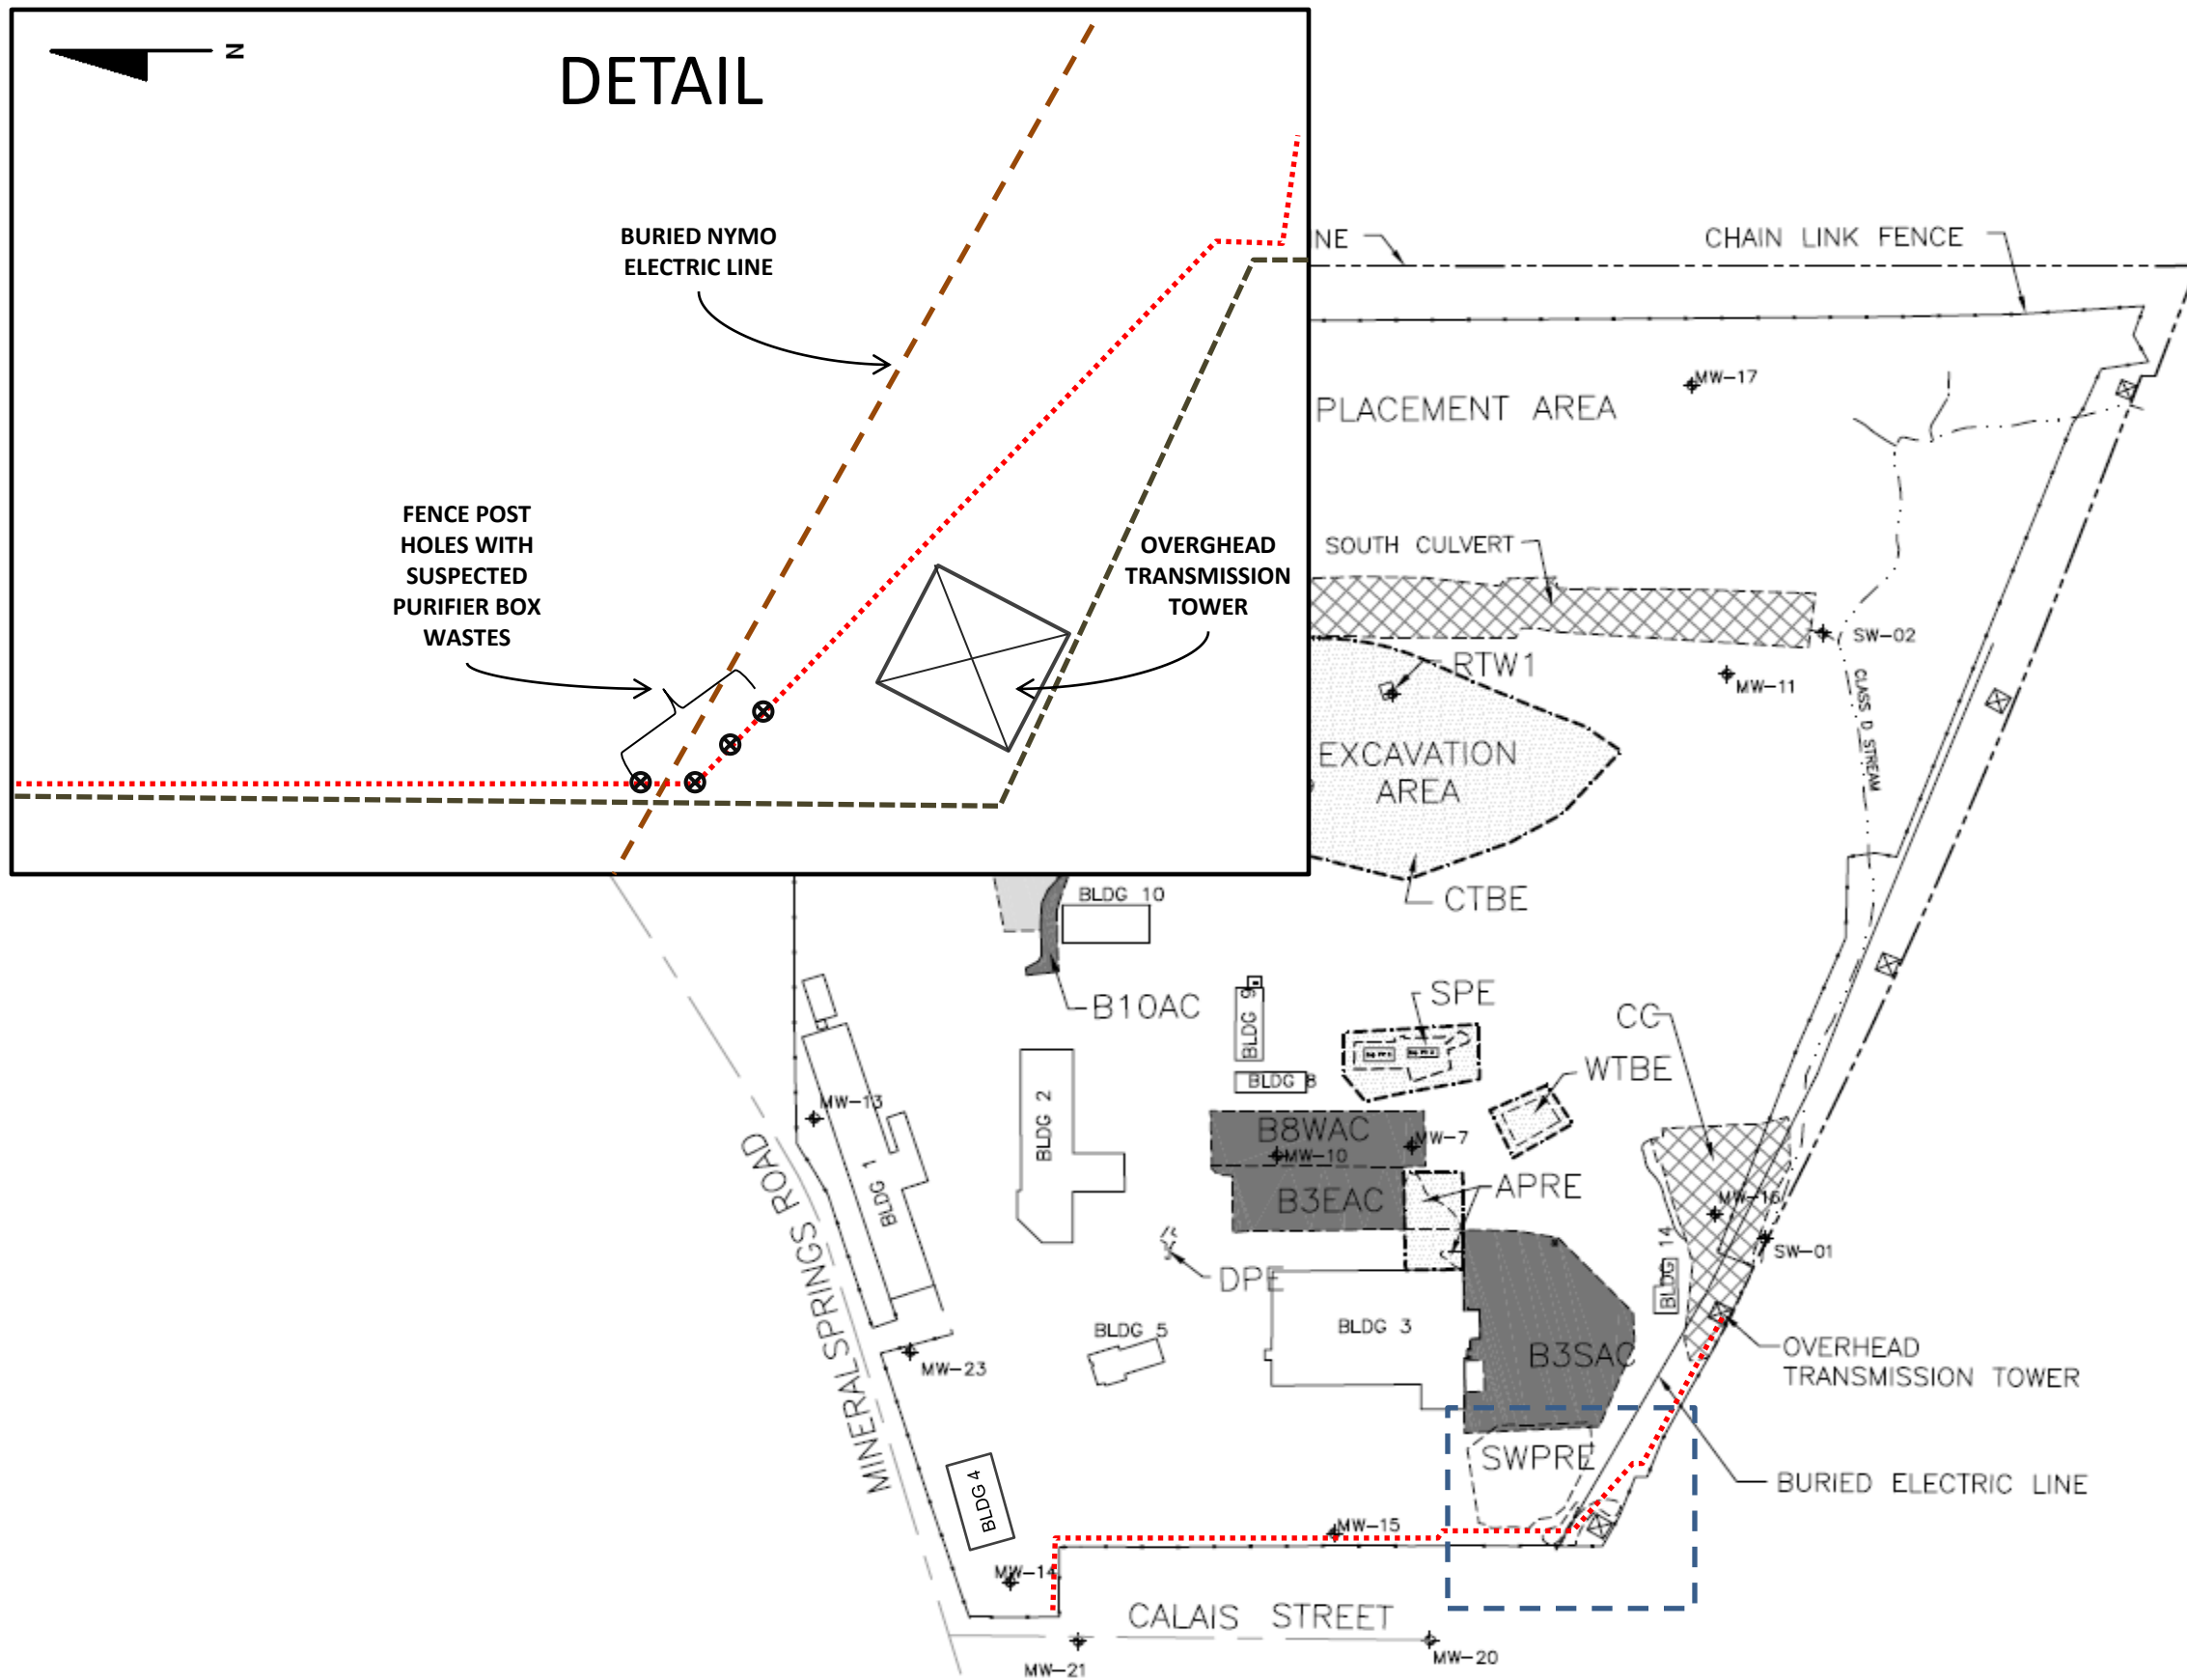
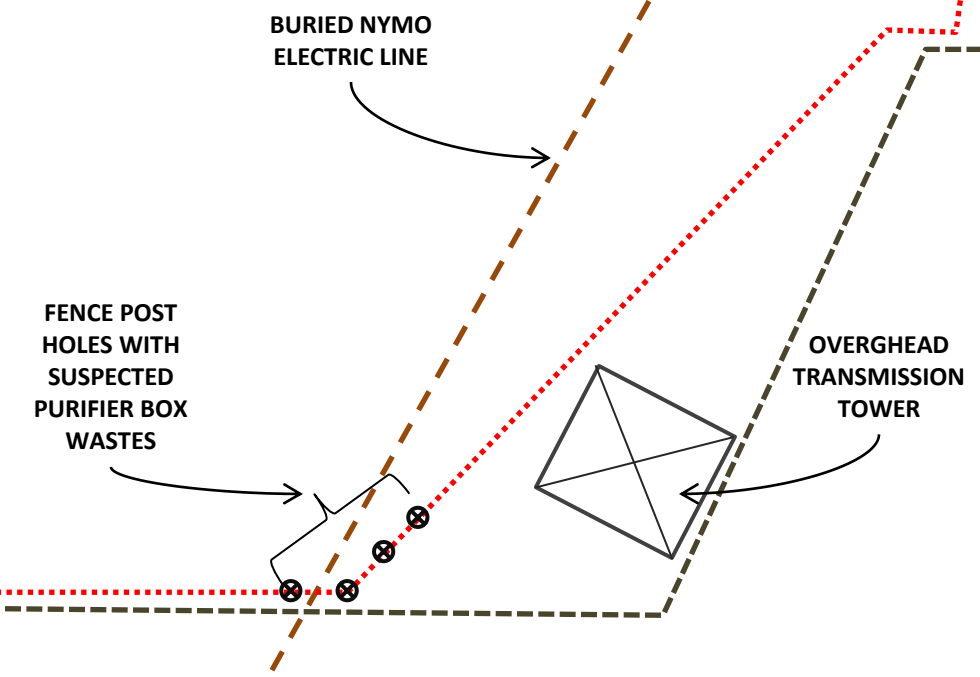
DETAIL

As we discussed, on June 26, 2013 some suspected purifier box wastes were encountered while advancing four new fencepost holes near the southwestern corner at our Mineral Springs facility. These locations are within National Fuels' property boundaries, adjacent to a buried NYMO transmission cable as shown on the attached figure and Photo 004. The materials exhibited the characteristic deep Prussian blue color. All suspect material was containerized in a new 55-gallon drum and will be sampled and disposed of properly.
