**Subject: Site Management Periodic Review Report and IC/EC Certification
Submittal – 2022, Revised PRR
Mineral Springs Road MGP Site (NYSDEC Site #V00195)**

Site Management Periodic Review Report and IC/EC Certification (2022)

NFG - Mineral Springs MGP - Site No. V00195
West Seneca, New York

December 2022 (Revised February 2023)

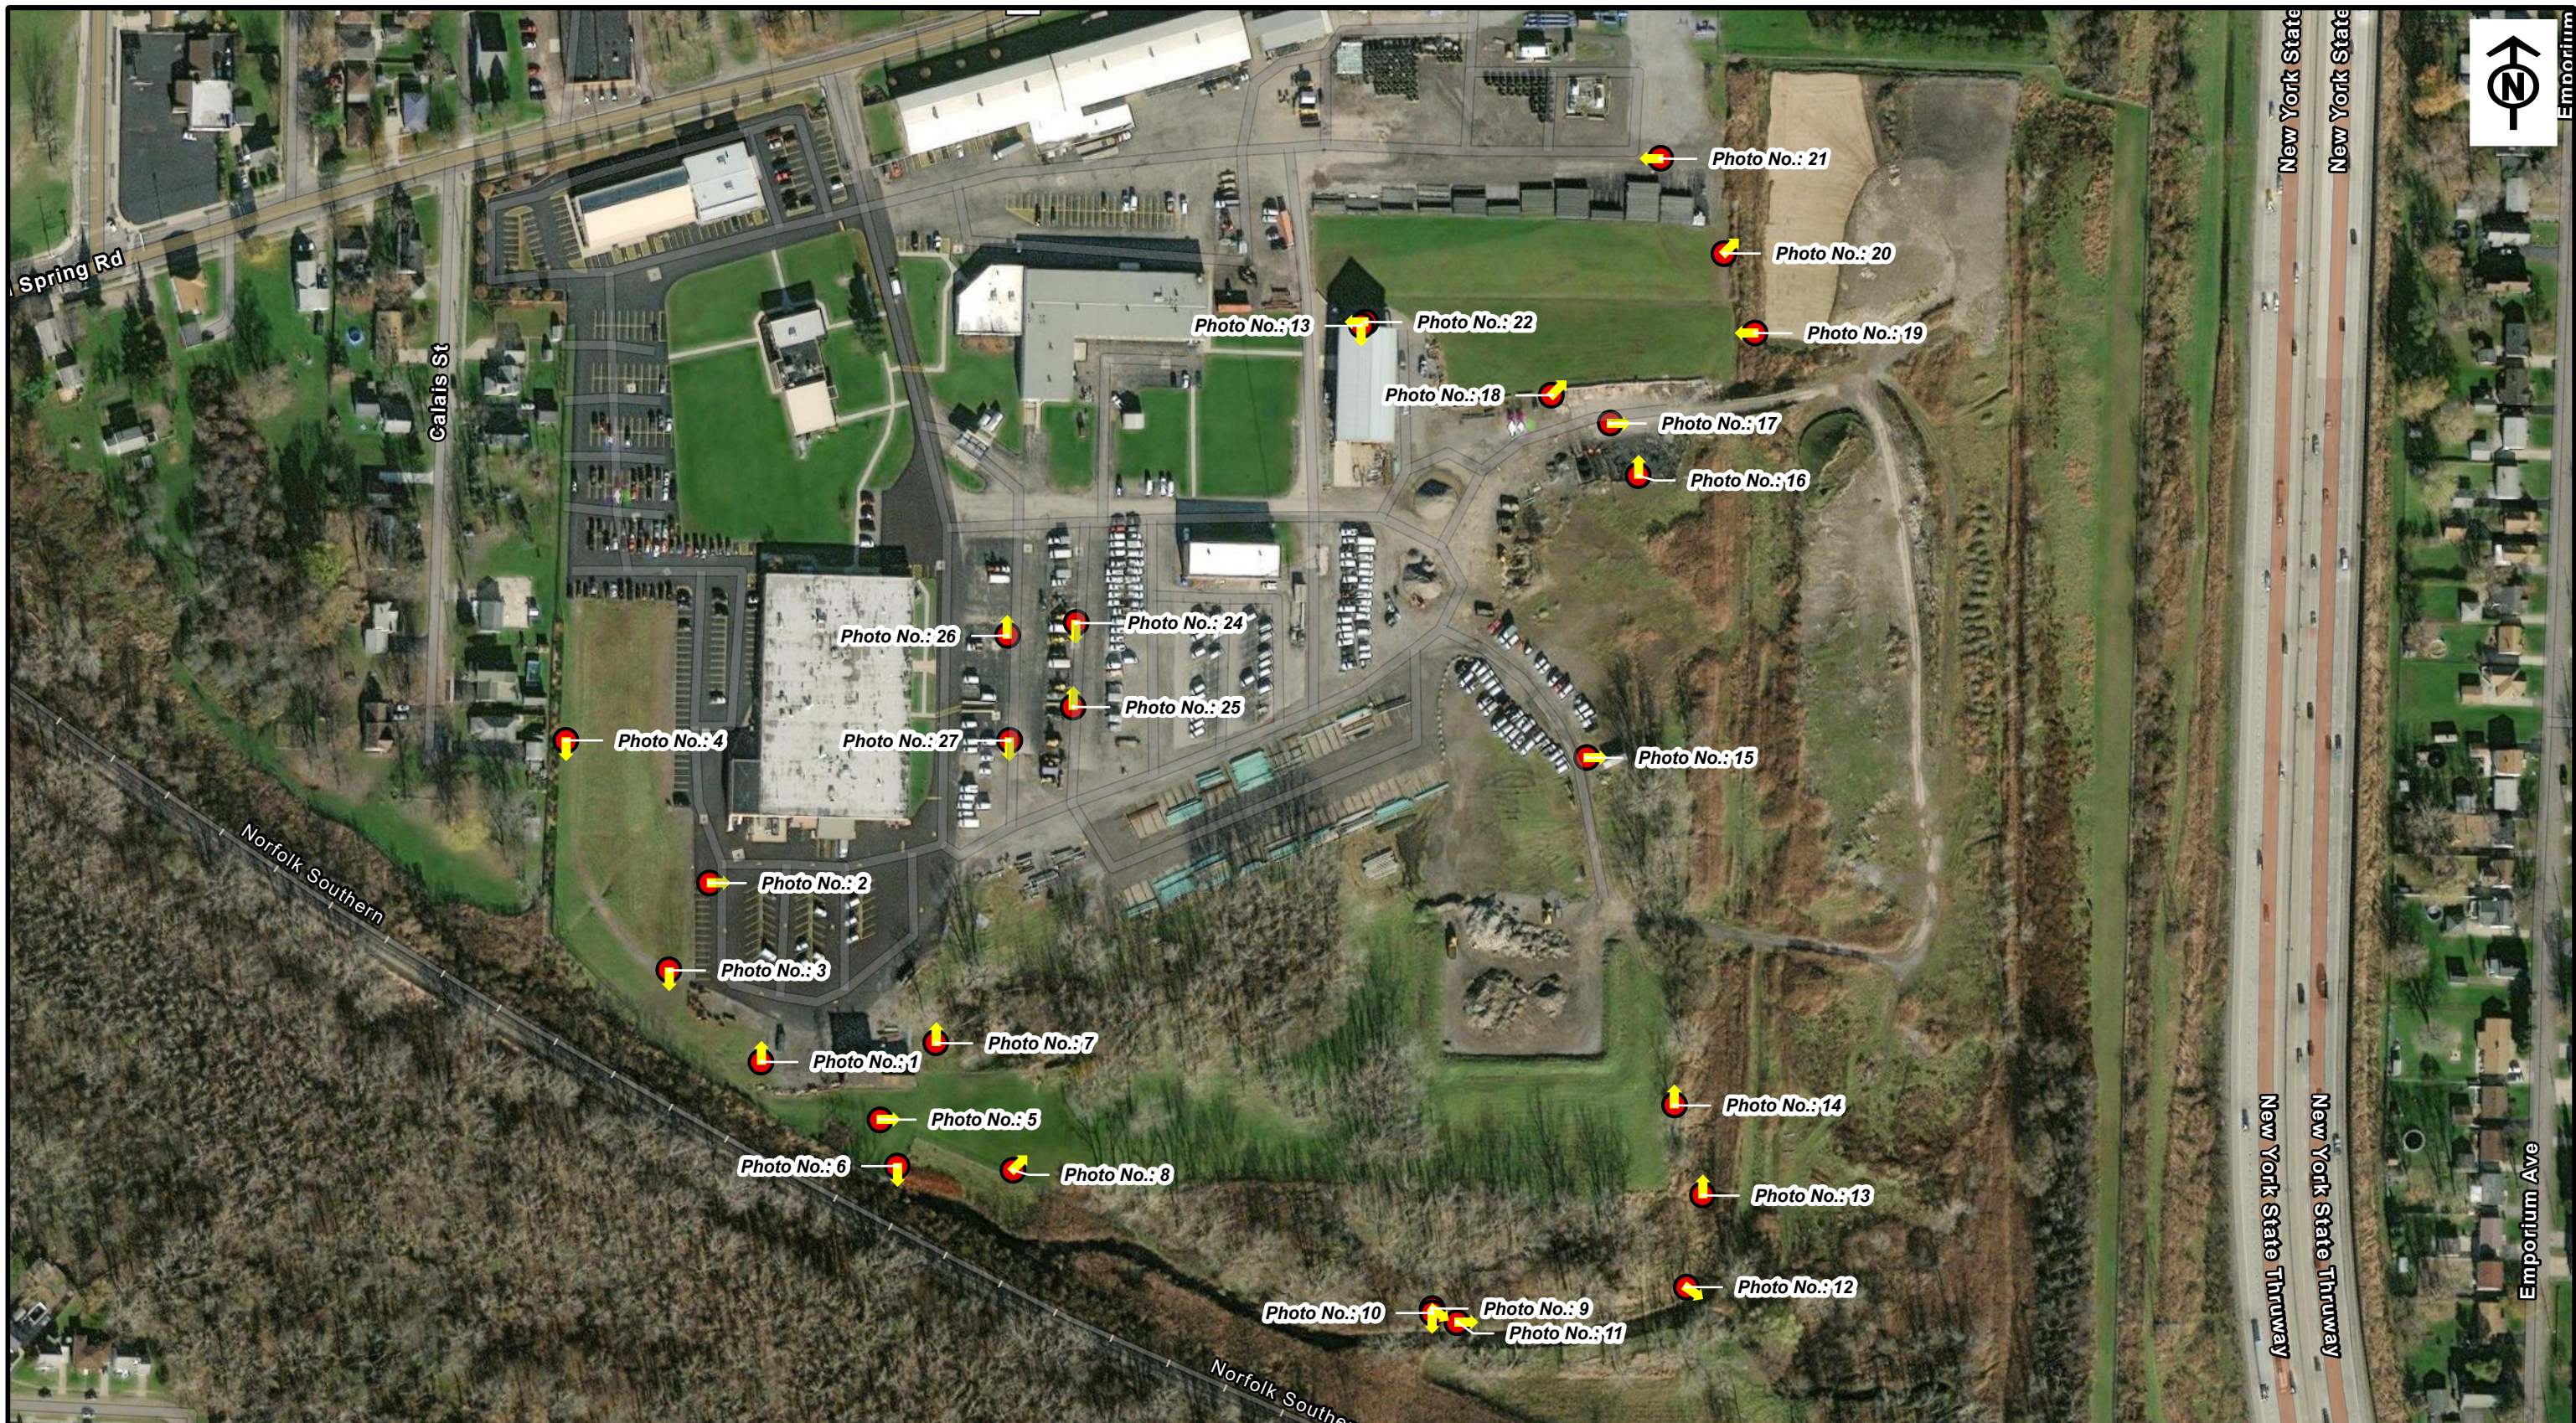
Fig. 1

Building 3 South Asphalt Cap (B3SAC): This cap was repaved in 2021 (as recommended in the 2021 PRR) and remains free of cracking with no significant weathering observed (Photos 1, 2). No edge erosion was observed.

4. The cable marking the edge of the Clay Cap between bollards east of Building 14 was observed to be missing and should be replaced. In addition, a new bollard should be installed outside the southwest corner of the Clay Cap near the southern perimeter fence to allow placement of a cable between the new bollard and the existing bollard in the northwest corner to restrict vehicle access along the west side of the cap. The cable should be equipped with a lock to allow permitted access along the right of way. Signage indicating restrictions on digging and vehicle access should also be added around the perimeter of the Clay Cap.
