RE: Periodic Review Report for Site No. V00314 & June 2017 Inspections.

**Periodic Review Report for Site No. V00314, Aurubis Buffalo, Inc., located @
Military and Sayre St. Buffalo, NY 14207**

Dated June 27, 2017

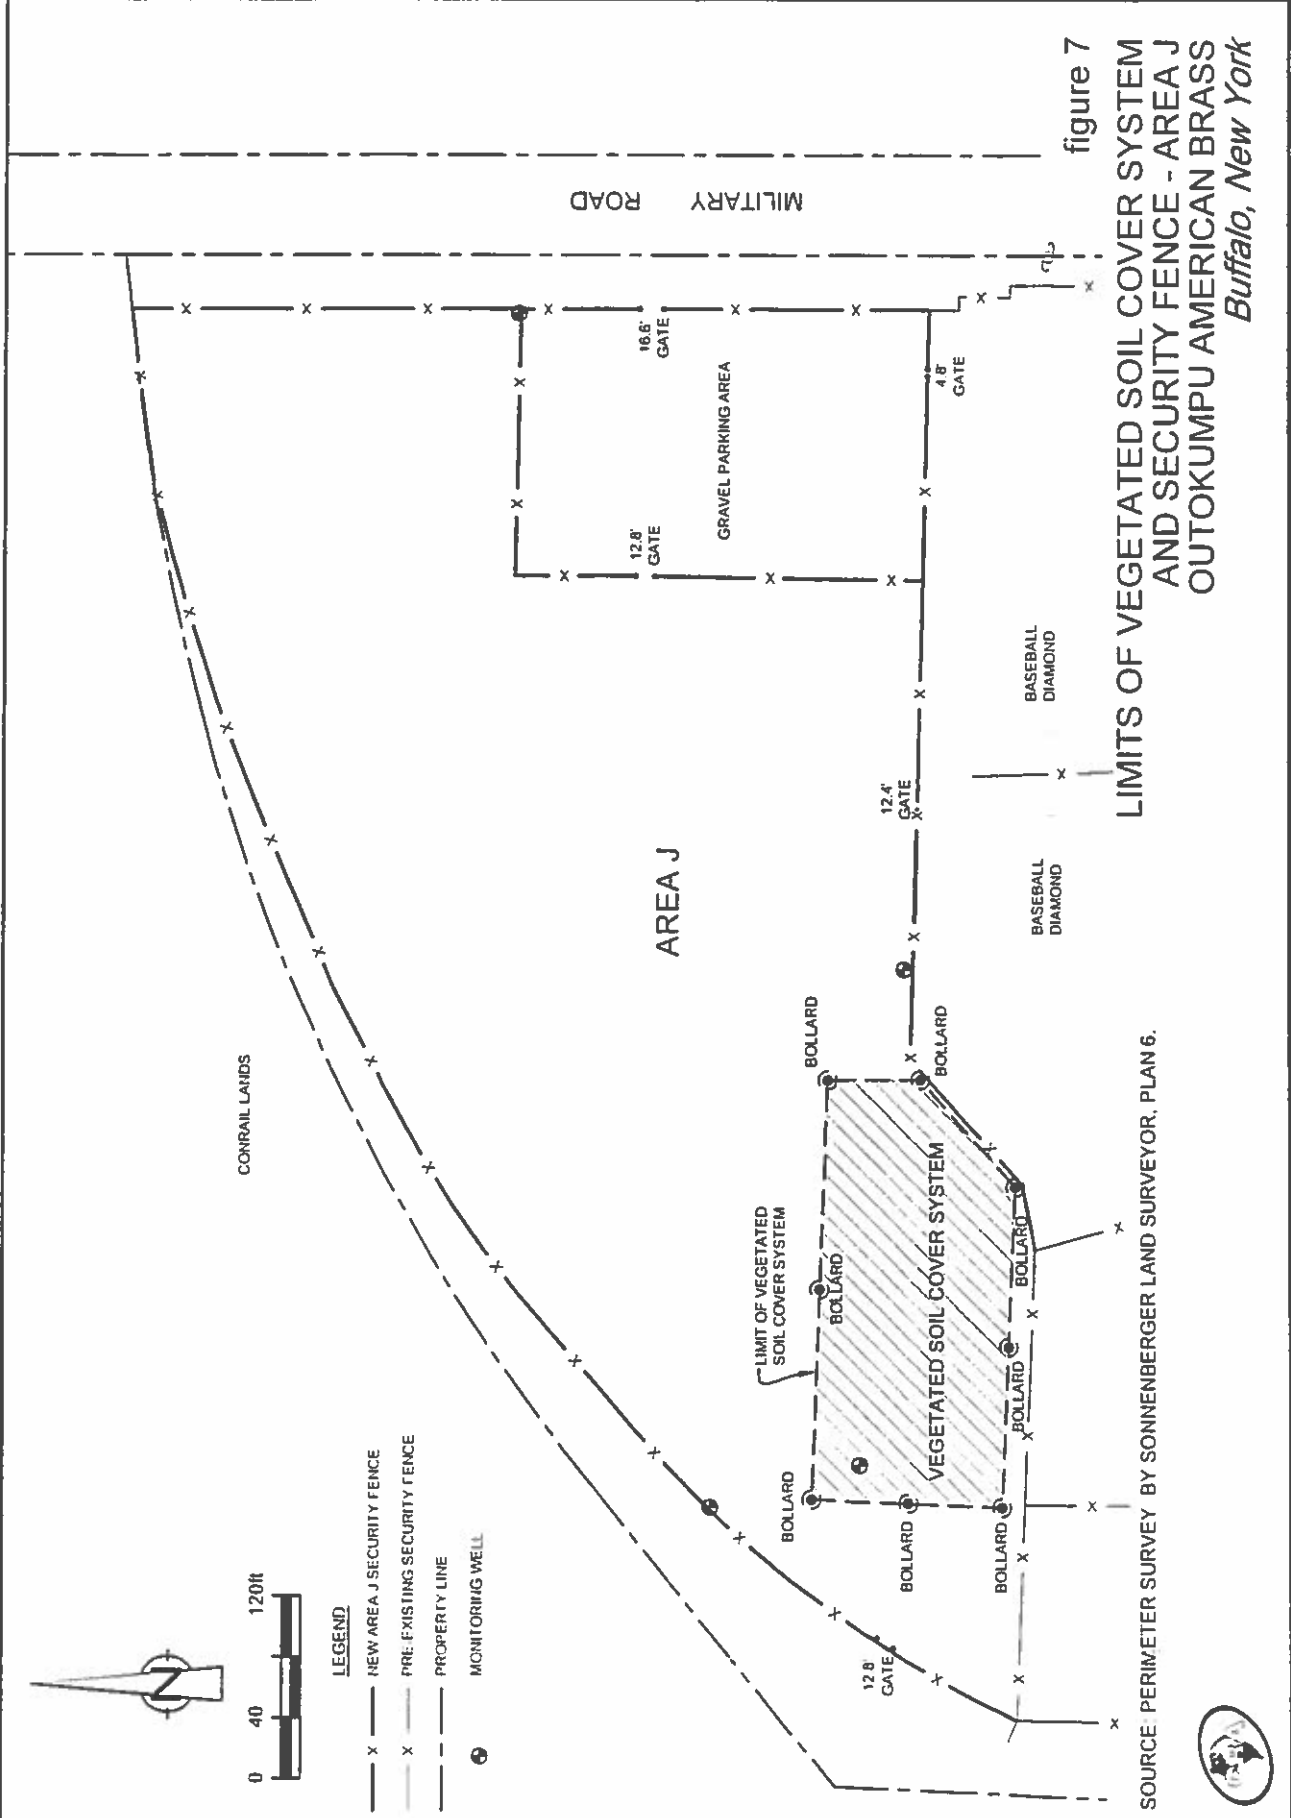
figure 7
**LIMITS OF VEGETATED SOIL COVER SYSTEM
 AND SECURITY FENCE - AREA J
 OUTOKUMPU AMERICAN BRASS
 Buffalo, New York**

Area J: Fence in good condition

Issue found in Area J: New hole in fence observed June 29, 2017 (It was not there on June 23). It looked like someone had entered just a short way past the opening.

Inspect For	Inspection Item Identified		Action Required		Comments
	Yes	No	Yes	No	
Erosion	Yes	No	Yes	No	
Bare Areas	Yes	No	Yes	No	
Ponding	Yes	No	Yes	No	
Distressed Vegetation	Yes	No	Yes	No	
Animal Holes/Burrows	Yes	No	Yes	No	
Woody Vegetation Present	Yes	No	Yes	No	
Damage to Bollards	Yes	No	Yes	No	
Damage to Fence Around Area J	Yes	No	Yes	No	The was a new hole in the fence that was not observed the week before a work order to correct will be submitted.
Other	Yes	No	Yes	No

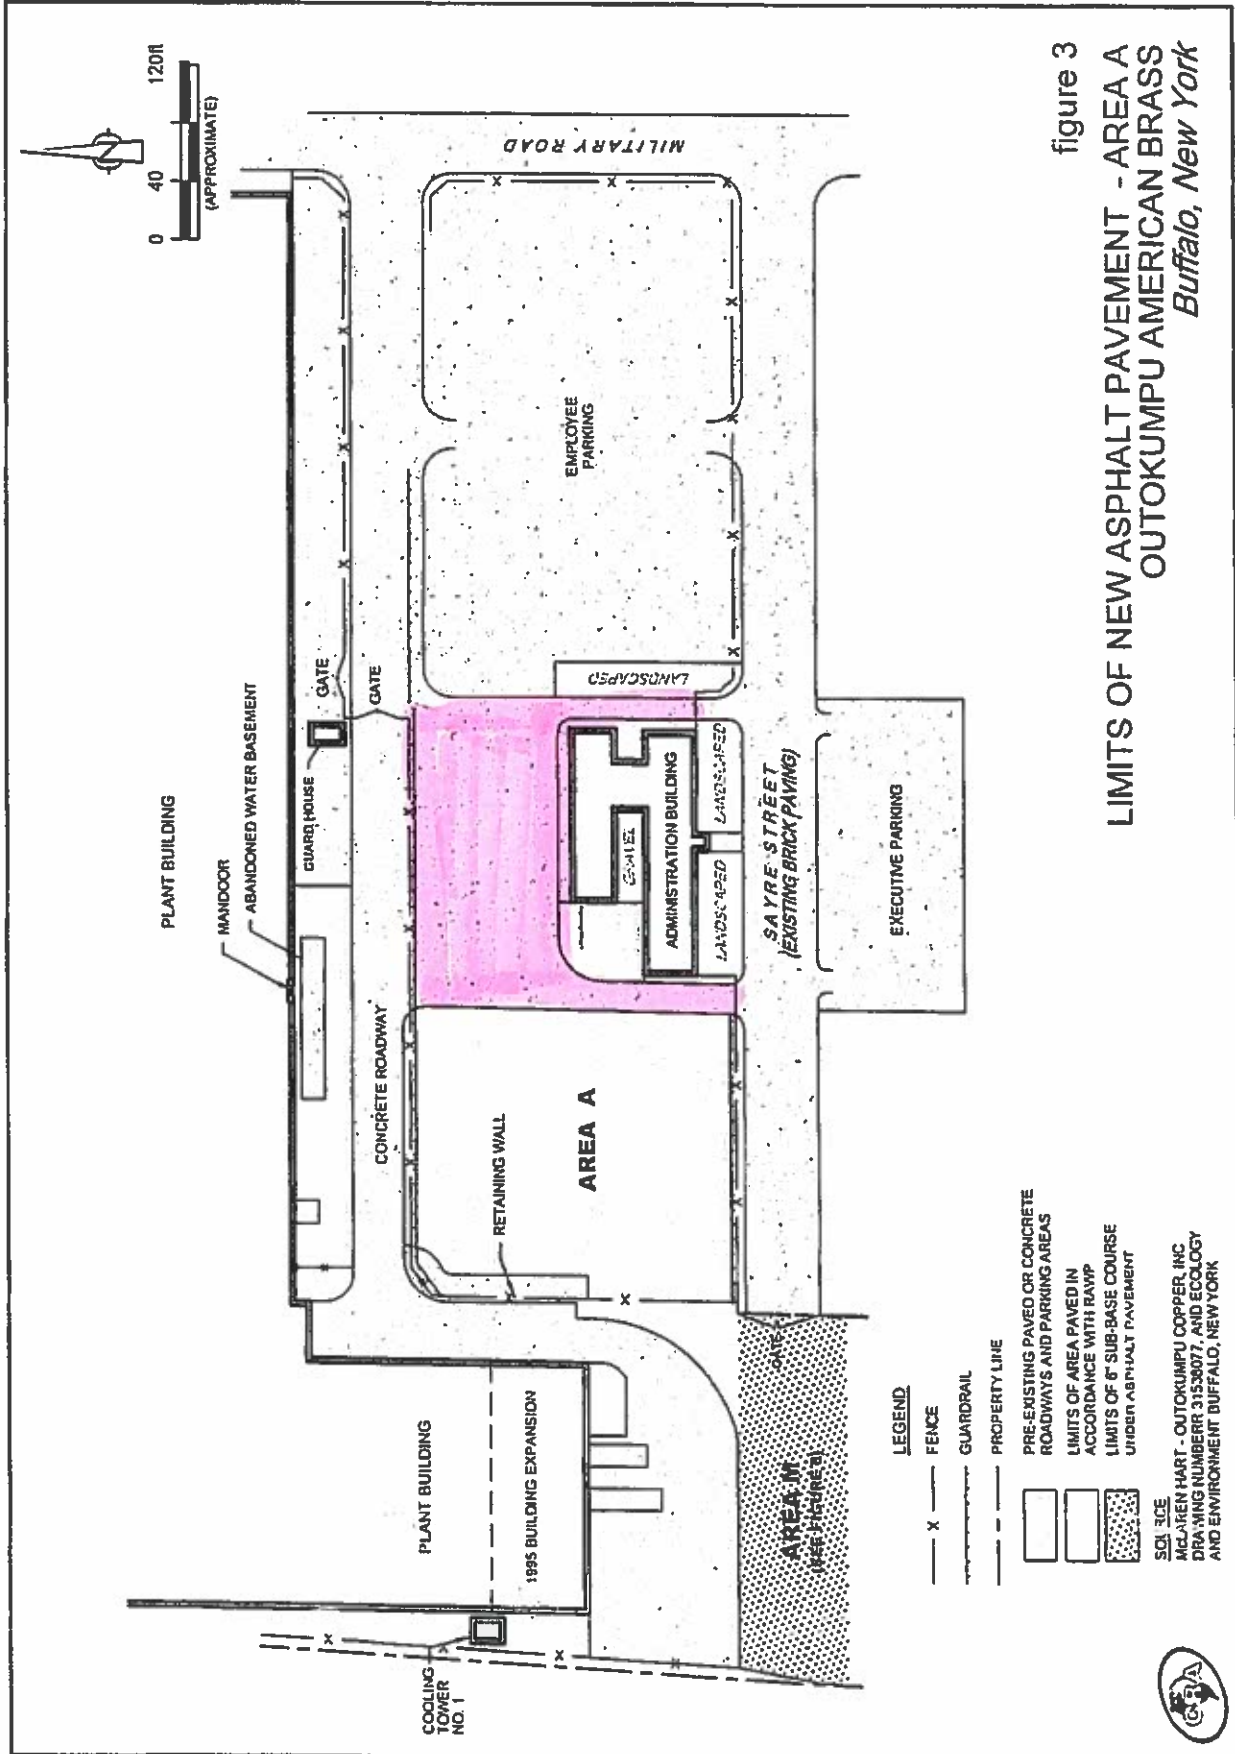
figure 3
 LIMITS OF NEW ASPHALT PAVEMENT - AREA A
 OUTOKUMPU AMERICAN BRASS
 Buffalo, New York

Asphalt covering Area A in good condition.

Date	Maintenance Performed and Location	Performed By	Comments
late fall 2016	1) Resurfacing of blacktop in area A as marked. No soil was removed (see highlighted area in pink)	Outside vendor	Arranged for by Maint. department.
	2) No known other maintenance activities performed based on conversations with Ron Kuta (Maintenance Dept) & Paul Badetkov (ETS Dept)
