RE: Transmittal - Period Review Report
NFG – Buffalo Service Center
95 Fourth Street
Buffalo, New York

Enclosure 2
NEW YORK STATE DEPARTMENT OF ENVIRONMENTAL CONSERVATION
Site Management Periodic Review Report Notice
Institutional and Engineering Controls Certification Form

Annual Inspection Form
Waterfront School Venting System/Concrete Condition
Buffalo, New York

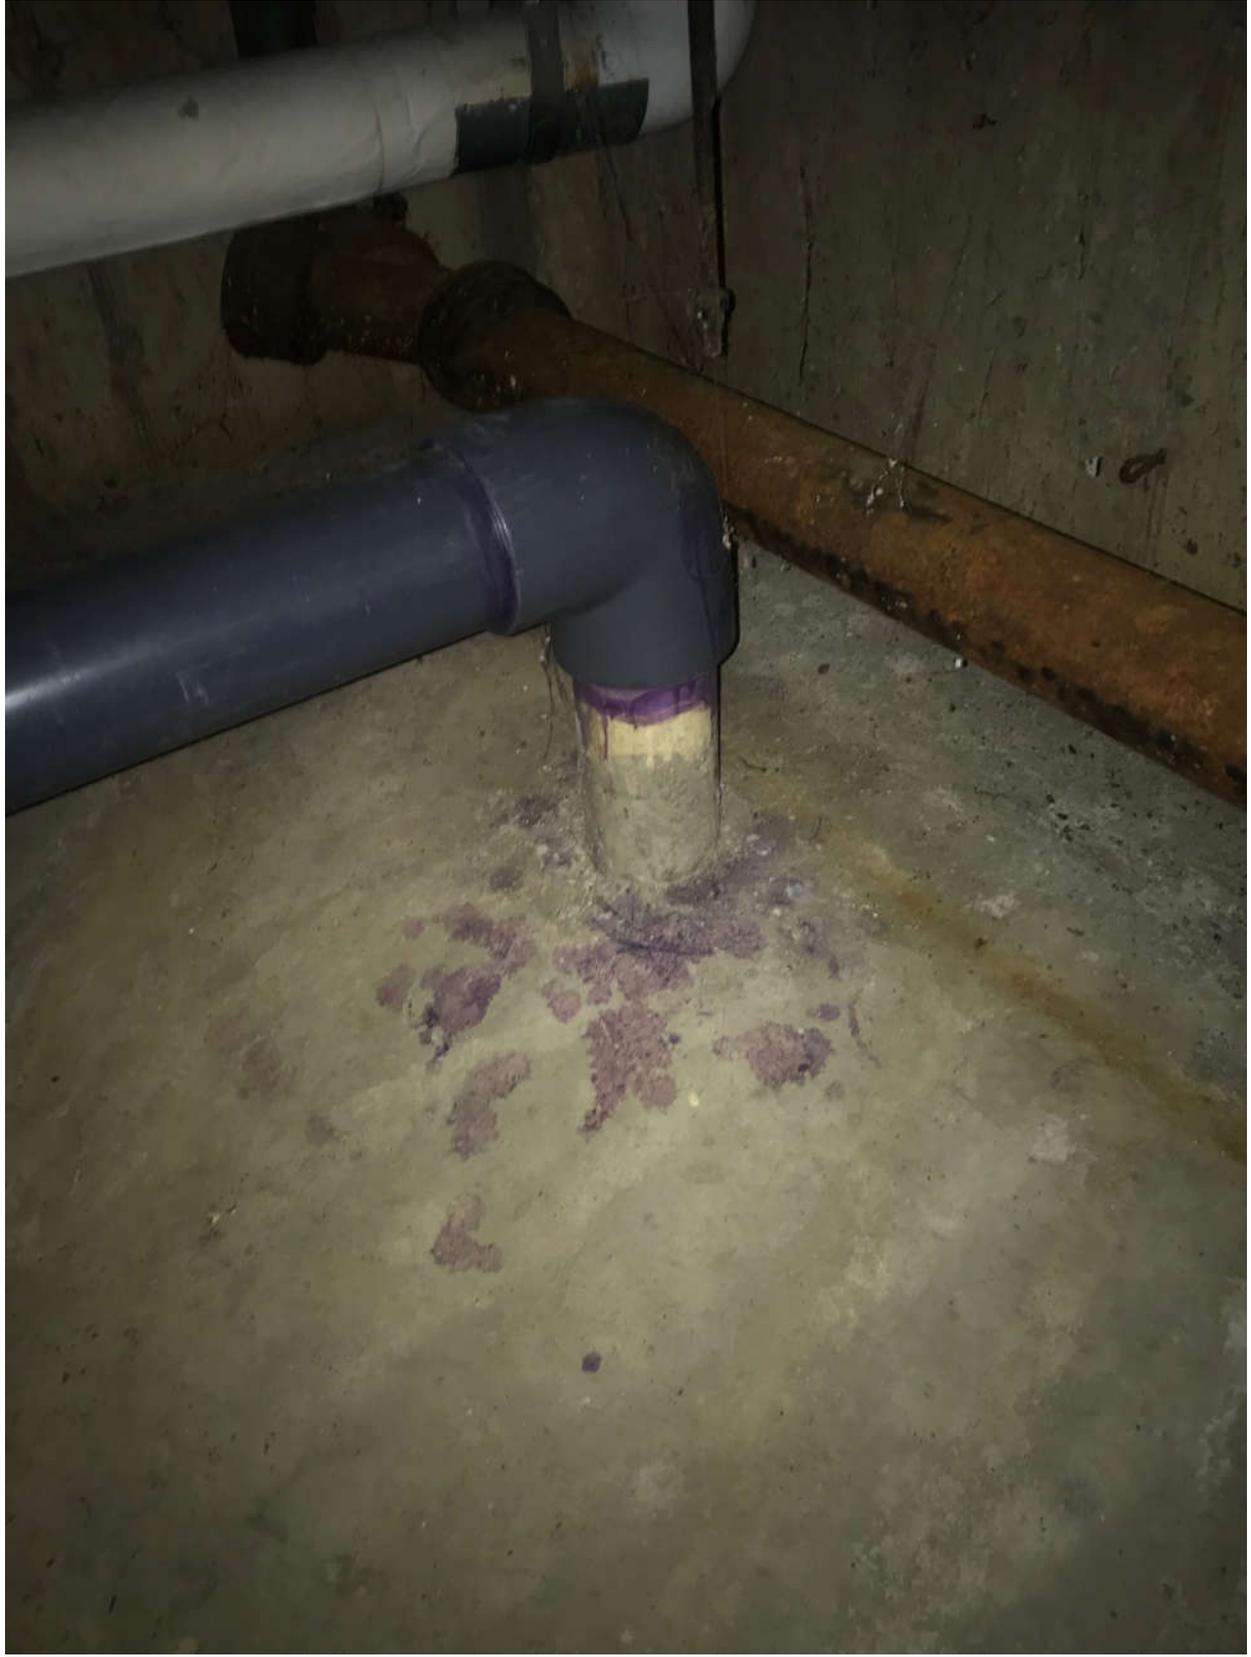
Fan appears to be working fine, from the 1st floor level in room 110, you can hear the fan running. I did not have a ladder to access the roof for inspection but the first photograph below is of the rain vent cap, in place and stack is clear. The second photo is in the basement showing the monometer indicating vacuum, the third photo is of the extraction point, slab is free of cracks. The rest of the basement however is flooded with a couple inches of standing water in places. Without pumping that down, I'm not able to thoroughly inspect for cracks. I did have caulk with me based on last years report but I think reference to cracks was for the greater basement area, not necessarily the area of influence from this vapor extraction point.
