**SITE ASSESSMENT OF 20 SUBSTATIONS
FOR MERCURY CONTAMINATION**

**METROPOLITAN TRANSPORTATION AUTHORITY
LONG ISLAND RAIL ROAD**

**DVIRKA AND BARTILUCCI CONSULTING ENGINEERS
(a Division of William F. Cosulich Associates, P.C.)
330 Crossways Park Drive
Woodbury, New York 11797**

DECEMBER 2000

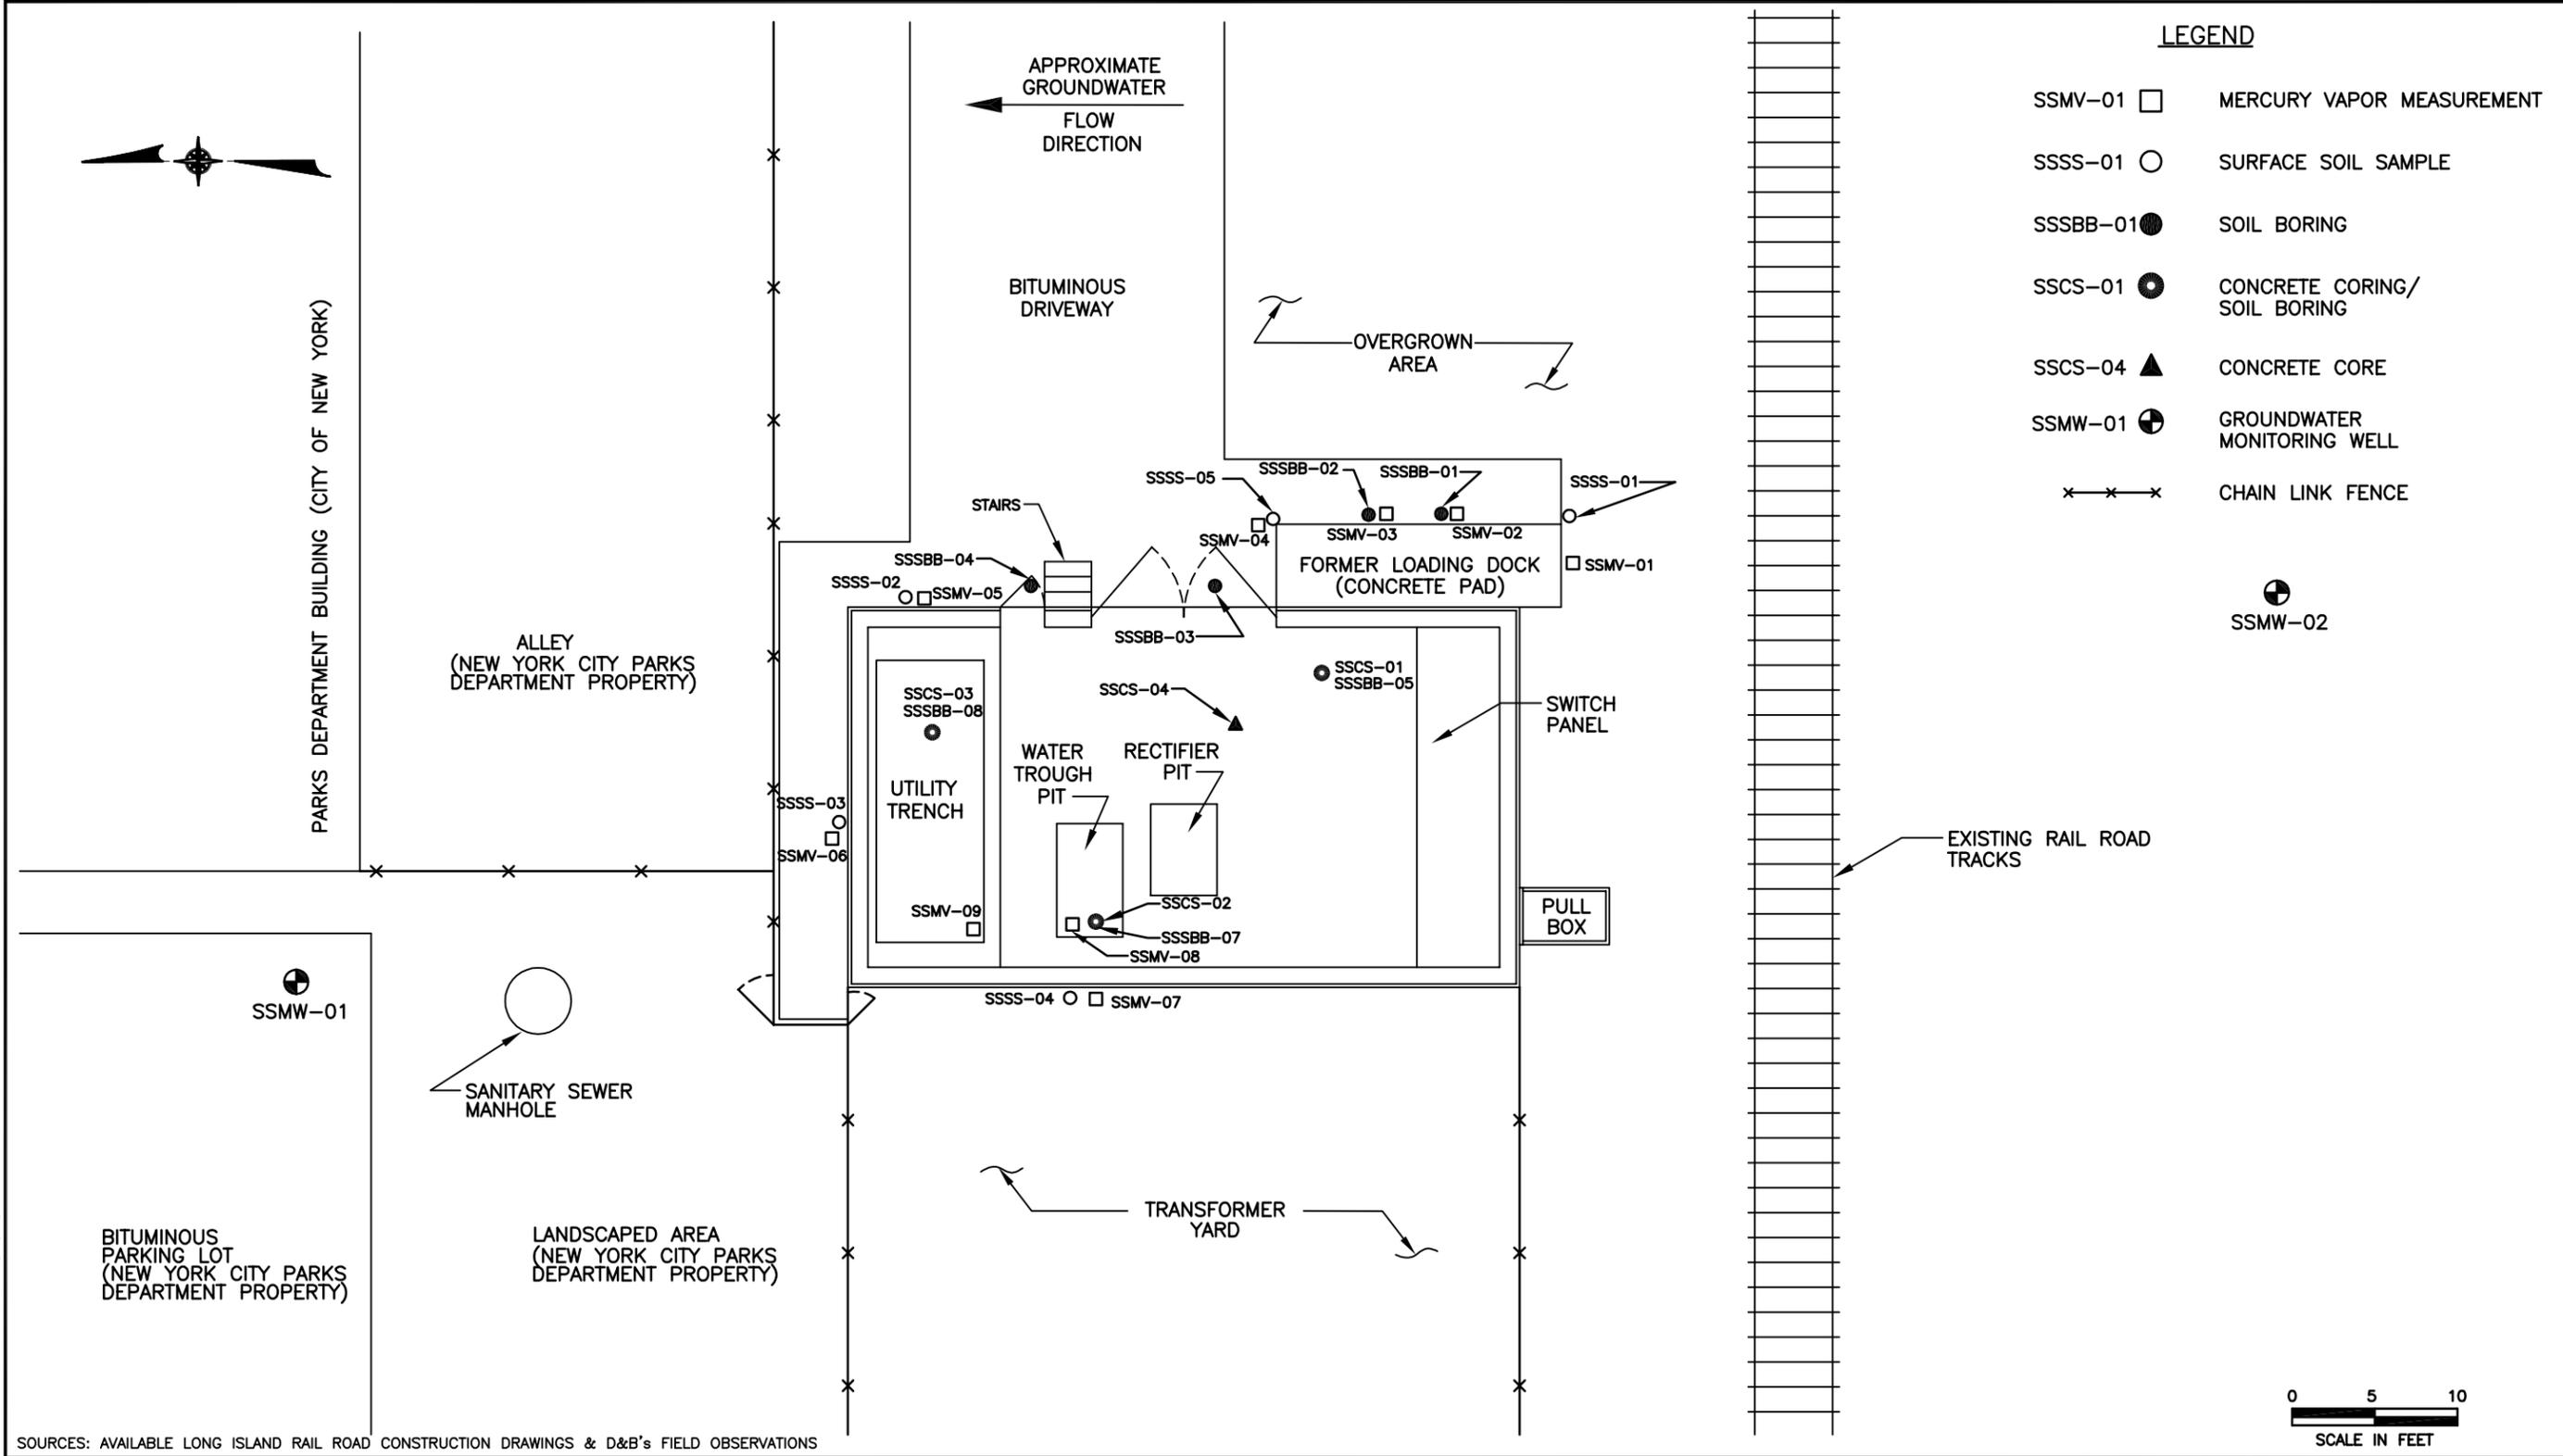
FIGURE 6.2-2

locations are presented on the sample and mercury vapor measurement location plan (see Figure 6.2-2). It should be noted that visible mercury beads were also observed during the MVA survey conducted adjacent to the concrete platform located along the east side of the substation.

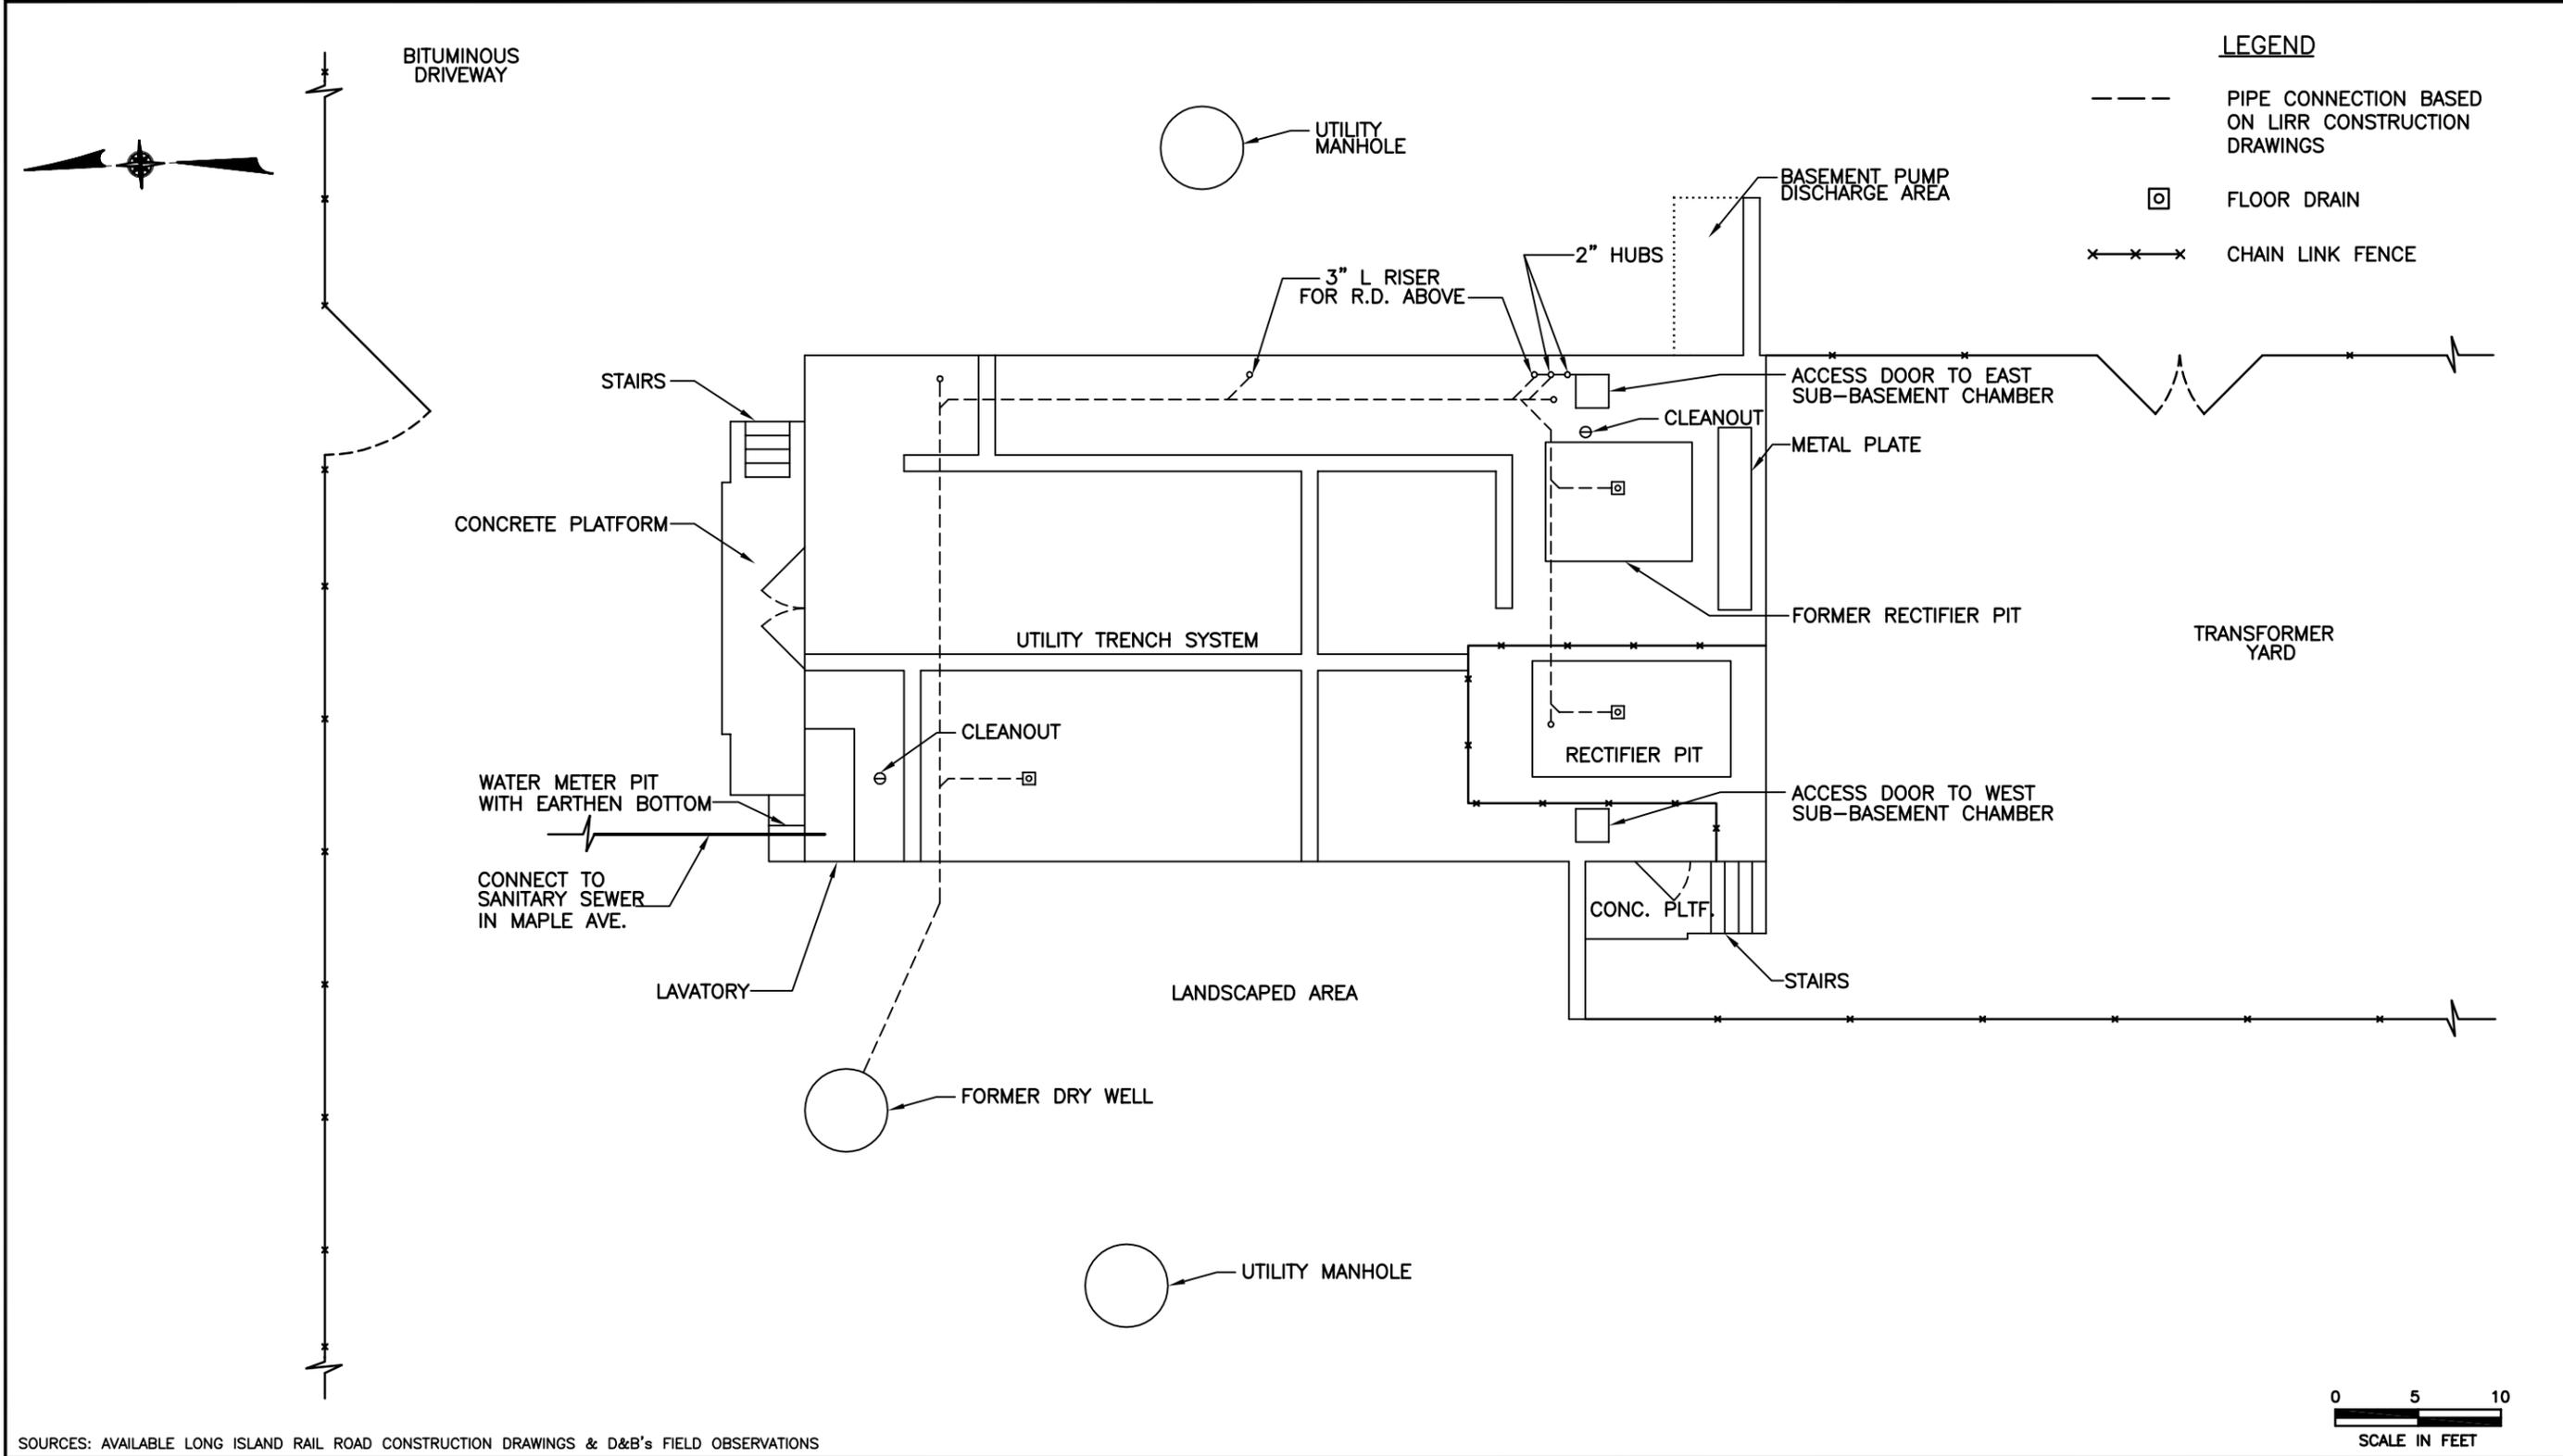
FIGURE 6.5-1

The Rockville Centre substation site is located in Rockville Centre, Nassau County, New York. The substation consists of a 58-foot by 30-foot one-story brick building as shown on Figure 6.5-1. A 54-foot by 40-foot transformer yard is located adjacent to the substation to the south and is enclosed by a chain-linked fence. The substation building and transformer yard is presently utilized to convert alternating current to direct current for the LIRR-Babylon branch. The areas surrounding the substation and the transformer yard are currently utilized as vehicular parking areas.

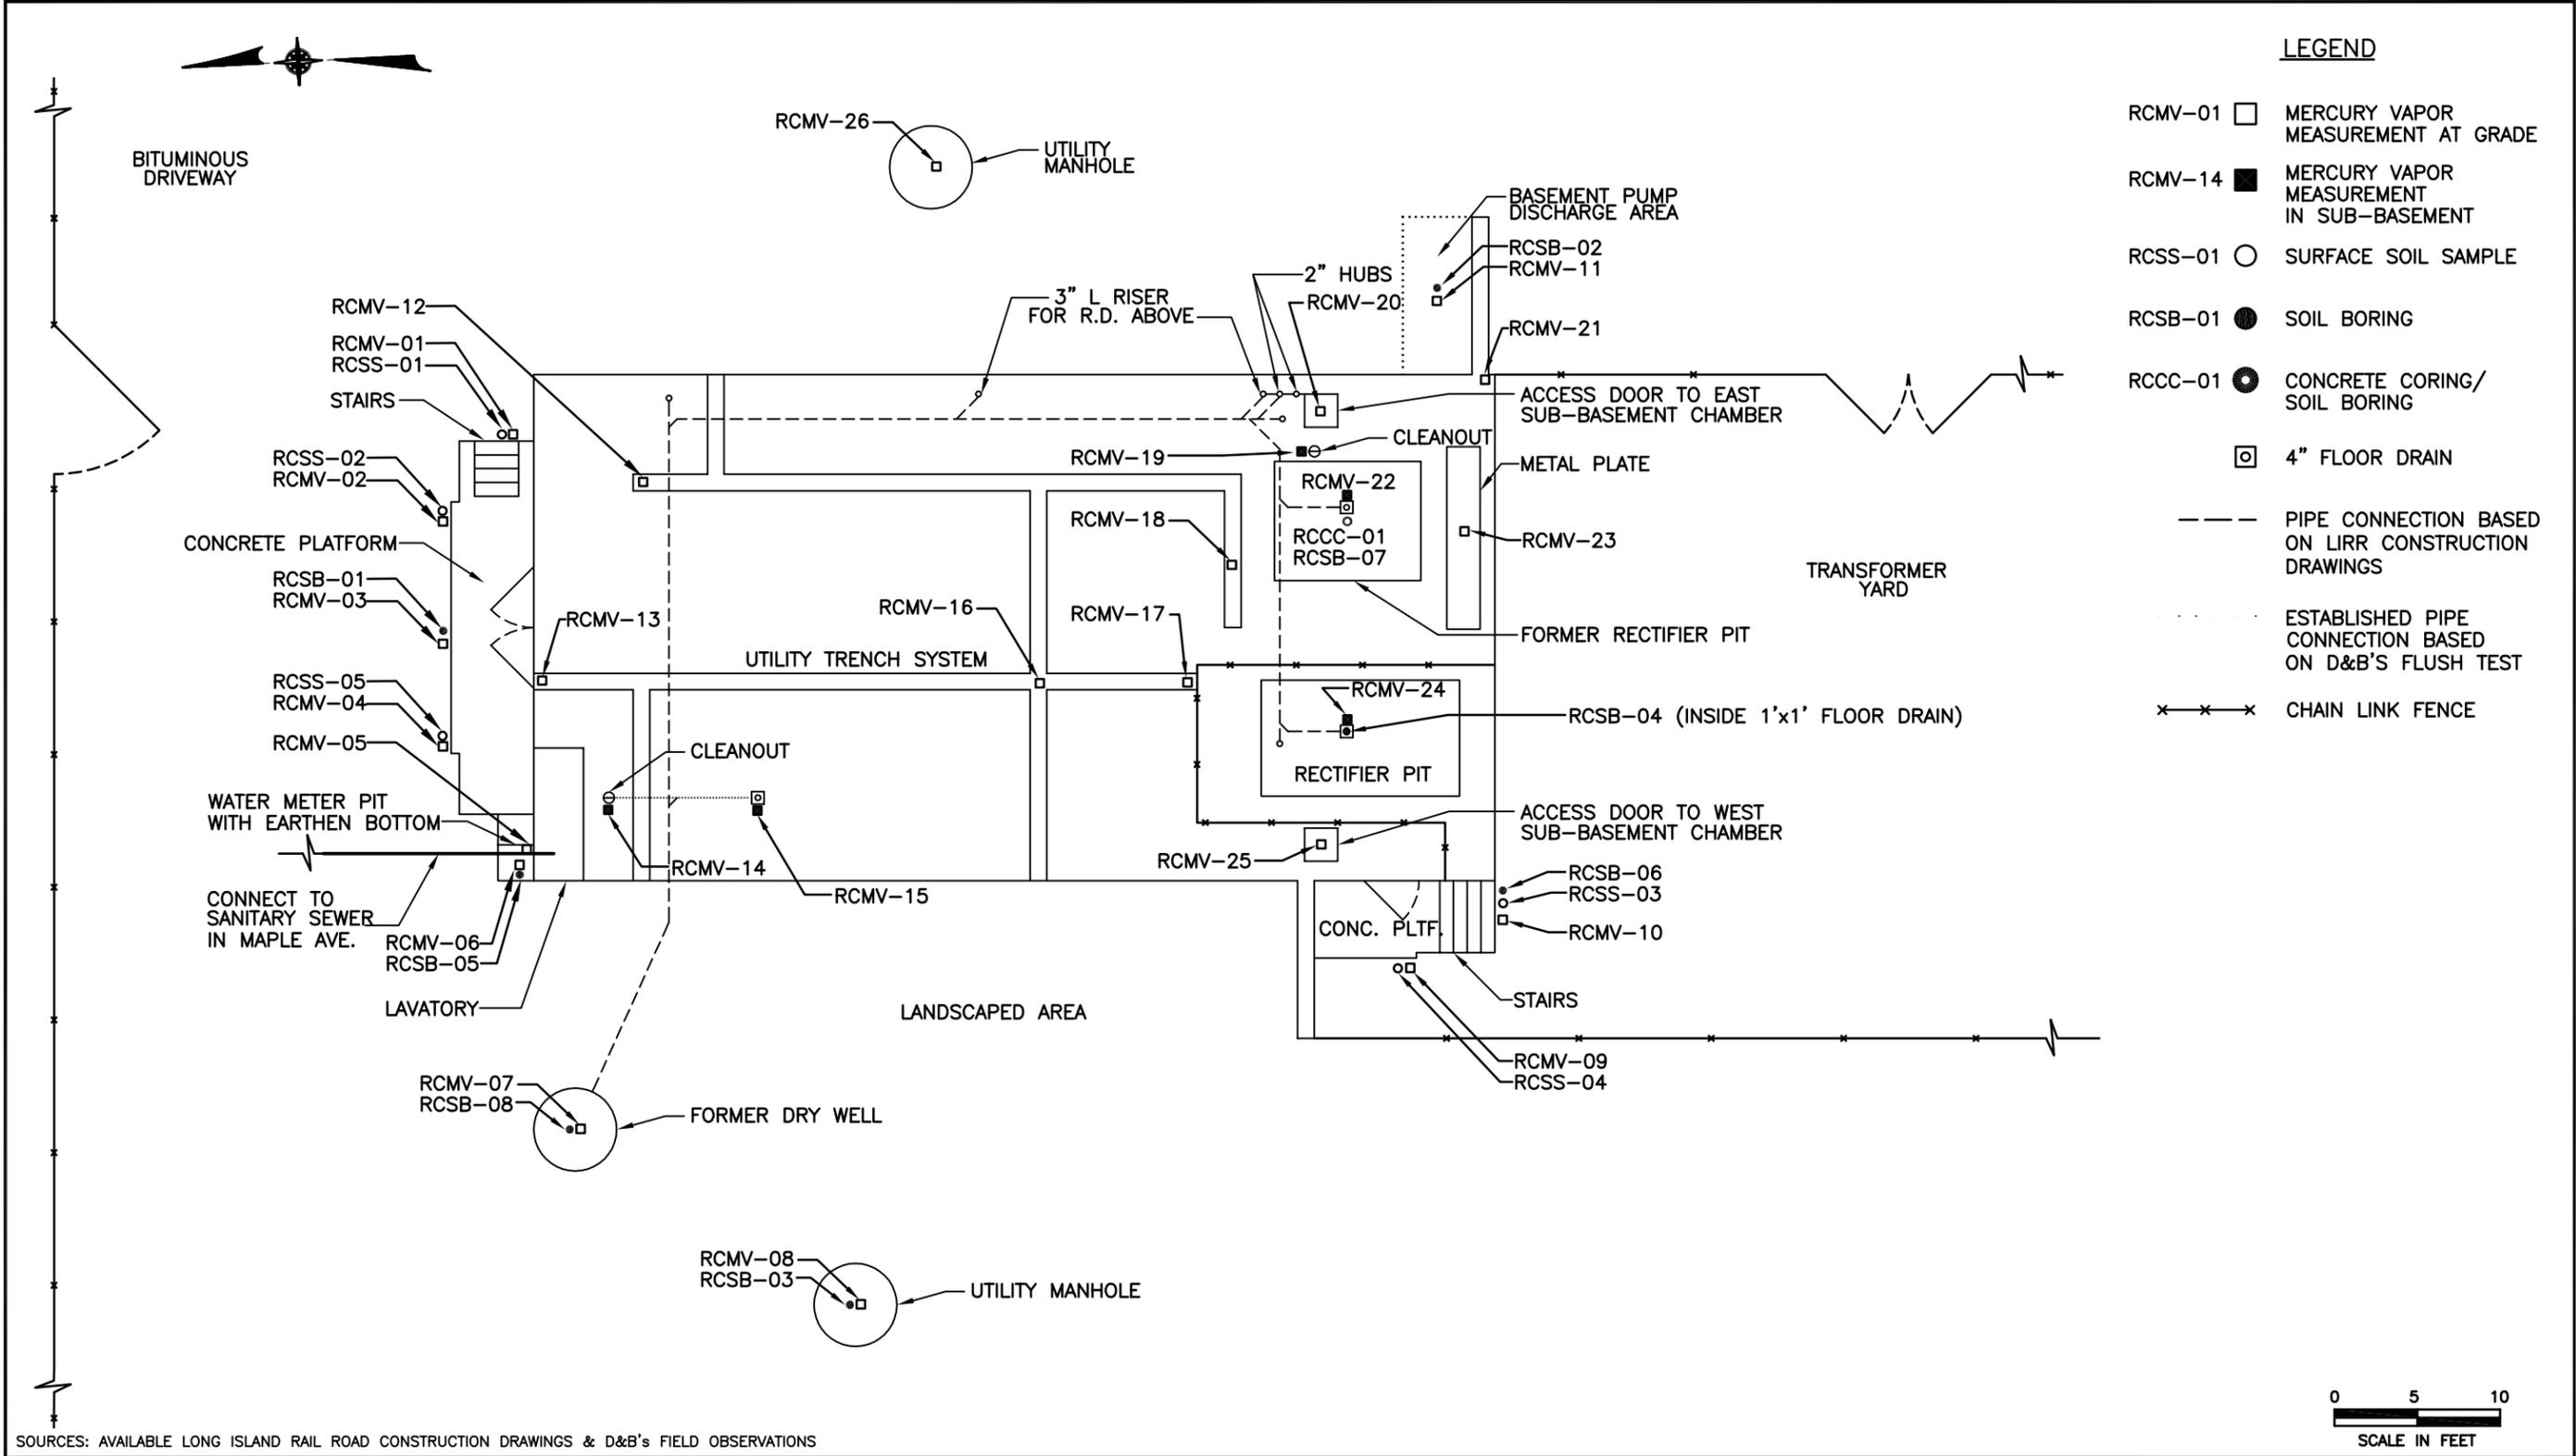
FIGURE 6.5-2

A total of 26 mercury vapor measurements were taken in and around the substation building. As indicated in Table A-5, 1 of the 26 measurements indicated the presence of mercury vapor at a concentration of 0.030 mg/m³ at location RCMV-19. These locations are presented on the mercury vapor measurement location plan (see Figure 6.5-2).

As indicated in Table D-5A, the following subsurface soil samples collected in and around the substation exhibited concentrations of mercury above the NYSDEC TAGM criterion of 0.2 mg/kg. The locations of these samples are presented on the sampling location plan (see Figure 6.5-2).

Analytical results for surface soil samples are presented in Table D-5B. The surface sample locations are shown on Figure 6.5-2. Mercury was detected at concentrations above the NYSDEC TAGM criterion of 0.2 mg/kg in all samples collected as summarized below:

Analytical results for concrete core samples are presented in Table D-5C and summarized below. The concrete core sample location is shown on Figure 6.5-2. Mercury was detected in the following sample:

East Rectifier Pit (Sample RCCC-01). Mercury was detected at a concentration of 3.5 mg/kg.

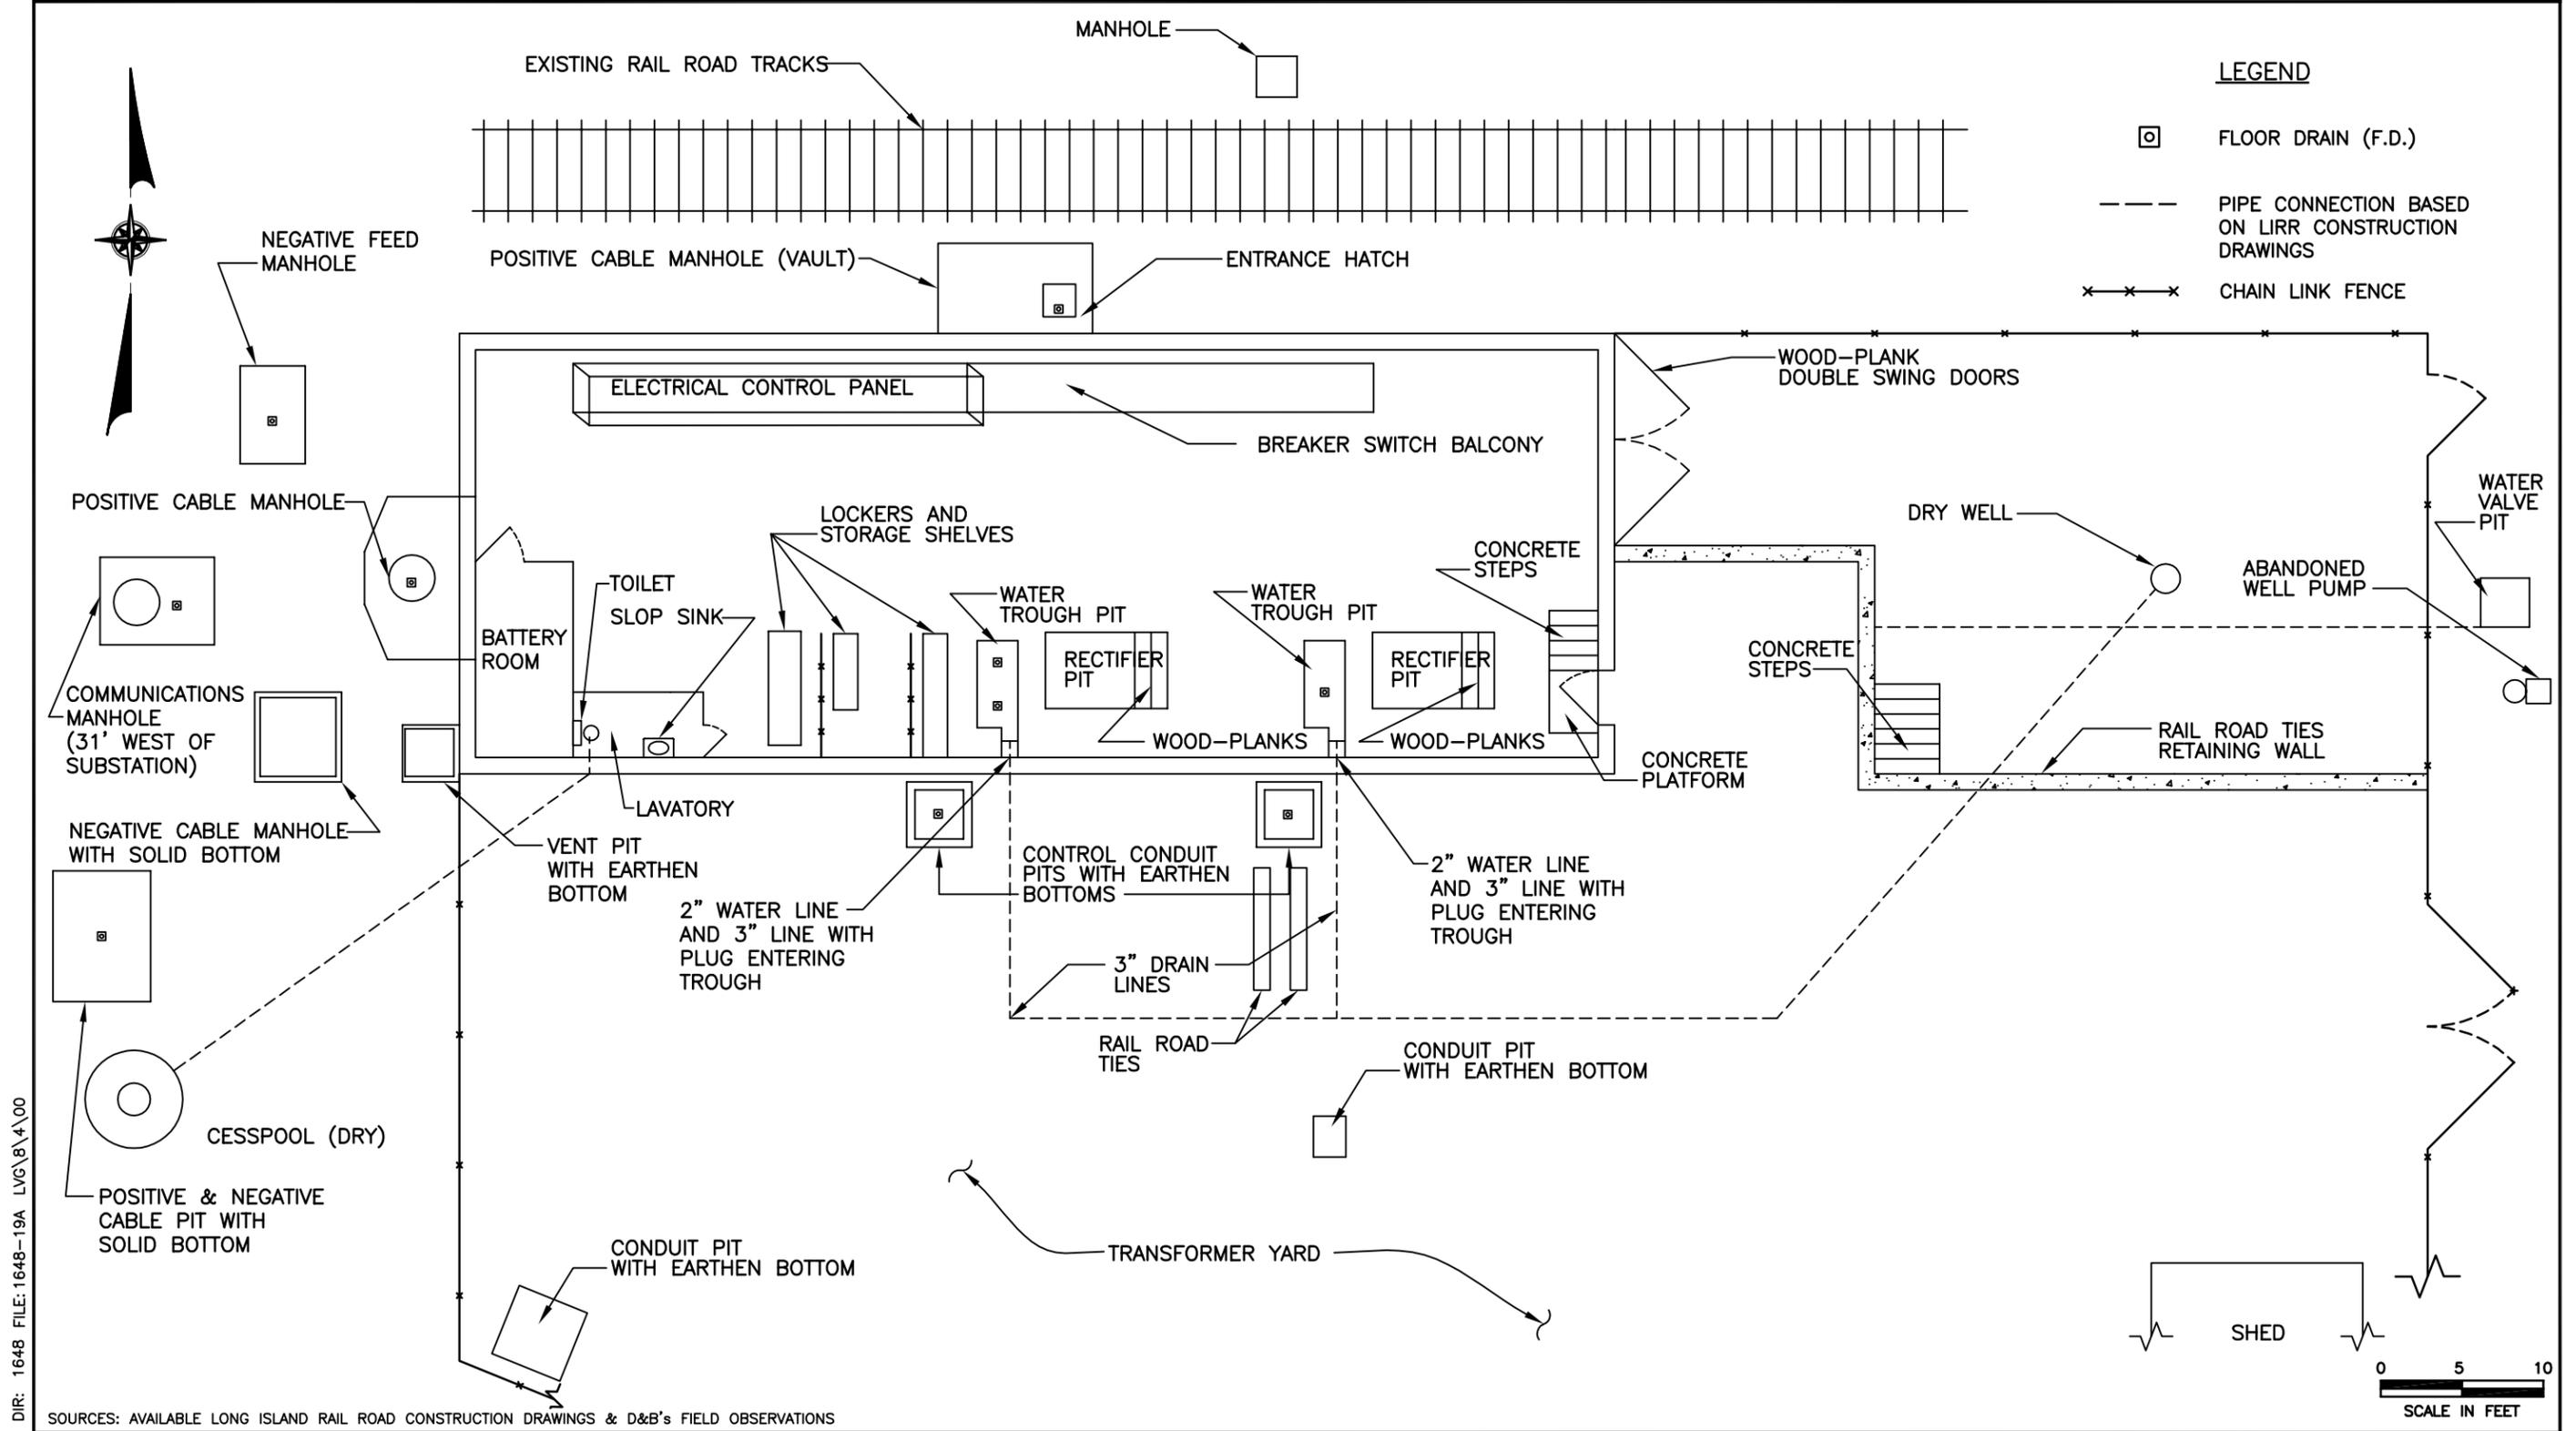
FIGURE 6.8-1

A total of three interior pit floor drains were flush tested utilizing potable water. One drain is located within the east water trough pit and two drains are located within the west water trough pit (see Figure 6.8-1). D&B determined that the southern most floor drain in the western water trough pit discharges directly to a dry well located approximately 35 feet east of the substation. The other three floor drains discharge directly to the ground. It should be noted that D&B confirmed the presence of the dry well by excavating at the location indicated by available LIRR construction drawings. In addition, the interior toilet and slop sink were observed to discharge to an on-site cesspool located approximately 30 feet off the southwest corner of the substation.

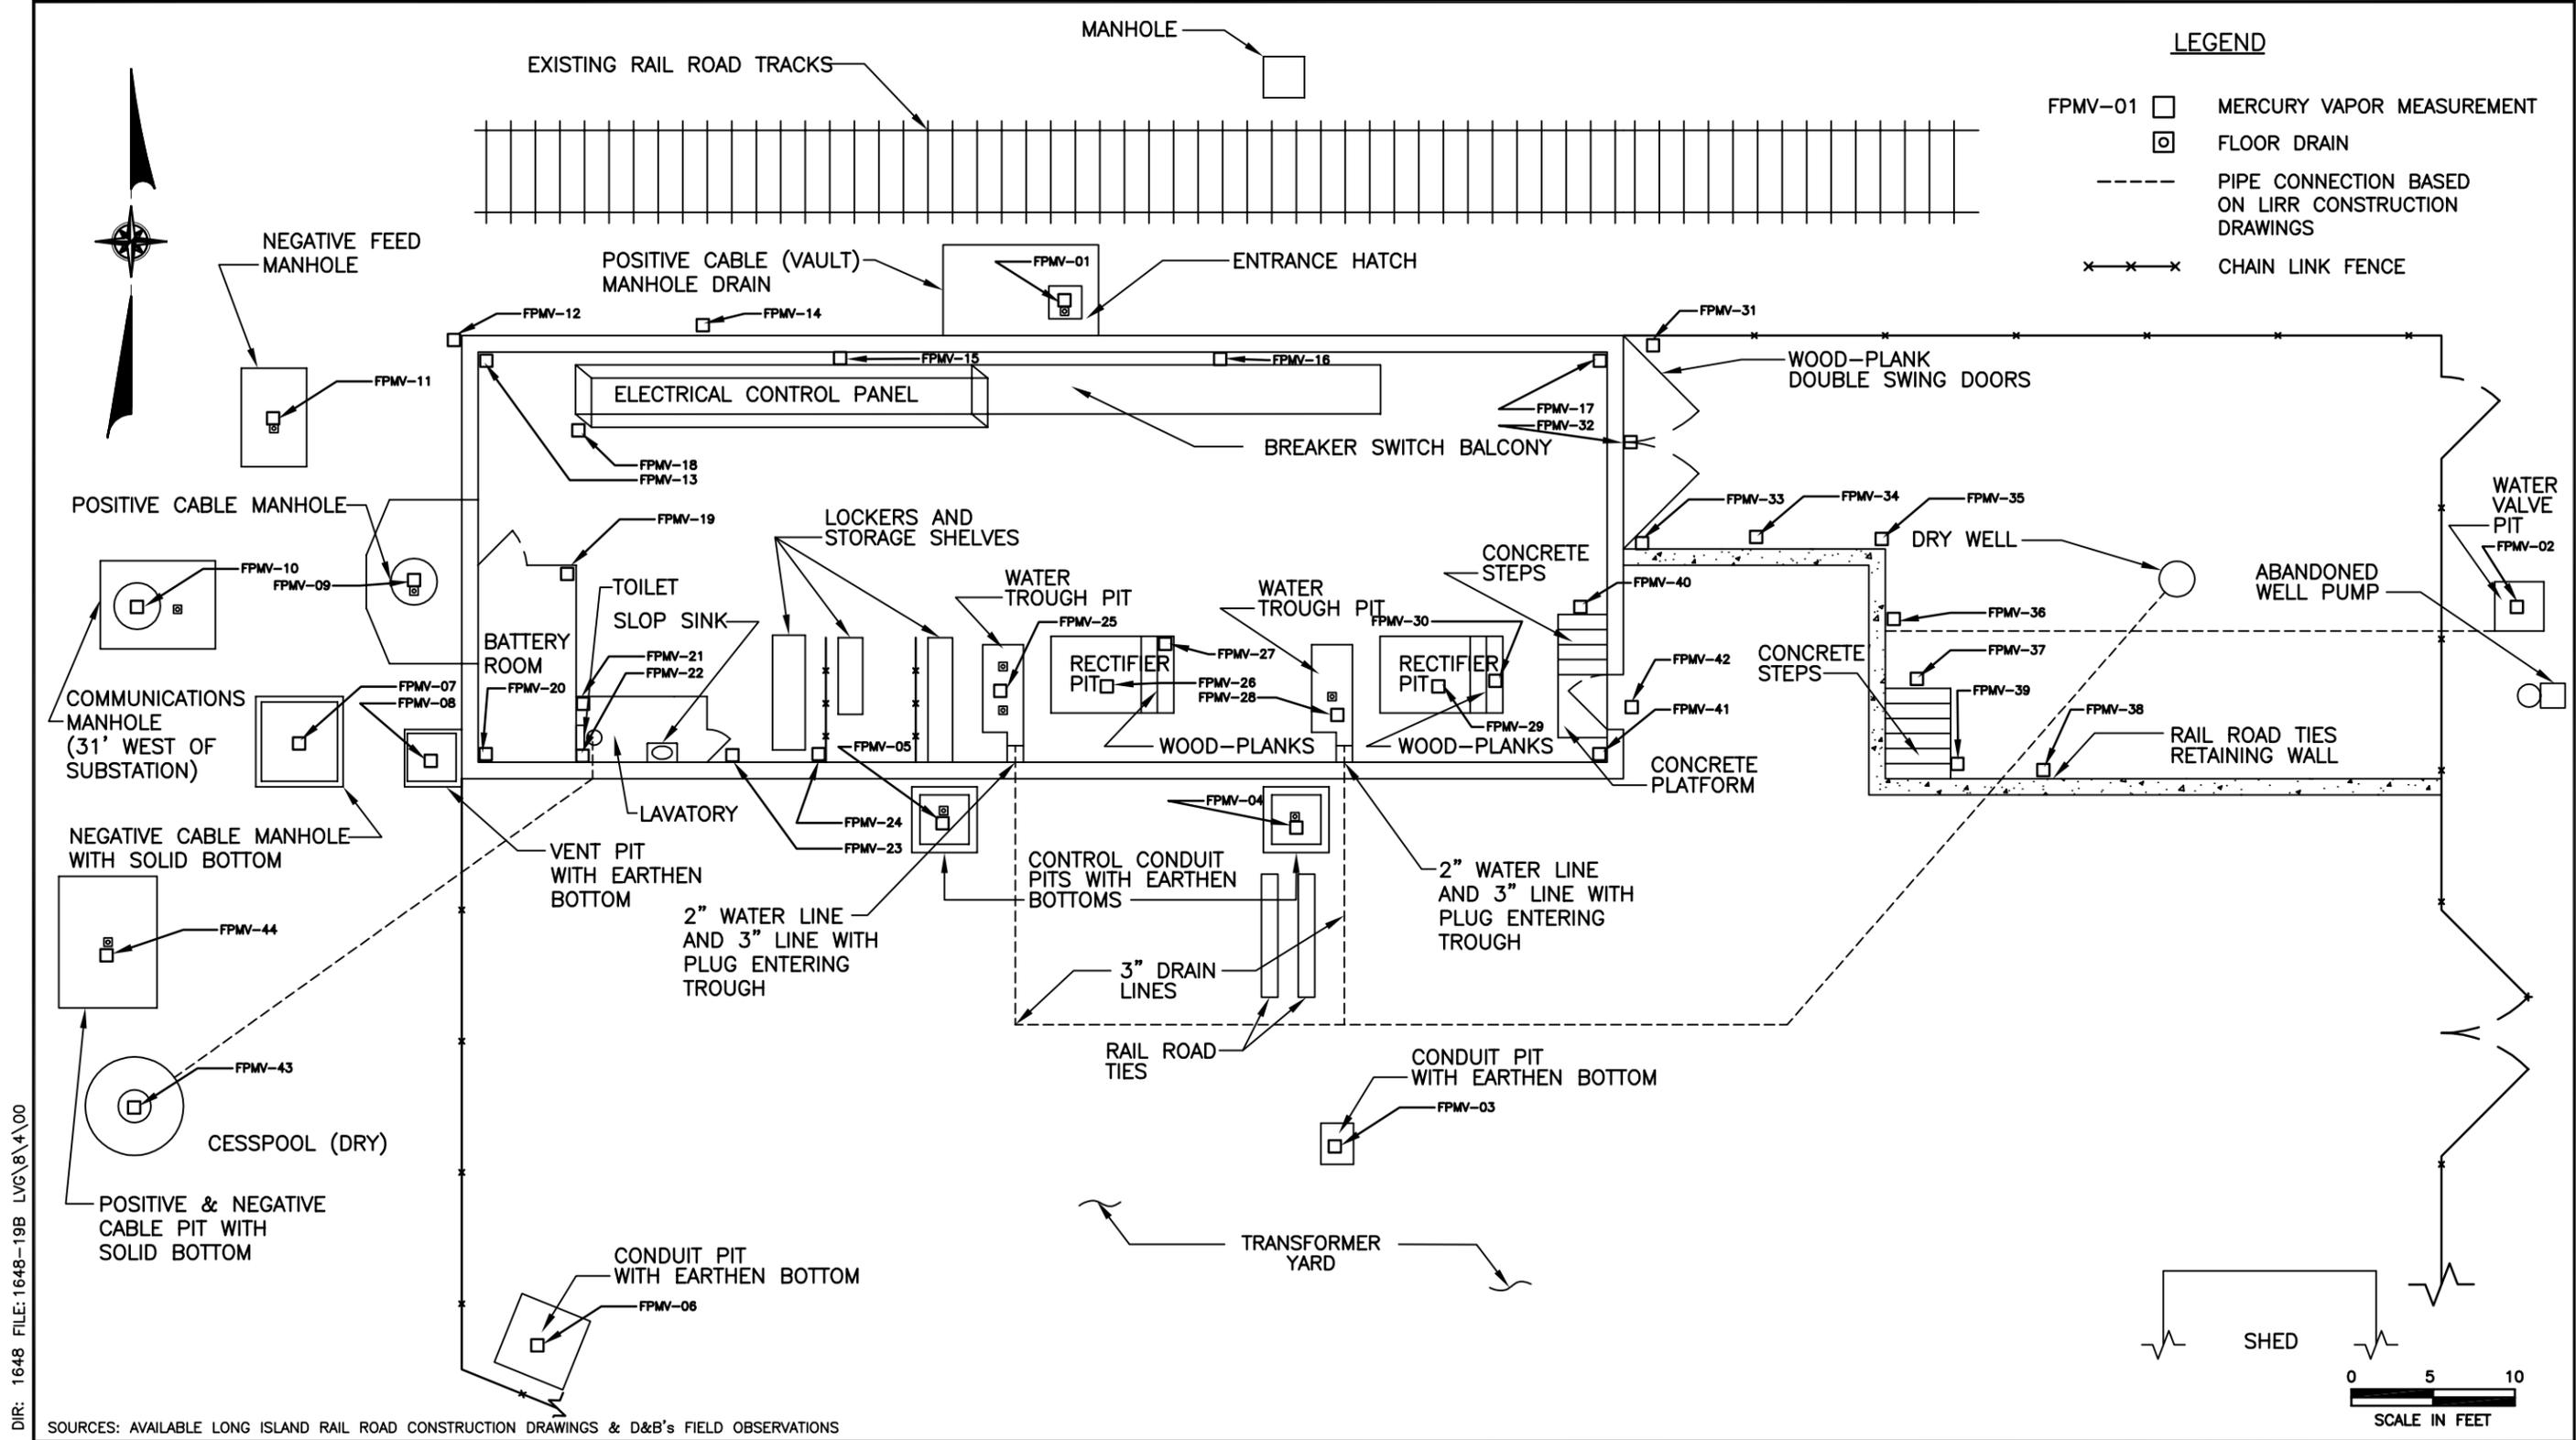
concentration of 0.010 mg/m³ at locations FPMV-32, FPMV-33, FPMV-35, FPMV-36, FPMV-38, FPMV-39 and FPMV-42. These locations are presented on the mercury vapor measurement location plan (see Figure 6.8-2). Although these values are not significantly elevated, it should be noted that visible mercury beads were observed during the MVA survey adjacent to the double swing doors located on the eastern side of the facility and in the vicinity of two railroad ties located to the south of the substation. These “low” mercury vapor readings are thought to be attributed to the fact that the mercury vapor analyzer may not have been functioning properly due to the fact that the sensor could have been saturated.

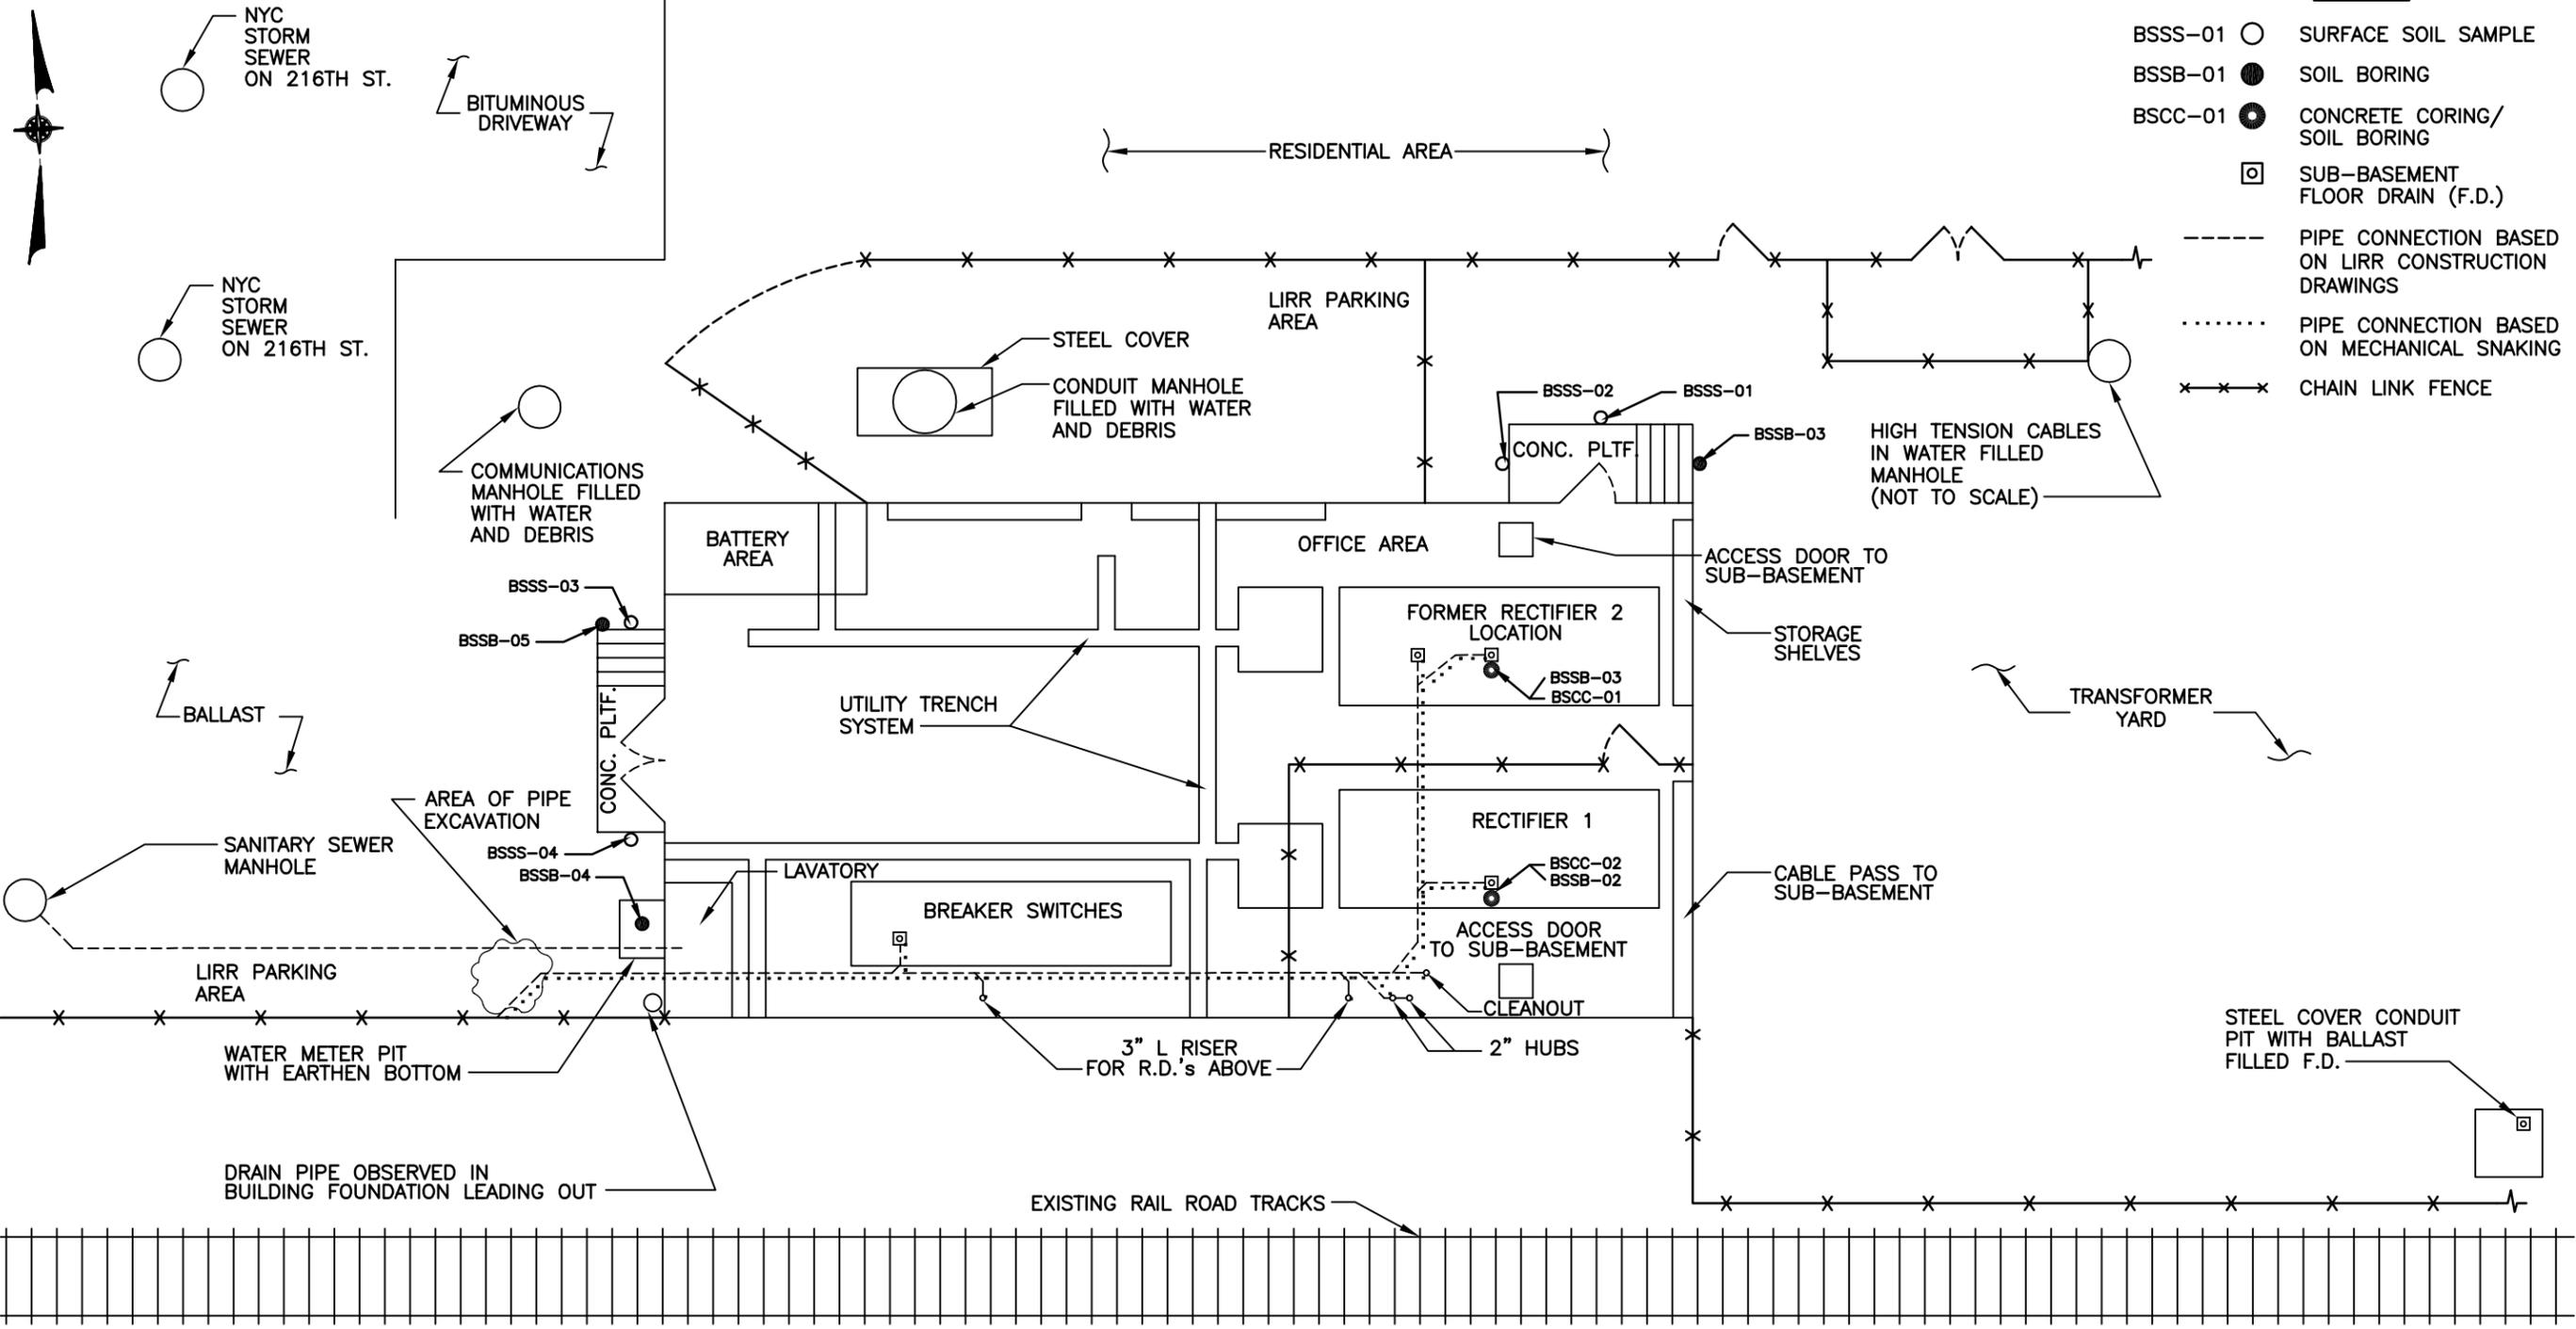
FIGURE 6.13-3

As indicated in Table D-13A, the following subsurface soil sample collected in and around the substation exhibited a concentration of mercury above the NYSDEC TAGM criterion of 0.2 mg/kg. The location of this sample is presented on the sampling location plan (see Figure 6.13-3).

Analytical results for surface soil samples are presented in Table D-13B. The surface sample locations are shown on Figure 6.13-3. Mercury was detected in all samples collected at concentrations above the NYSDEC TAGM criterion of 0.2 mg/kg as summarized below:

Analytical results for concrete core samples are presented in Table D-13C and summarized below. The concrete core sample locations are shown on Figure 6.13-3. Mercury was detected in the following samples:
