**SITE ASSESSMENT OF 20 SUBSTATIONS
FOR MERCURY CONTAMINATION**

**METROPOLITAN TRANSPORTATION AUTHORITY
LONG ISLAND RAIL ROAD**

**DVIRKA AND BARTILUCCI CONSULTING ENGINEERS
(a Division of William F. Cosulich Associates, P.C.)
330 Crossways Park Drive
Woodbury, New York 11797**

DECEMBER 2000

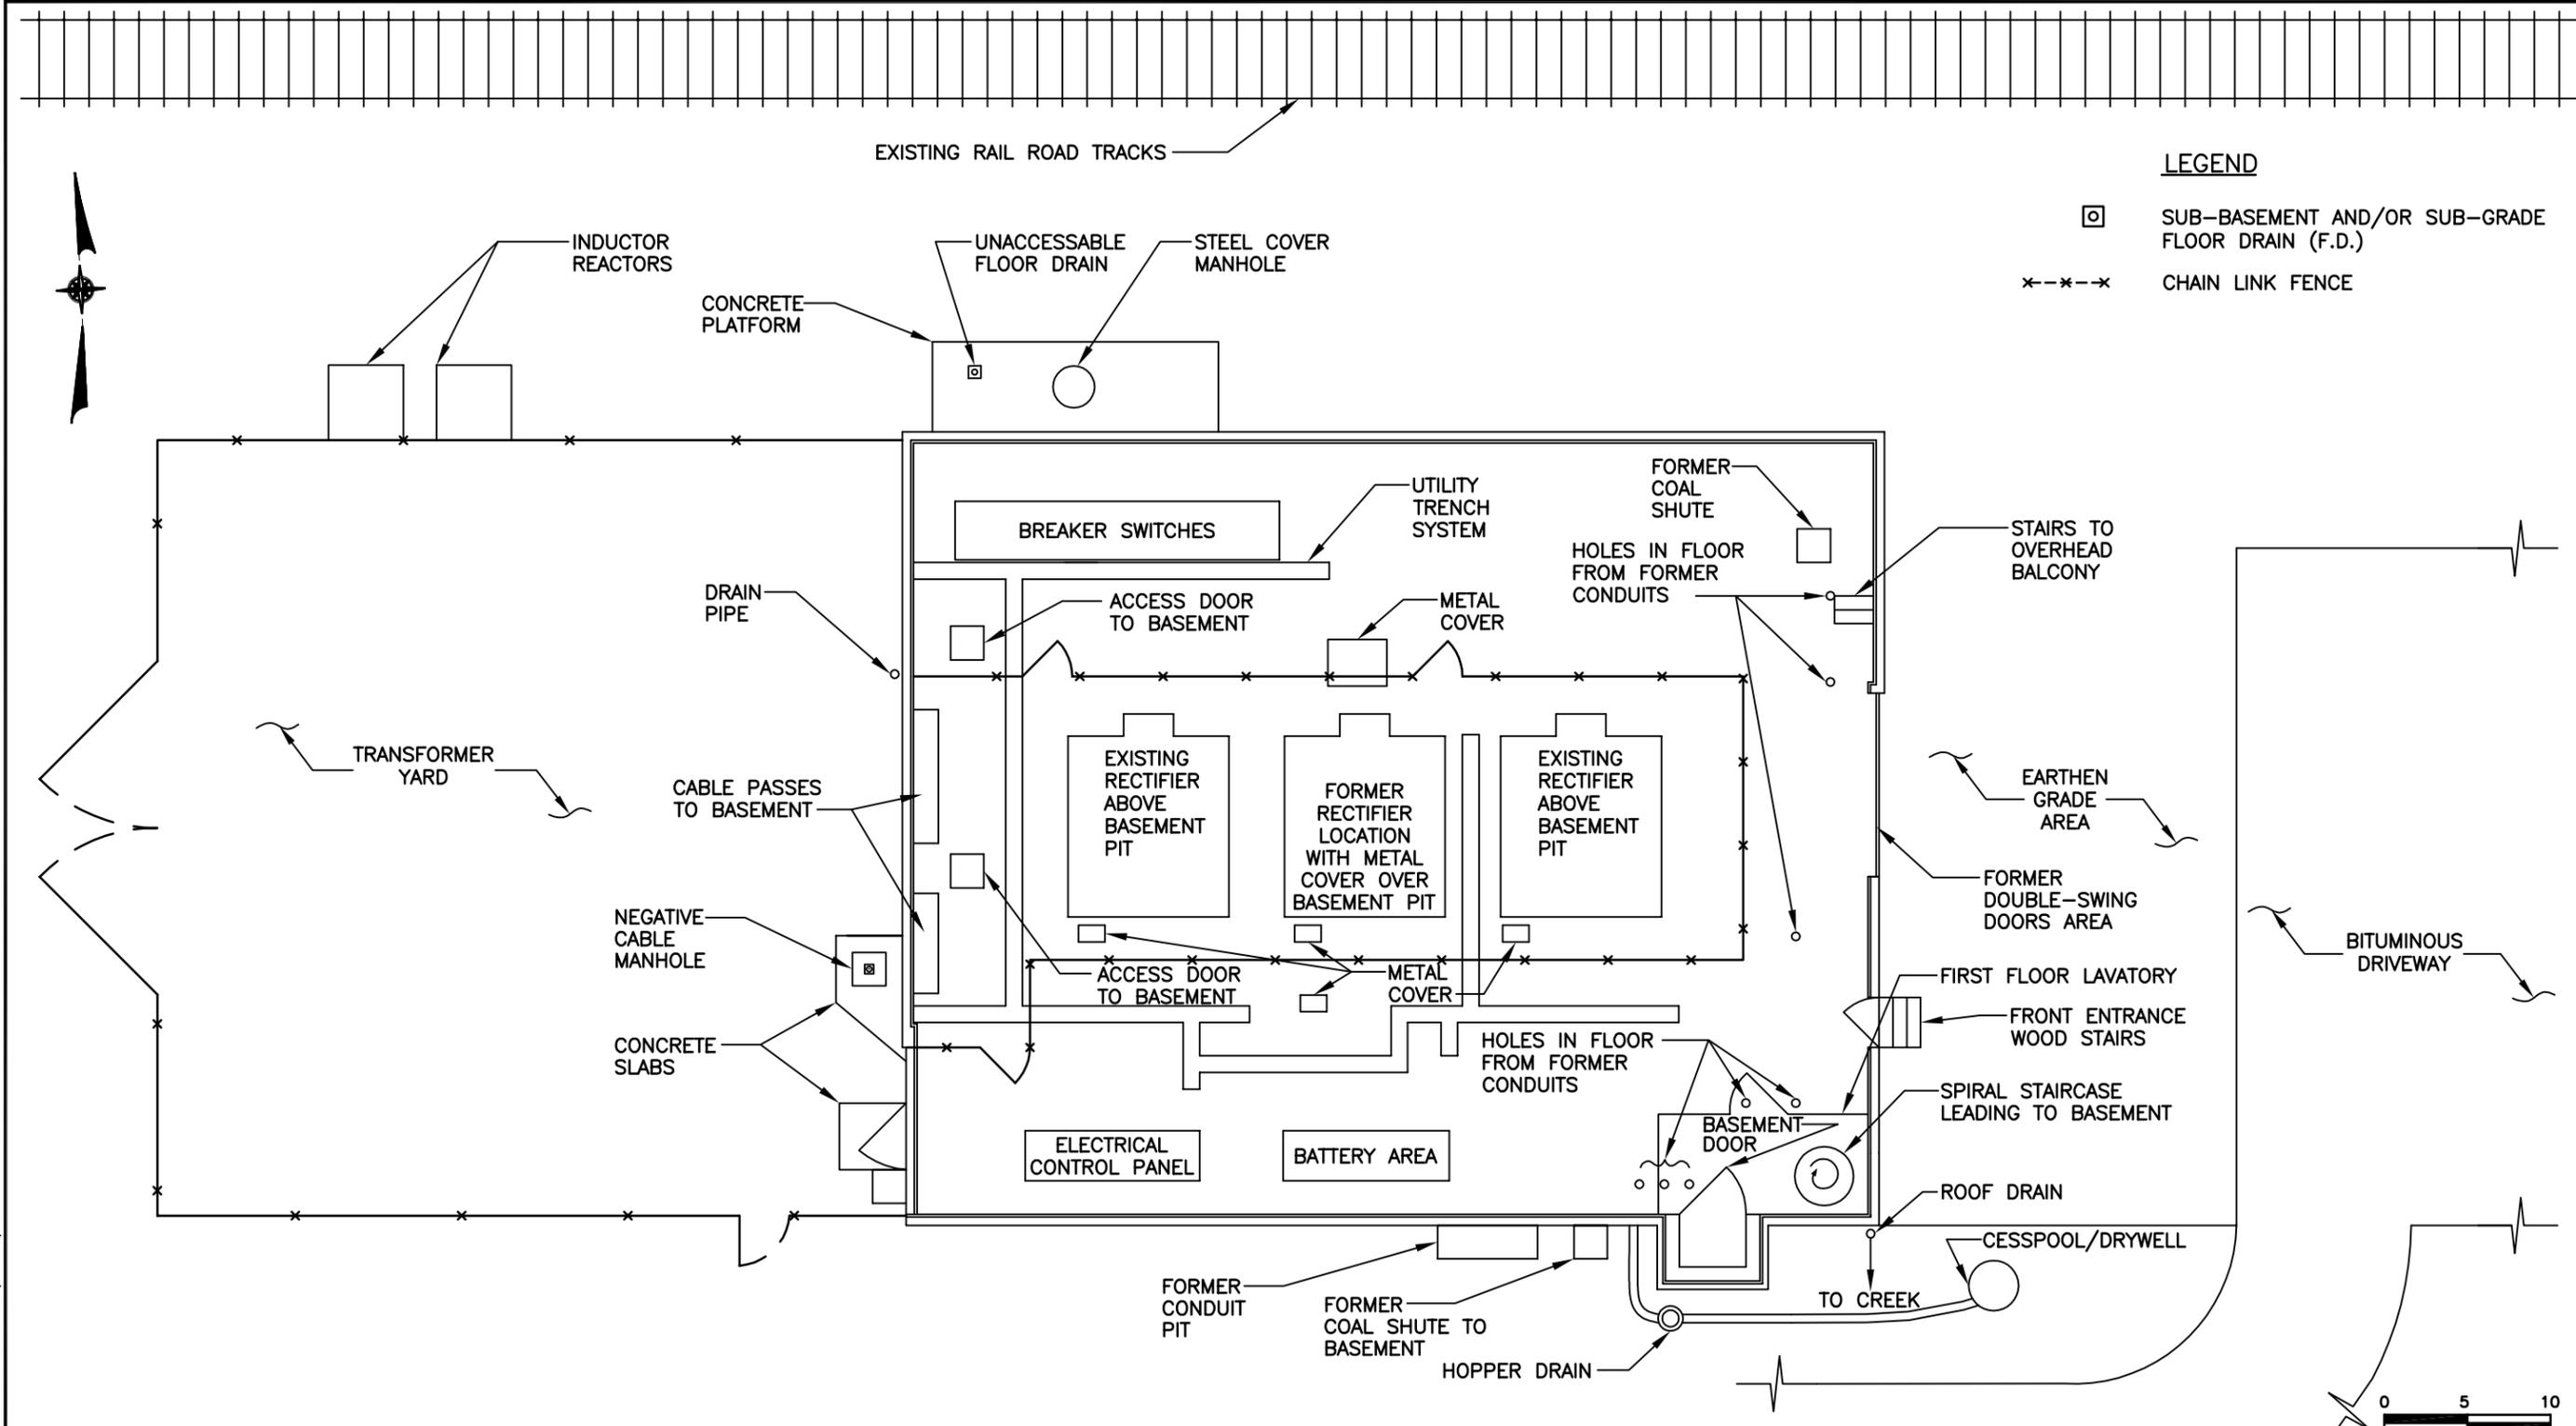
FIGURE 6.14-1

The Little Neck substation site is located in Great Neck, Nassau County, New York. The substation consists of an approximately 2,500 square foot two-story brick building as shown on Figure 6.14-1. An approximately 2,100 square foot transformer yard is located adjacent to the substation to the west and is enclosed by a chain-linked fence. The substation building and transformer yard is presently utilized to convert alternating current to direct current for the LIRR-Port Washington branch. The areas surrounding the substation and the transformer yards are located within the LIRR right-of-way.

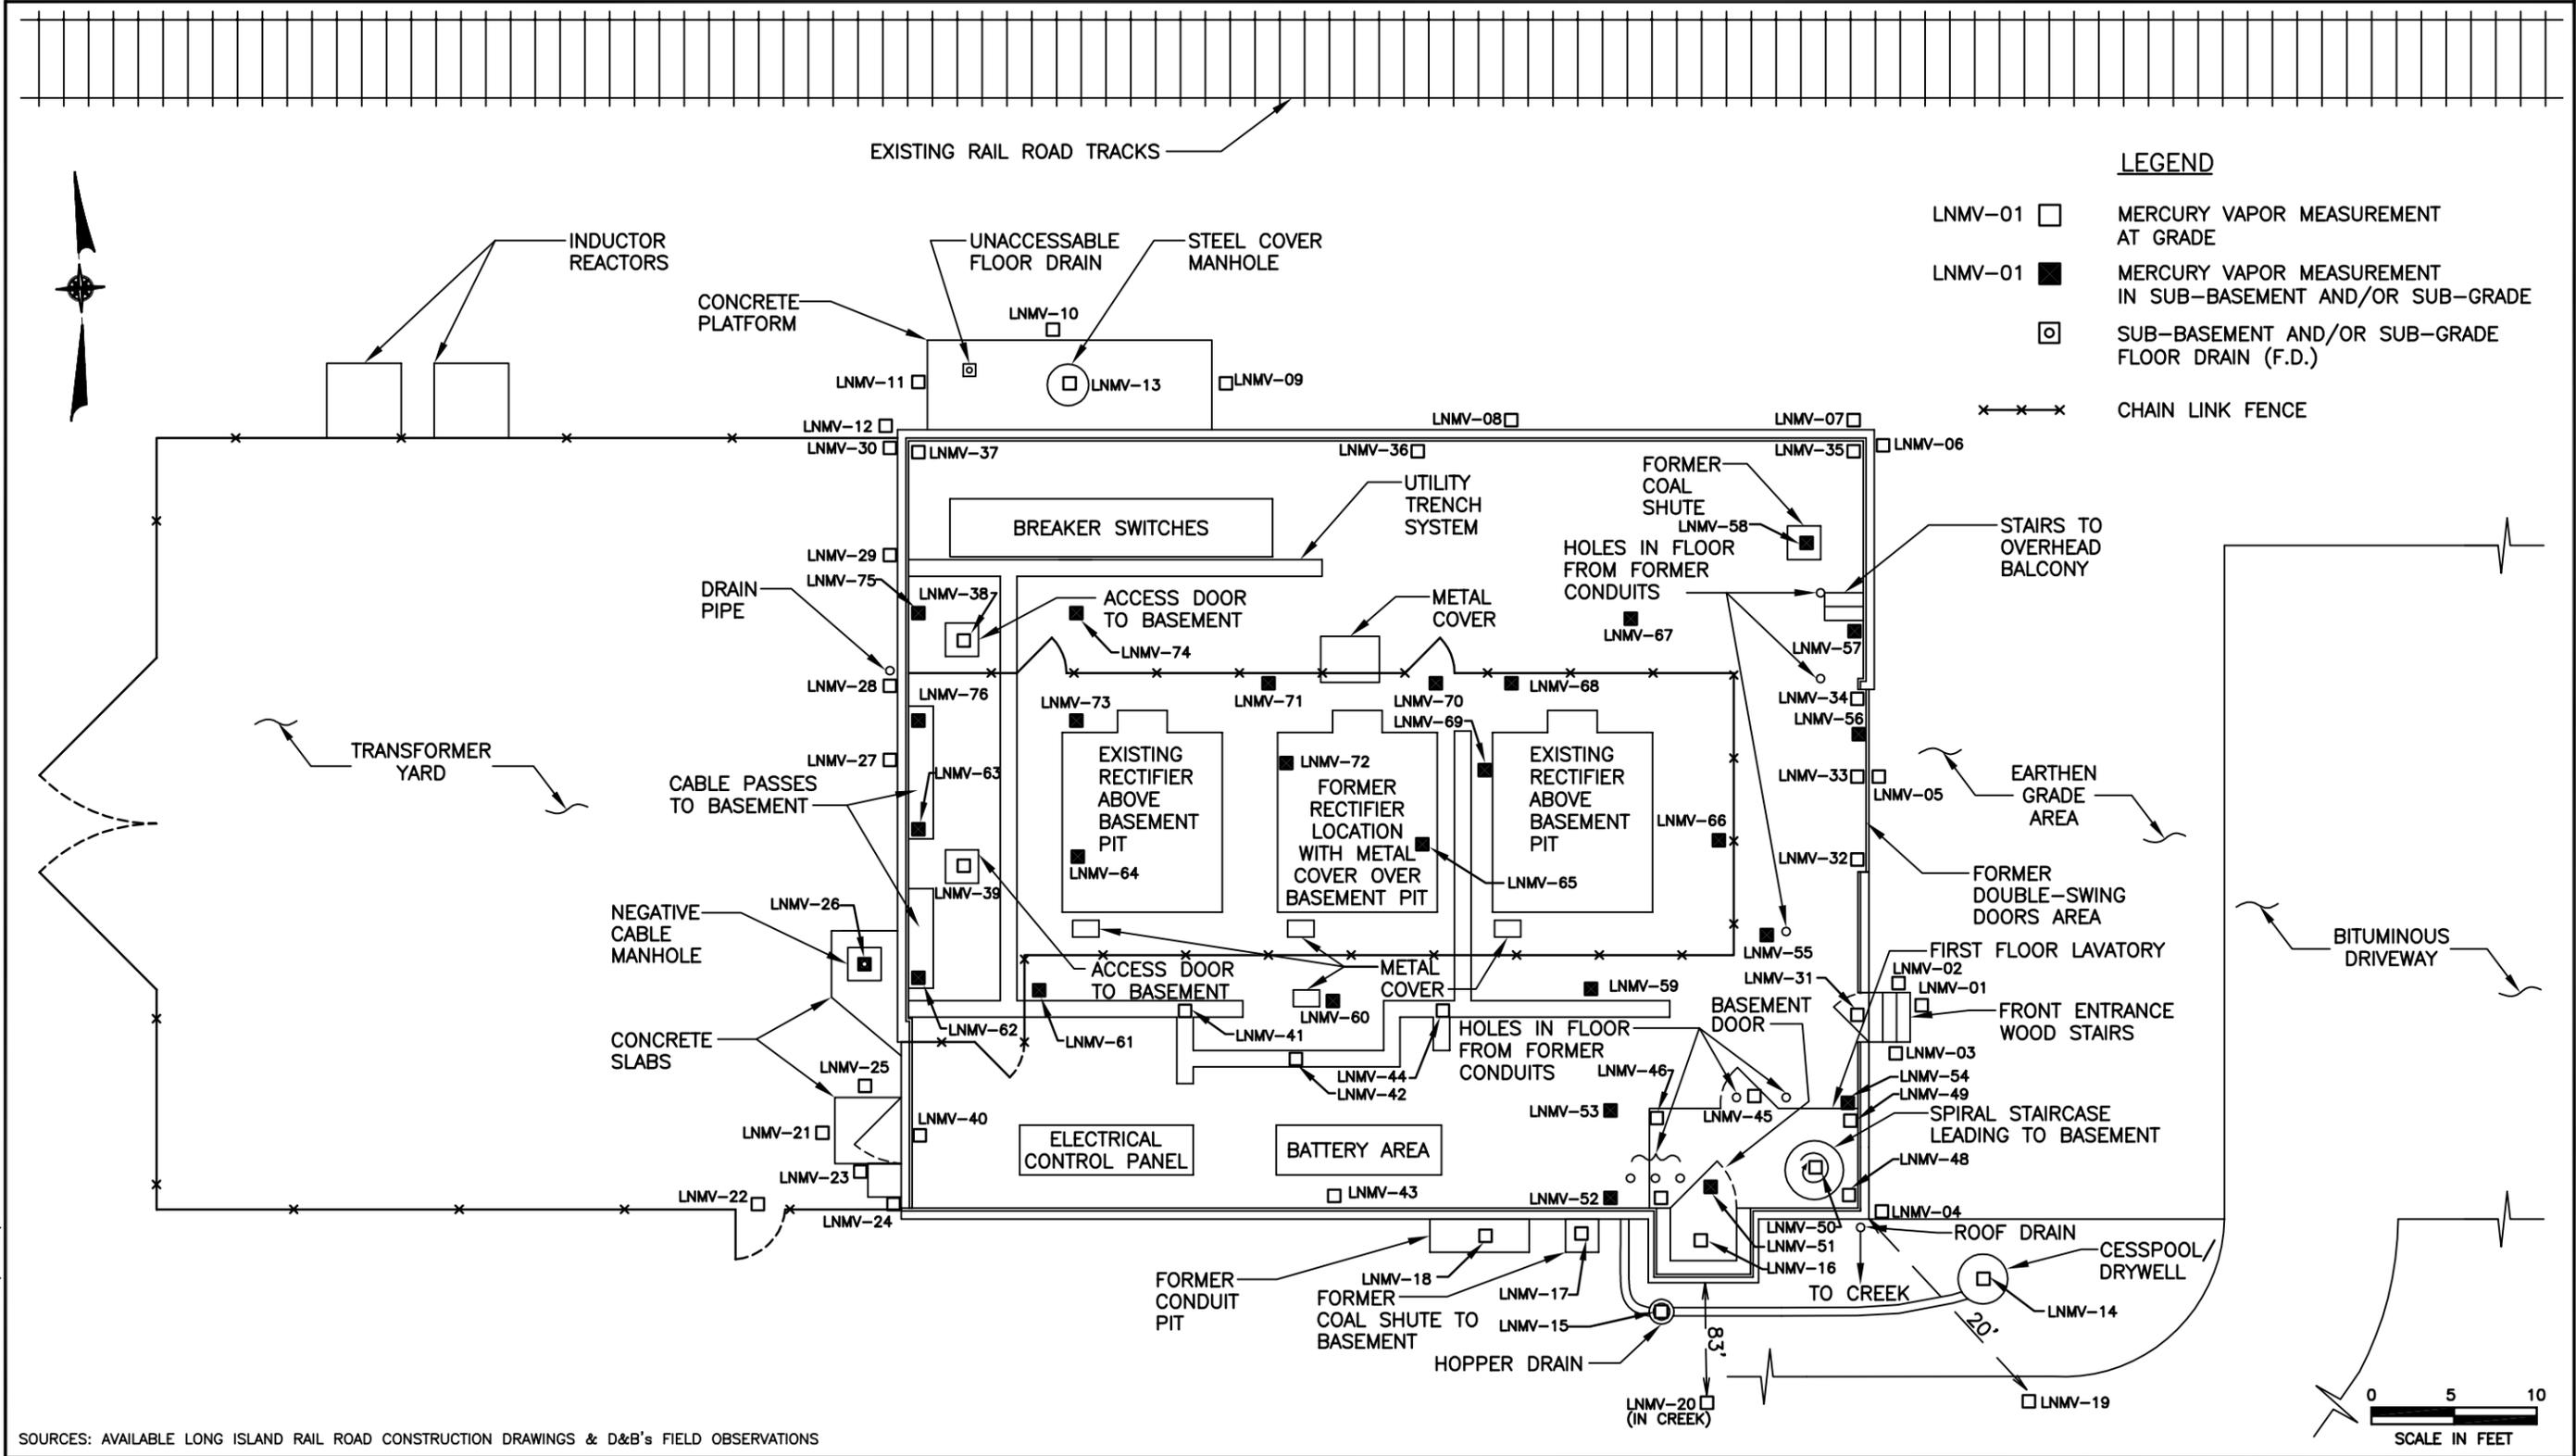
FIGURE 6.14-2

A total of 76 mercury vapor measurements were taken in and around the substation building. As indicated in Table A-14, none of the 76 measurements indicated the presence of mercury vapor. These locations are presented on the mercury vapor measurement location plan (see Figure 6.14-2).

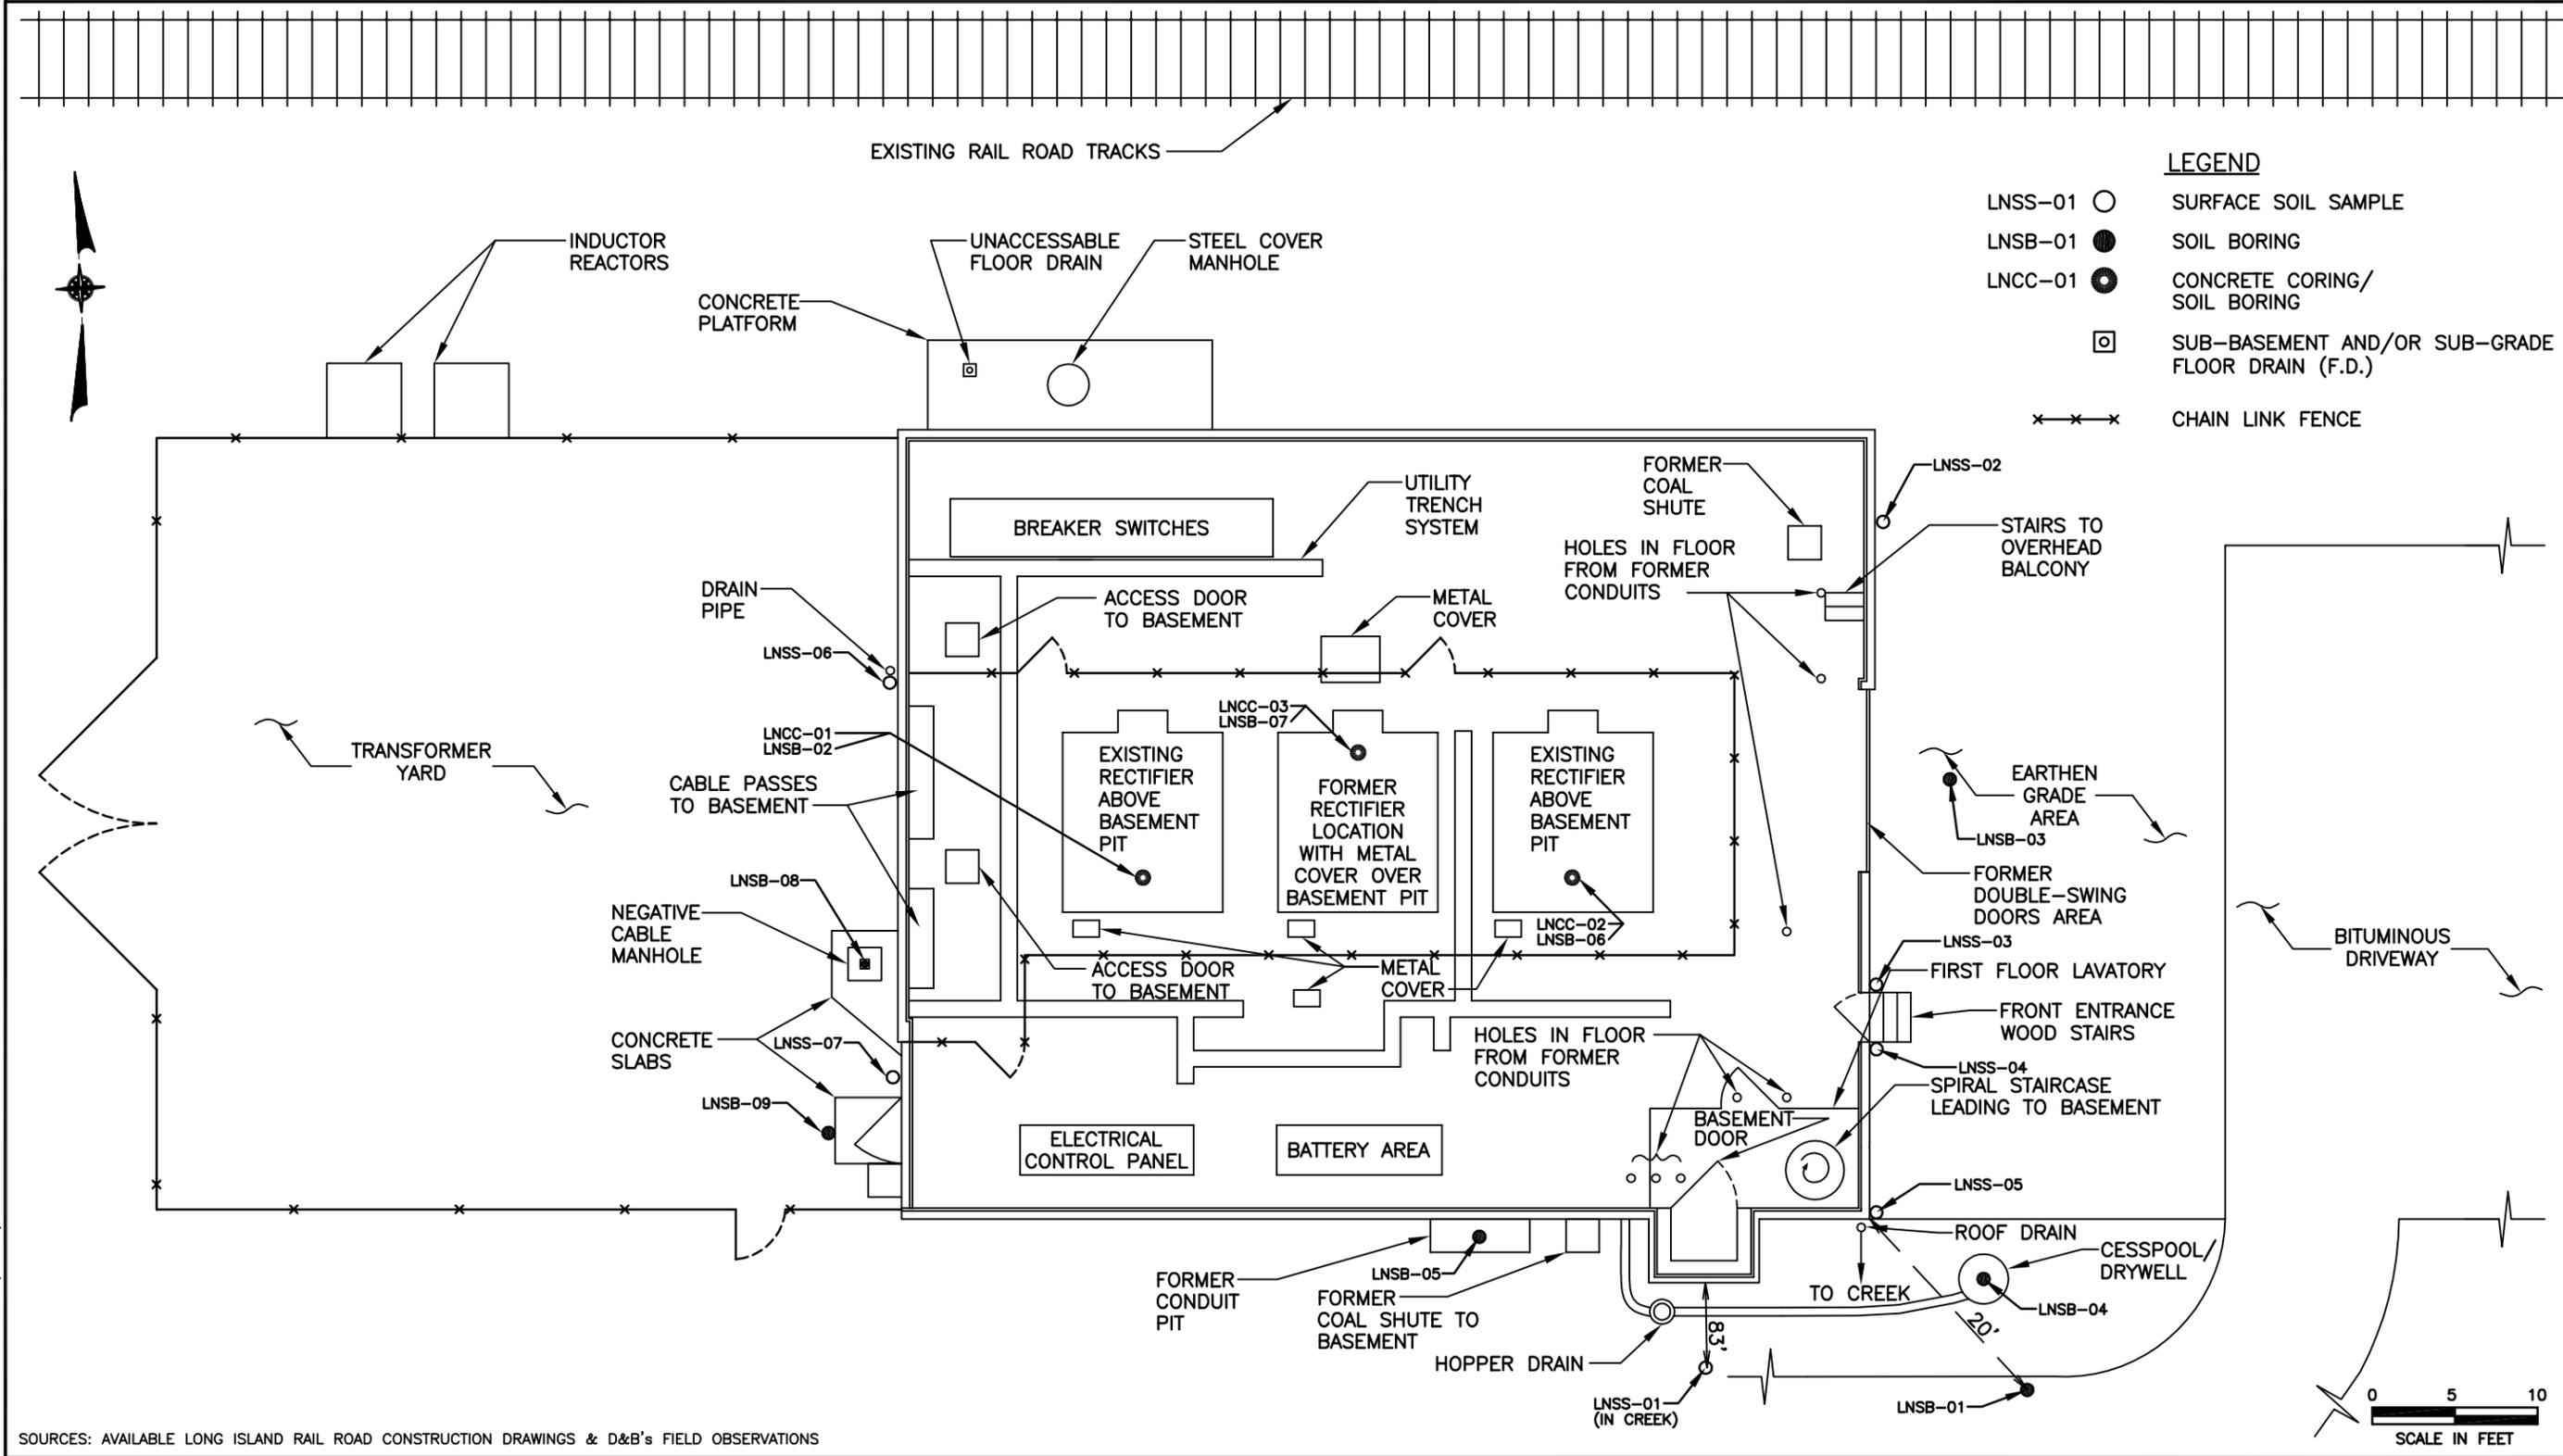
FIGURE 6.14-3

As indicated in Table D-14A, the following subsurface soil samples collected in and around the substation exhibited concentrations of mercury above the NYSDEC TAGM criterion of 0.2 mg/kg. The locations of these samples are presented on the sampling location plan (see Figure 6.14-3).

Analytical results for surface soil samples are presented in Table D-14B. The surface sample locations are shown on Figure 6.14-3. Mercury was detected at concentrations below the NYSDEC TAGM criterion of 0.2 mg/kg except for the following:

Analytical results for concrete core samples are presented in Table D-14C and summarized below. The concrete core sample locations are shown on Figure 6.14-3. Mercury was detected in the following samples:

East Basement (Sample LNCC-02). Mercury was detected at a concentration of 48.3 mg/kg.

Central Basement (Sample LNCC-03). Mercury was detected at a concentration of 12.6 mg/kg.

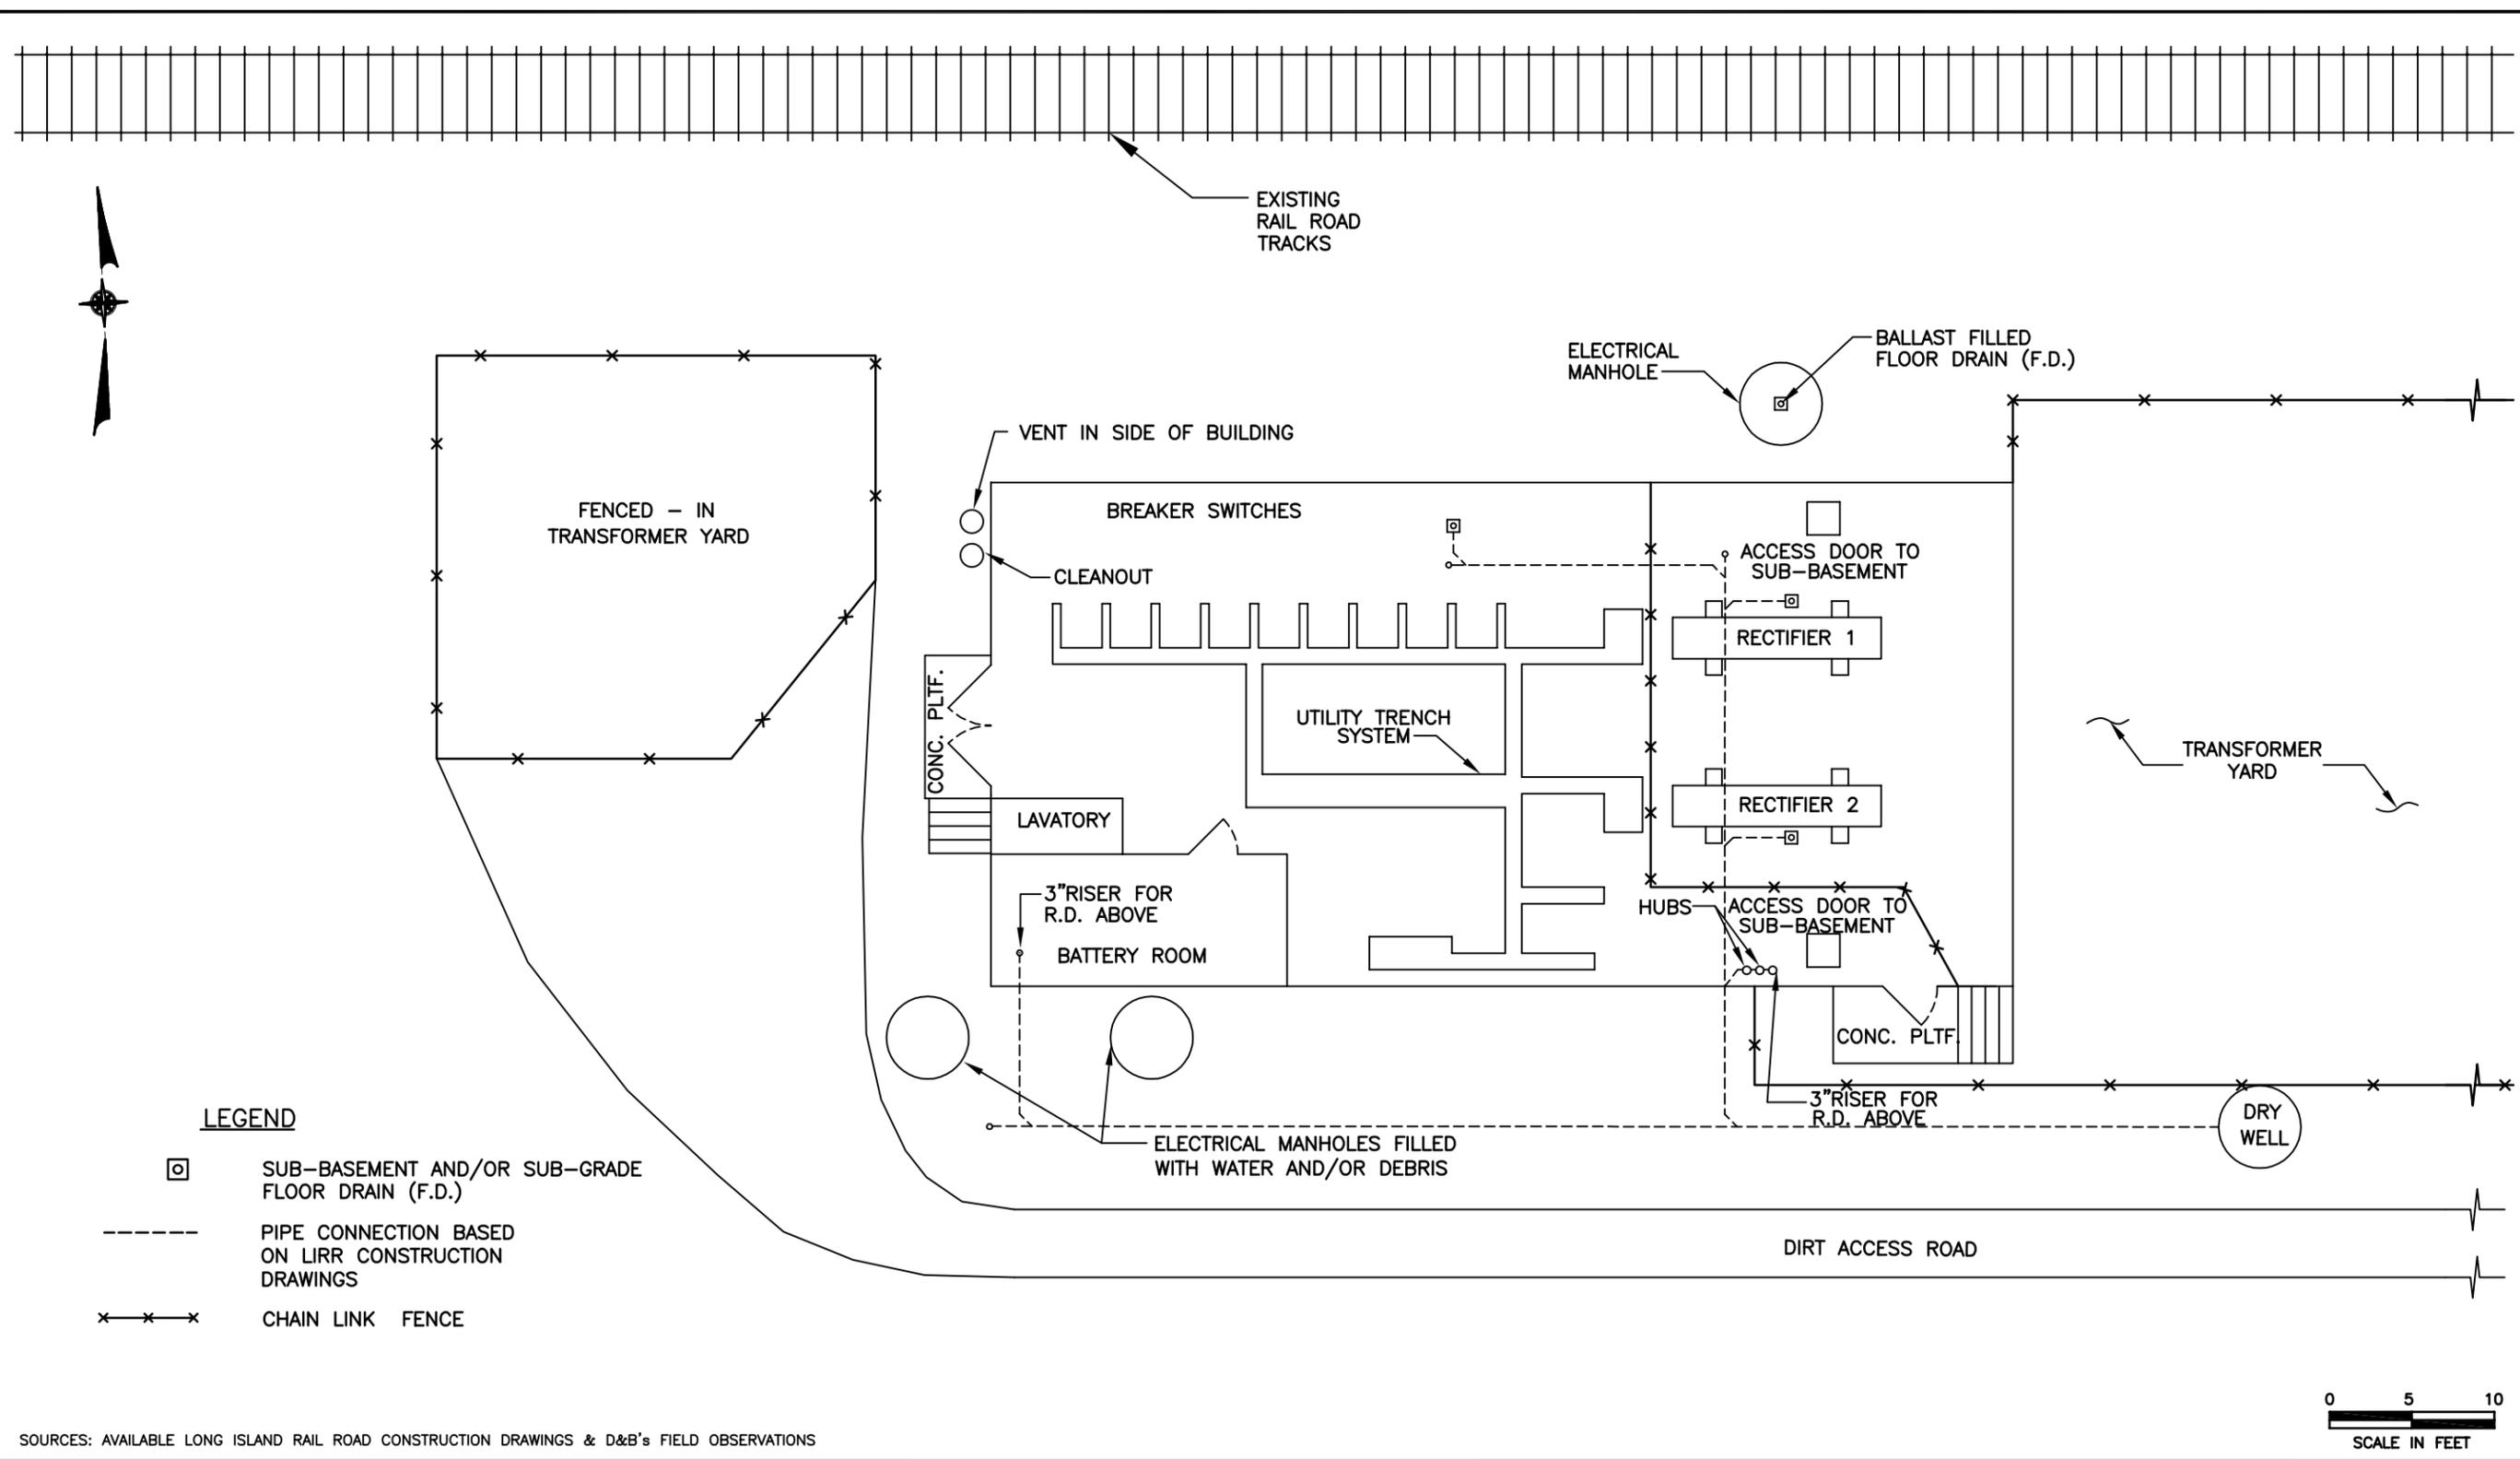
The Bellaire substation site is located in Bellaire, Queens County, New York. The substation consists of an approximately 1,800 square foot one-story brick building shown on Figure 6.15-1. Two transformer yards totaling approximately 2,200 square feet are located to the east and west of the substation and are enclosed by a chain-linked fence. The substation building and transformer yard is presently utilized to convert alternating current to direct current for the LIRR-Hempstead branch. The areas surrounding the substation and the transformer yards are located within the LIRR right-of-way.

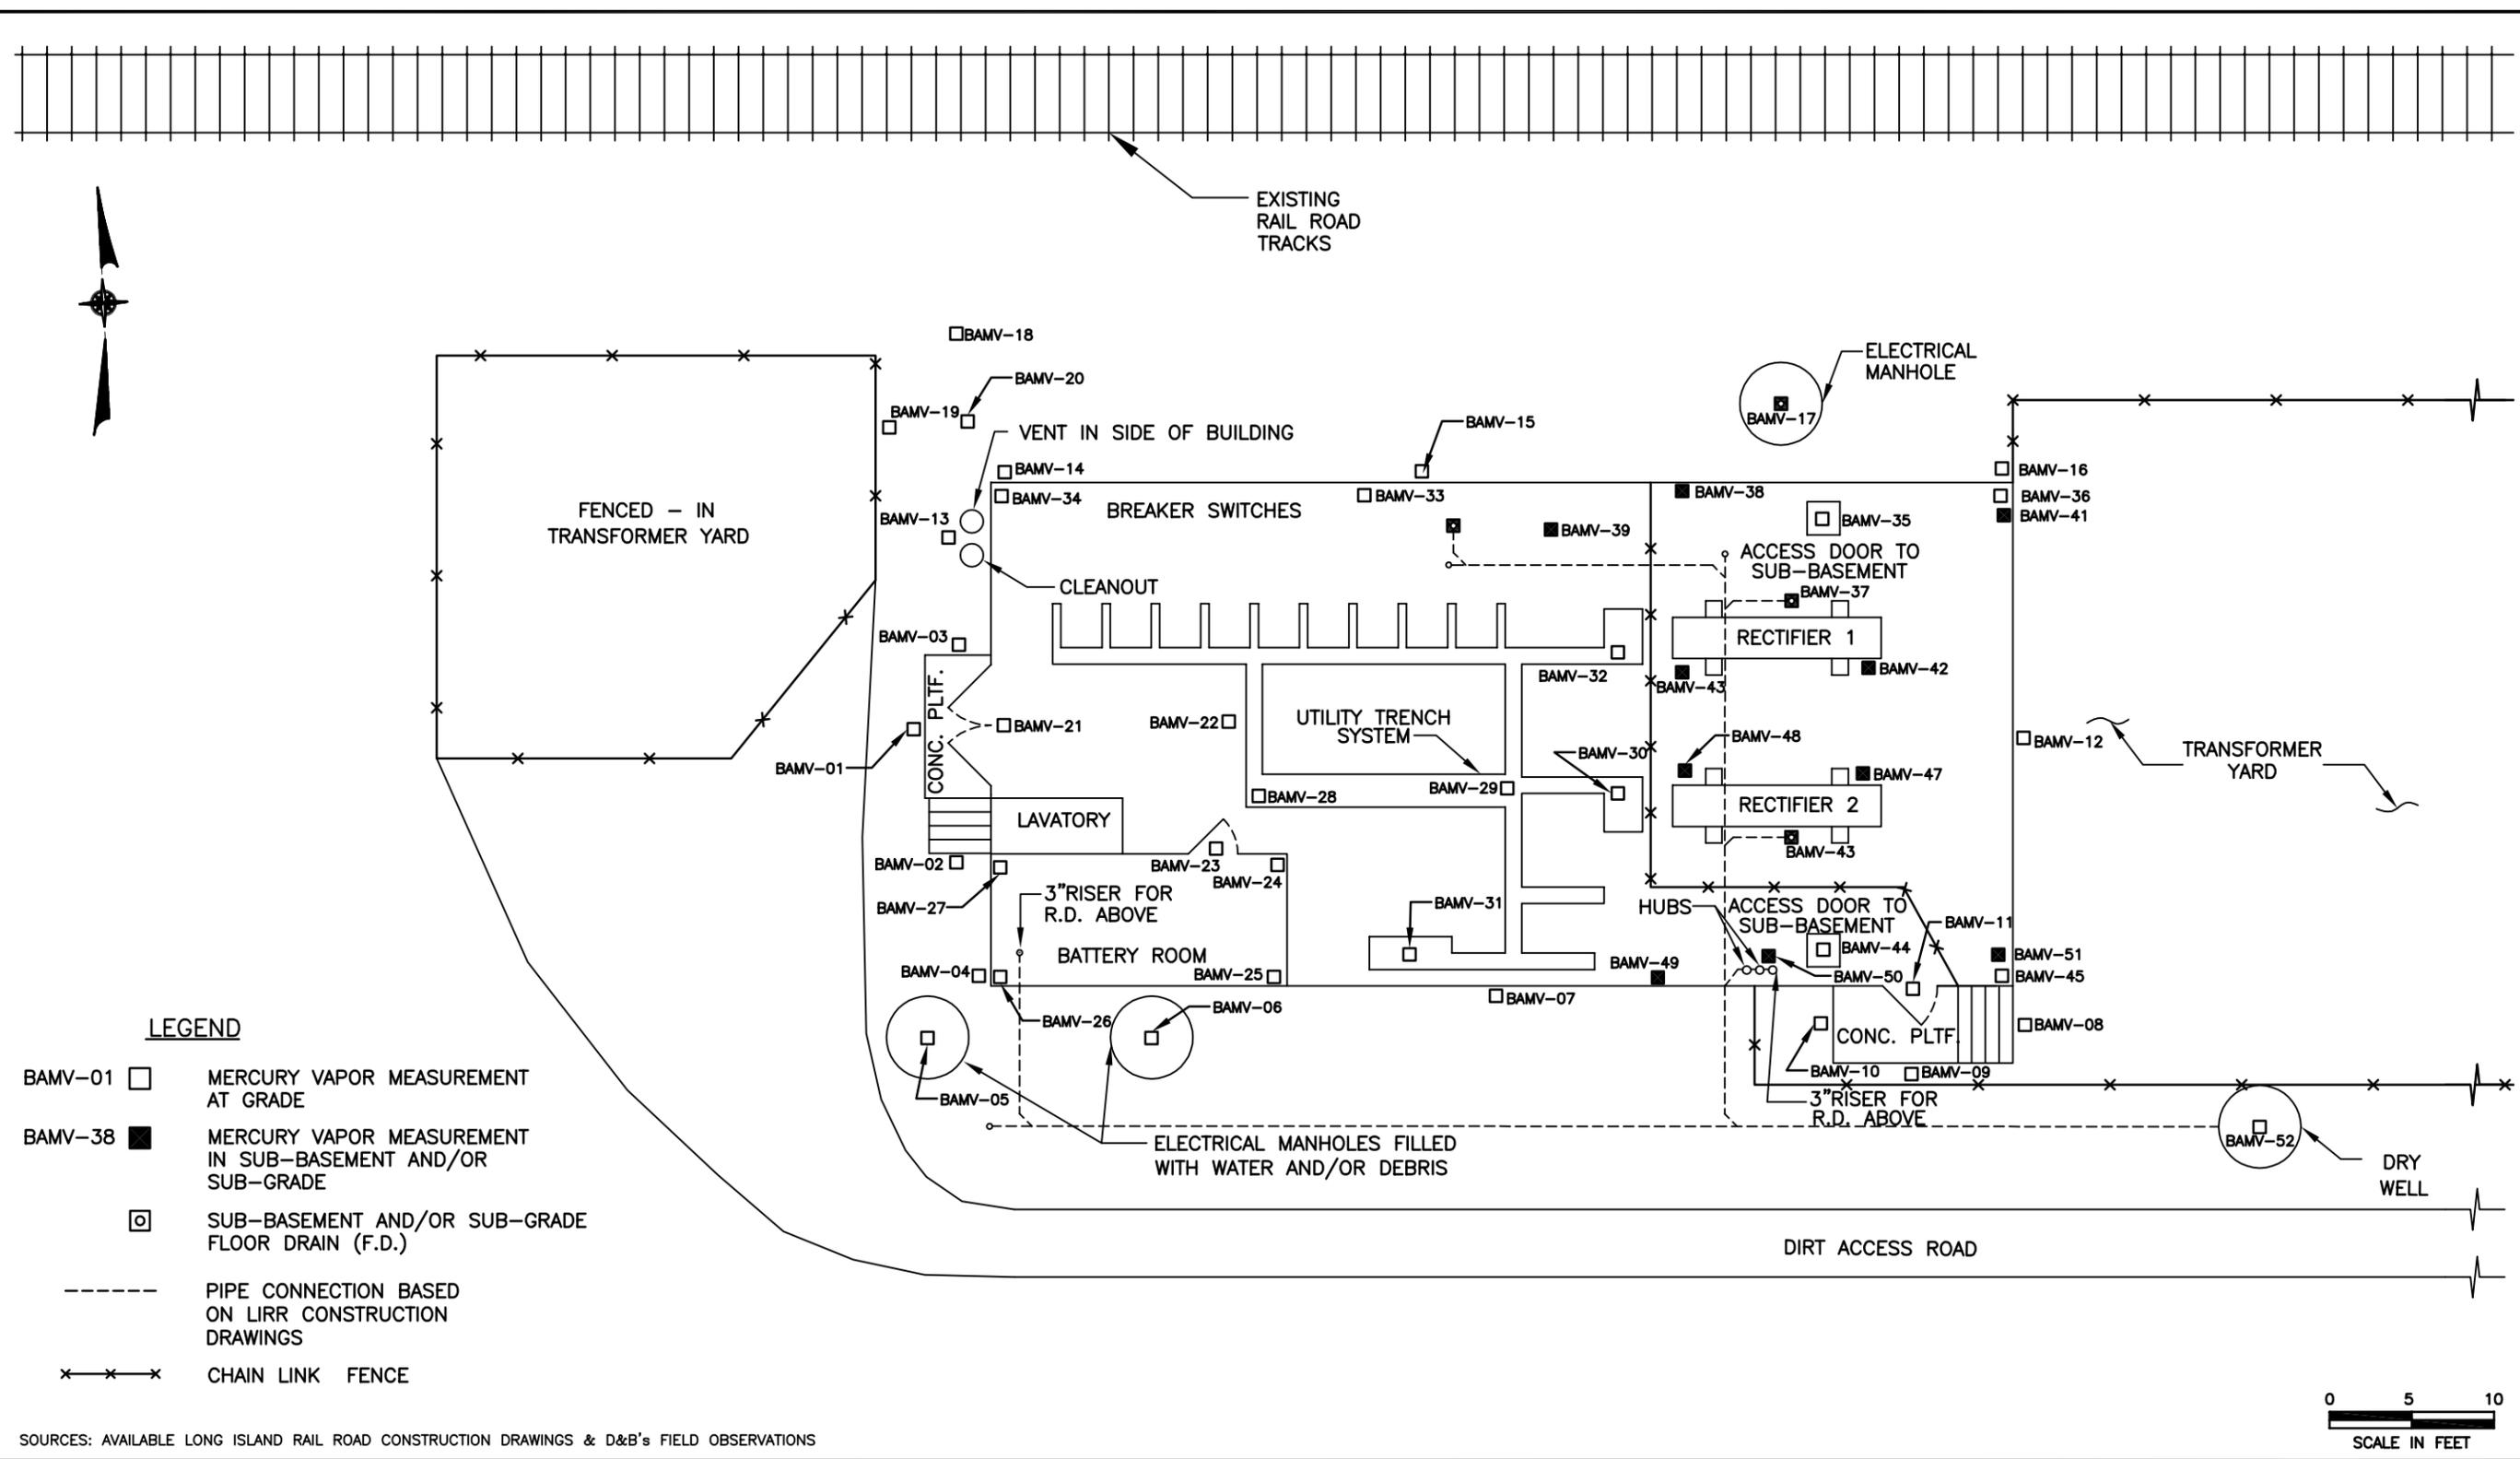
FIGURE 6.15-2

A total of 52 mercury vapor measurements were taken in and around the substation building. As indicated in Table A-15, none of the 52 measurements indicated the presence of mercury vapor. These locations are presented on the mercury vapor measurement location plan (see Figure 6.15-2).

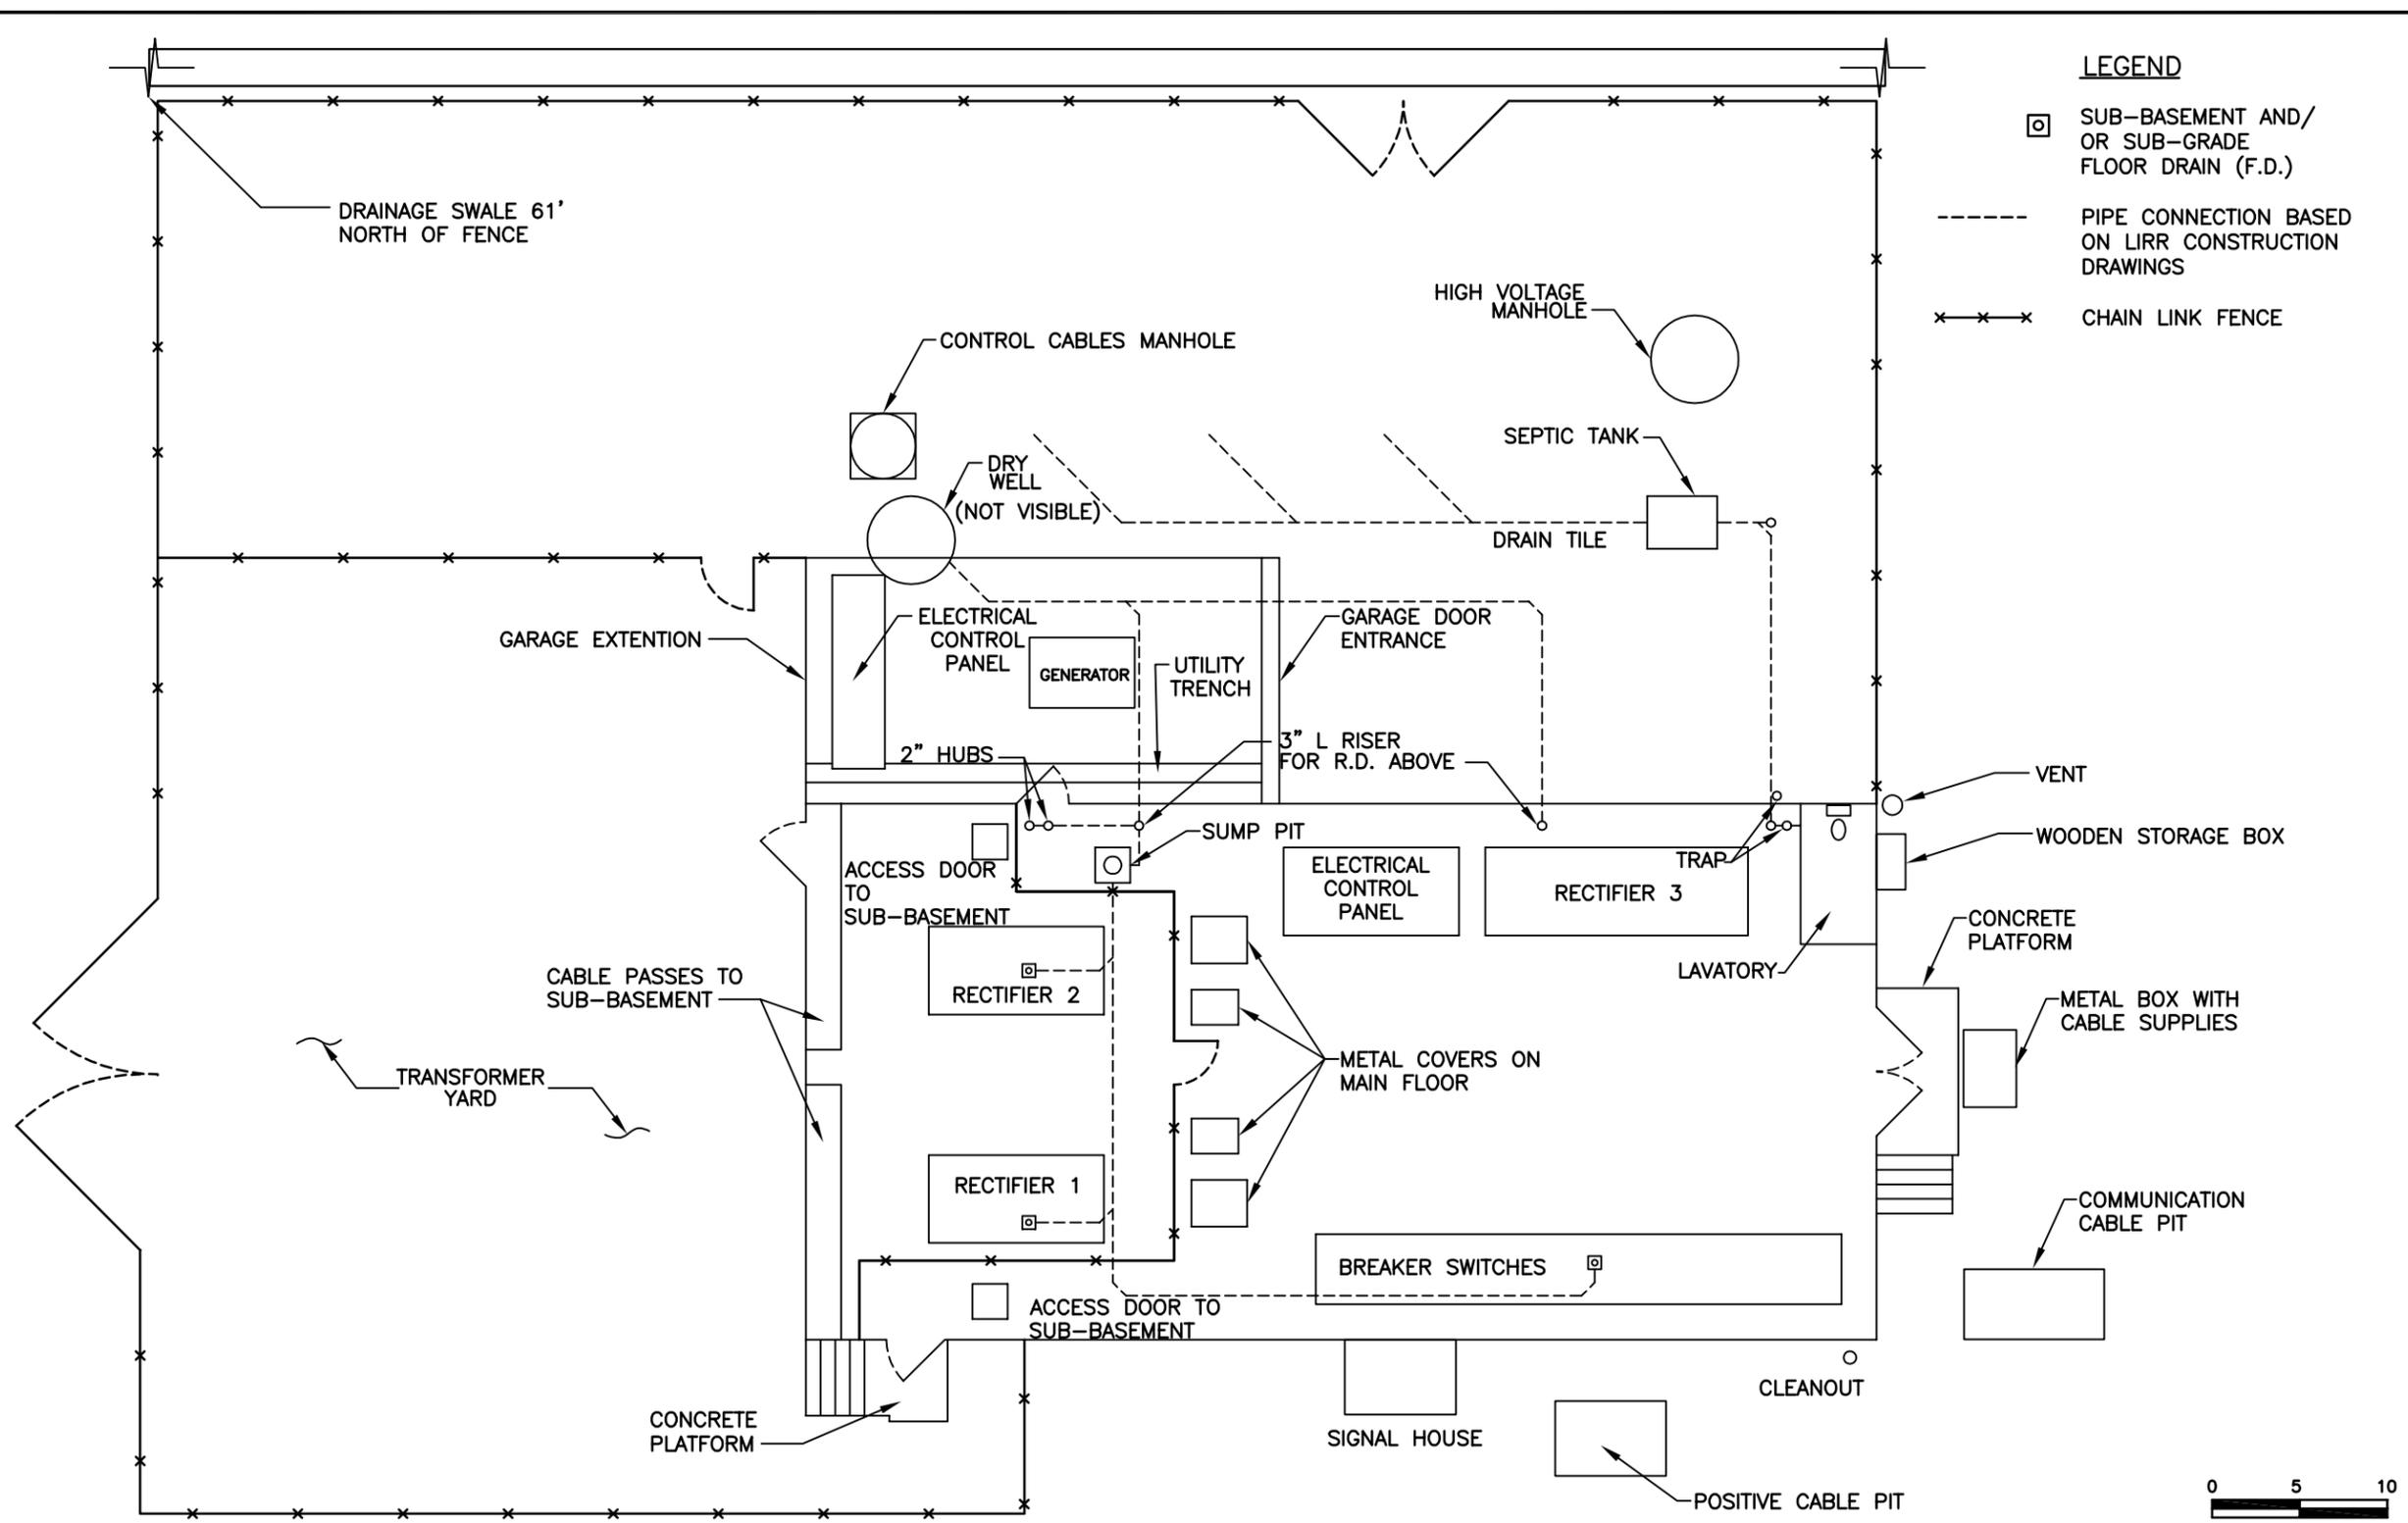
North Sub-Basement Under Rectifier 2 (Sample BYCC-01). Mercury was detected at a concentration of 5.6 mg/kg.

North Sub-Basement West of Sump Pit (Sample BYCC-02). Mercury was detected at a concentration of 0.37 mg/kg.
