October 18, 2005

The following provides a summary of methods and findings associated with the field reconnaissance performed by National Grid on August 24, 2005 at our Malone (Amsden St.) former manufactured gas plant (MGP) site (Site). Specifically, in accordance with an addendum to the draft Remedial Investigation Work Plan (RIWP), dated July 21, 2005, a reconnaissance survey was performed along the section of the Salmon River that extends from the southern property boundary of the Site, approximately 2 miles down stream north to the Macomb Hydroelectric facility on Lamica Lake. The reconnaissance work was conducted jointly by National Grid, TRC, and NYSDEC personnel. This letter summarizes the nature of the field inspection and the findings of that effort.

**TABLE 1: SUMMARY OF OBSERVATIONS
Salmon River, Malone, NY**

FORMER MGP SITE
MALONE, NEW YORK

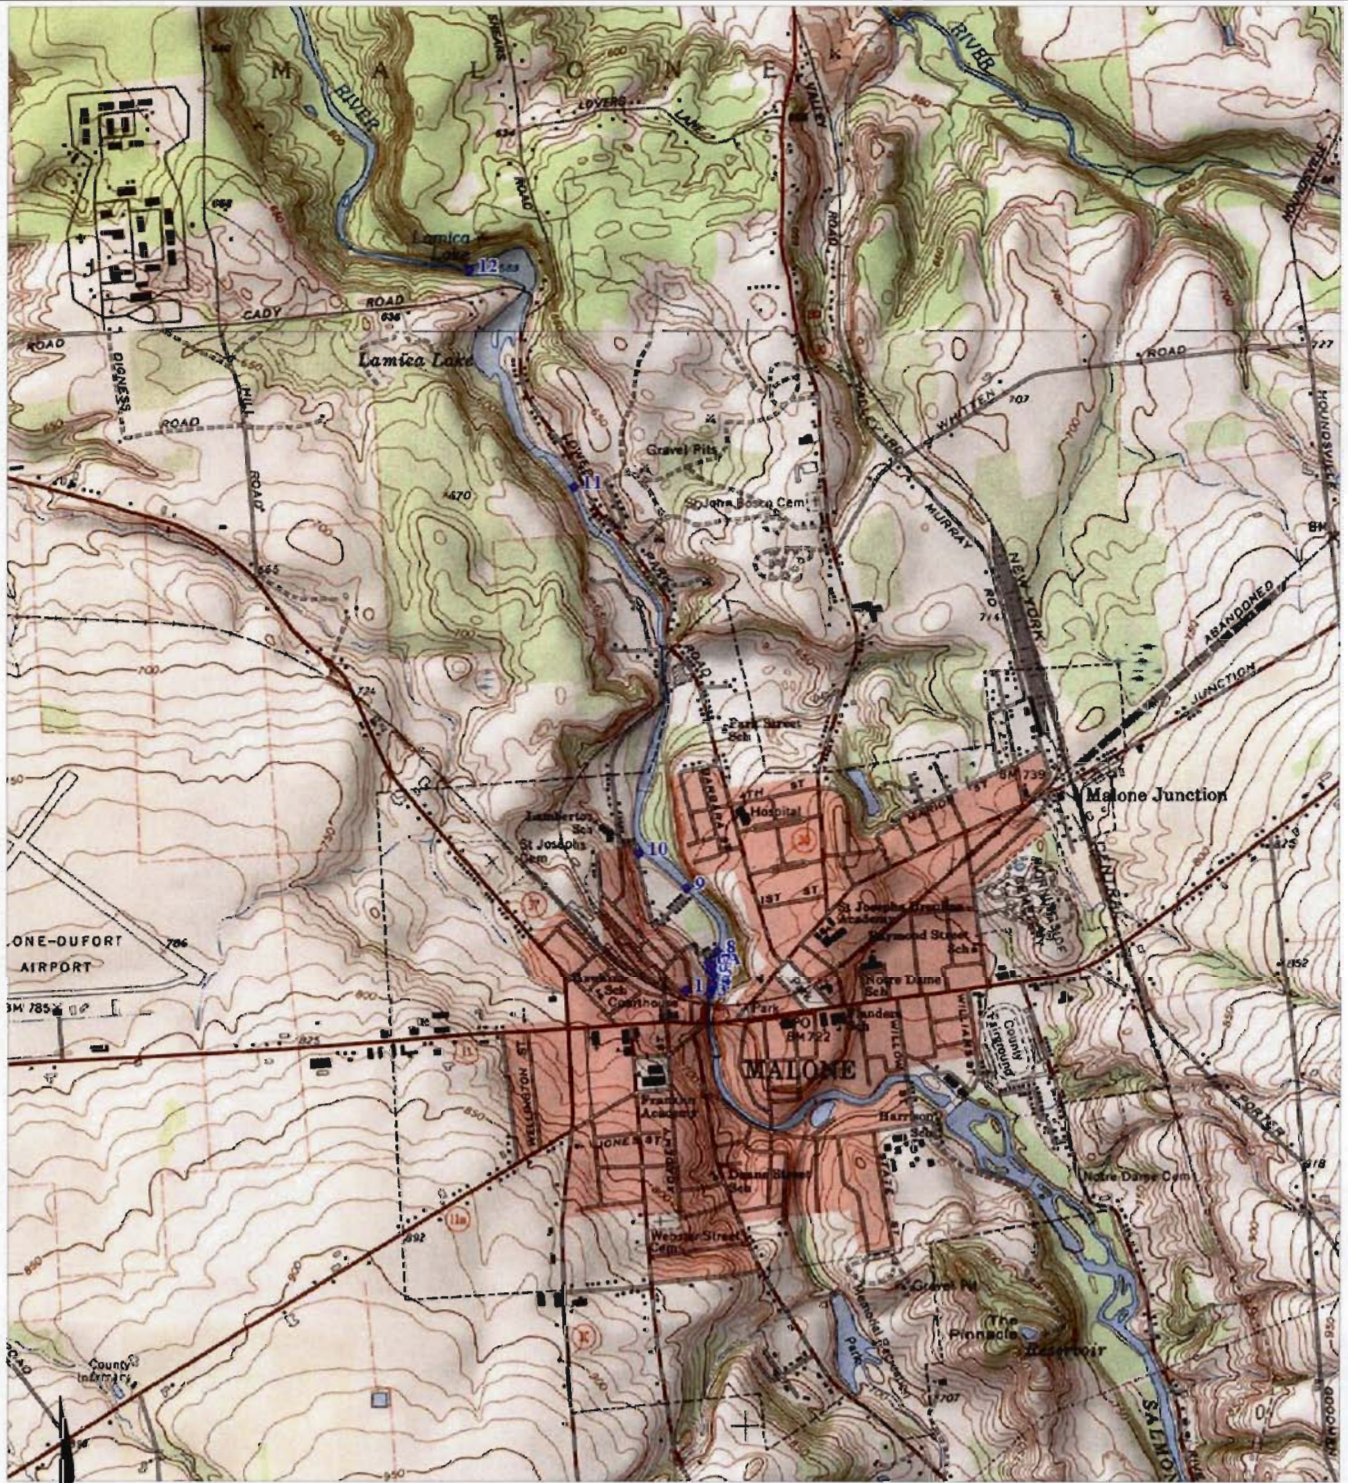
**FIGURE 1
RIVER BANK INSPECTION LOCATIONS**

A detailed visual inspection of the western riverbank segment was first performed from the Site downstream to the cul-de-sac location at the end of Coffee Street (refer to Figure 1 and Figure 2). Further evaluation was then completed from Coffee Street to the cul-de-sac at the end of Factory Street, then an additional ¼-mile segment ending at a cleared portion of the riverbank, before safe access was no longer achievable. Visual inspection was then predominantly conducted from the roadway, except for a section that was publicly-accessible at the first quiescent section of Lamica Lake located approximately ½-mile from the Macomb facility. The Macomb facility and associated Lamica Lake impoundment were inspected from the shoreline. Additionally, subsequent discussions were held with BRASCAN regarding the current operations and condition of the facility, as well as future operation and maintenance plans.
