# Remedial Investigation / Interim Remedial Measures / Alternatives Analysis Report

## 402 & 430 Buffalo Avenue Site

August 2015

402 AND 430 BUFFALO AVENUE SITE  
NIAGARA FALLS, NEW YORK  
BCP SITE No. C932164

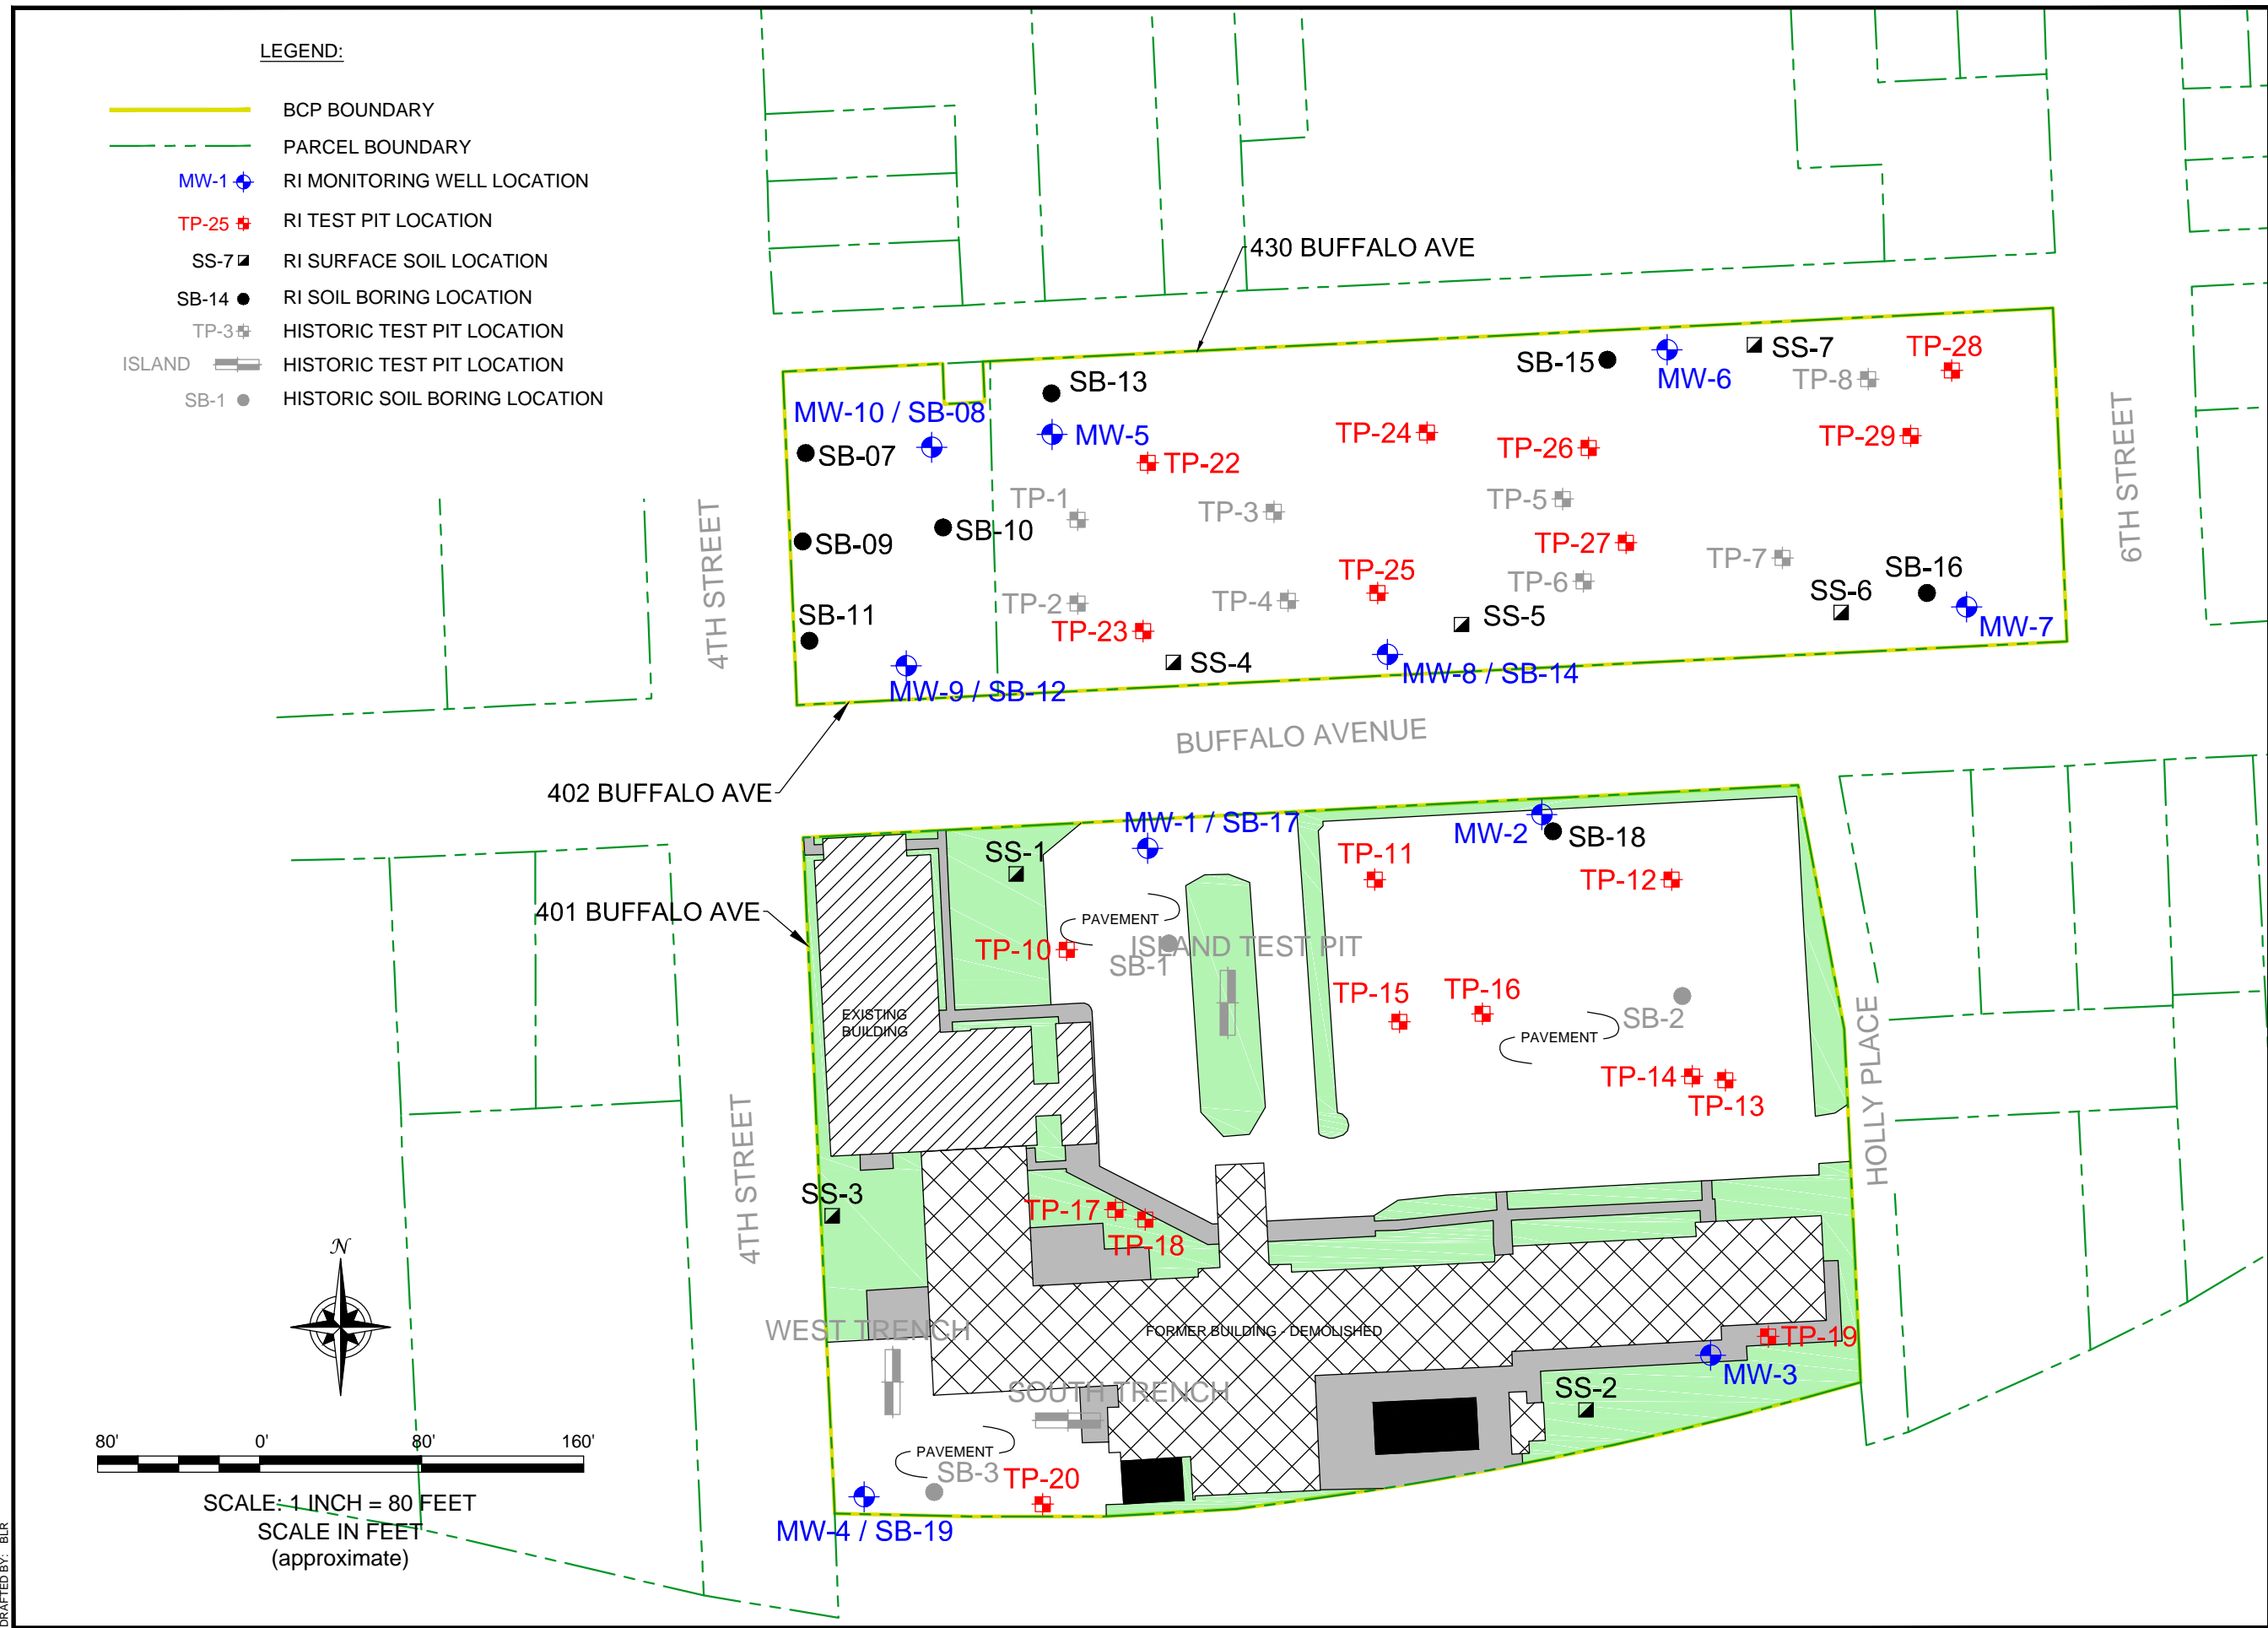
A total of 12 historic soil/fill samples were collected and selectively analyzed for VOCs, SVOCs, PCBs, and metals. Table 3 summarizes the historic soil/fill analytical results with comparison to applicable Part 375 SCOs. Historic sample locations are identified on Figure 3.

Elevated SVOCs were detected above their respective RRSCOs and Commercial Use SCOs (CSCOs) at several locations across the Site, primarily located on the 430 Buffalo Avenue parcel (see Table 3 and Figure 3). Lead and barium were detected above CSCOs at certain locations, with lead being detected above Industrial Use SCOs (ISCOs) at TP-3.

Benchmark-TurnKey completed surface and subsurface sampling across the Site to further assess on-Site conditions. Tables 4 and 5 summarize the surface soil and subsurface soil/fill samples, respectively, with comparison to applicable Part 375 SCOs. Sample locations are shown on Figure 3. Boring and test pit logs are provided in Appendix B.

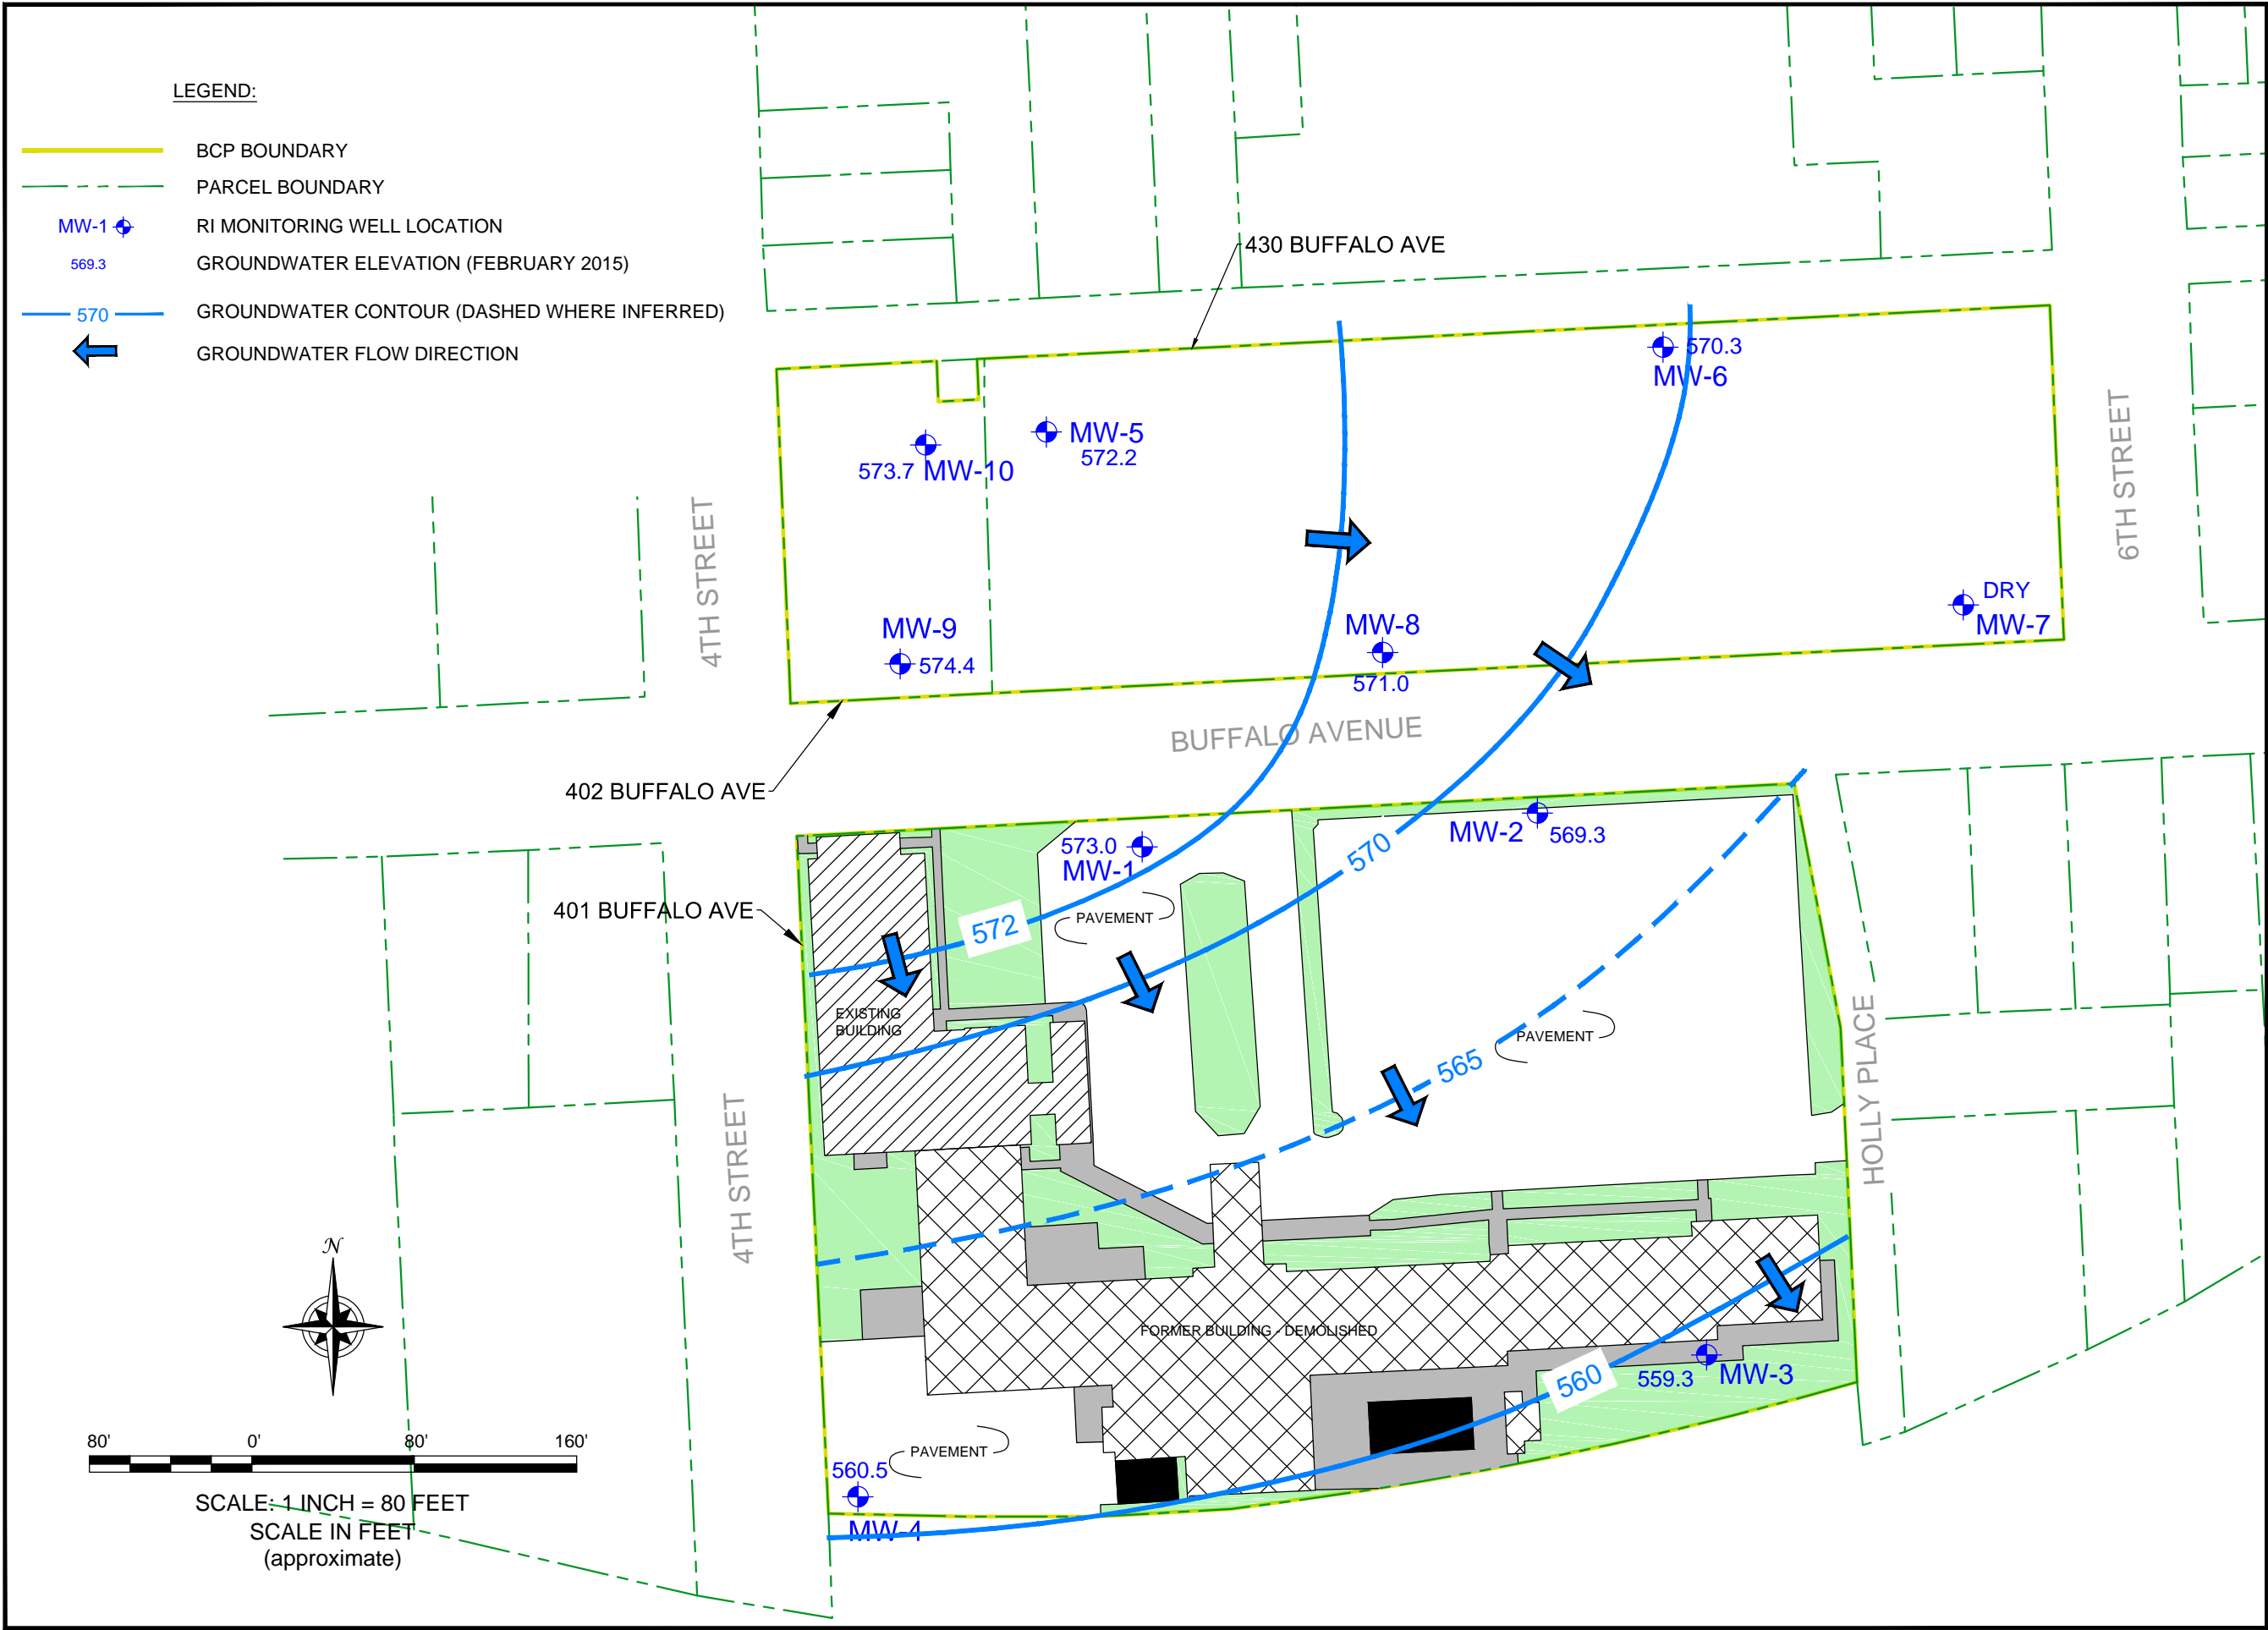
**FIGURE 4**

Benchmark-TurnKey personnel provided oversight for the installation of ten (10) groundwater monitoring wells, identified as MW-1 through MW-10, to investigate on-Site groundwater flow direction and quality. Wells were installed in April 2015. Details of the well installation, well development, and groundwater sampling are provided below. Figure 4 presents the location of the monitoring well network.

Groundwater elevation data was collected in April 2015. Depth to overburden groundwater was encountered at depths ranging from five (5) to greater than 11 fbg, with the exception of MW-7 which was dry. The Site hydrogeology is complicated by the presence of municipal subgrade utilities surrounding the Site, particularly along Buffalo Avenue that intersects the Site, and the presence of the elevated Robert Moses Parkway to the south. In general, localized groundwater flow was estimated to flow in a southern direction toward the Niagara River. Figure 4 depicts the estimated overburden groundwater isopotential map based on the water level measurements collected in April 2015.
