Final Engineering Report

402 & 430 Buffalo Avenue Site
BCP Site No. C932164
Niagara Falls, New York

Revised December 2015

Merani Hospitality, Inc.

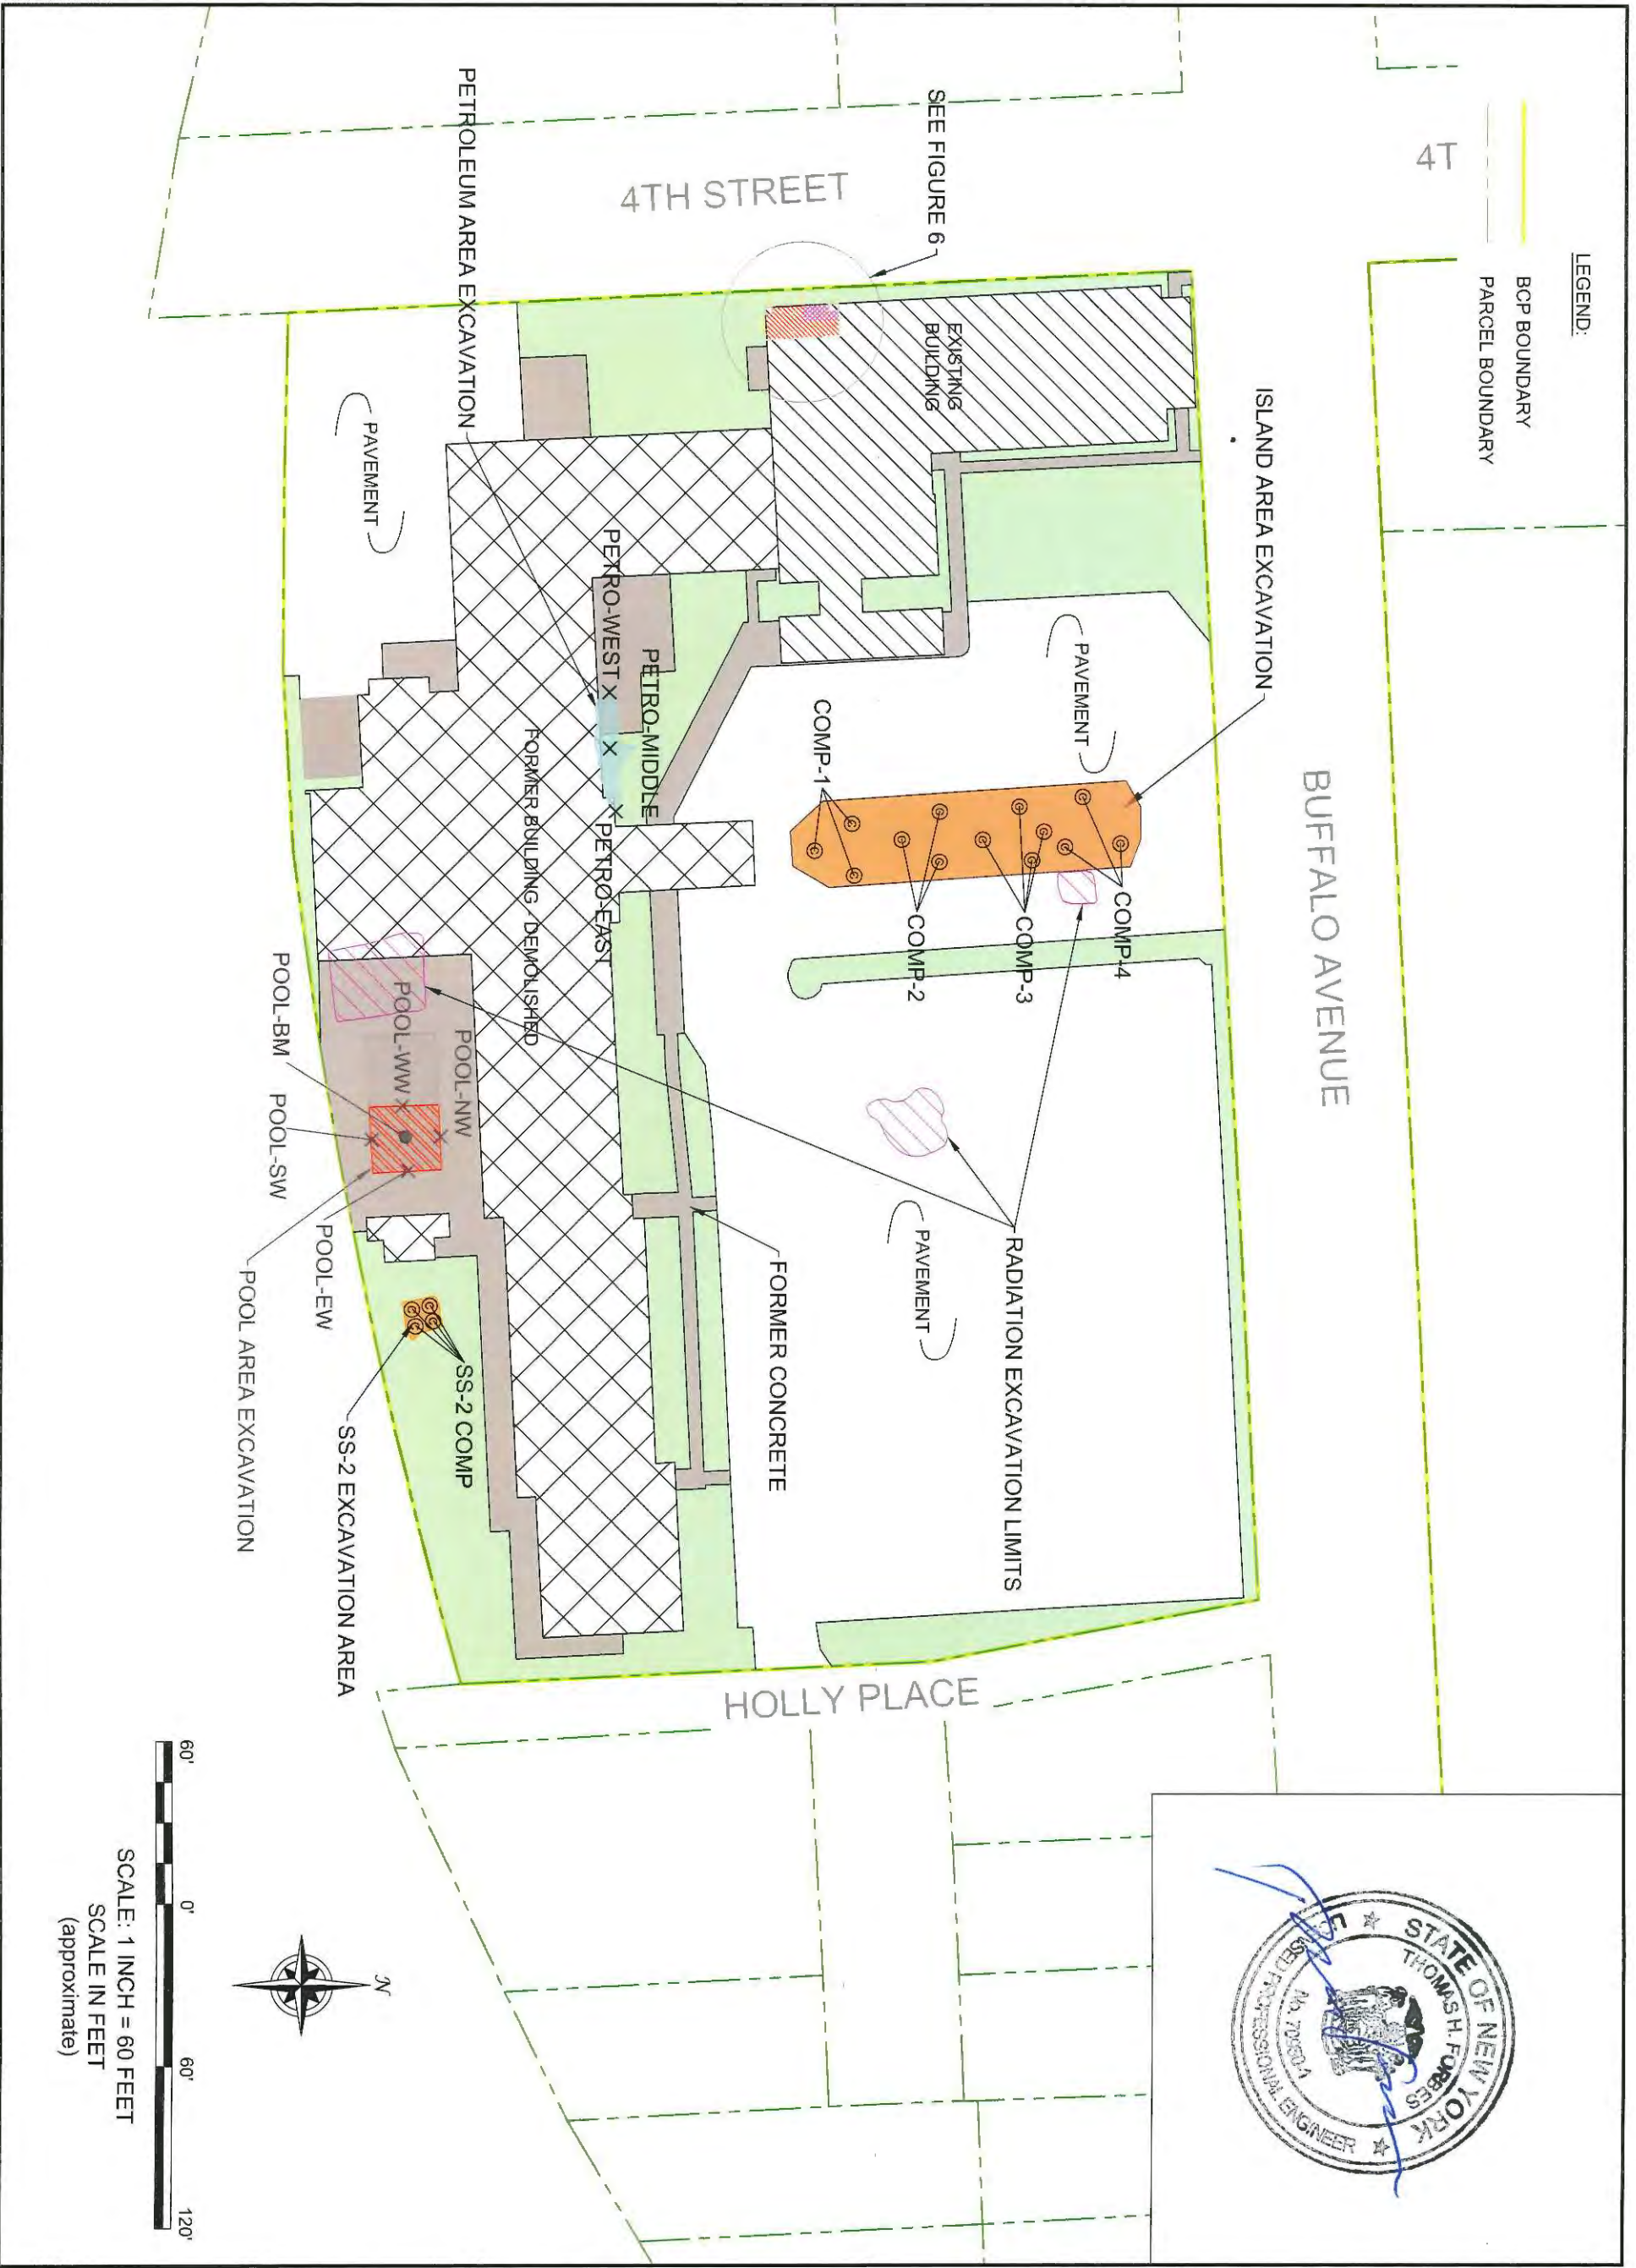
FIGURE 4

An area beneath the asphalt lot on 402 Buffalo Avenue was identified to have elevated readings ranging from 20,000 to 45,000 cpm. Several locations were identified on the 401 Buffalo Avenue parcel to be slightly above background, ranging from 10,000-20,000 cpm, in addition to the previously identified pool area (see Figure 4).

A total of seven (7) surface soil samples, and 32 subsurface soil samples were advanced across the Site (see Figure 4).
