Interim Remedial Measure Work Plan for the Stormwater Drainage System

Saint-Gobain Performance Plastics Site
1 Liberty Street
Village of Hoosick Falls
Rensselaer County, New York
NYSDEC Site # 442048

SAINT-GOBAIN PERFORMANCE PLASTICS, CORP.
14 McCaffrey Street
Hoosick Falls, New York 12090

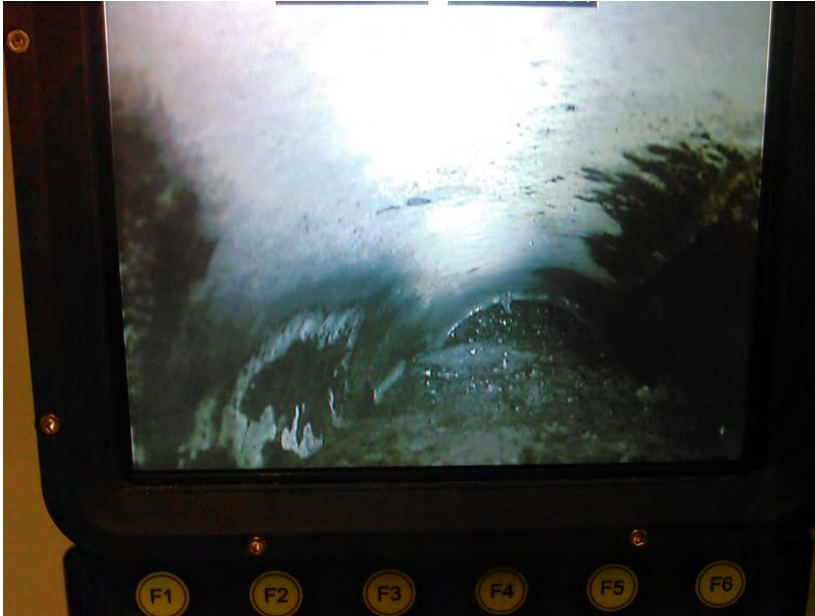
Picture of the drain pipe in the compressor room.

Material in the pipe appears to be absorbent spill granules saturated with oil.

Pipe needs to be cleaned out to verify that it is only in the compressor room and doesn't continue into the manufacturing area.

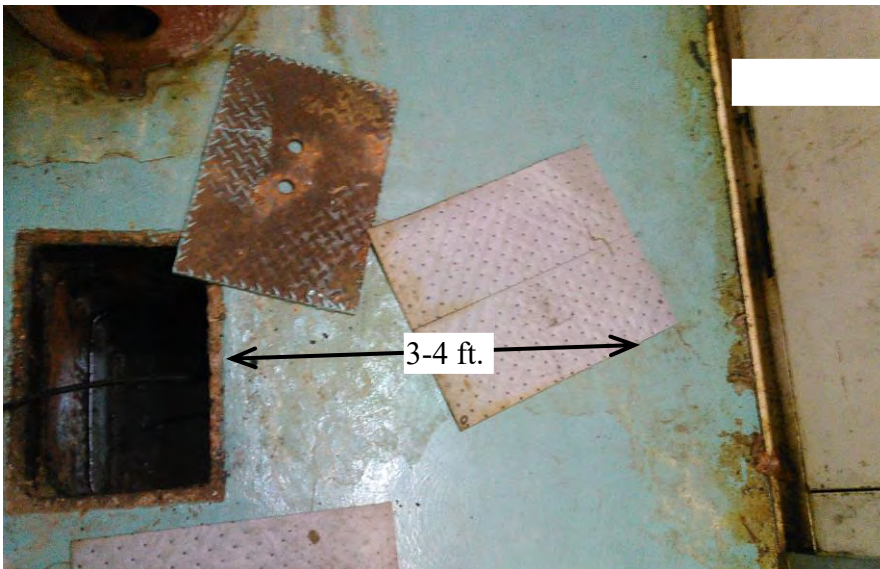
The camera only traveled 3-4 feet into the pipe due to the blockage.

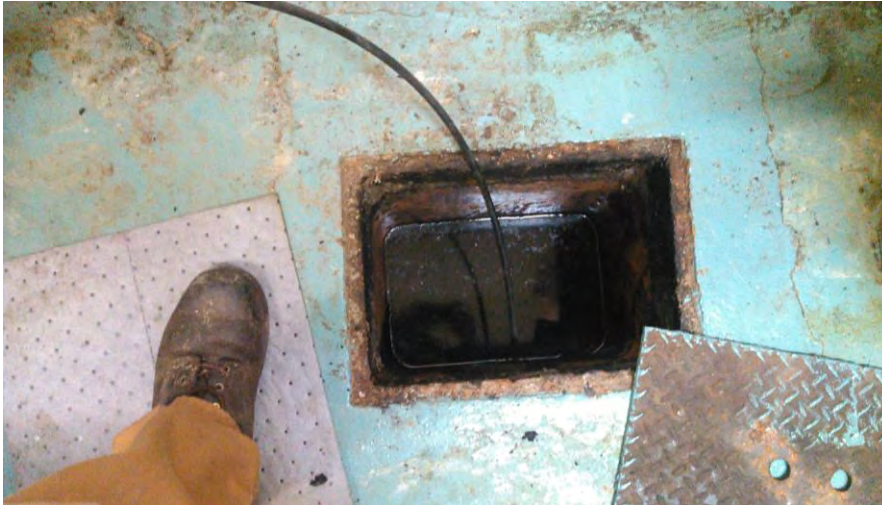
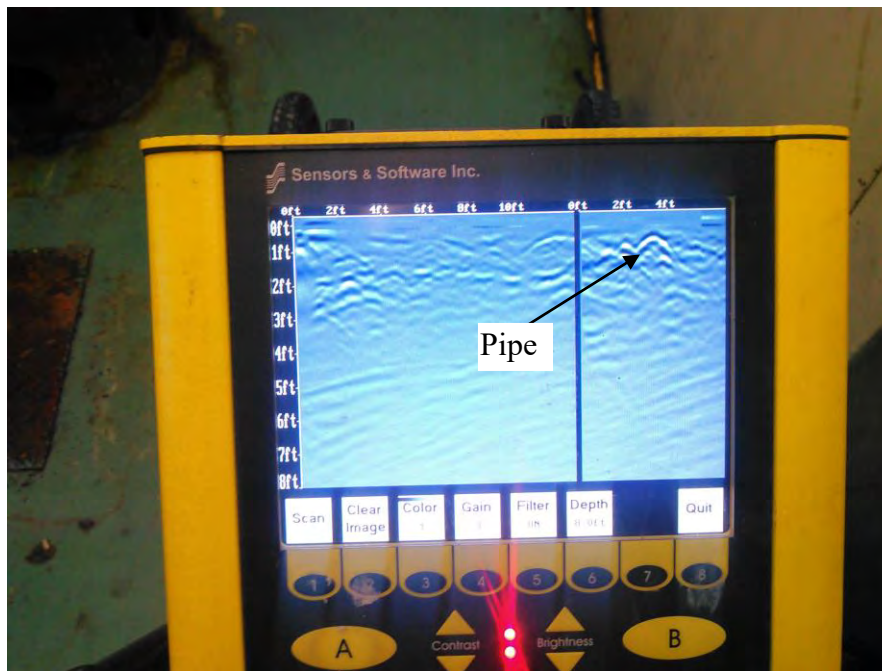
GPR image of the drain pipe in the compressor room.

Image didn't continue into the manufacturing area.

The pipe is just below the concrete slab for the compressor room.

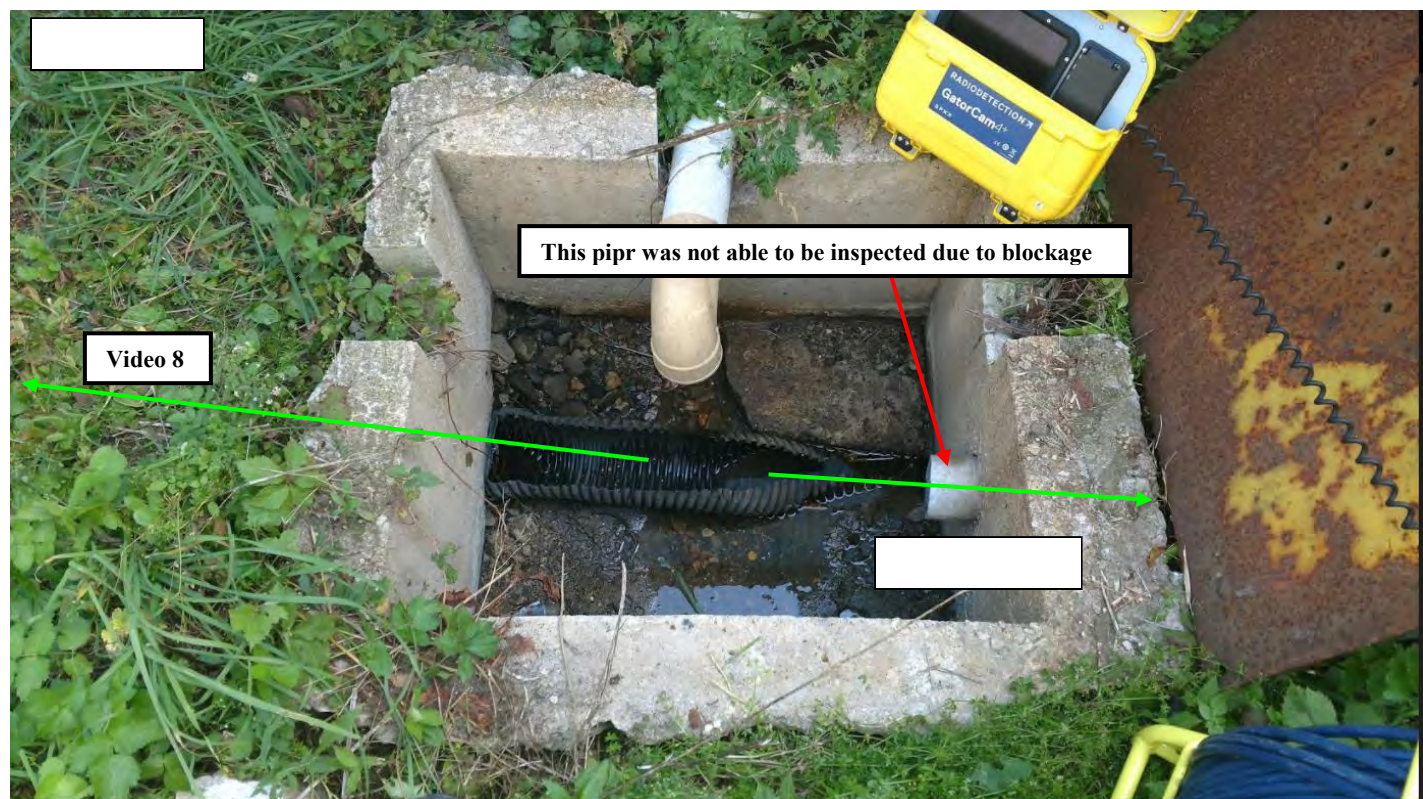
Video 8 – Storm : Was able to record full run from MH to MH (Pipe 4" – Video Inspection 45 feet long). For the majority of this inspection the camera was submerged under water but was able to record the full run.

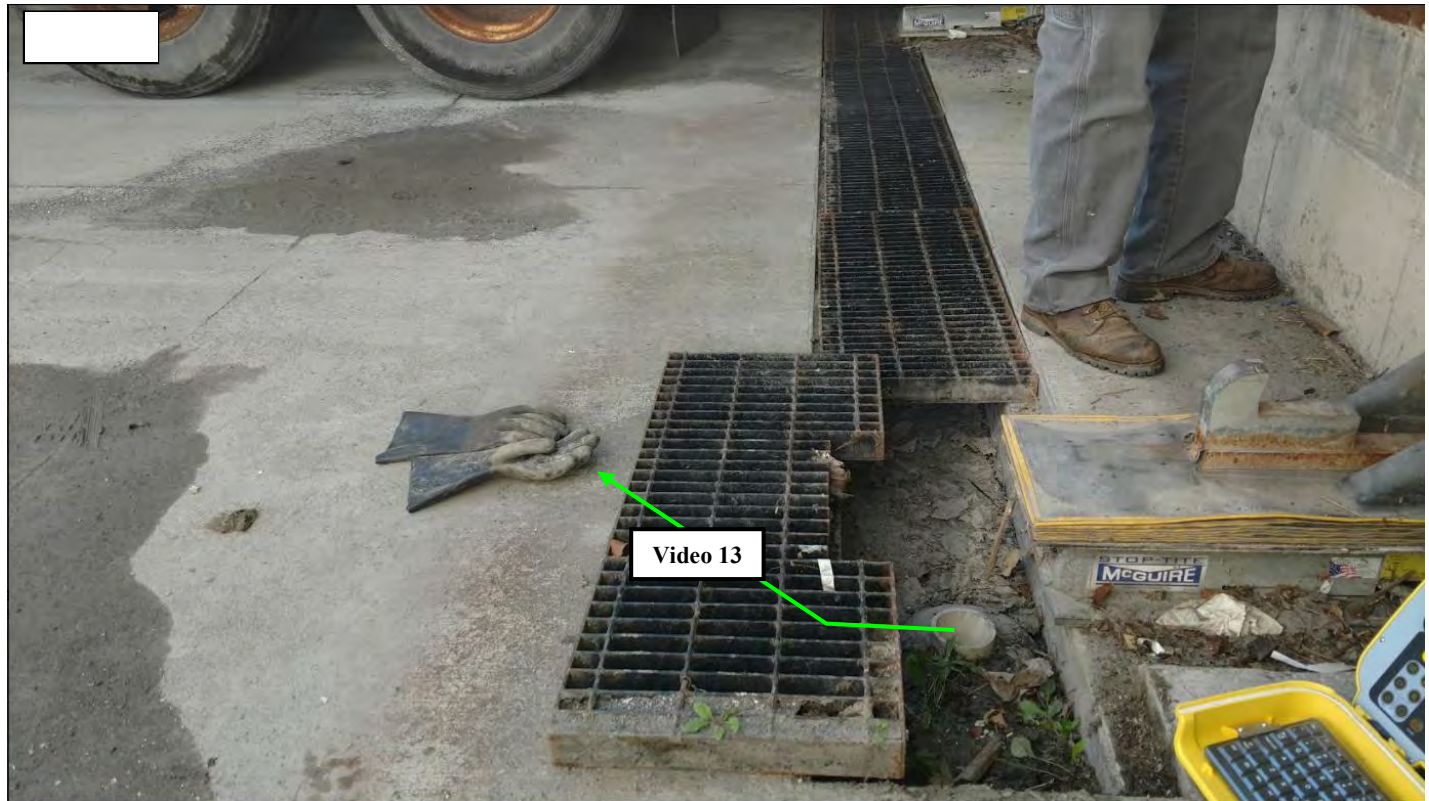
Video 13– Storm : Was able to record partial run from trench drain (Pipe 3" – Video Inspection 9 feet long). Inspection was stopped short due to blockage in the pipe at 9 feet. It is suspected this line is tied into the pipe in video 12

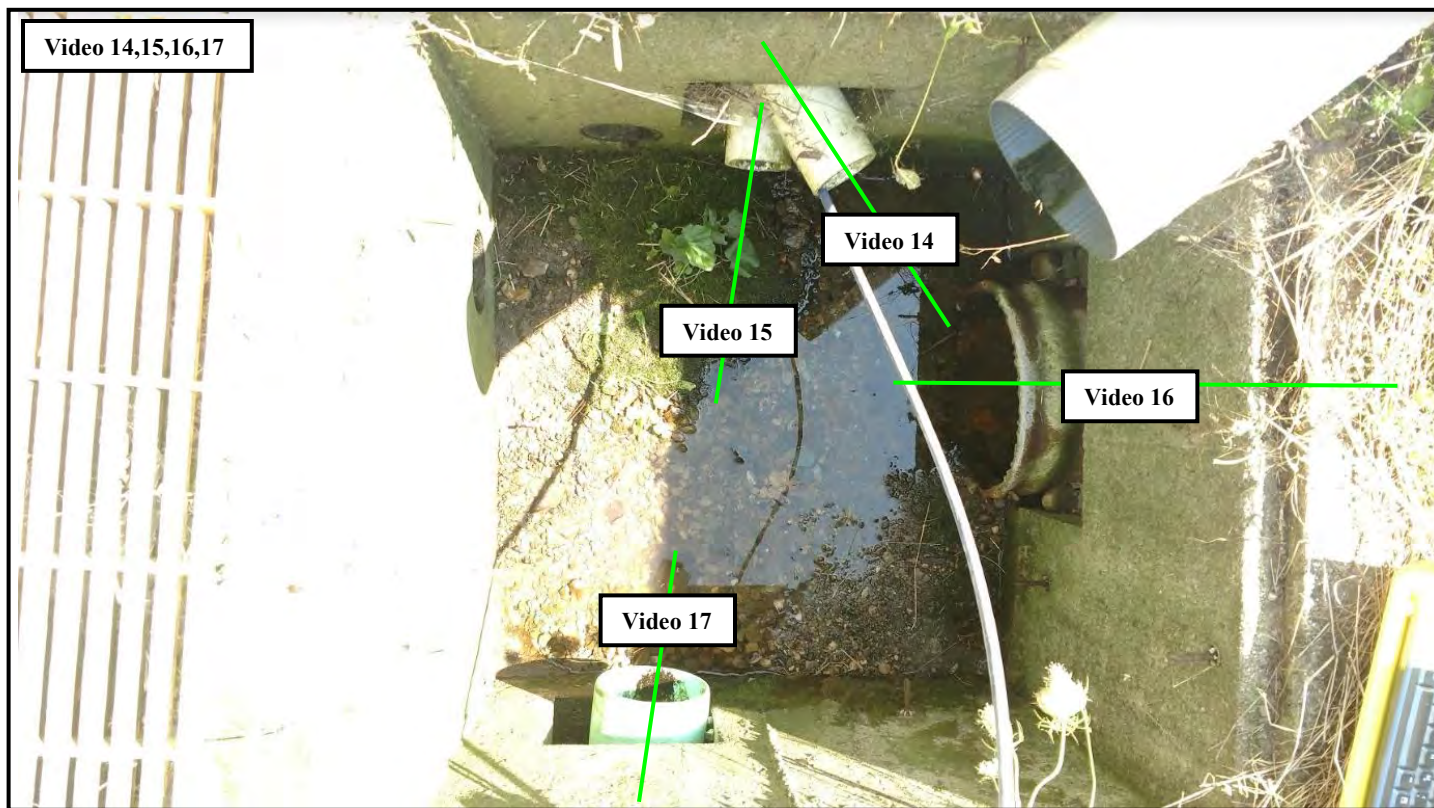
Video 14 – Storm : Was able to record full run from MH to the end of pipe (Pipe 4" – Video Inspection 44 feet long). This pipe was all clear and was determined to be a perimeter drain
