**FORMER SPERRY REMINGTON SITE
(NYSDEC SITE I.D. #808043)**

**REVISED
INTERIM REMEDIAL MEASURE
WORK PLAN**

CITY OF ELMIRA, CHEMUNG COUNTY, NY

7 October 2019

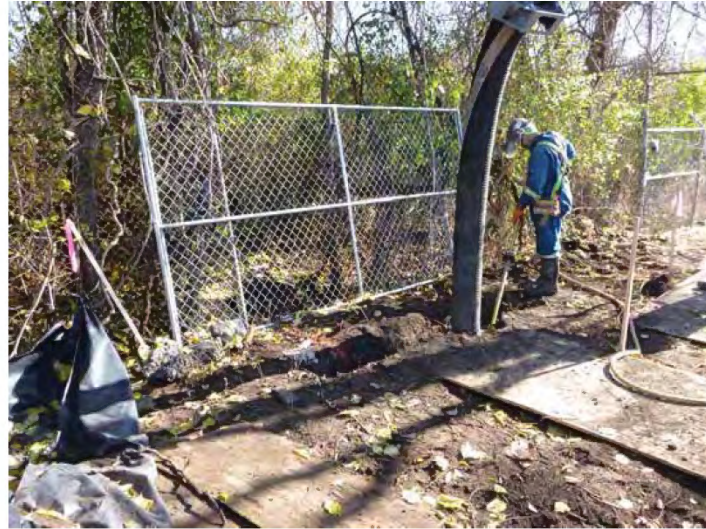
Comments: Test Pit-2.1 south of
CB-15, orange paint marks indicate
the edge of the 5 ft culvert.

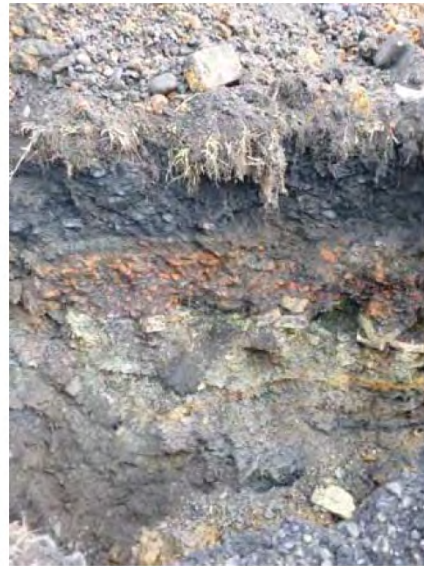
Comments: TP-1.1 lithology consisted of topsoil, underlain by dark gray fill dominated gravelly silt, orange mottled silty sand with gravel and underlying yellow-brown sandy silt with an abundance of yellow brick.

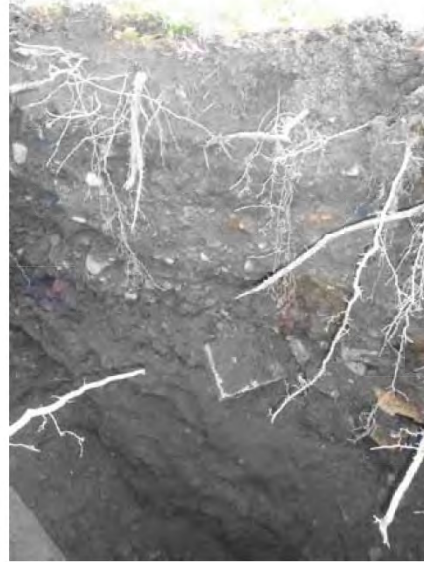
Comments: TP-3.1 and TP-3.2 contained soil of similar color and composition, the soil color alternated between yellow-brown to dark brown and ranged in composition from silty sand with gravel to silty gravel with coarse sand.

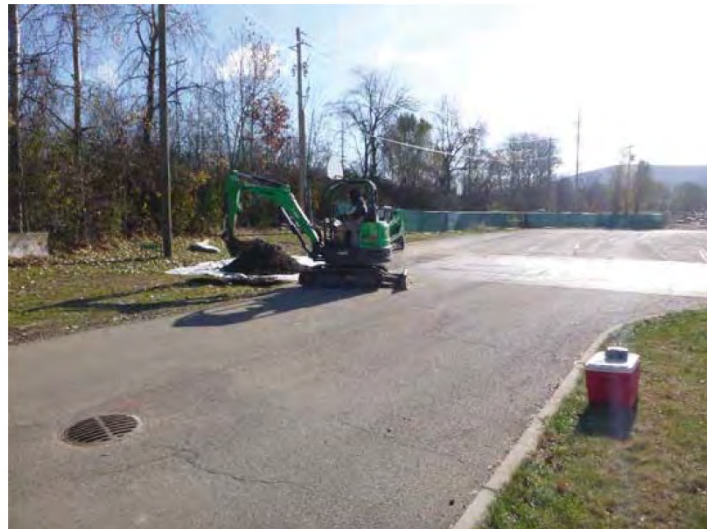
Photograph ID: 10

Comments: TP-3.2 was located closer to CB-6 (bottom left), at the location where the previous camera survey showed a sewer line take a sharp right turn. No structures were encountered.

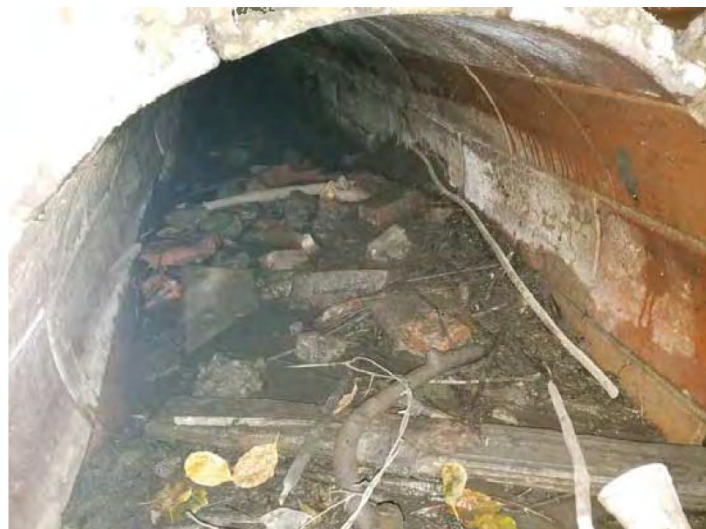
**Comments: The connection
leaving CB-15 headed northwest
was constructed of clay tile and
appeared to run parallel to the
EHS property line.**
