FLOOD MITIGATION & RESILIENCE REPORT

Little Chazy River - SD122

New York State Department of Environmental Conservation,
in cooperation with the New York State Office of General Services

June 2022

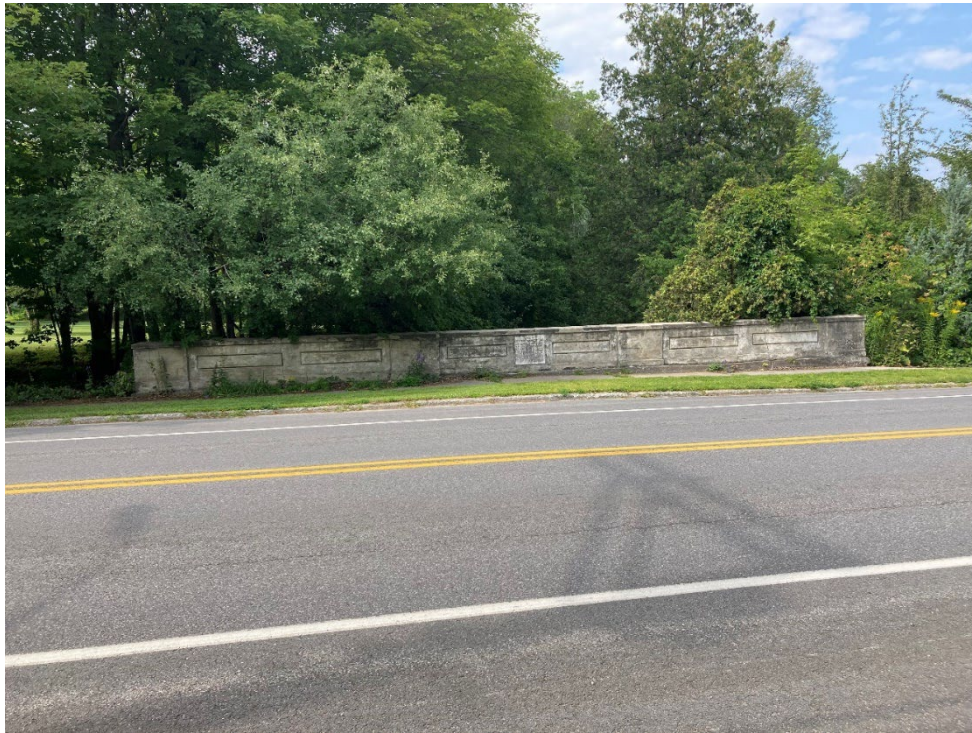
Figure 4-21: West Church Street bridge, looking downstream across the road surface

West Church Street crosses the Little Chazy River at STA 786+50 with a concrete and stone masonry arch bridge that was constructed in 1909, shown in Figure 4-21 (NBI BIN: 3336190). The bridge is undersized, generating over 6 feet of additional backwater in the 100-year flood event, contributing to excess flooding as far as 900 feet upstream of the bridge, which affects 12 homes. The projected future 100-year flood event is expected to overtop the bridge deck and roadway by as much as 1.6 feet. The channel upstream and downstream is entrenched and confined by dry-laid masonry walls on both banks, shown in Figure 4-22. Injected-grout pillows were observed along the toes of this bridge's abutments; the presence of these remediating scour countermeasures indicate a history of inadequate hydraulic performance and susceptibility to and prior instances of scour. It is recommended that this bridge be replaced with a minimum 90-foot single-span bridge, to be accompanied by channel restoration and floodplain enhancements upstream and downstream of the bridge to alleviate the current entrenched condition. Modeled floodplain reconnection included regrading of about 300 feet of the vertically walled right bank to a more natural bank slope of 2H:1V, and excavation of between 1 foot and 4 feet along a roughly 400-foot long, 25-foot-wide strip of connected floodplain along the left bank. Properties upstream and downstream of the bridge are affected by these modifications, although the proposed disturbance is essentially limited to the immediate overbank areas, and no structures are impacted. This is necessary to allow the proposed bridge to achieve sufficient hydraulic performance to generate the flood mitigation benefits described above.

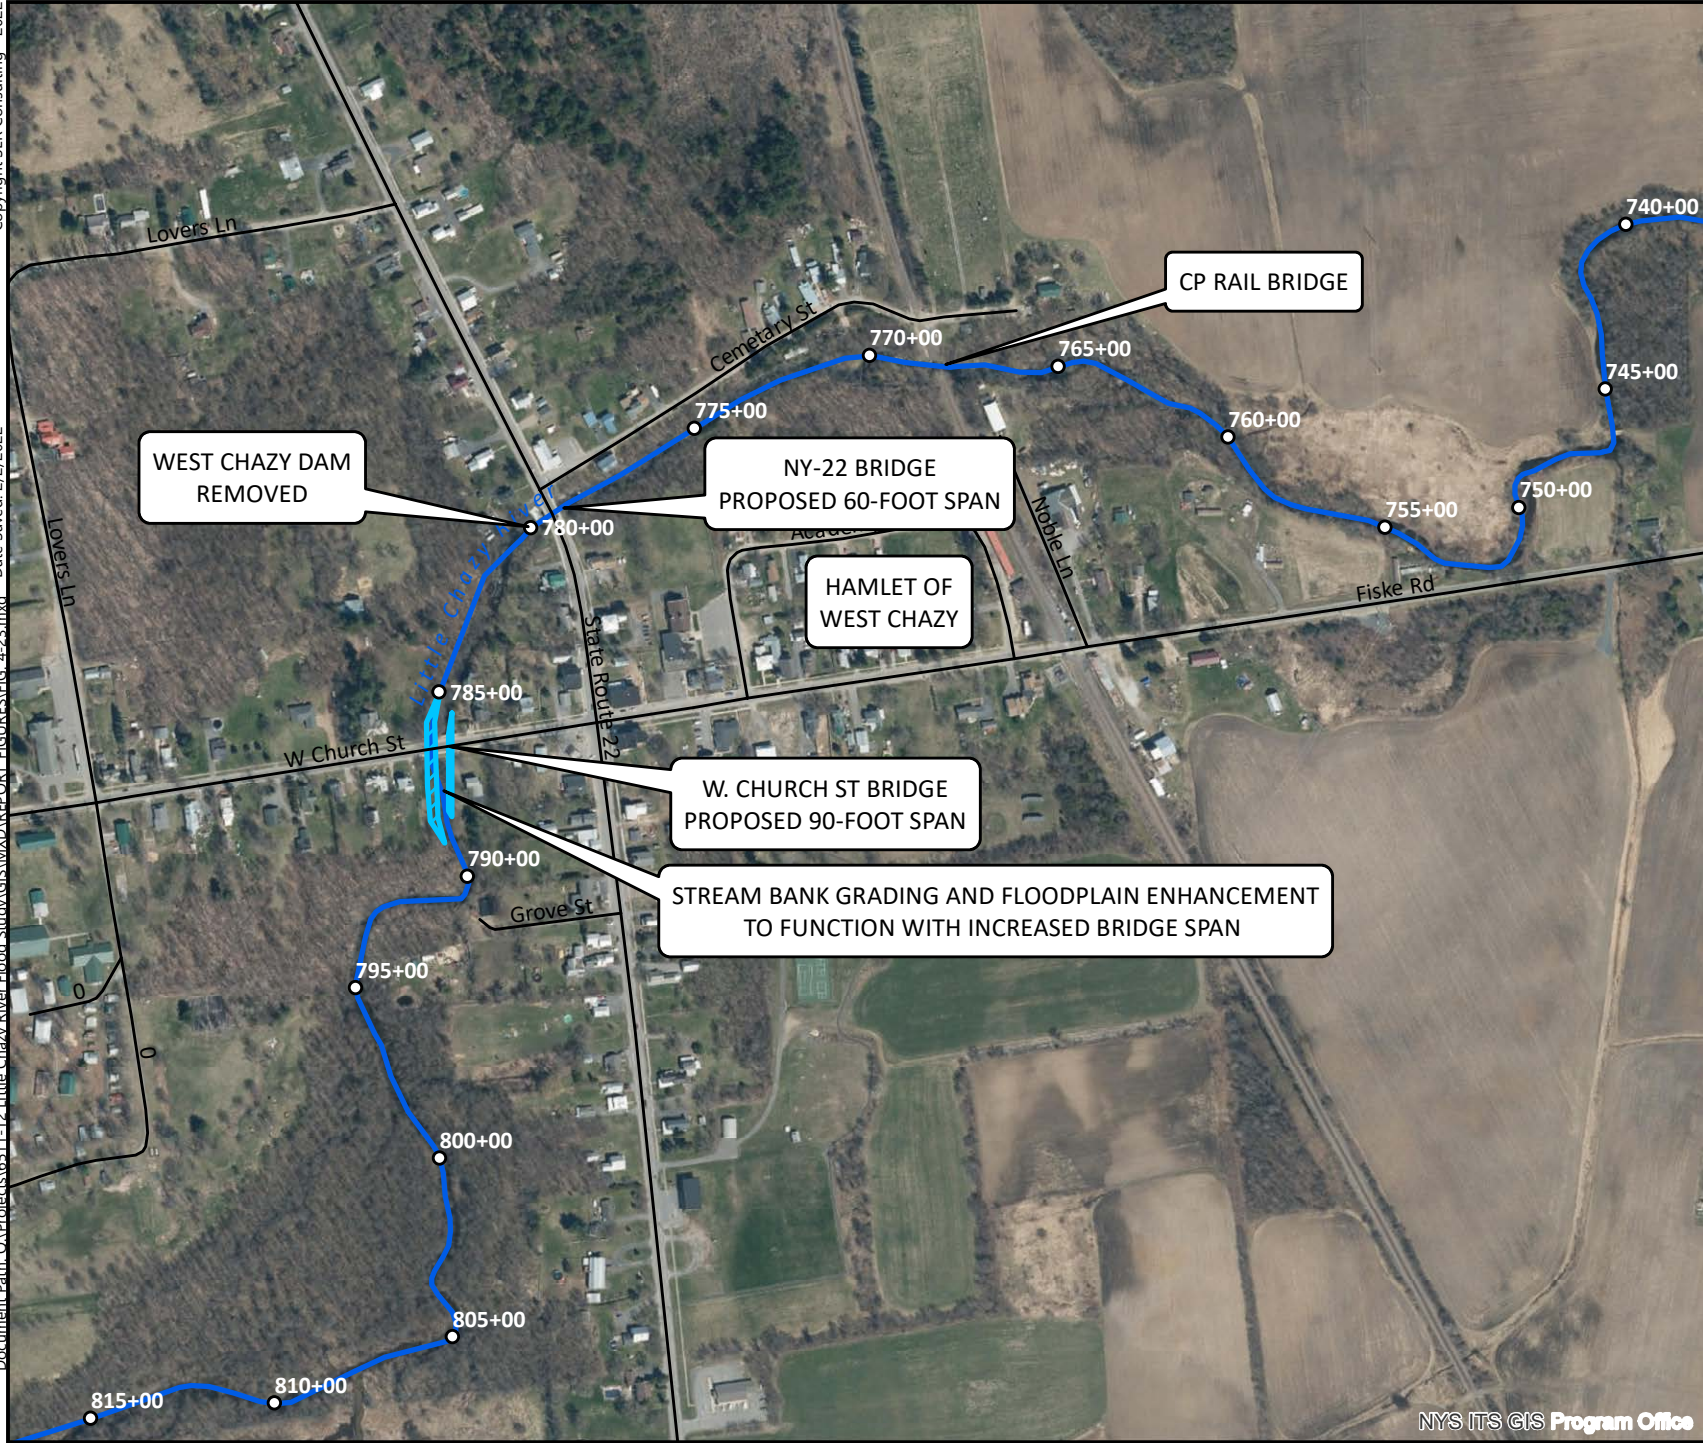
FIG. 4-23

With the proposed modifications for HRA 2, shown conceptually in Figure 4-23, eight homes and businesses may be removed from the 100-year floodplain and an additional three homes from the projected future 100-year floodplain. Due to the Little Chazy River's flat slope upstream of the West Church Street bridge, which can be seen in longitudinal profile in Figure 4-24, only minor flood mitigation benefits are possible beyond those seen with the dam and existing bridge constrictions removed. Flood mapping showing the depth and extent of flooding in the 10-year and 100-year current and future flood events, under existing and proposed conditions, is presented in Figures 4-25 through 4-28.

HRA #2 - HAMLET OF WEST CHAZY CONCEPT LAYOUT
 LITTLE CHAZY RIVER FLOOD & ICE JAM STUDY
 SD122
 CLINTON COUNTY
 NEW YORK

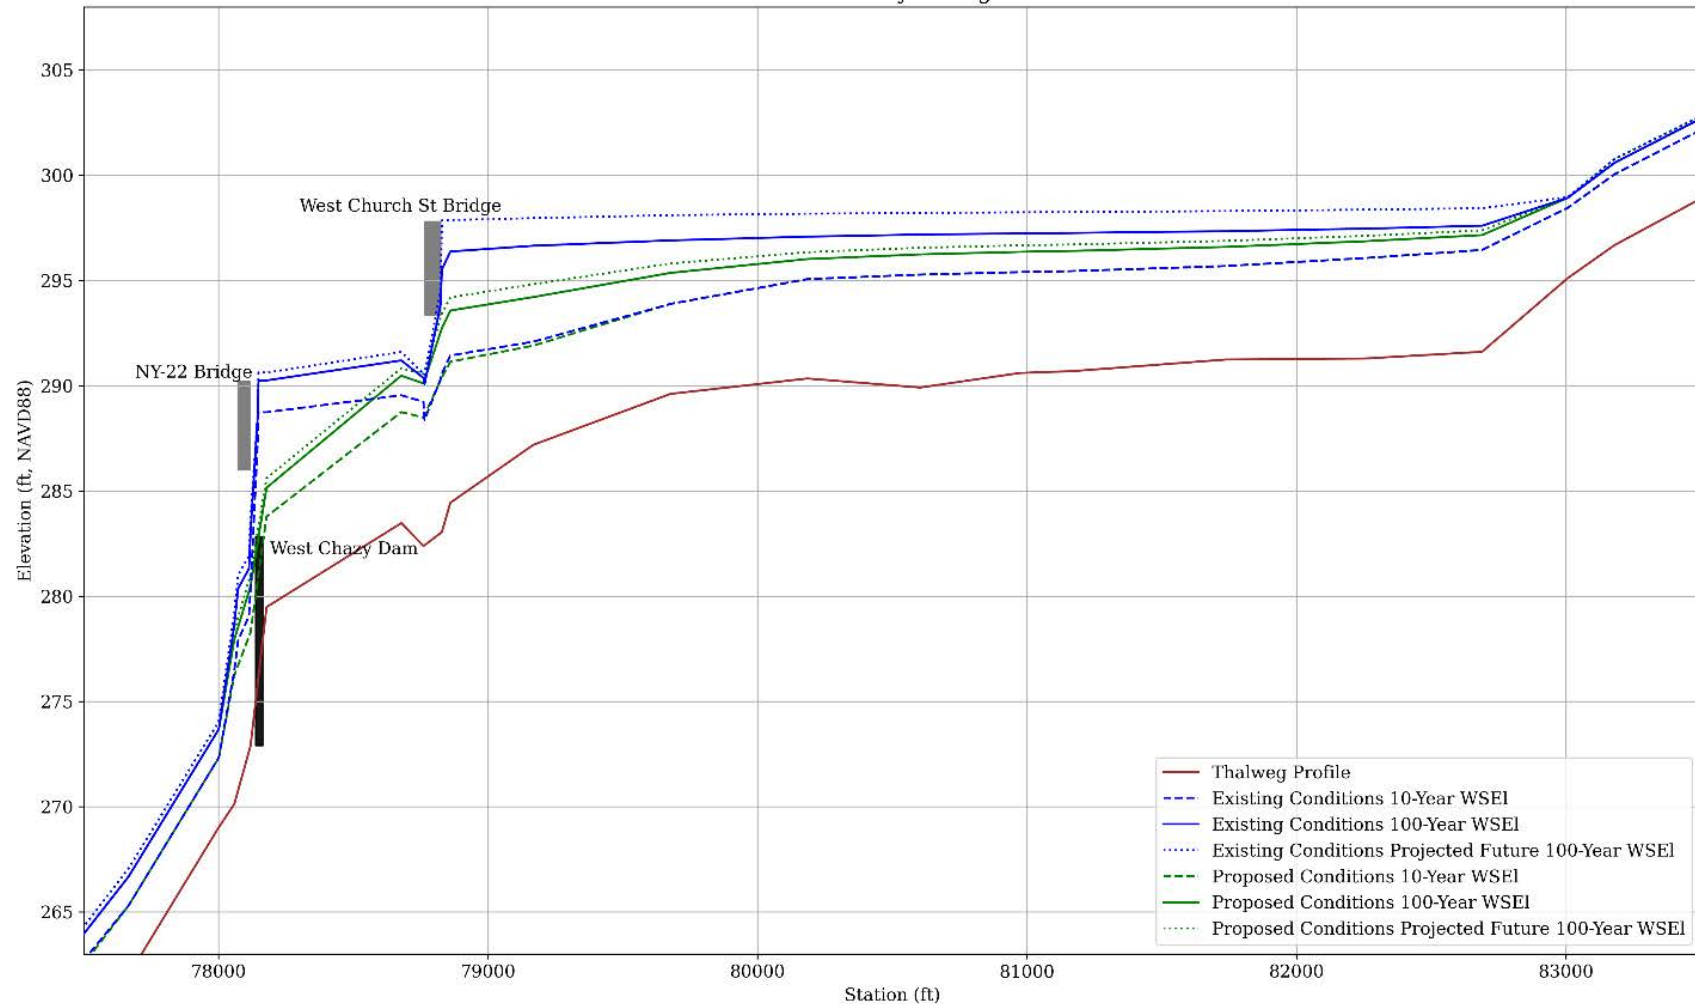
Figure 4-24: Longitudinal flood profiles in HRA 2 showing the current 10-year flood event and current and projected future 100-year floods under existing conditions and proposed conditions, which include replacement of both the NY-22 and W. Church Street bridges, and removal of the West Chazy Dam. Flood mitigation benefits are at their greatest in the vicinity of the dam and bridges, diminishing upstream due to the river's naturally flat slope.

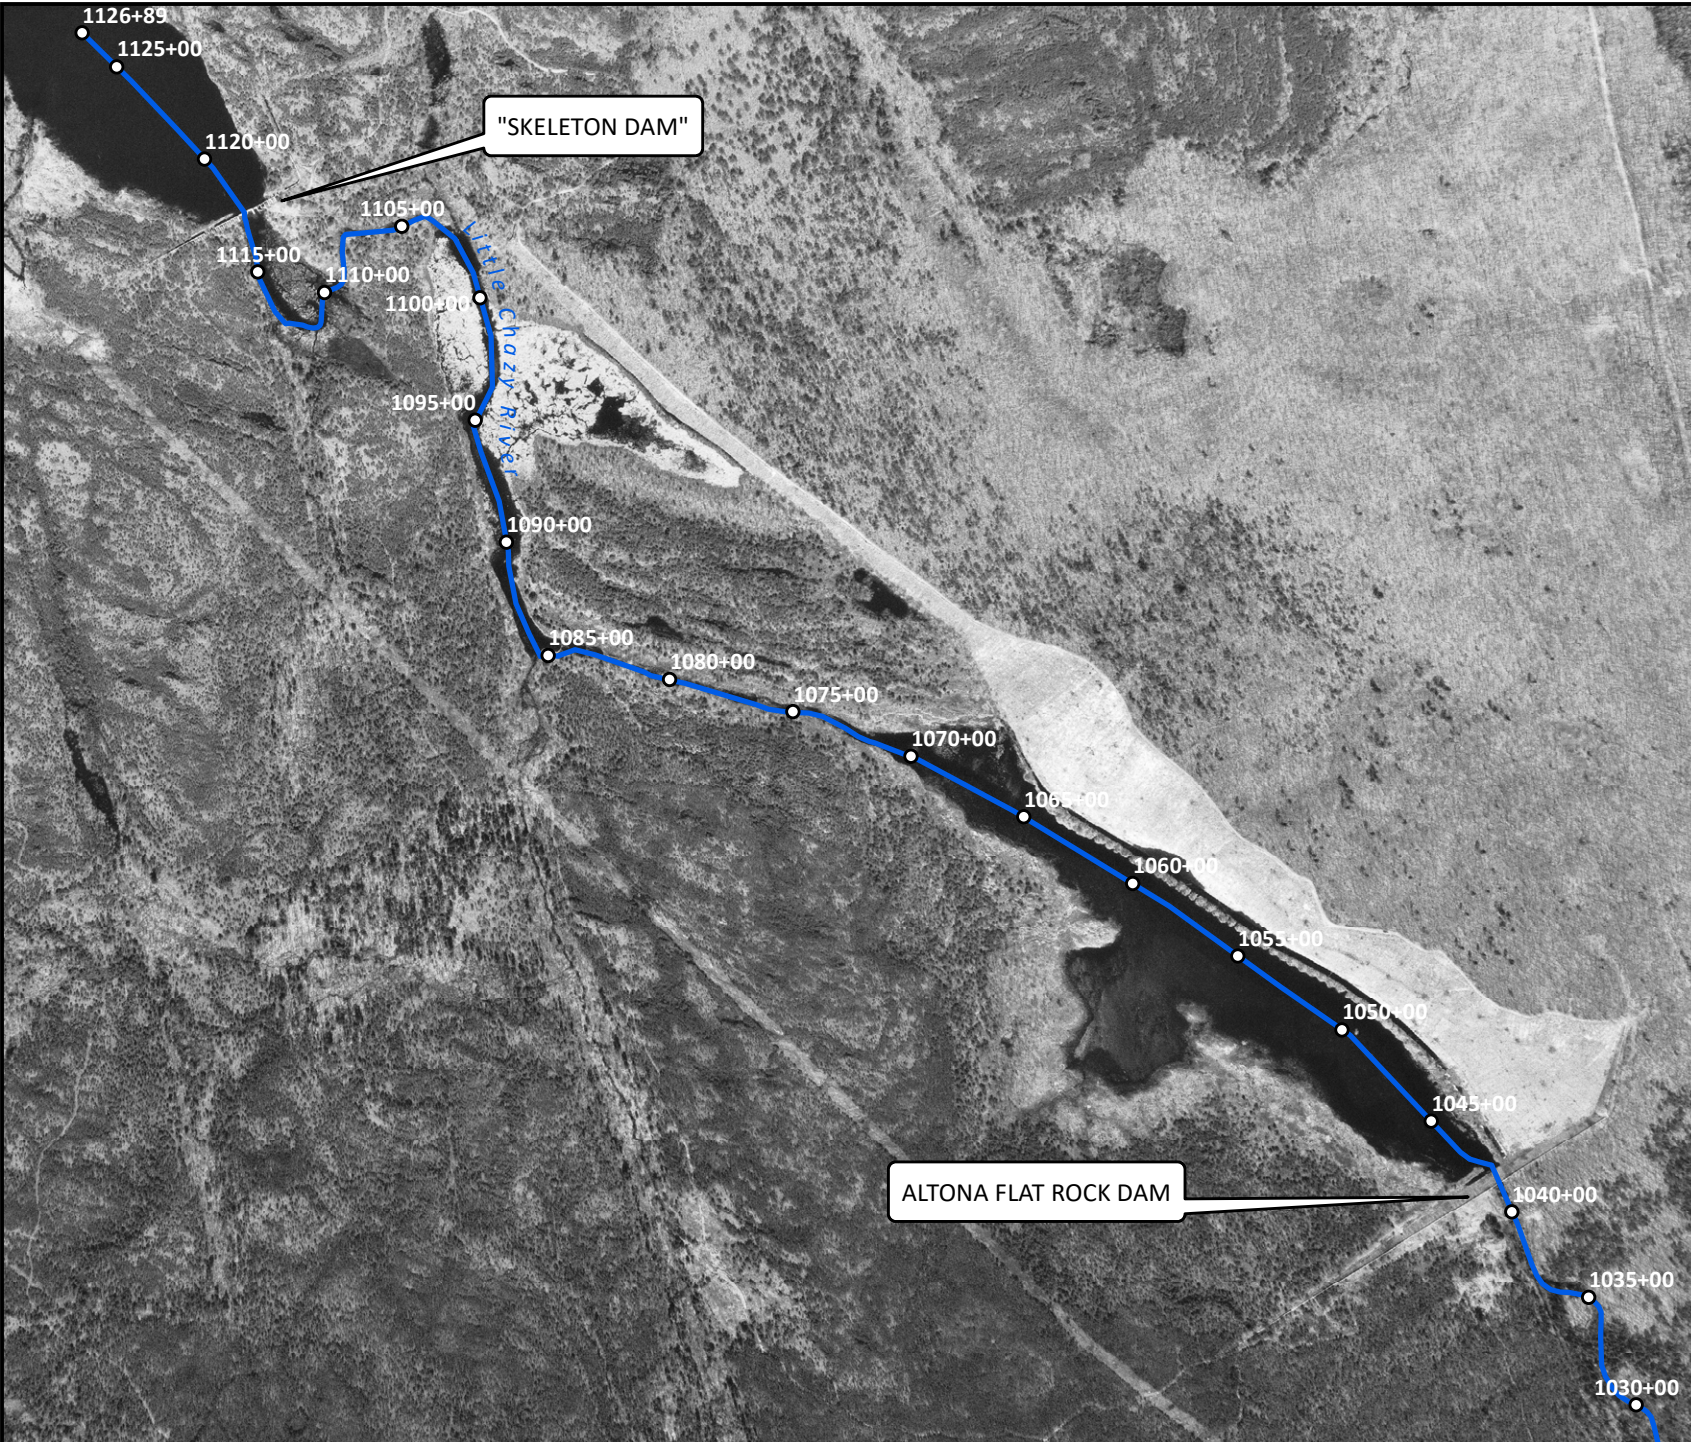
FIG. 4-29A

Upstream of West Chazy, two nonoperational dams are present in the Altona Flat Rock State Forest. The first, at STA 1041+00, an Ambursen-style flat slab and buttress dam built by W.H. Miner, and originally designed to hold 1.5 billion gallons (4,600 acre-feet) of water for hydroelectric power (NYSDEC: ID 217-0165; Federal ID: NY13636). Construction began in 1911, but after filling the impoundment initially in 1917, the dam was plagued by seepage and mechanical issues, and the project was abandoned after just 7 years. The majority of the impoundment's left bank was reportedly covered in concrete in an effort to inhibit this seepage, to no avail. This is visible in historical and modern aerial imagery shown in Figures 4-29A (1964 aerial) and 4-29B (2020 aerial). The NYSDEC dam inventory refers to this 2,300-foot-long, 30-foot-high dam as "Miner Dam" but is alternatively known as the Altona Dam or Flat Rock Dam; colloquially the boondoggle is known as the "Million Dollar Dam." Hereafter in this report, it is referred to as the Altona Flat Rock Dam to avoid confusion with the Miner Dam at STA 131+30. The NYSDEC dam inventory lists the owner of the Altona Flat Rock Dam as William H. Miner, who passed away in 1930, although the property is currently operated by the William H. Miner Agricultural Research Institute.

Flows currently pass through the dam via a small breach in one of the concrete slabs adjacent to the original outlet works. Based on 0.5-foot resolution aerial orthoimagery collected in 2020, the breach is estimated to be approximately 15 to 18 feet wide and is therefore likely to be prone to debris and possibly ice jamming; excess ice formation in the dam's dead pool is also possible. Jamming or clogging may cause the impoundment to fill if coincident with a discharge that exceeds the rate of seepage into the adjacent ground; both conditions may be expected in a flood event. Blockage of the breach may also result from or be exacerbated by beaver activity. The area surrounding this dam is operated by the William H. Miner Agricultural Research Institute, but this dam has been abandoned for a century, and it may no longer be capable of bearing the forces generated by even a partially filled reservoir. This is discussed further in Section 4.3.

This dam is currently rated as a Class D Negligible or No Hazard Dam. This categorization may underestimate the dam's hazard, given that the majority of this very large dam is in place and the potential exists for some portion of the considerable impoundment to fill during flood conditions or due to blockage of the current small breach. The consequences of dam failure could affect downstream property and infrastructure and present a life safety hazard. Reconsideration of this dam's current hazard classification is recommended based on an assessment that includes dam break scenarios that consider partially full and full impoundment levels. Removal of this dam is recommended; because it is more than half a mile long, complete removal may not be feasible, in which case removal of approximately 300 feet of the structure, roughly centered at the dam's outlet, would allow unrestricted passage of modeled flood flows.

HRA #2 - ALTONA FLAT ROCK & "SKELETON" DAMS - 1964 AERIAL
 LITTLE CHAZY RIVER FLOOD & ICE JAM STUDY
 SD122
 CLINTON COUNTY
 NEW YORK

Just upstream of the intended impoundment of the Altona Flat Rock Dam, another of W.H. Miner's concrete slab-and-buttress dams is present at STA 1117+50. This 700-foot-long dam is not in the NYSDEC's current dam inventory (February 2021 Revision) but is colloquially known as the "Skeleton Dam" due to its appearance as many of the buttresses were completed, but the project was abandoned before all of the slabs were constructed. It can be seen in Figures 4-29A (1964 aerial) and 4-29B (2020 aerial). The incomplete structure obstructs flow and is an impediment to ice and debris passage, potentially leading to blockage of the river and filling of some portion of the impoundment. This may also result from or be exacerbated by beaver activity. Because it was never completed and has been abandoned for a century, the structure is presumed to be unsound and unlikely to withstand significant loadings, presenting a safety hazard. Inspection by NYSDEC for inclusion in the dam database is recommended. Removal of this dam is recommended.

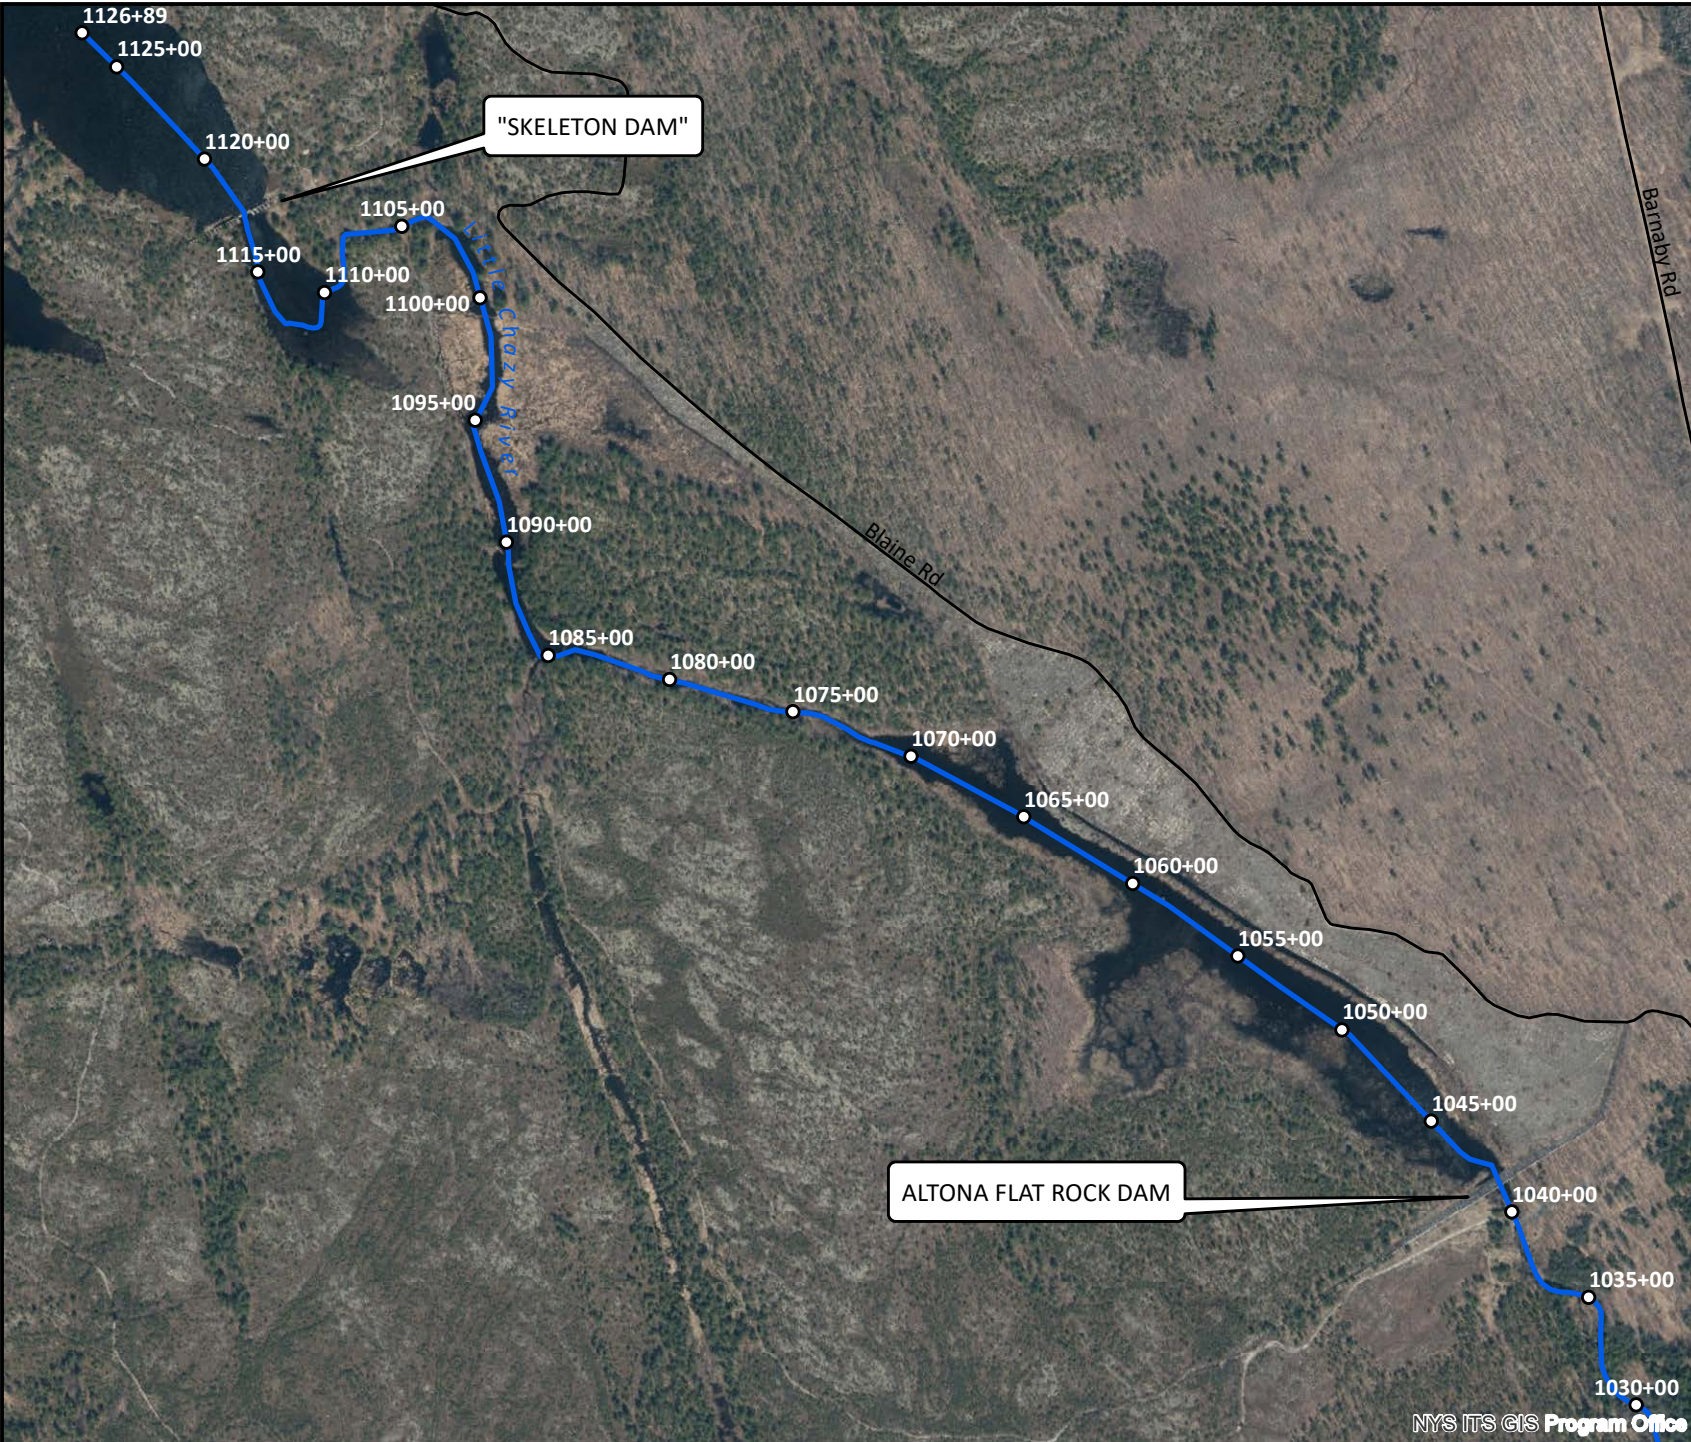
FIG. 4-29B

HRA #2 - ALTONA FLAT ROCK & "SKELETON" DAMS - 2020 AERIAL
 LITTLE CHAZY RIVER FLOOD & ICE JAM STUDY
 SD122
 CLINTON COUNTY
 NEW YORK

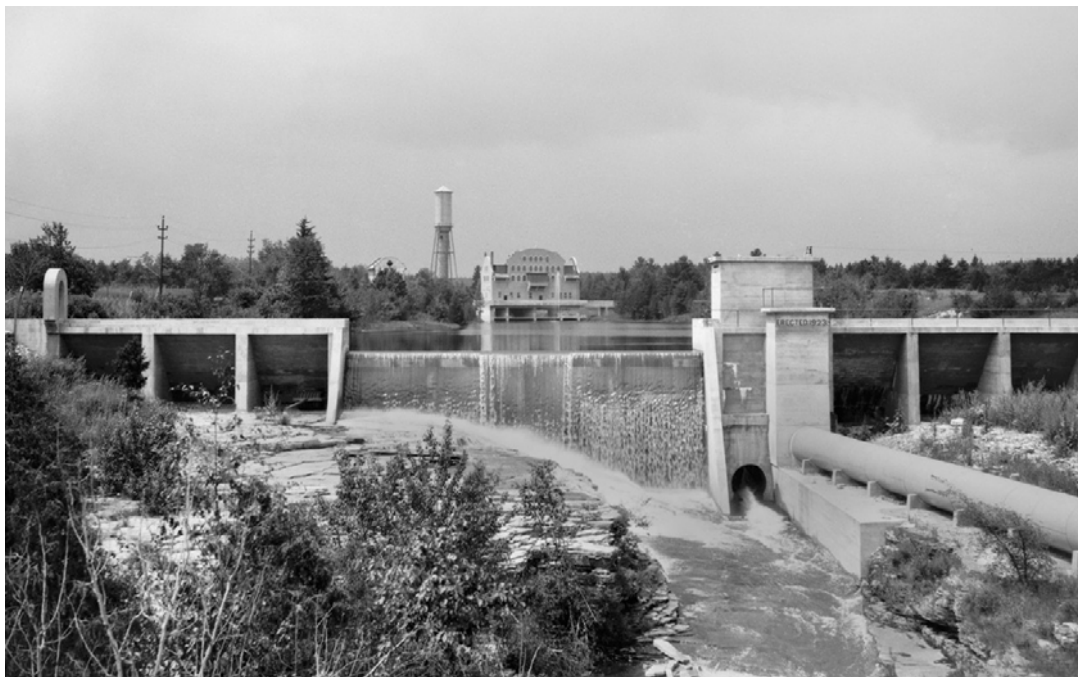
The images in Figures 4-33 and 4-34 depict the LaSell Dam on the Great Chazy River after completion in the 1920s and in 2007 after nearly 50 years of abandonment, respectively. This dam is discussed in the Great Chazy River Flood Mitigation and Resilience Report (SLR, 2022). Note the severe deterioration of the structural concrete and that one of the slabs in the dam’s primary spillway section had failed, although the impoundment would still fill and spill over the dam during high flows. This dam was removed following further damage sustained during Tropical Storm Irene in 2011.

Figure 4-33: LaSell Dam on the Great Chazy River in the 1920s. McGregor Powerhouse in background.

While there are many unknowns regarding the exact construction techniques used in specific dams, these are fundamental characteristics of many of these dams’ type and age that may be responsible for structural and/or hydraulic deficiencies today. While decades of neglect and lack of maintenance can exacerbate these issues considerably, even with regular upkeep, these structures have surpassed their service life and may pose a safety hazard. For long-abandoned dams, the necessary repairs may be so extensive as to be considered reconstruction, thus requiring adherence to modern dam safety requirements for new dams, including stability, spillway hydraulic performance, and impoundment evacuation. For many such deteriorating dams, the cost of rehabilitation or replacement is generally prohibitive, especially since there is no longer an active use for most of these dams. Deferment is not appropriate given the emergent safety hazards of a structurally or hydraulically deficient dam. Often, the only feasible alternative is dam removal. If these dams continue to decay without intervention, they will eventually collapse into the streams and rivers they impound, the consequences of which could be severe, especially if coincident with flooding. Removal of abandoned nonoperational dams to eliminate the hazards they present is recommended as general practice.
