# FLOOD MITIGATION & RESILIENCE REPORT

## Saddle River Watershed SD114

New York State Department of Environmental Conservation,  
in cooperation with the New York State Office of General Services

June 2022

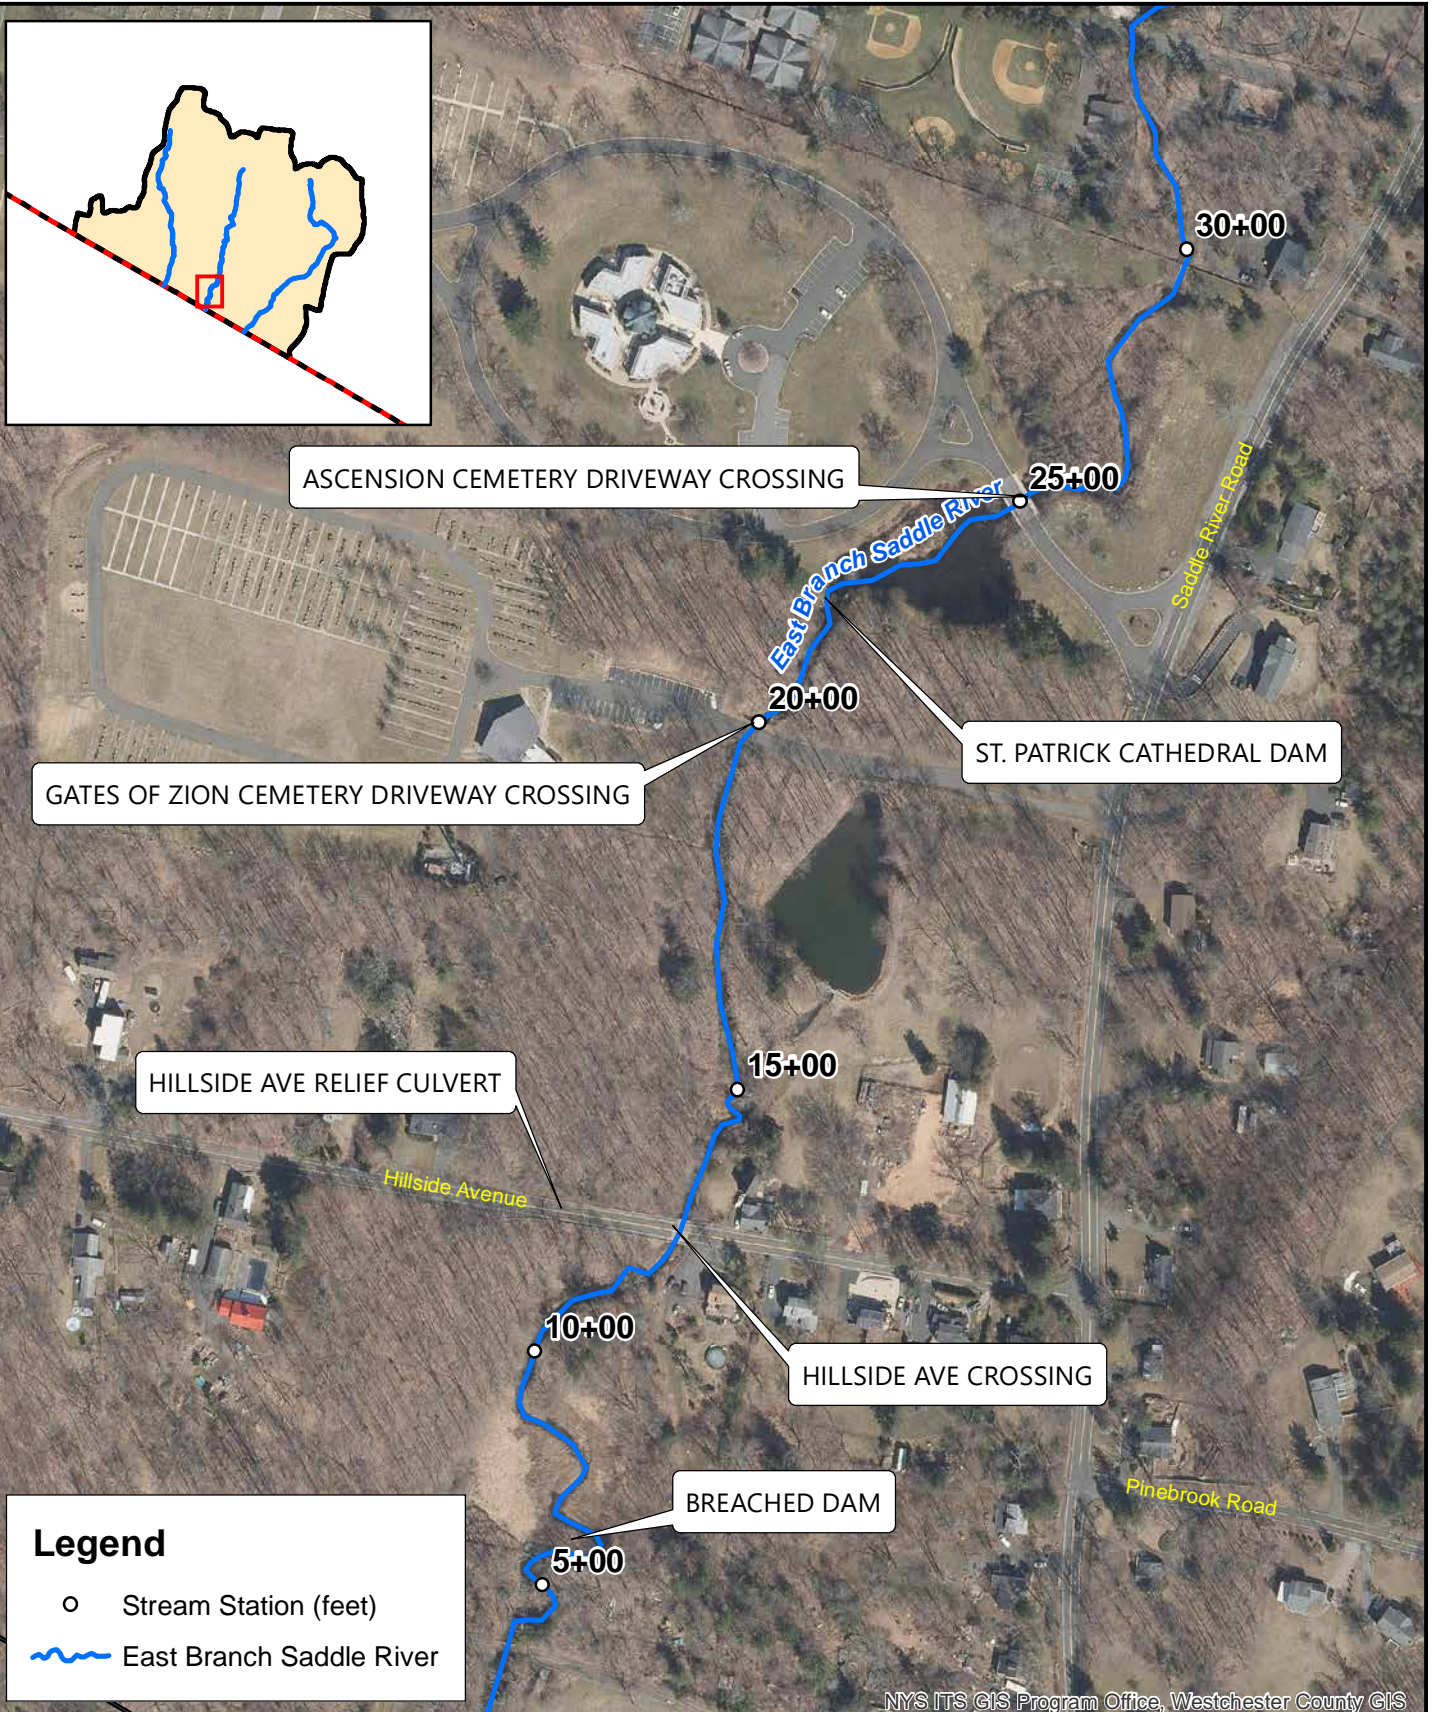
Furthest upstream in this section, the privately owned Ascension Cemetery driveway crosses the East Branch Saddle River at STA 25+00 with two open-bottom concrete arches (Figure 4-6). An HY-8 analysis of the crossing shows a capacity of 413 cfs. This is less than the 10-year flood peak flow of 710 cfs, resulting in overtopping of the crossing. The slope of the tailwater is very flat due to a downstream dam.

**Figure 4-6: Ascension Cemetery driveway crossing of East Branch Saddle River**

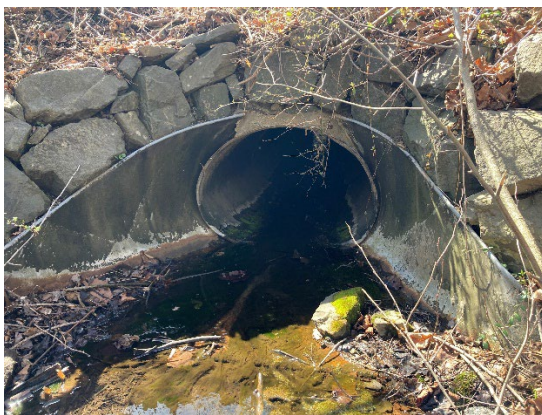
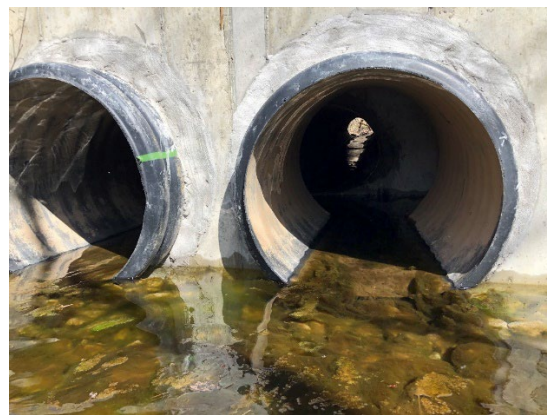
Hillside Avenue crosses the East Branch Saddle River at STA 12+80 with a concrete box culvert (BIN 2224150), shown in Figure 4-9. Approximately 150 feet west along Hillside Avenue is a relief culvert (Figure 4-10). The inlet of the relief culvert is a single metal pipe that empties into a concrete chamber. The chamber connects to the outlet via two plastic pipes, approximately 10 feet long. It appears that other drainage pipes empty into the chamber as well.

**Figure 4-10: Relief culvert along Hillside Avenue: Single inlet (L) splits into two outlet pipes (R)**

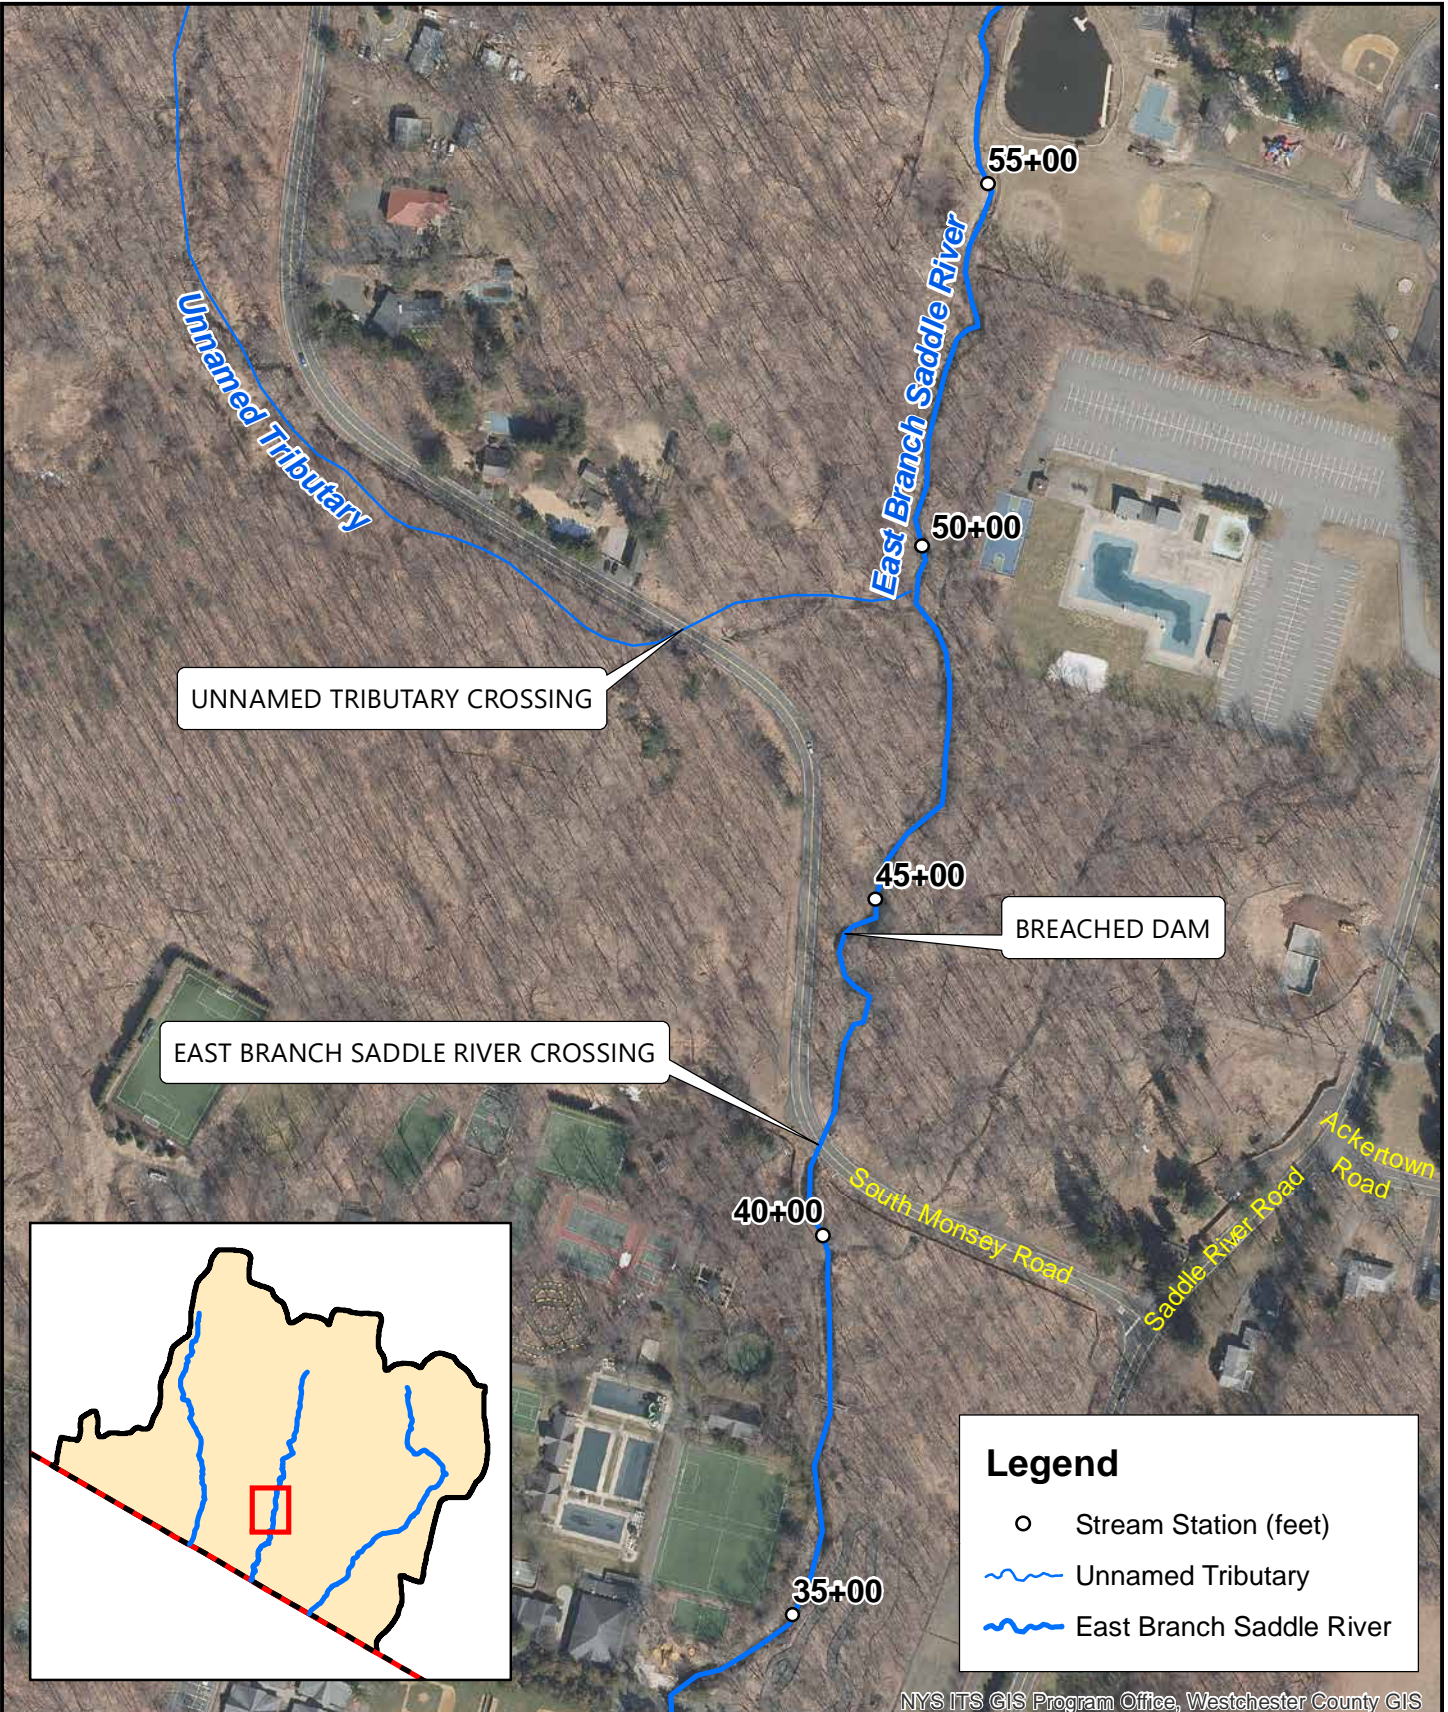
The crossing of South Monsey Road over the East Branch Saddle River at STA 41+30 is a concrete box culvert with a span of 8 feet and a rise of 3.5 feet (Figure 4-15). An HY-8 analysis evaluates the culvert using peak flow data from the FEMA FIS report, reproduced in Table 2-9. Flows for the location nearest the crossing – approximately 554 feet upstream of South Monsey Road – are used to assess the culvert. The flow capacity of the culvert is 242 cfs, about half of the peak flow of a 10-year flood, 480 cfs. According to the USGS Future Flows Explorer online tool, the peak flows will increase by about 10 percent over the next 50 to 100 years. The design 100-year flood flow is 957 cfs.

**Figure 4-15: Inlet of South Monsey Road crossing of East Branch Saddle River**

For the East Branch Saddle River crossing, an open-bottom crossing is recommended by the NYSDEC. The bed slope should match that of the tailwater, 2.5 percent. This is an increase from 0.5 percent slope of the current culvert, which will increase the capacity of the crossing. The HY-8 analysis of a crossing with a 34-foot span, 4-foot rise, open bottom, and 2.5 percent slope gives a capacity of 998 cfs and no overtopping of the road in 100-year future flow. A detailed hydraulic and hydrologic analysis is recommended to properly size a replacement structure. Restoration of the channel upstream and downstream of the crossing is recommended to address the change in slope.

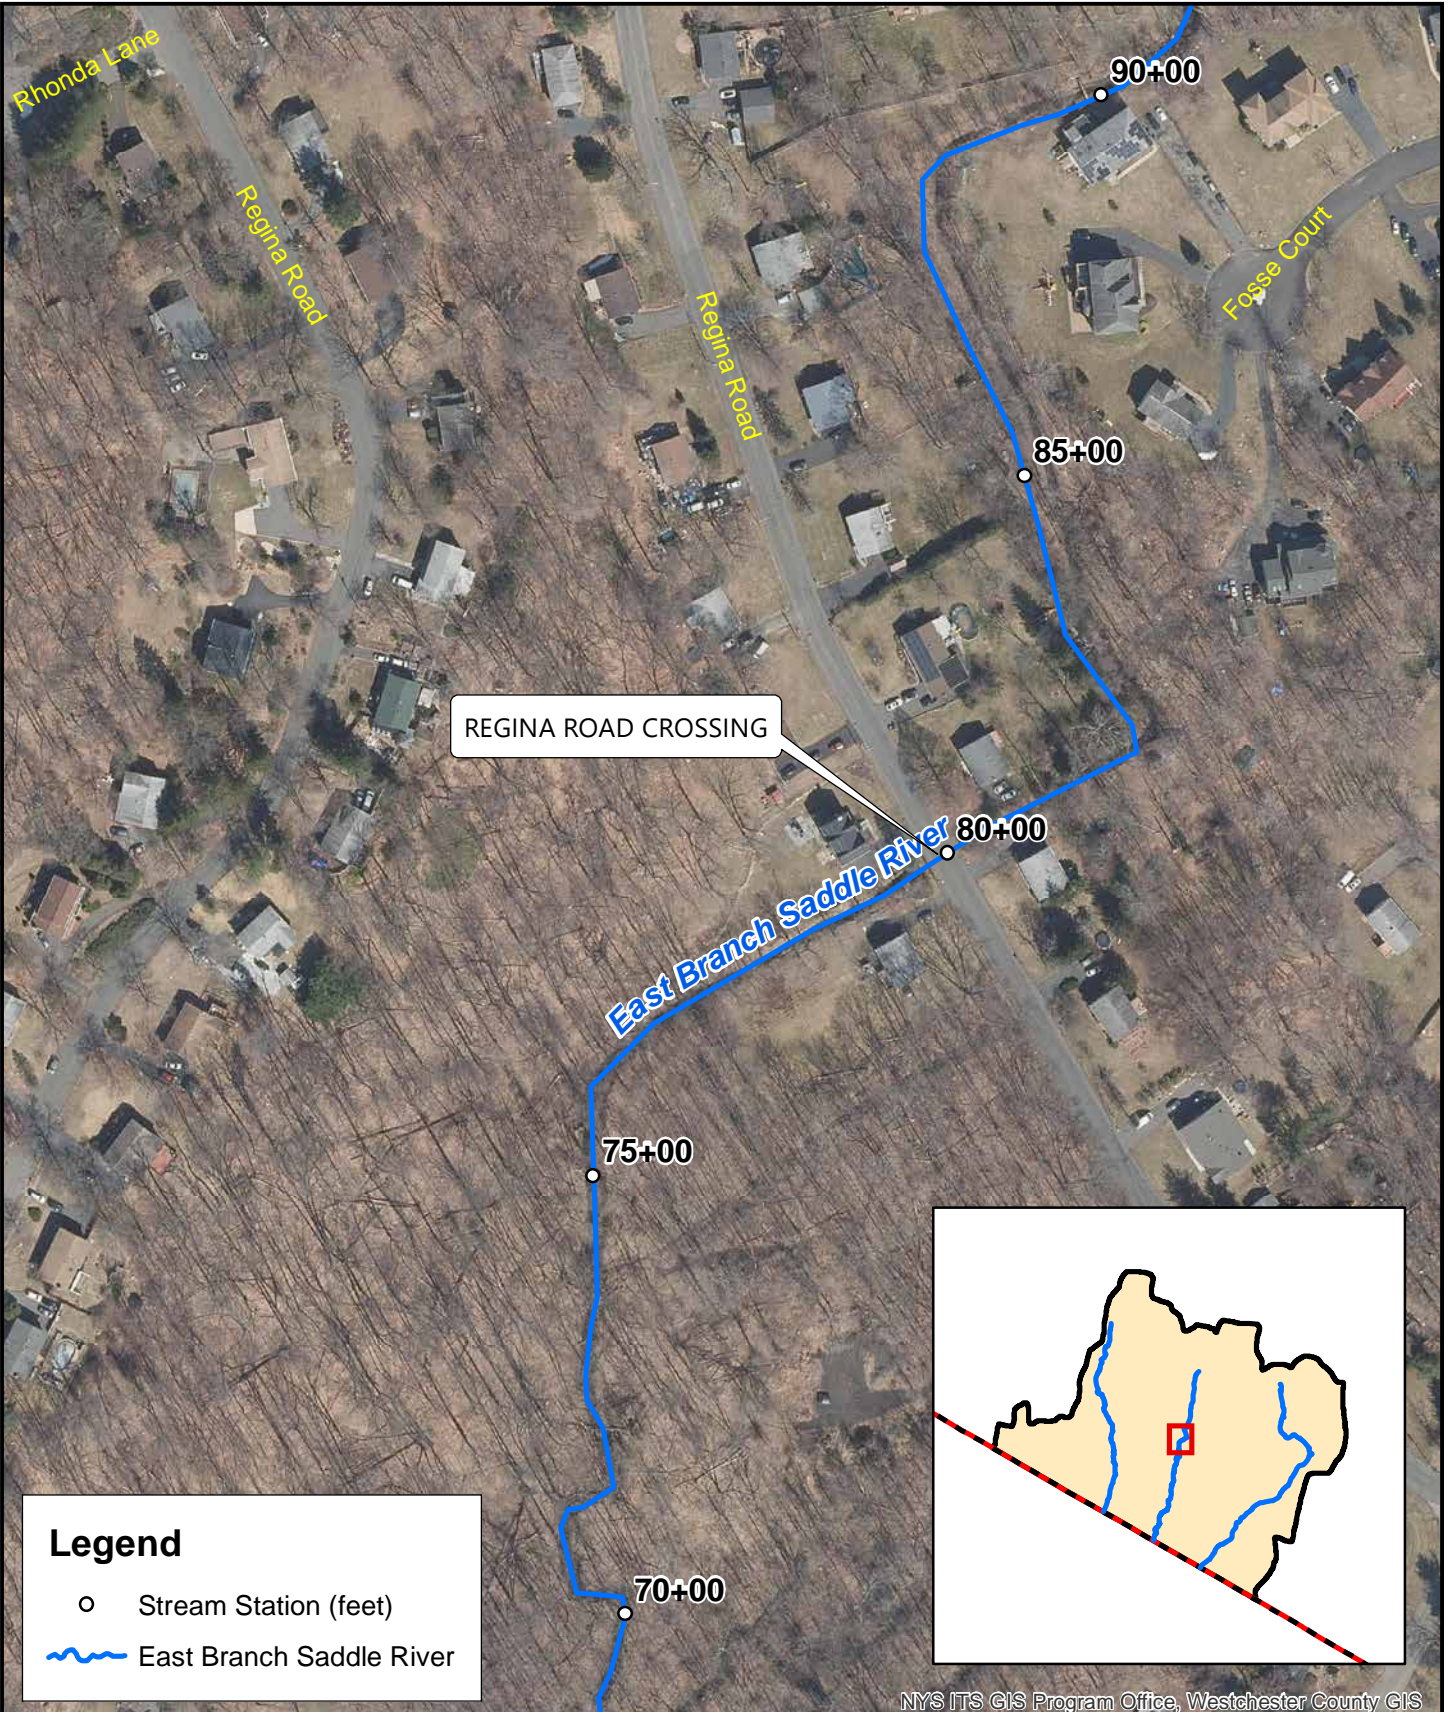
The Regina Road crossing of the East Branch Saddle River at STA 80+00 is a concrete box culvert with a span of 10 feet and a negative slope of -0.007 (Figure 4-19). An HY-8 analysis was used to evaluate the crossing. Peak flow data for the site is assumed to be the same as the nearest location listed in the FEMA FIS report (reproduced in Table 2-9), which is approximately 425 feet downstream of the crossing. The current culvert configuration has a capacity of 362 cfs, which results in overtopping of the road during a 10-year flood event with flows of 450 cfs. Peak flow data for higher frequency flood events are not included in the FIS report.

**Figure 4-19: Outlet of Regina Road crossing of East Branch Saddle River**

The NYSDEC recommends a stream bottom to improve aquatic organism passage rather than the closed bottom currently at the site. The slope should match the stream bed slope at about 2 percent. The current 100-year flow rate is estimated to be 620 cfs. A 10 percent increase in peak flows is expected over the next 100 years, resulting in design flow of 682 cfs.

The HY-8 analysis of a crossing with a 22-foot span, 3.4-foot rise, open bottom, and slope of 2 percent shows a capacity of 690 cfs, which passes the 100-year future flow without overtopping. When due for replacement, a detailed hydraulic and hydrologic analysis is recommended to properly size a replacement structure for the culvert under Regina Road and should include restoration of the upstream and downstream channel sections to correct for the break in slope.

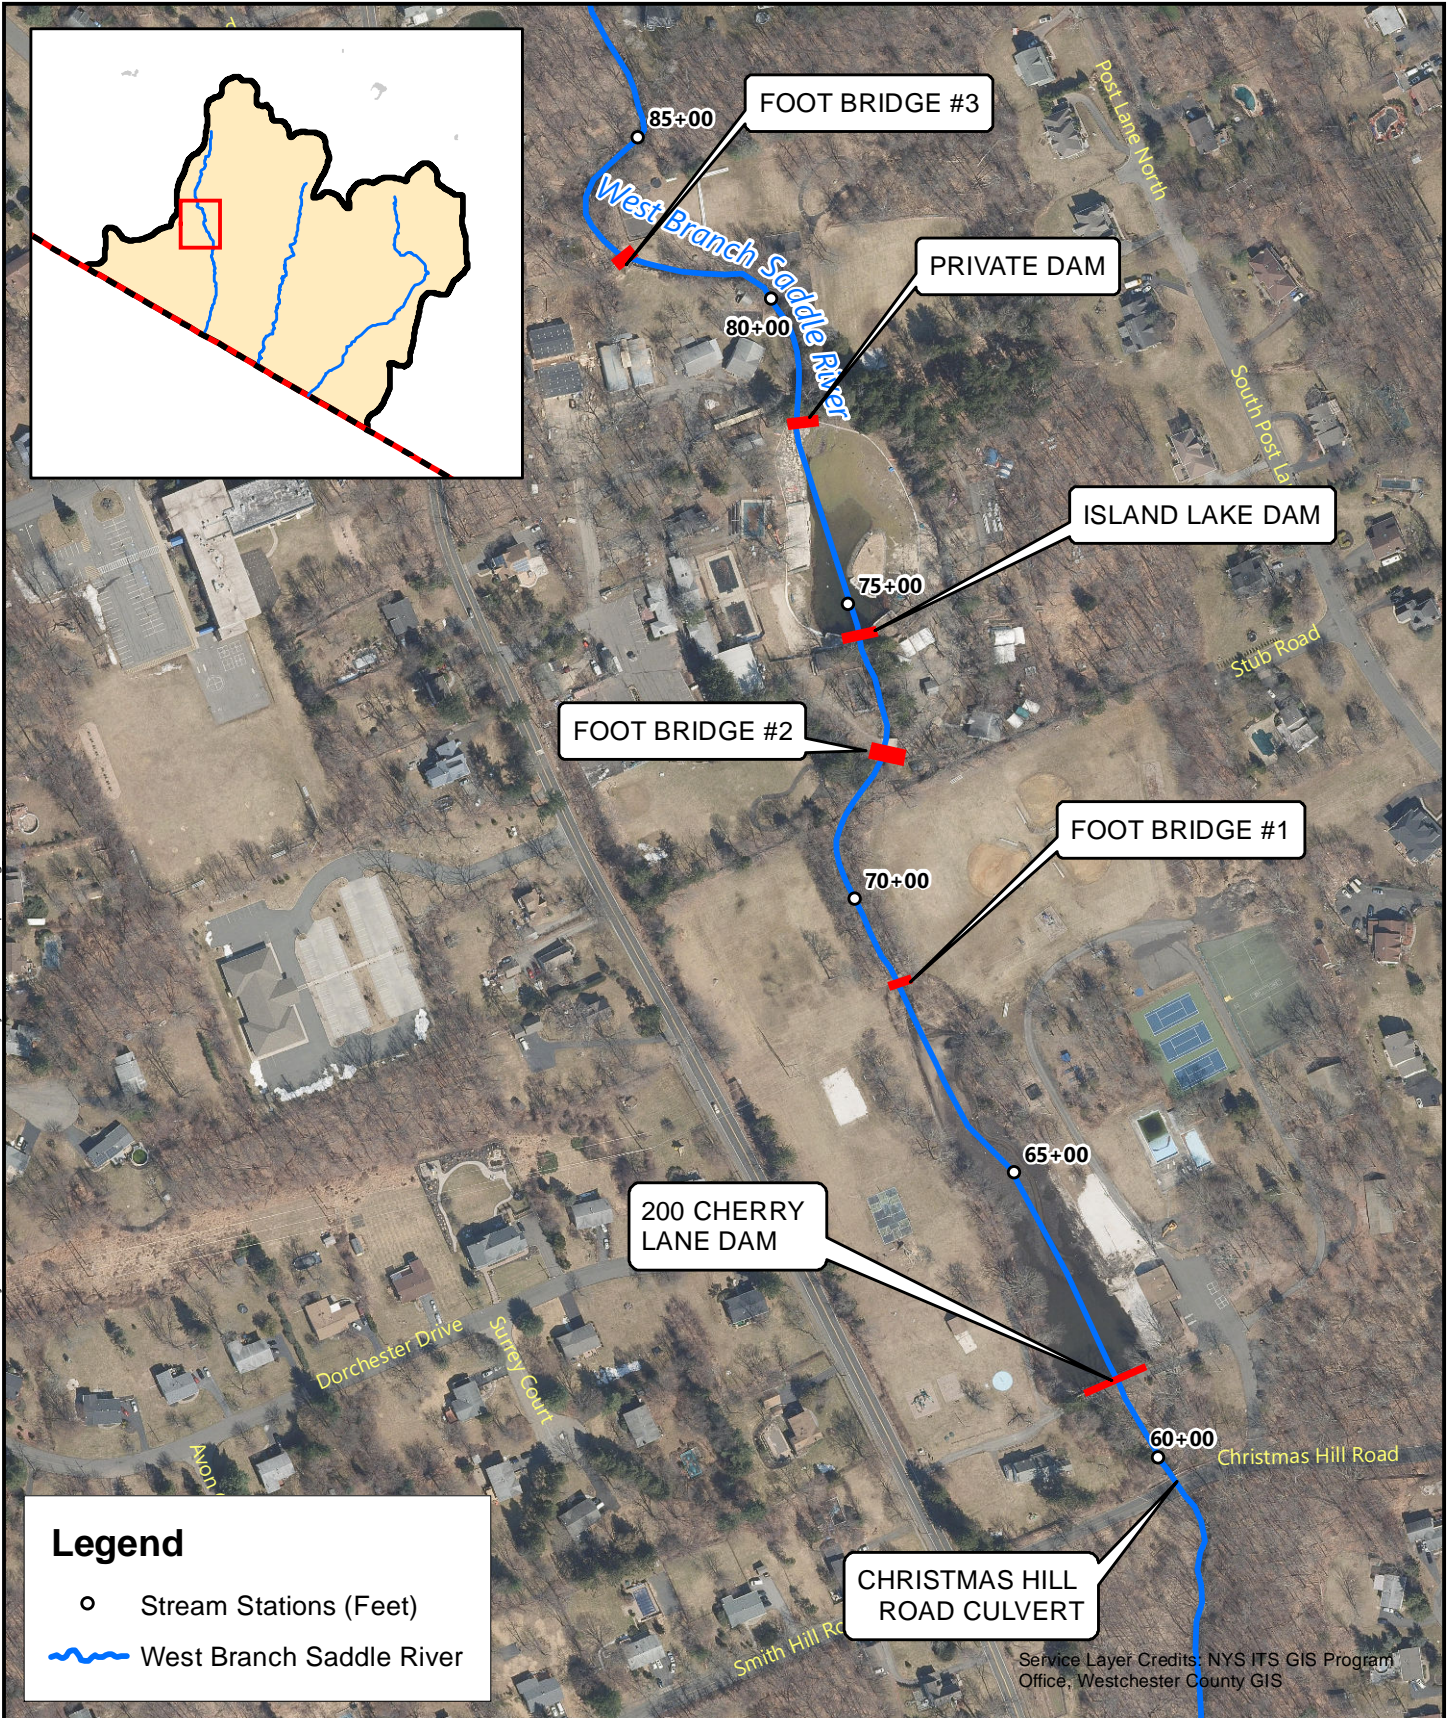
**Figure 4-23: Looking upstream at the outlet of Christmas Hill Road culvert**

The stream crossing at Christmas Hill Road (ownership unknown) consists of a corrugated metal closed-bottom arch culvert with a span of 17 feet and a rise of 6.5 feet (Figure 4-23). The culvert currently passes up to the current 50-year flood event but overtops at the current 100-year and 500-year flood events. Based on modeling results, the structure is flanked by floodwaters at the current 50-year flood event at a low spot in the road to the right of the culvert (Figure 4-24). The culvert lacks the hydraulic capacity to pass the future 50-year, 100-year, or 500-year flood events. The structure's hydraulic performance is controlled by its outlet. While visiting the structure for a field assessment, it was noted that the floor of the culvert was severely deteriorated. The culvert outlet is perched, which presents a barrier to aquatic organism passage, and a scour pool was observed at the outlet, indicating high velocities through the culvert during high flow events.

The hydraulic model was used to evaluate the Christmas Hill Road culvert if it were to be replaced with a new structure spanning 19 feet and a rise of 7 feet. Replacement of the Christmas Hill Road culvert with a single-barrel concrete box culvert of those dimensions lowers the current 50-year and the future 50-year flood event headwater depths by 0.7 and 0.6 feet, respectively. The structure overtops at the current 500-year and future 100-year flood event but can pass all other modeled flood events.

It is recommended to replace the Christmas Hill Road culvert and entirely removing the three dams. Replacing the Christmas Hill Road crossing with a structure containing a minimum span of 19 feet and a minimum rise of 7 feet would adequately prevent the road from overtopping during modeled storm events. In addition, removing the three dams from the stream will reduce flood depths and eliminate

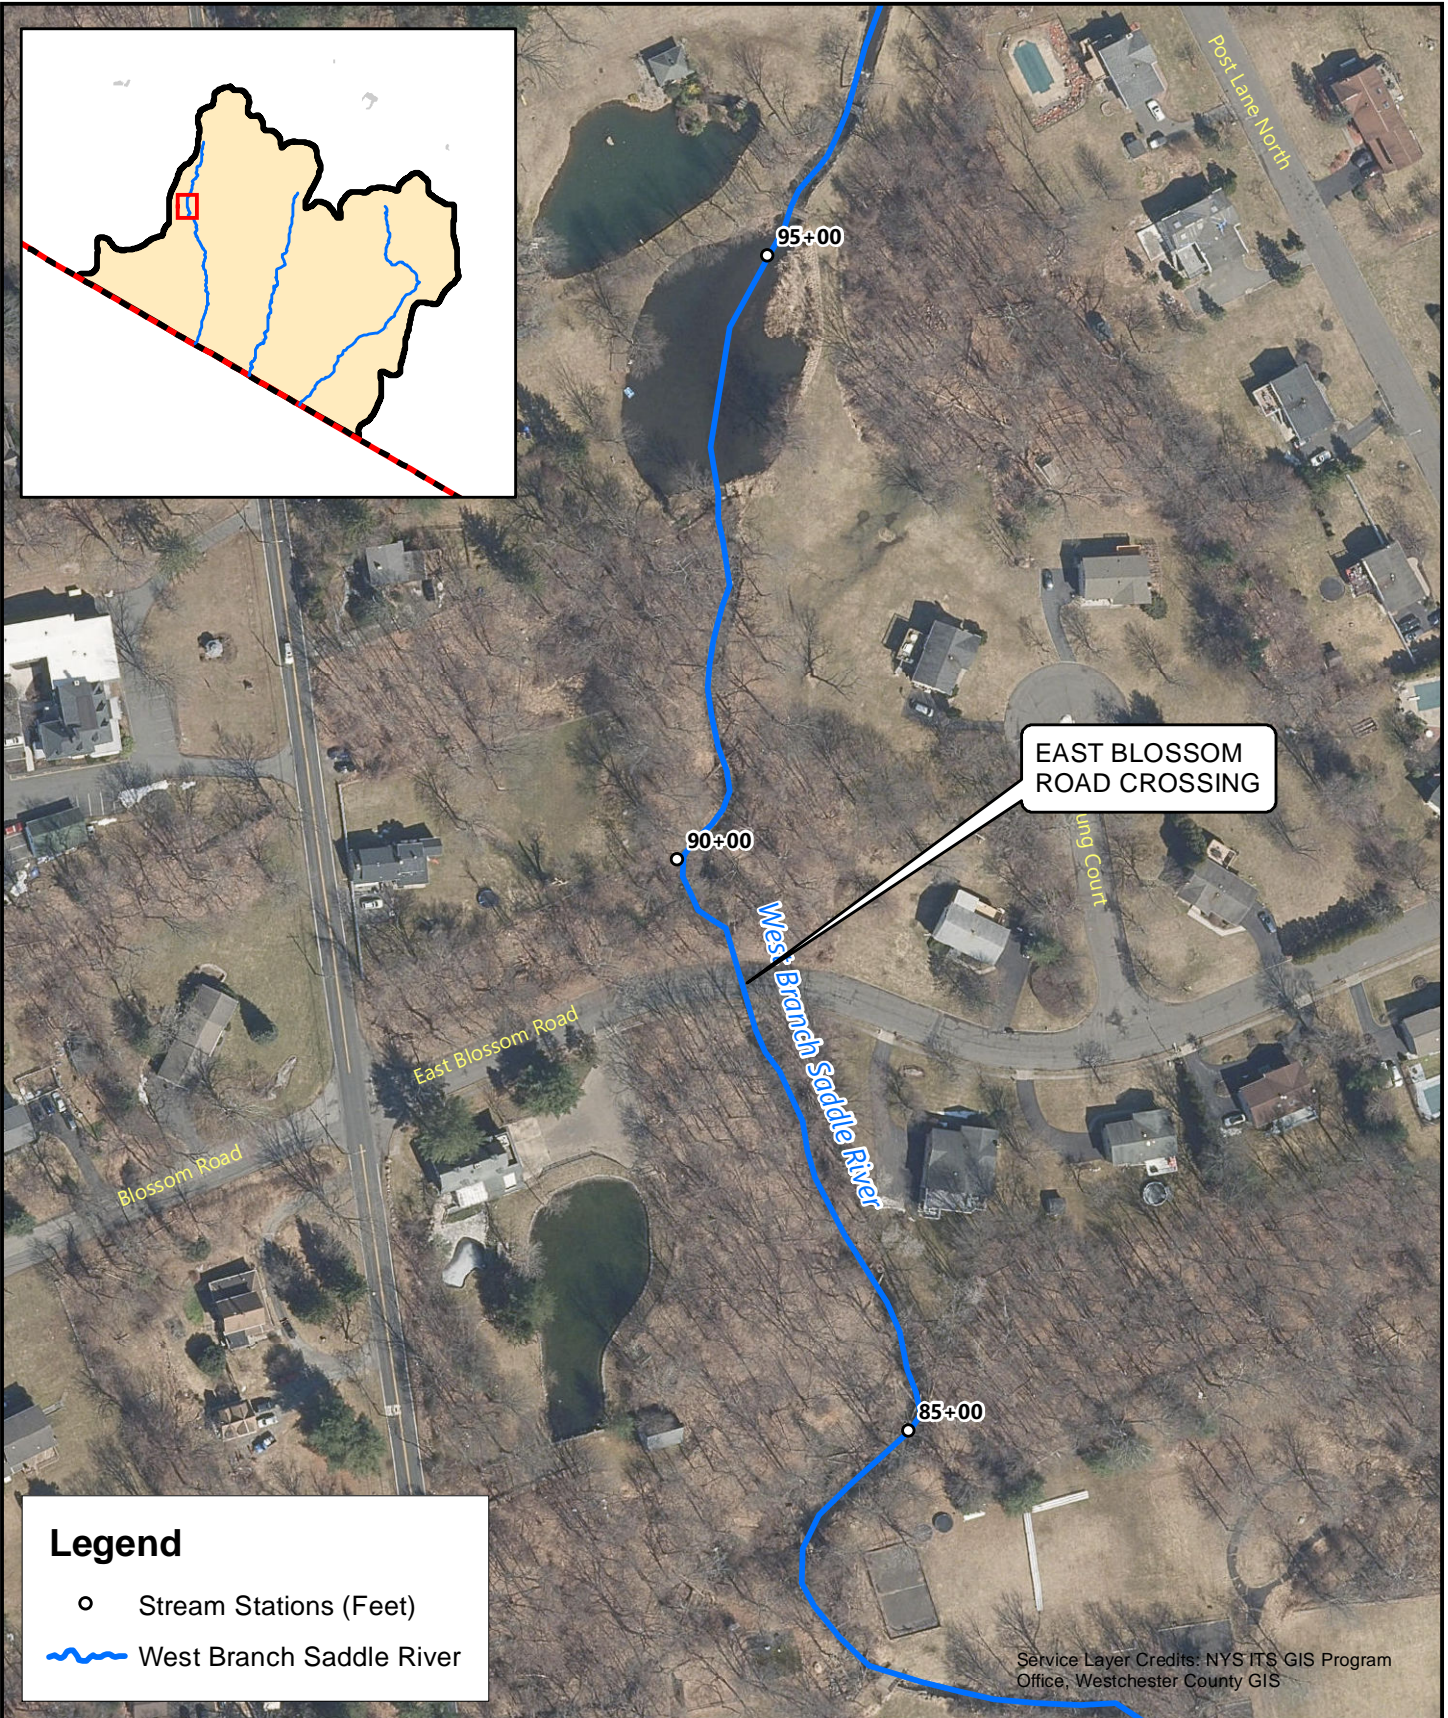
SCALE 1" = 150'  
DATE 6/7/2022  
PROJ. NO. 16511.00009  
**FIG. 4-28**

The stream crossing at East Blossom Road (STA 88+80), ownership unknown, consists of two corrugated metal arch culverts (Figure 4-29). The left culvert has a height of 3.55 feet and a width of 5.5 feet. The right culvert has a height of 3.1 feet and a width of 5.5 feet. Both culverts are likely supposed to be identical and have a height of 4.0 feet, but deposition of fine sediment at the inlet has created some discrepancies in height. Upon inspection in the field, the right culvert appears to be bowing at the center underneath the road and may have started to collapse (Figure 4-30). Based on hydraulic modeling results, the twin culverts are capable of passing the current 10-year flood event but overtop at the 50-, 100-, and 500-year flood events. The culverts cannot pass any of the modeled future flood events. A map of the East Blossom Road crossing is depicted in Figure 4-28.

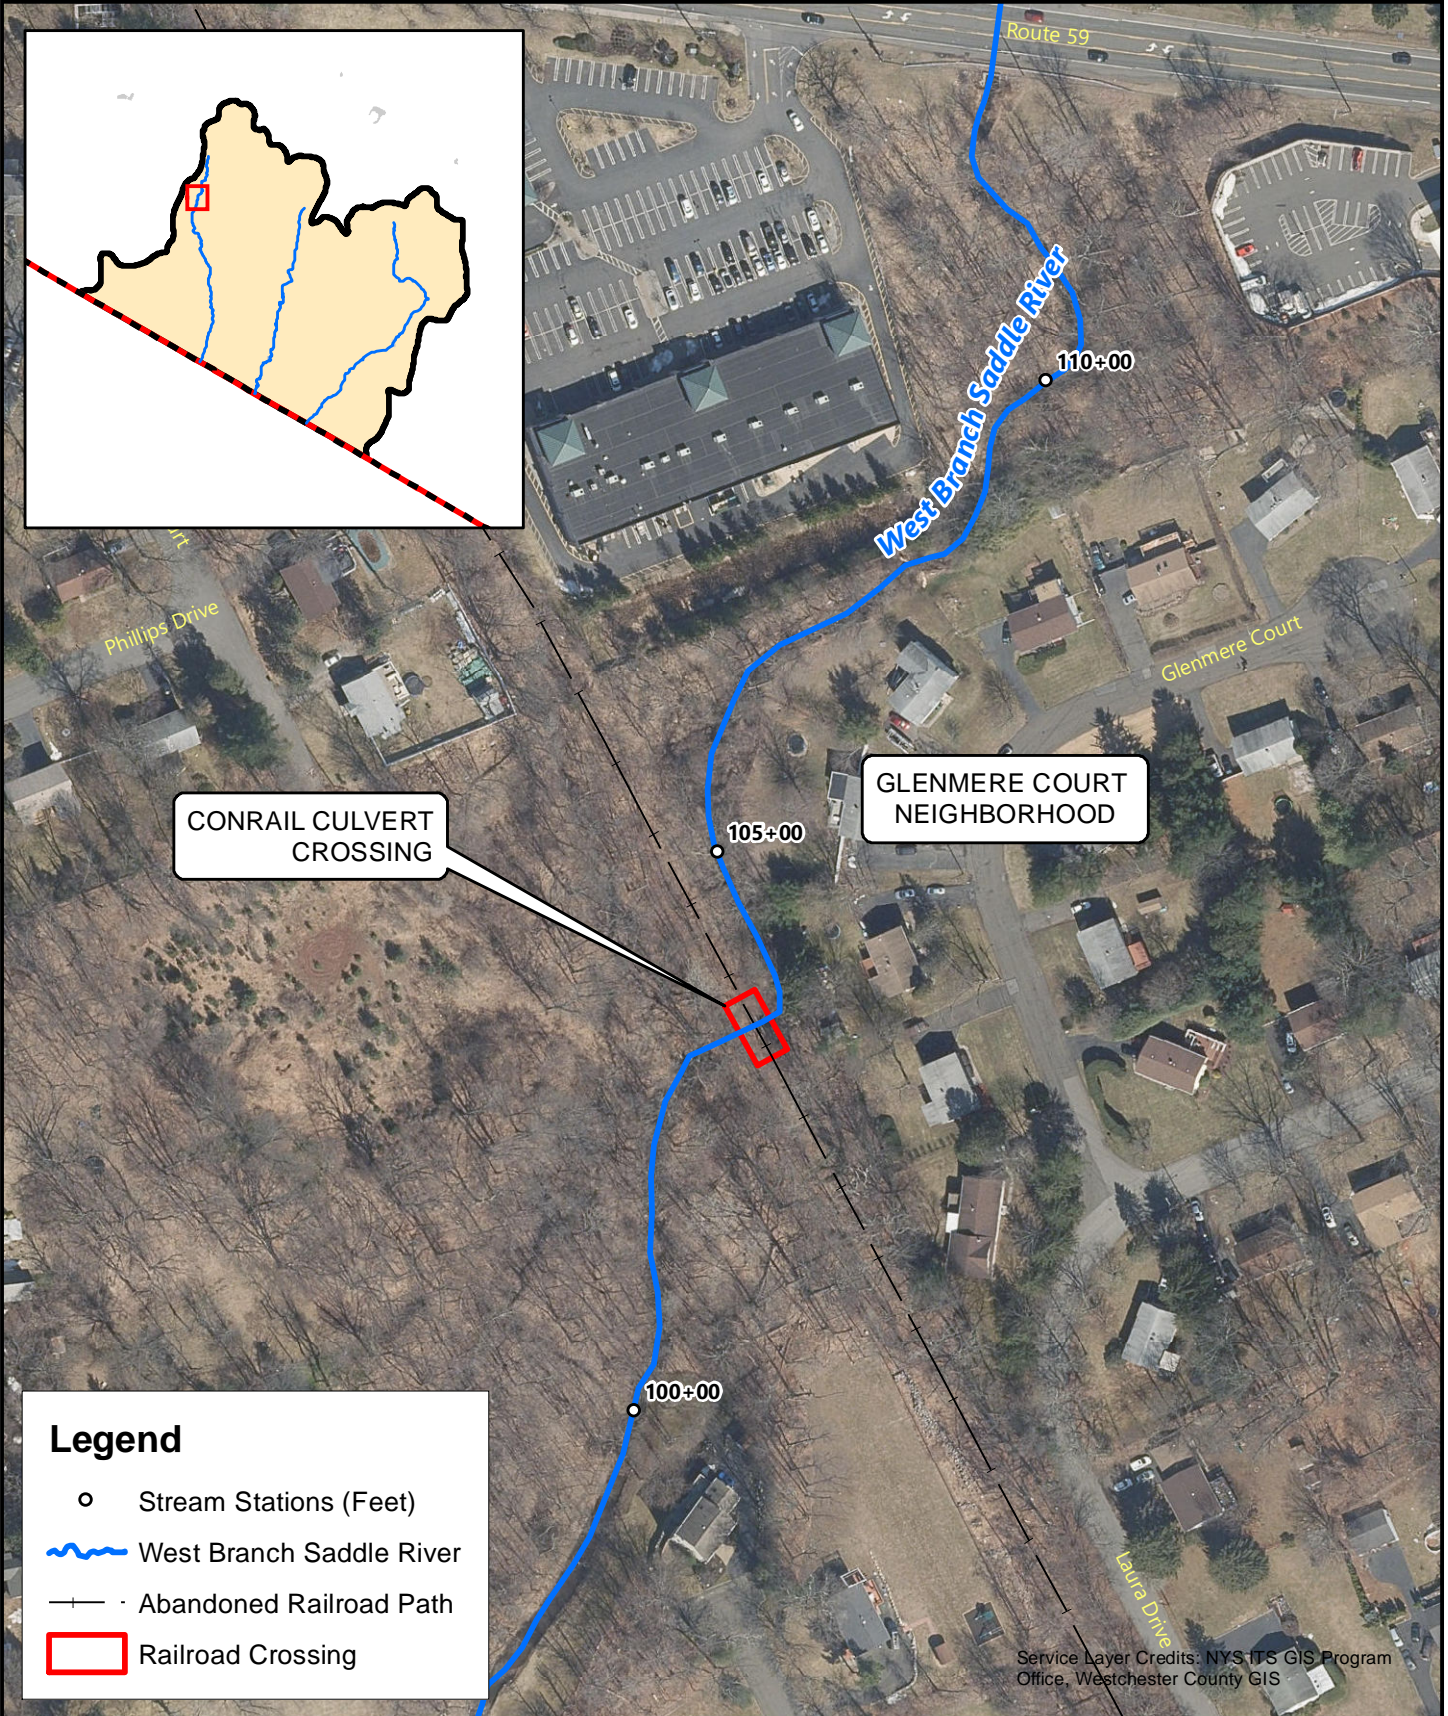
The stream crossing at the Conrail railroad tracks is located at STA 104+00 and consists of a concrete arch culvert approximately 7.6 feet high and 6 feet wide (Figure 4-34). The culvert has a rectangular curb at the bottom right of the arch that is approximately 1.5 feet high. The West Branch Saddle River enters the inlet at a near 90-degree bend. The drainage area at this location is 0.65 square miles. The West Branch Saddle River flows through a moderately developed area in this reach and is sandwiched between properties on Glenmere Court on its river left, with a plaza and an abandoned railroad embankment on its river right. While the neighborhood is not shown to be in the FEMA Special Flood Hazard 100-year or 500-year floodplain, it was noted in the Rockland County Hazard Mitigation Plan that the area is prone to flooding. A map of the railroad crossing is depicted in Figure 4-33.

Hydraulic modeling shows that the railroad structure can pass all modeled flood events but creates a backwater effect that extends over 300 feet upstream of the culvert inlet, with flood depths at the 10-year flood event ranging from 6 feet at the inlet to 3 feet near the upstream end of the backwater. The structure is controlled by its inlet, which means the culvert is capable of carrying more flow than the inlet will accept. The combination of the skewed inlet and the perched inlet caused by the rectangular curb, along with the undersized inlet, contributes to the inlet control demonstrated in this crossing.

Upon research and visual inspection in the field, the railroad line that passes over the West Branch Saddle River at this location is determined to be abandoned. Therefore, rather than replacing the structure, it is recommended to remove the crossing completely and restore the channel. Hydraulic modeling shows that the backwater effect is eliminated, and flood depths decrease by 3 feet when the railroad structure is removed.

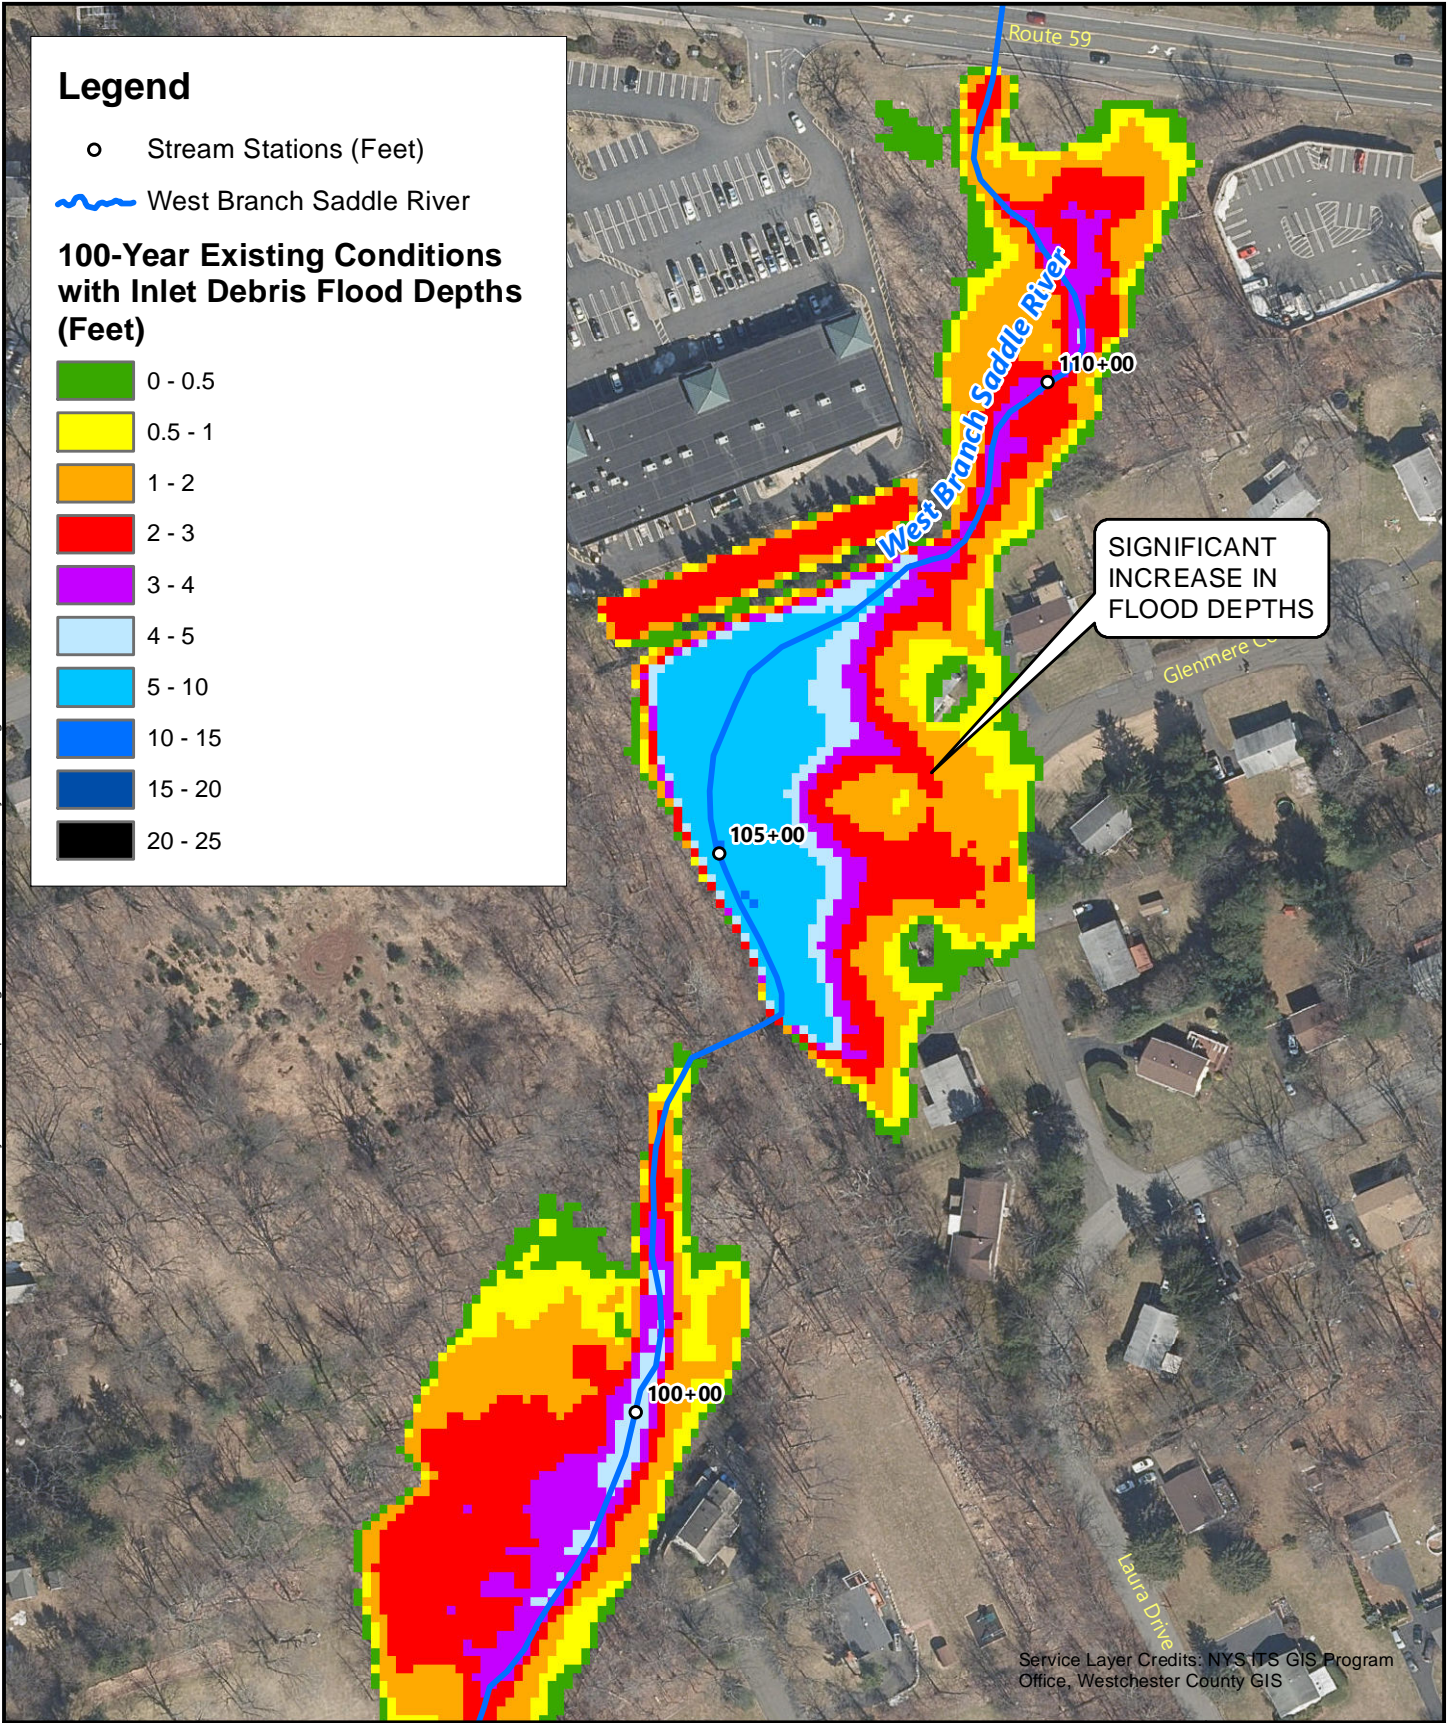
## FIG. 4-38

While conducting a field inspection, woody debris was noted to be partially obstructing the inlet (Figure 4-35). Additional debris, both woody and anthropogenic, was noted along the stream upstream of the inlet. According to the NYSDEC, crossings that are susceptible to be clogged or partially clogged, especially undersized ones, can intensify the effect of floods. When the structure is modeled with an inlet 25 percent clogged by debris to represent conditions observed in the field, flood extents expand during all modeled flood events. Multiple houses adjacent to the West Branch Saddle River on river left become inundated during the current 50- and 100-year flood events.
