# FLOOD MITIGATION & RESILIENCE REPORT

## Saddle River Watershed SD114

New York State Department of Environmental Conservation,  
in cooperation with the New York State Office of General Services

June 2022

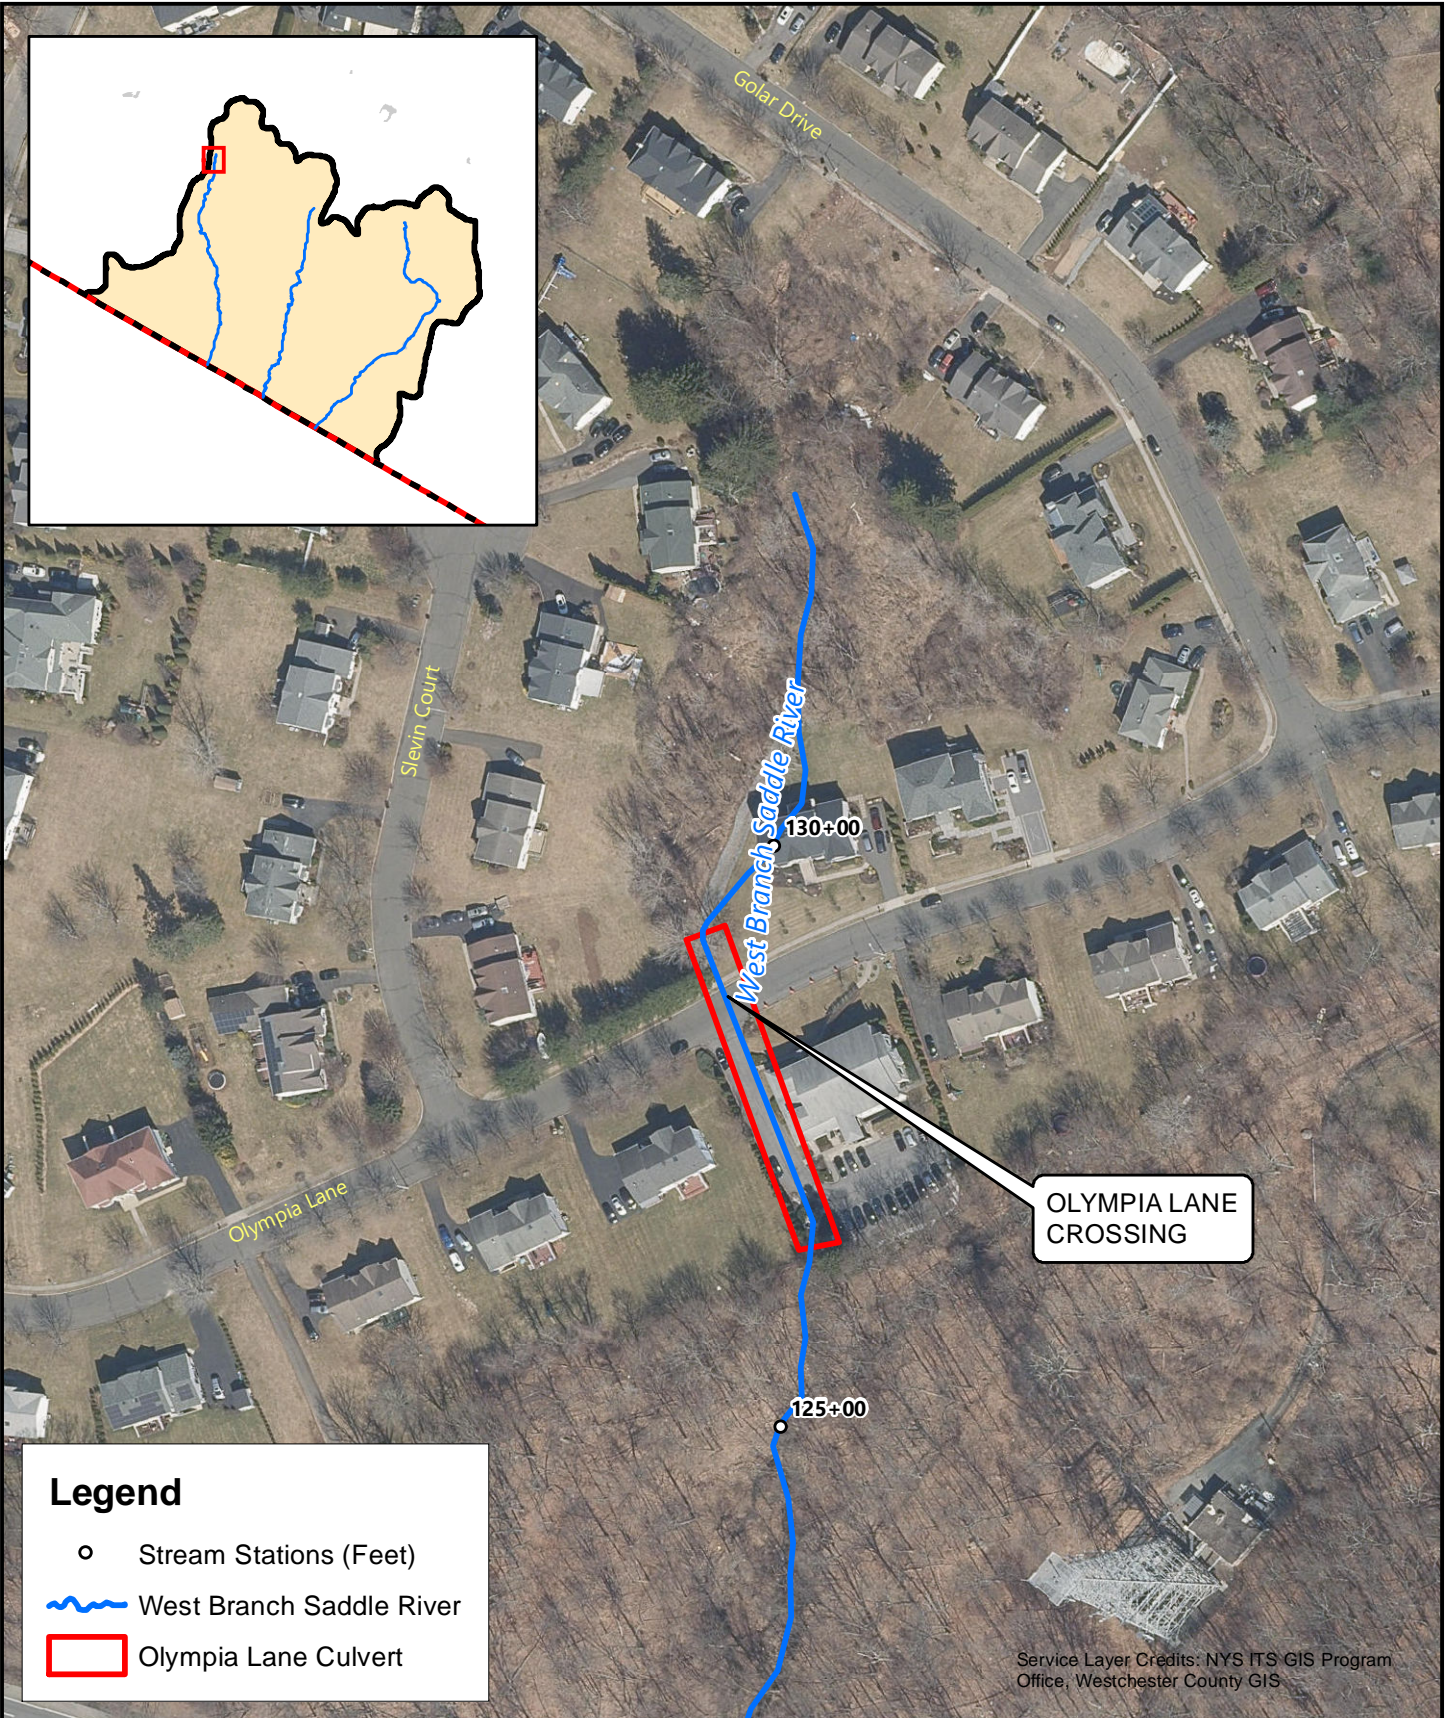
**Figure 4-41: Looking downstream at the inlet of the Olympia Lane culvert**

The most upstream stream crossing in HRA 5 is at Olympia Lane (Figure 4-41). This crossing (STA 129+25), ownership unknown, is within the headwaters of the West Branch Saddle River watershed, which is located within the hamlet of Viola. The West Branch Saddle River flows through a residential neighborhood in this section. The Olympia Lane crossing consists of a 6-foot circular concrete pipe and has a length of approximately 280 feet. The pipe bends approximately 30 degrees underground (Figure 4-42). The structure is capable of passing the 10-year flow event but overtops at the 50-year, 100-year, and 500-year flood events. A map of the Olympia Lane crossing is depicted in Figure 4-40.

The hydraulic model was used to evaluate the Olympia Lane crossing if it were to be replaced with a new structure spanning 10 feet with a rise of 6 feet. Replacement of the Olympia Lane culvert with a single-barrel concrete box culvert of those dimensions reduces the current 50-year and future 50-year headwater depths by 4.5 and 4.3 feet, respectively. The flood reduction is depicted in longitudinal profile 4-44. The replacement structure would be able to pass all modeled current and future flow events. With the new structure, the house adjacent to the river left of the culvert on the upstream end would no longer be flooded during the 100-year flood event.

It is recommended that the Olympia Lane culvert is replaced by a structure with a minimum span of 10 feet and a rise of 6 feet, free of bends and straight. Given the length of the culvert, it is also suggested to daylight the stream where possible. Daylighting the stream would include, at minimum, physically uncovering the culvert, removing it, and restoring the channel. Channel restoration would include excavation of a properly sized, multistage channel and floodplain, installation of grade control structures and/or scour protection measures along the restored channel to prevent channel incision and protect upstream infrastructure, and installation of native plantings.
