NEW YORK STATE SITE REGISTRY DELISTING PETITION SITE 6 (RUNWAY) HICKSVILLE, NEW YORK

GRUMMAN AEROSPACE CORPORATION
BETHPAGE, NEW YORK

Dvirka and Bartilucci
Consulting Engineers

FEBRUARY 1993

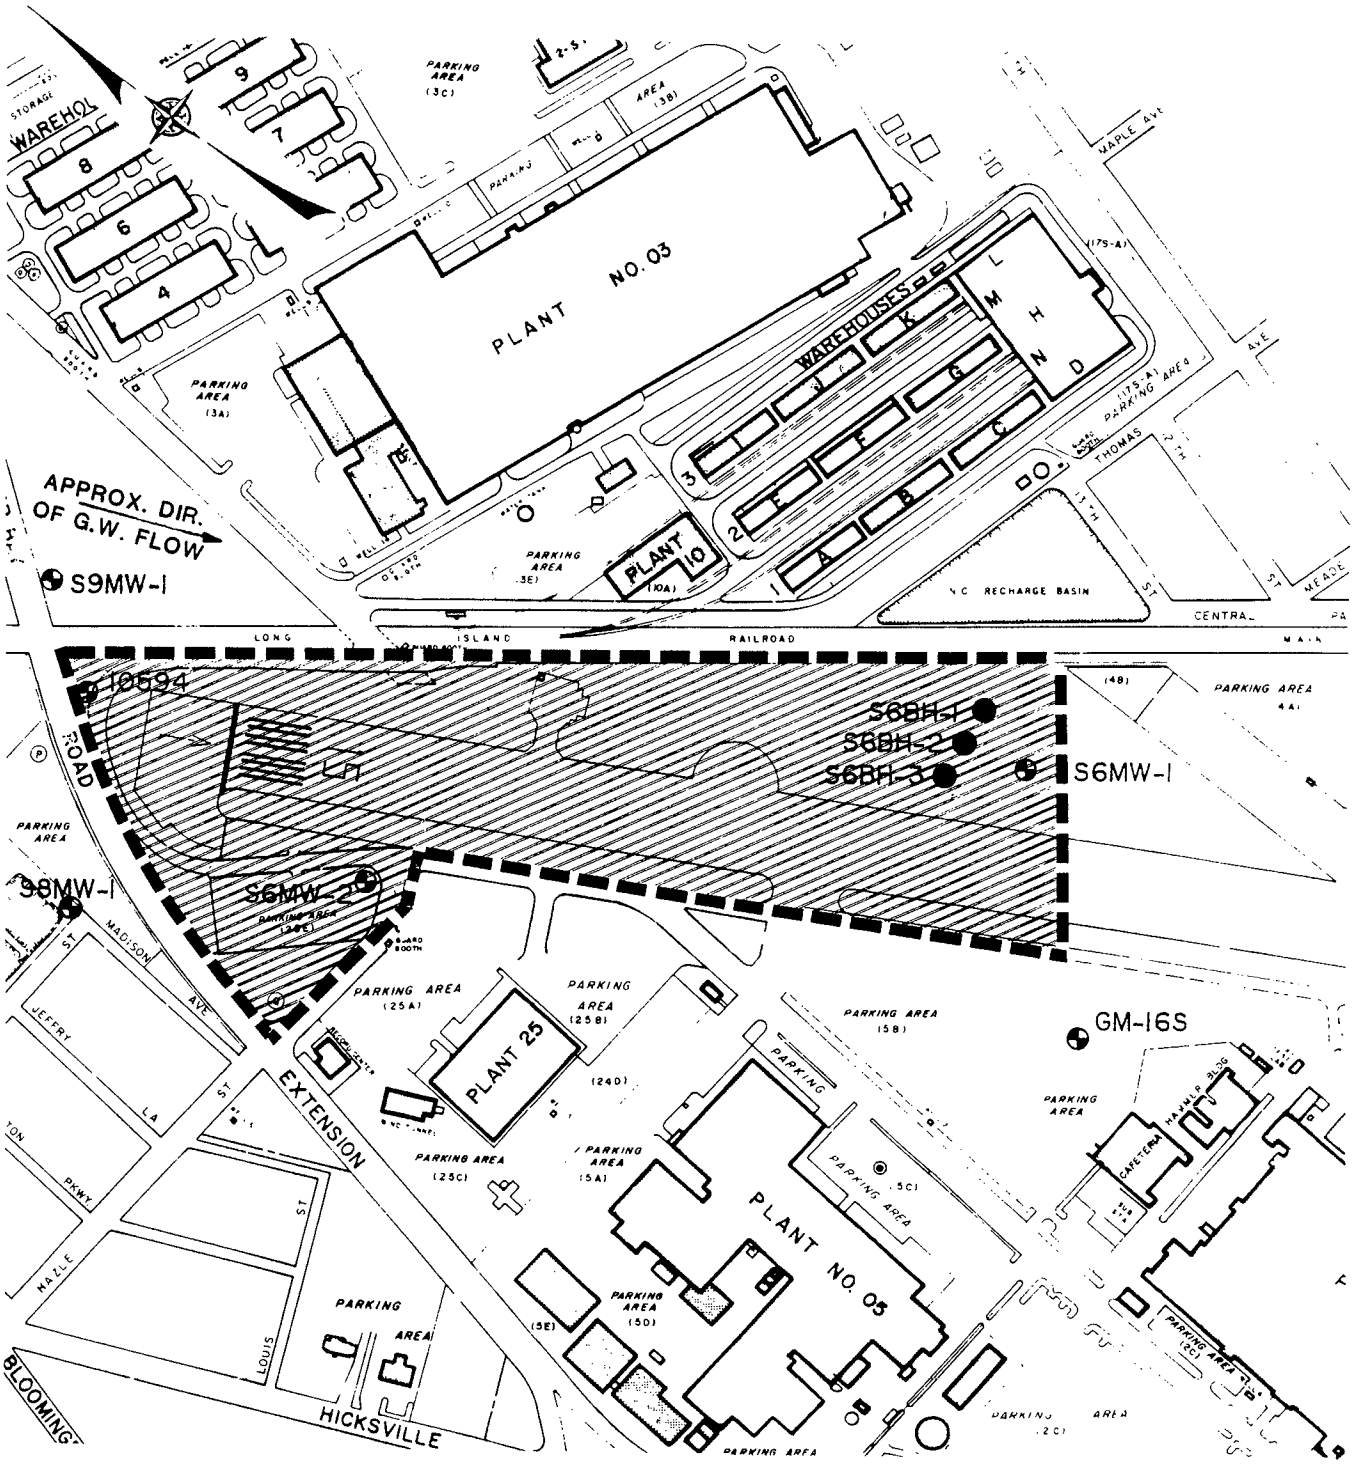
FIGURE 3 - 1

WELL AND BORING LOCATIONS
