Re: Town of Oyster Bay
Interim Remedial Measure at Bethpage Community Park
Sampling Plan for Potential Backfill from Borella Field
H2M Project No. TOBY 04-02

Proposed Environmental Sampling Plan of Town of Oyster Bay Soil Stockpiles at Syosset DPW Yard

FIGURE 1. SCHEMATIC OF SOIL PILES AT TOWN OF OYSTER BAY DPW YARD
 (Source of soil: Regrading at Borella Field, Plainview Road, Bethpage, NY)

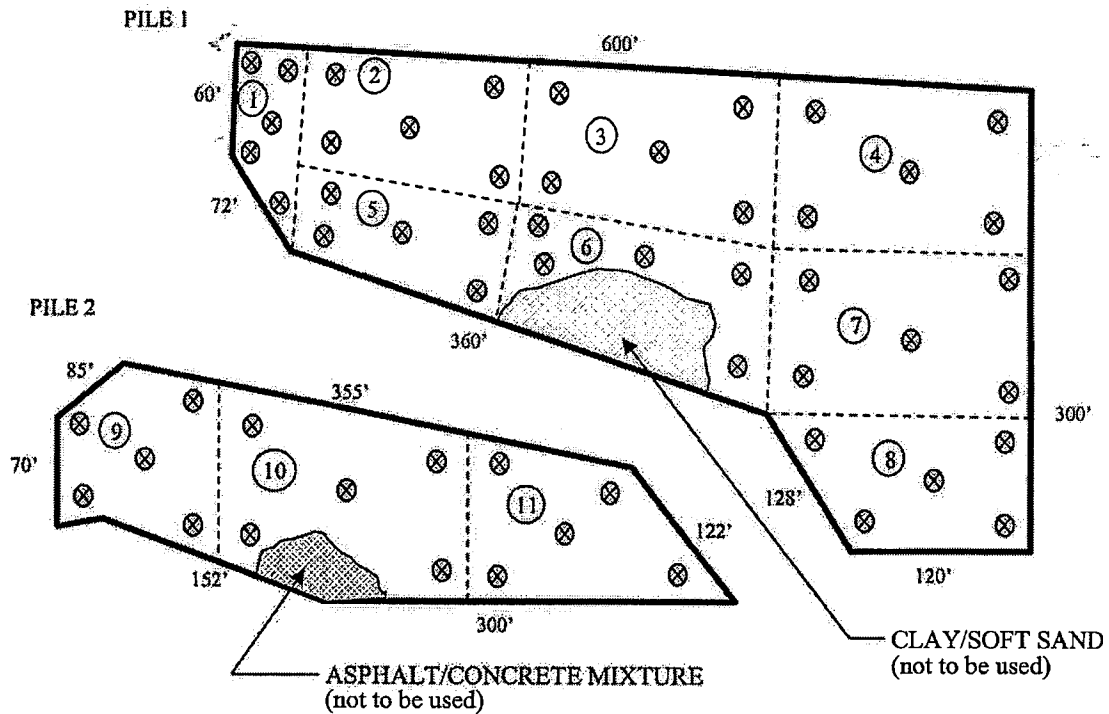
- Two stockpiles total approx. 40-60,000 cubic yards.
- Stockpiles subdivided into (11) areas, each measuring approx. 3,500 – 5,500 cubic yards.
- (11) Composite samples for PCBs, Metals, VOCs, SVOCs, Pesticides and Herbicides.
- *Each composite to comprise (5) grab samples.
- **Any visible asphalt/concrete or organic matter (i.e., tree roots) to be segregated and excluded as potential fill.

- ② Subdivided Soil Stockpile Area and Sample Number
- ⊗ Approximate Grab Sample Location

Comment 1. Page 1 Second Paragraph and Figure 1: Pile two indicates a substantial amount of asphalt and construction and demolition debris. Are all these materials from Borella field, or is there an additional source, or sources, such as Town highway work, etc.? If so, what significance does this have on using this material for backfill?

⁽¹⁾ Reference Figure 1. Soil Pile Schematic

Previously submitted to you in our letter dated July 6, 2006, were copies of the Phase I ESA for Borella Field with aerial photographs and Borella Field site photographs. Attached herein, please find Figure 1, which is a revised schematic of the two soil stockpiles at the Town yard in Syosset.

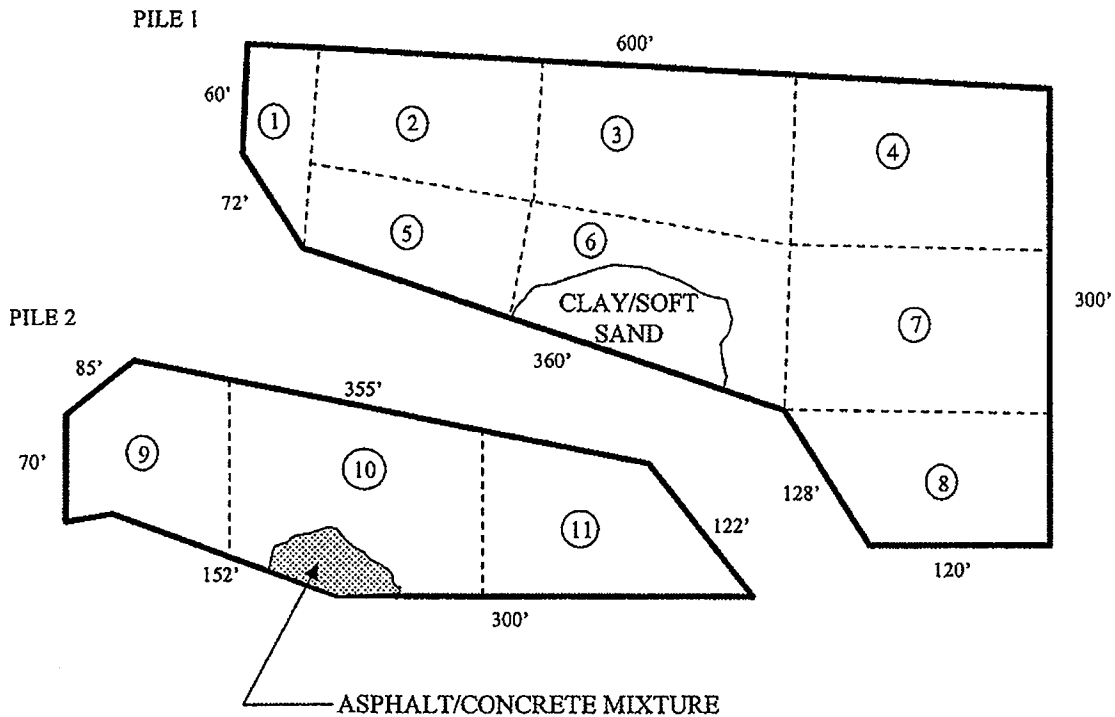
Schematic of soil piles located at Town of Oyster Bay DPW facility in Syosset, NY.

Proposed Environmental Sampling Plan of Town of Oyster Bay Soil Stockpiles at Syosset DPW Yard

- Two stockpiles total approx. 40-60,000 cubic yards.
- Stockpiles subdivided into (11) areas, each measuring approx. 3,500 – 5,500 cubic yards.
- (11) Composite samples for PCBs, Metals, VOCs, SVOCs, Pesticides (8081, 8141), and Herbicides (8151)
- *Each composite to comprise (5) grab samples collected from random areas within the pile using an excavator.
- **Any visible asphalt/concrete or organic matter (i.e., tree roots) to be segregated and excluded as potential fill.

Source of soil: Regrading at Borella Field (Former farm and baseball fields), Plainview Road, Bethpage, NY

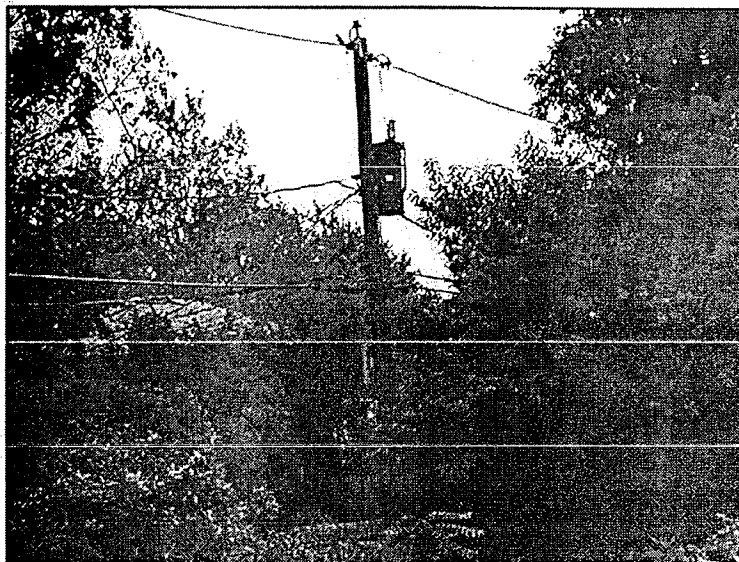
Photograph #9 - View of a pole-mounted transformer located on the northern property line.

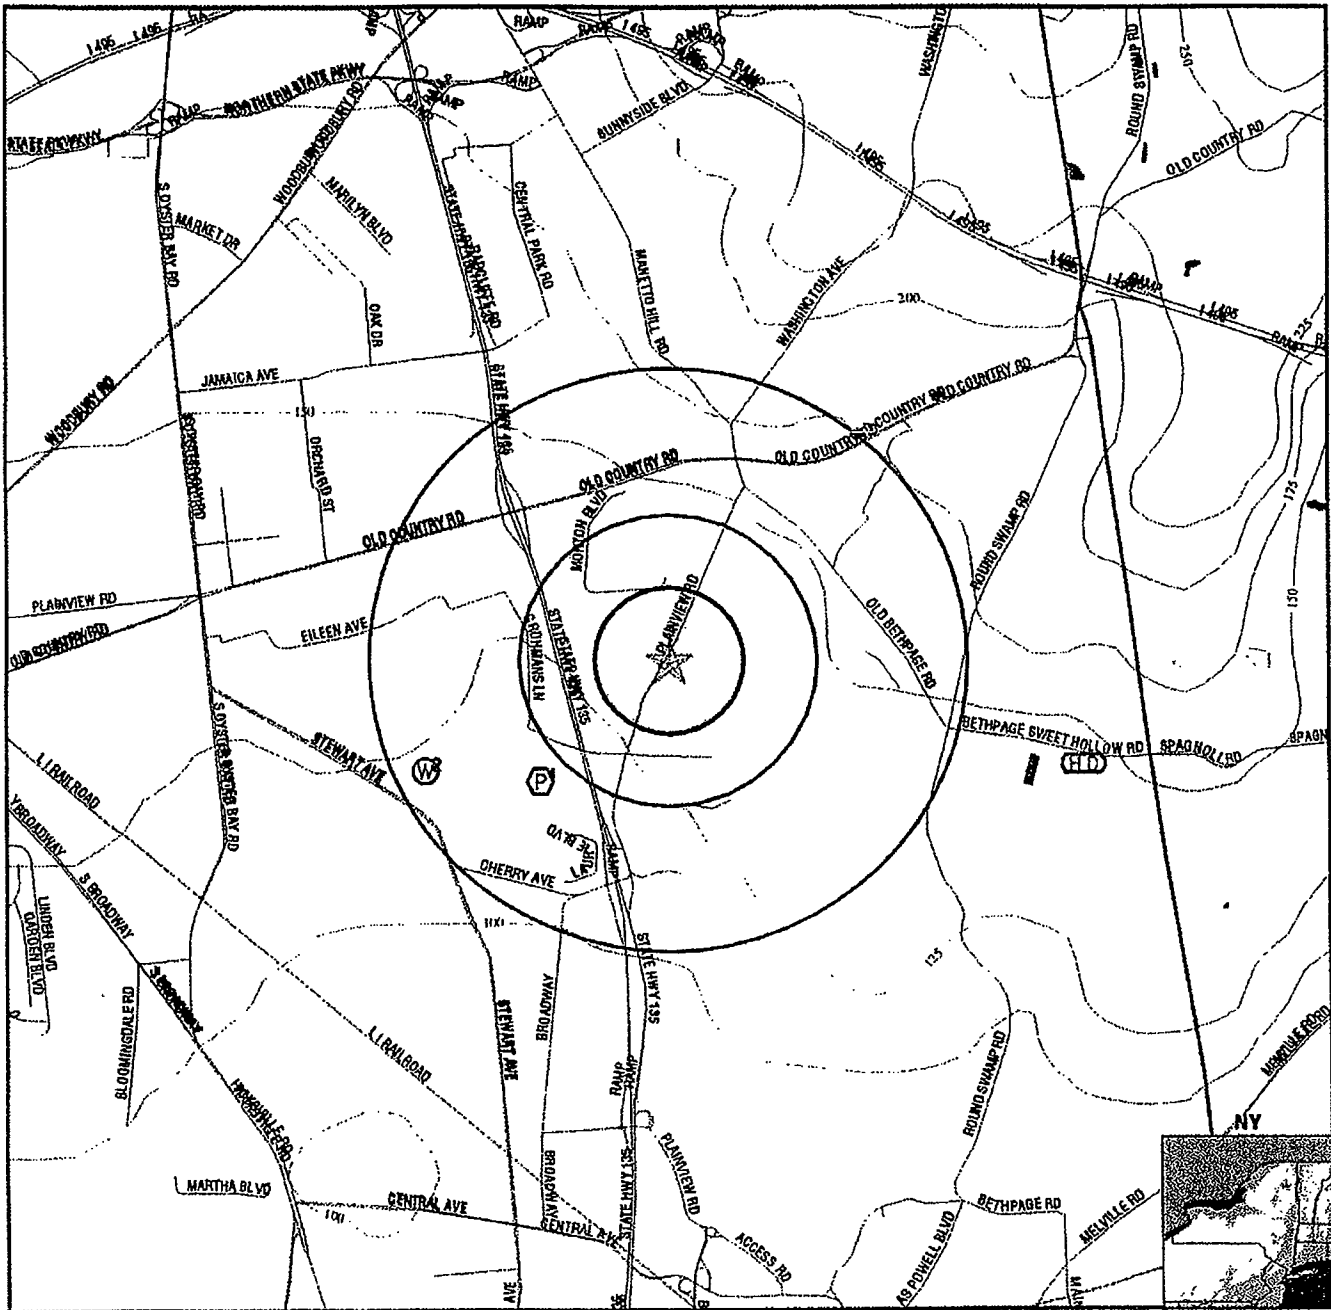
PHYSICAL SETTING SOURCE MAP - 858632.3s

- ↗ Major Roads
- ⋯ Contour Lines
- ⊙ Water Wells
- Ⓟ Public Water Supply Wells
- ↑ Groundwater Flow Direction
- Ⓛ Indeterminate Groundwater Flow at Location
- Ⓢ Groundwater Flow Varies at Location
- Cluster of Multiple Icons
- ⊙ Earthquake epicenter, Richter 5 or greater
- Ⓛ Hydrogeological Data
