Project: East Hampton Housing Authority

September 7, 1993

**Re: East Hampton Housing Authority - Accabonac Project,
Situate Accabonac Highway, Town of East Hampton
SCTM No.: 0300-149-02-56.1.**

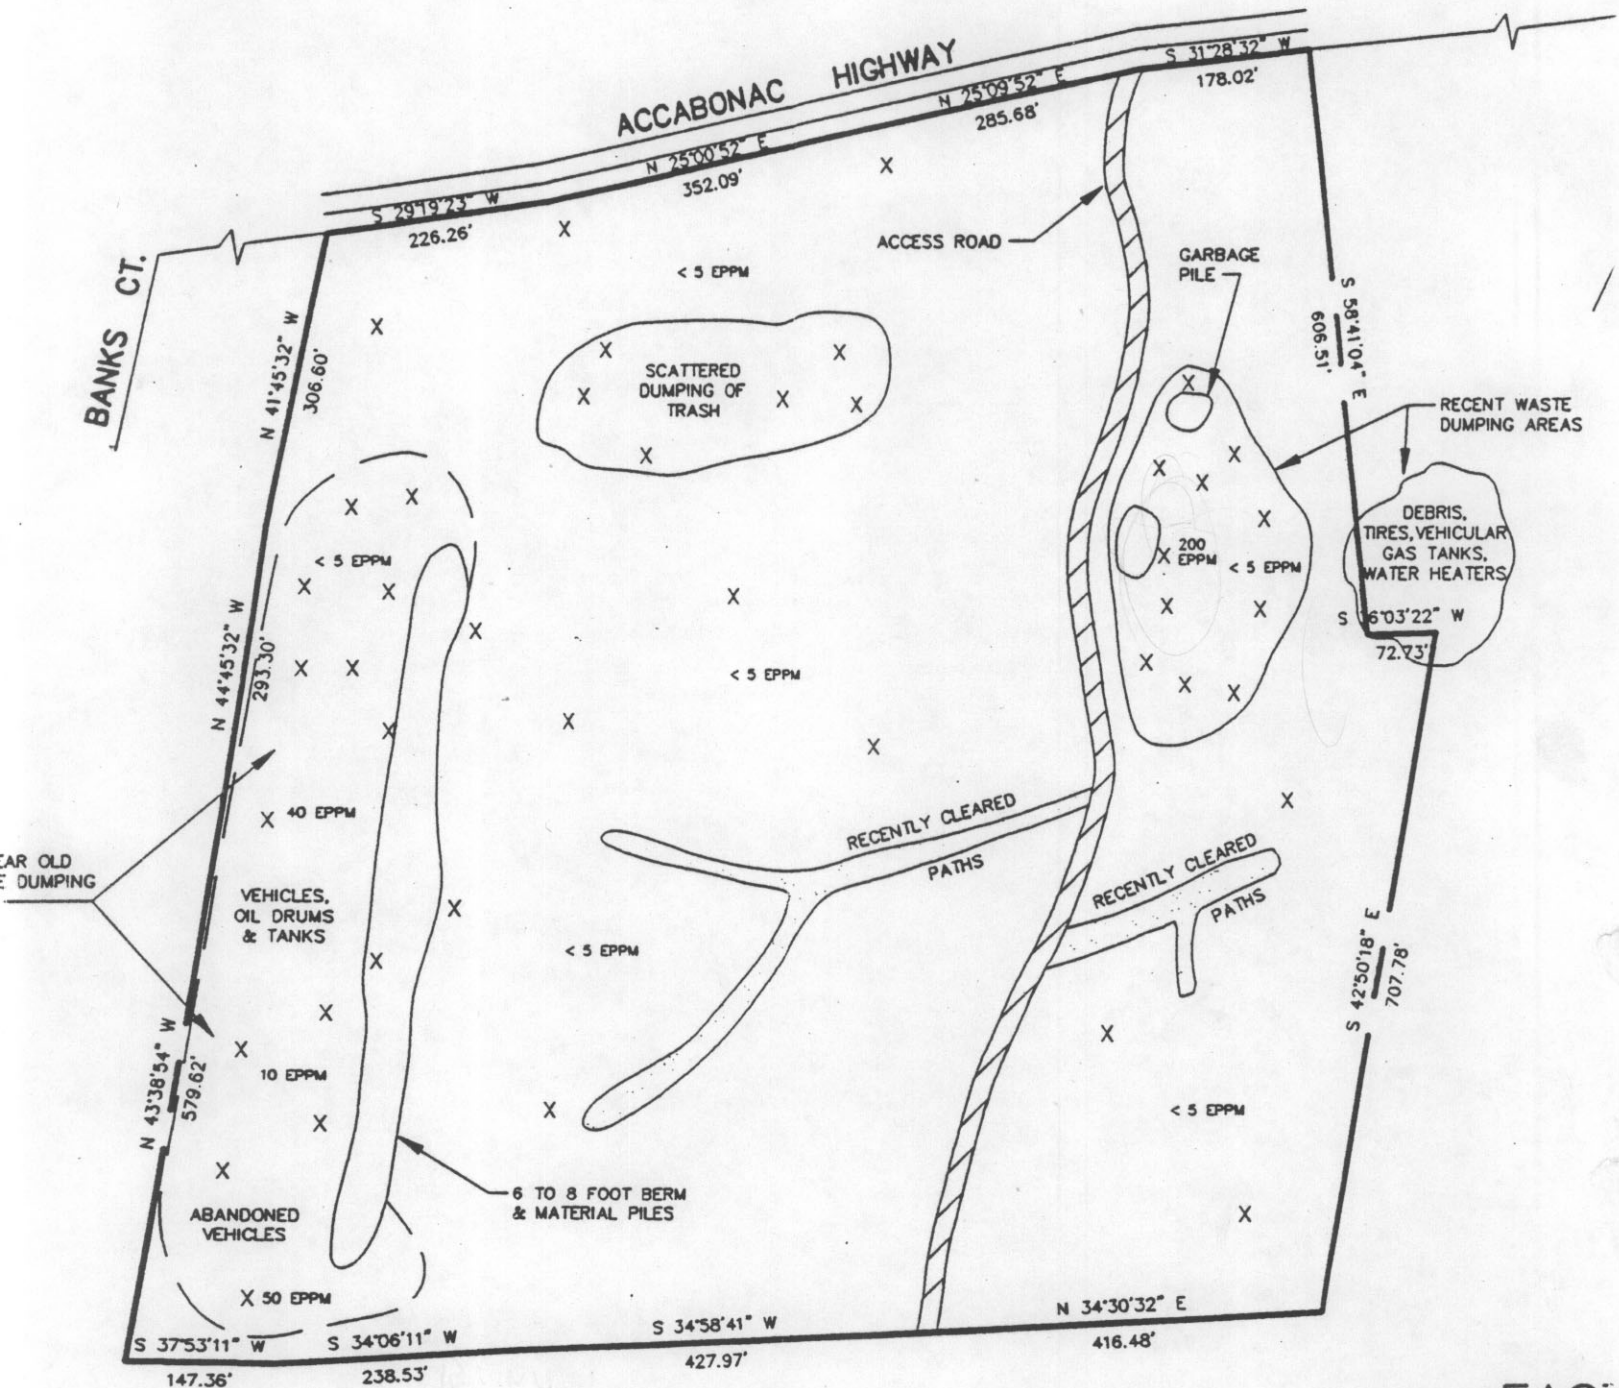
SITE PLAN

Elevated PID readings were revealed at certain small and specific areas during the intensive photoionization detection (PID) sweep of the "cleaned" area of surficial disposal situated along the southern property line. These identified elevated readings were only observed at a few of the flagged locations where abandoned vehicles had previously been situated. Surficial soil samples were therefore collected at this time for further analysis to determine the actual surficial soil contaminant present in these limited "spots."

The results of this limited surficial soil sampling have recently been received by this office and have been attached for your reference. Based upon a review of these results, it appears that, although no petroleum hydrocarbon contamination was found to exist on this site, 1,1,1-trichloroethane was revealed to be present in all three (3) of the VOC samples. Two of these three samples contained concentrations of this constituent which exceeded NYSDEC soil guideline limits.

It is therefore recommended that a proper removal of these affected soils off-site be conducted. Such a remediation will involve the identification of each affected area by use of a PID and the subsequent excavation of the contaminated soils from each of these specific locations. These soils would then be stockpiled together onto polysheeting, with one (1) composite soils sample collected for TCLP (Toxic Characteristic Leaching Procedure) analysis. This specific test will characterize these contaminated soils for proper disposal by determining whether this removed material is considered hazardous or non-hazardous.

Confirmatory (endpoint) samples will be collected from at least three (3) separate excavation areas to ensure that a complete remediation has been accomplished. Each of these created "holes" will be fenced-off until the receipt of these confirmatory sample analyses. If these results indicate a complete remediation, each of these holes will subsequently be backfilled with an equivalent amount of clean fill.
