**From:** "Cofman, John" <john.cofman@ngc.com>  
**To:** sxscharf@gw.dec.state.ny.us  
**CC:** David.Stern@arcadis-us.com; bill.trillo@ngc.com; kent.smith@ngc.com  
**Date:** 9/4/2008 9:31 AM  
**Subject:** OU2 Well No. 18 Failure  
**Attachments:** Well 17.TCE.pdf; Well 18.TCE.pdf; Well 19.TCE.pdf

Trichloroethene Concentration in OU2 Remedial Well Well 17  
 Northrop Grumman Systems Corporation, Bethpage, New York

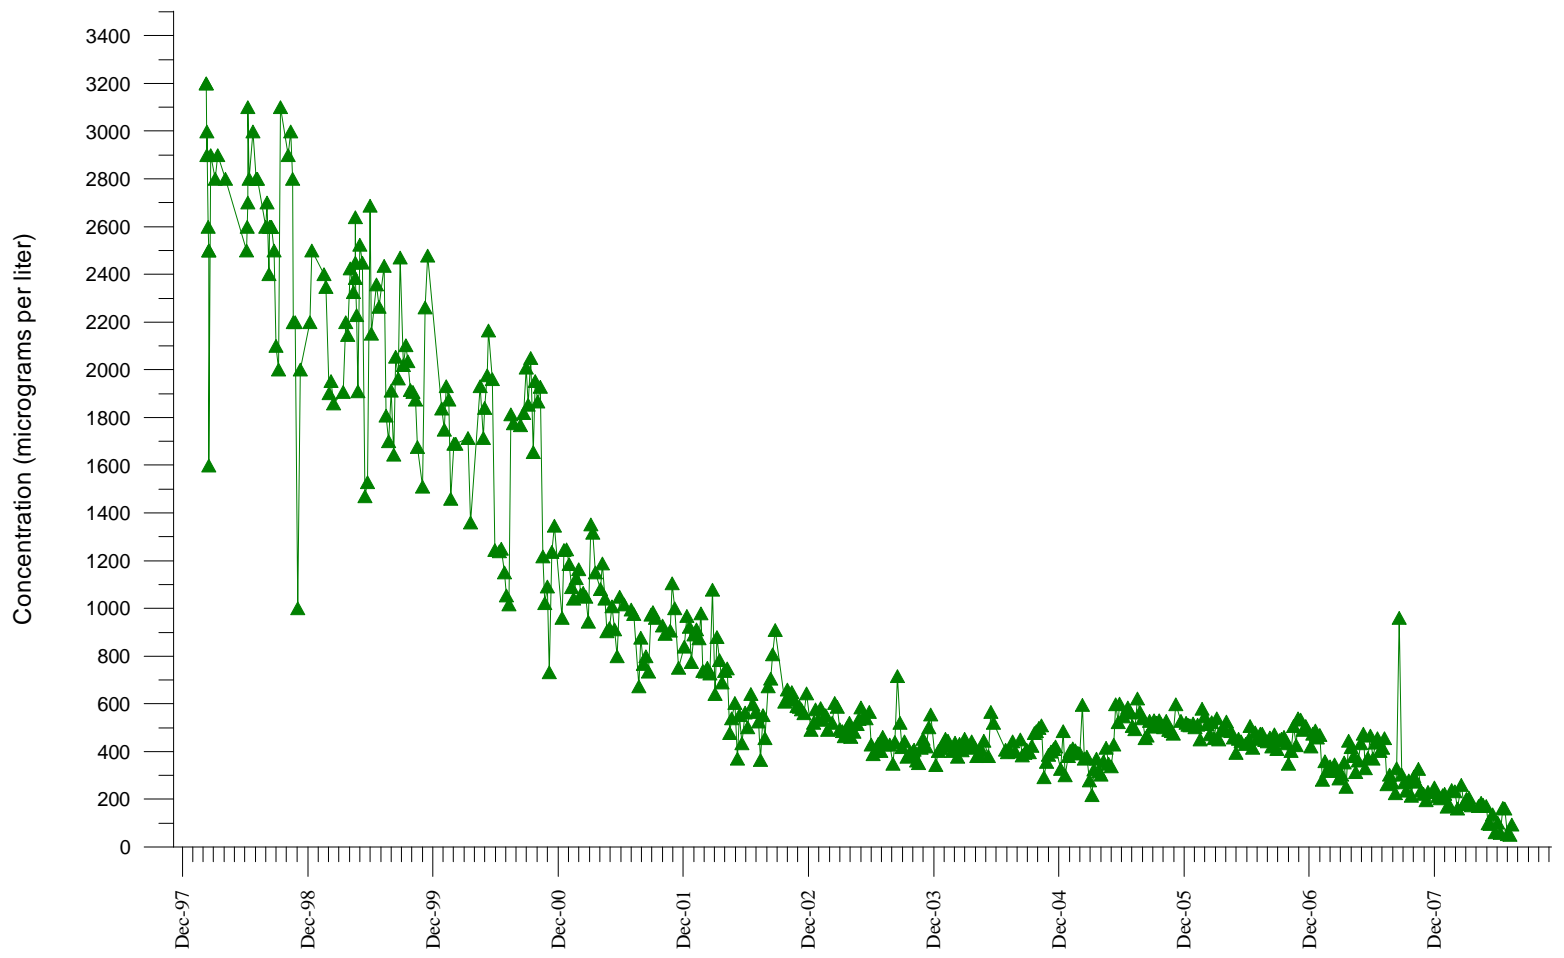
FIGURE  
 3

Data Not Shown on Graph:  
 Well ONCT-1 TCE concentrations on January 7, 1998 (5500 ug/L),  
 January 14, 1998 (7200 ug/L), and January 21, 1998 (4600 ug/L).

By the way, attached are plots of the weekly lab results of samples taken at extraction wells 17, 18 and 19 for TCE which we do in order to monitor the status of our treatment operations. As you can see, we have come a long way!

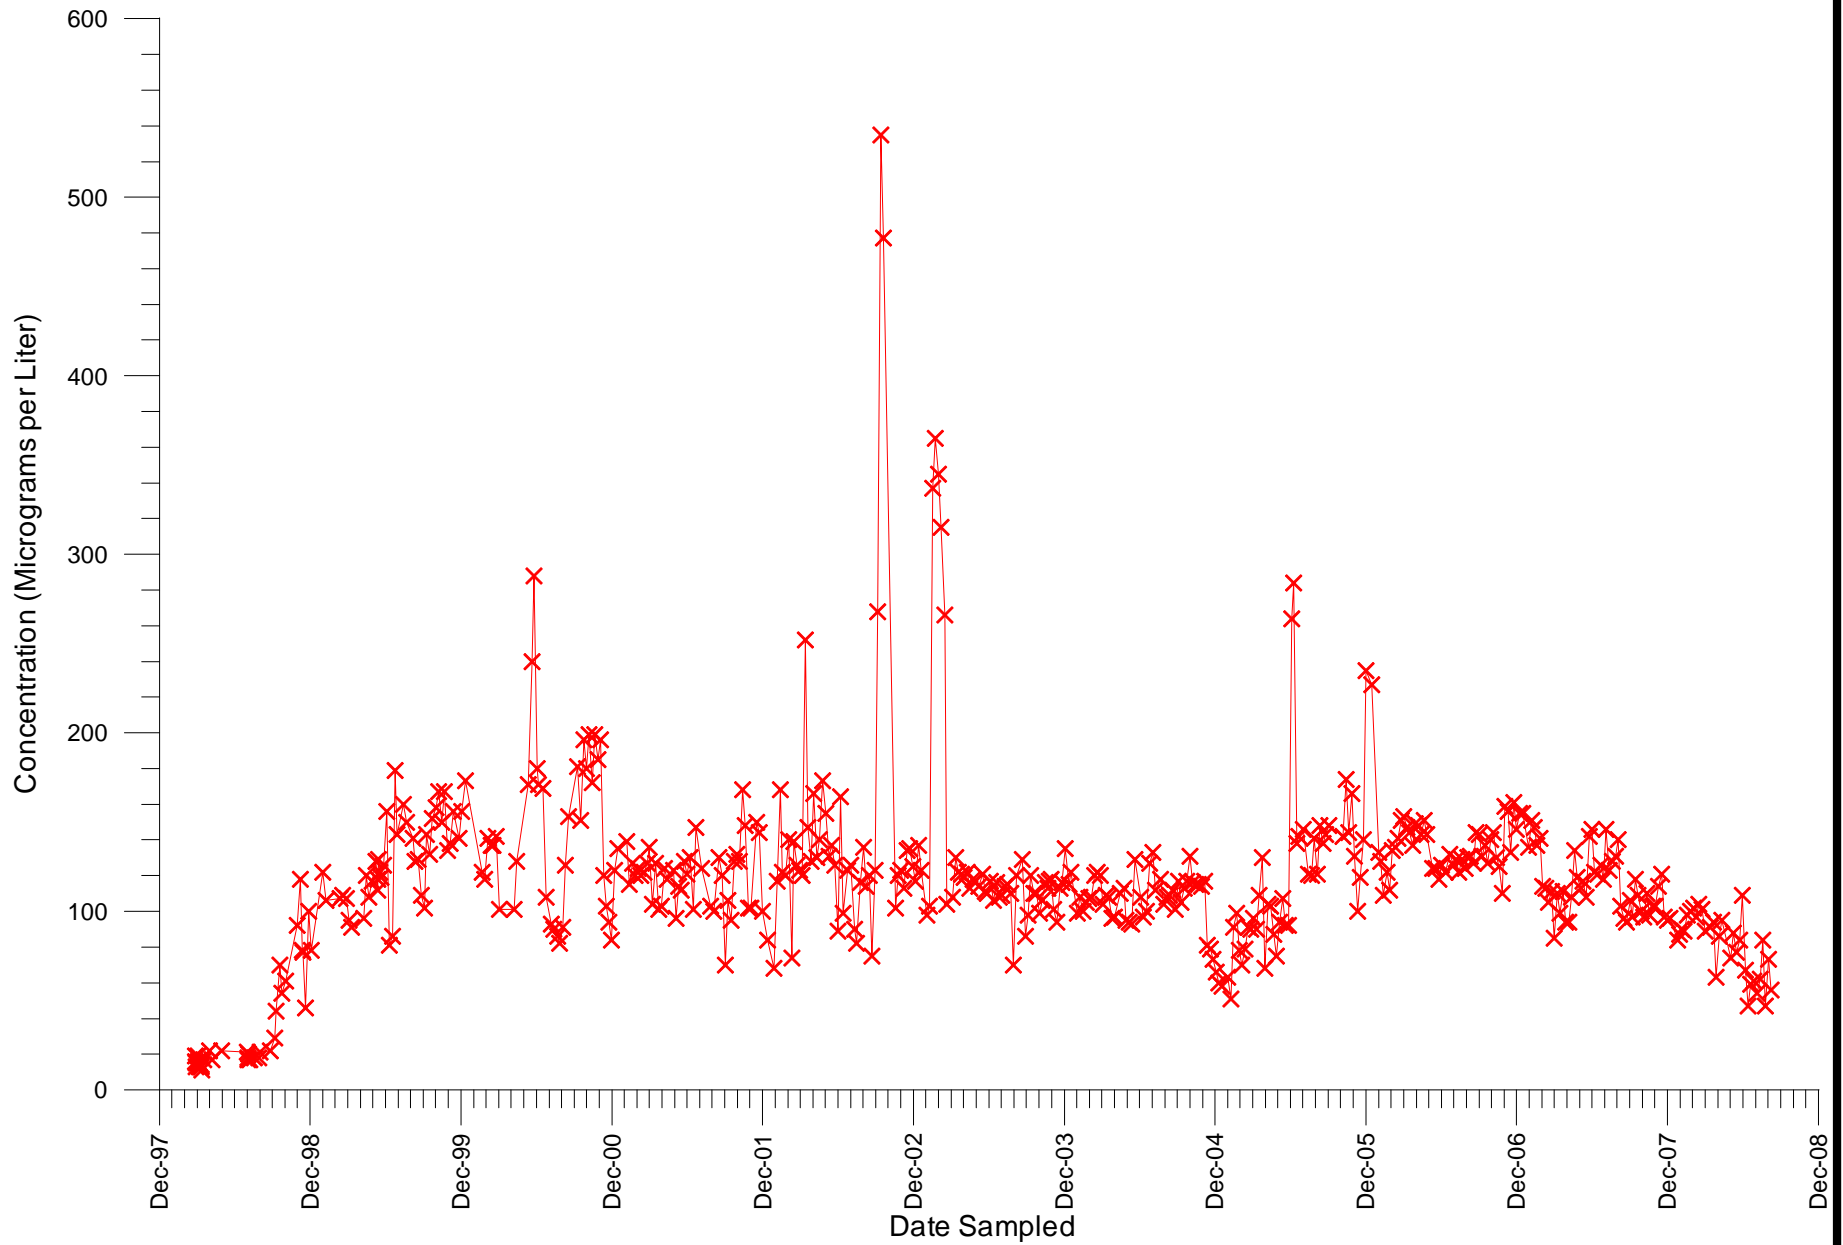
FIGURE  
4

Trichloroethene Concentration in Remedial Well Well 18  
Northrop Grumman Systems Corporation, Bethpage, New York

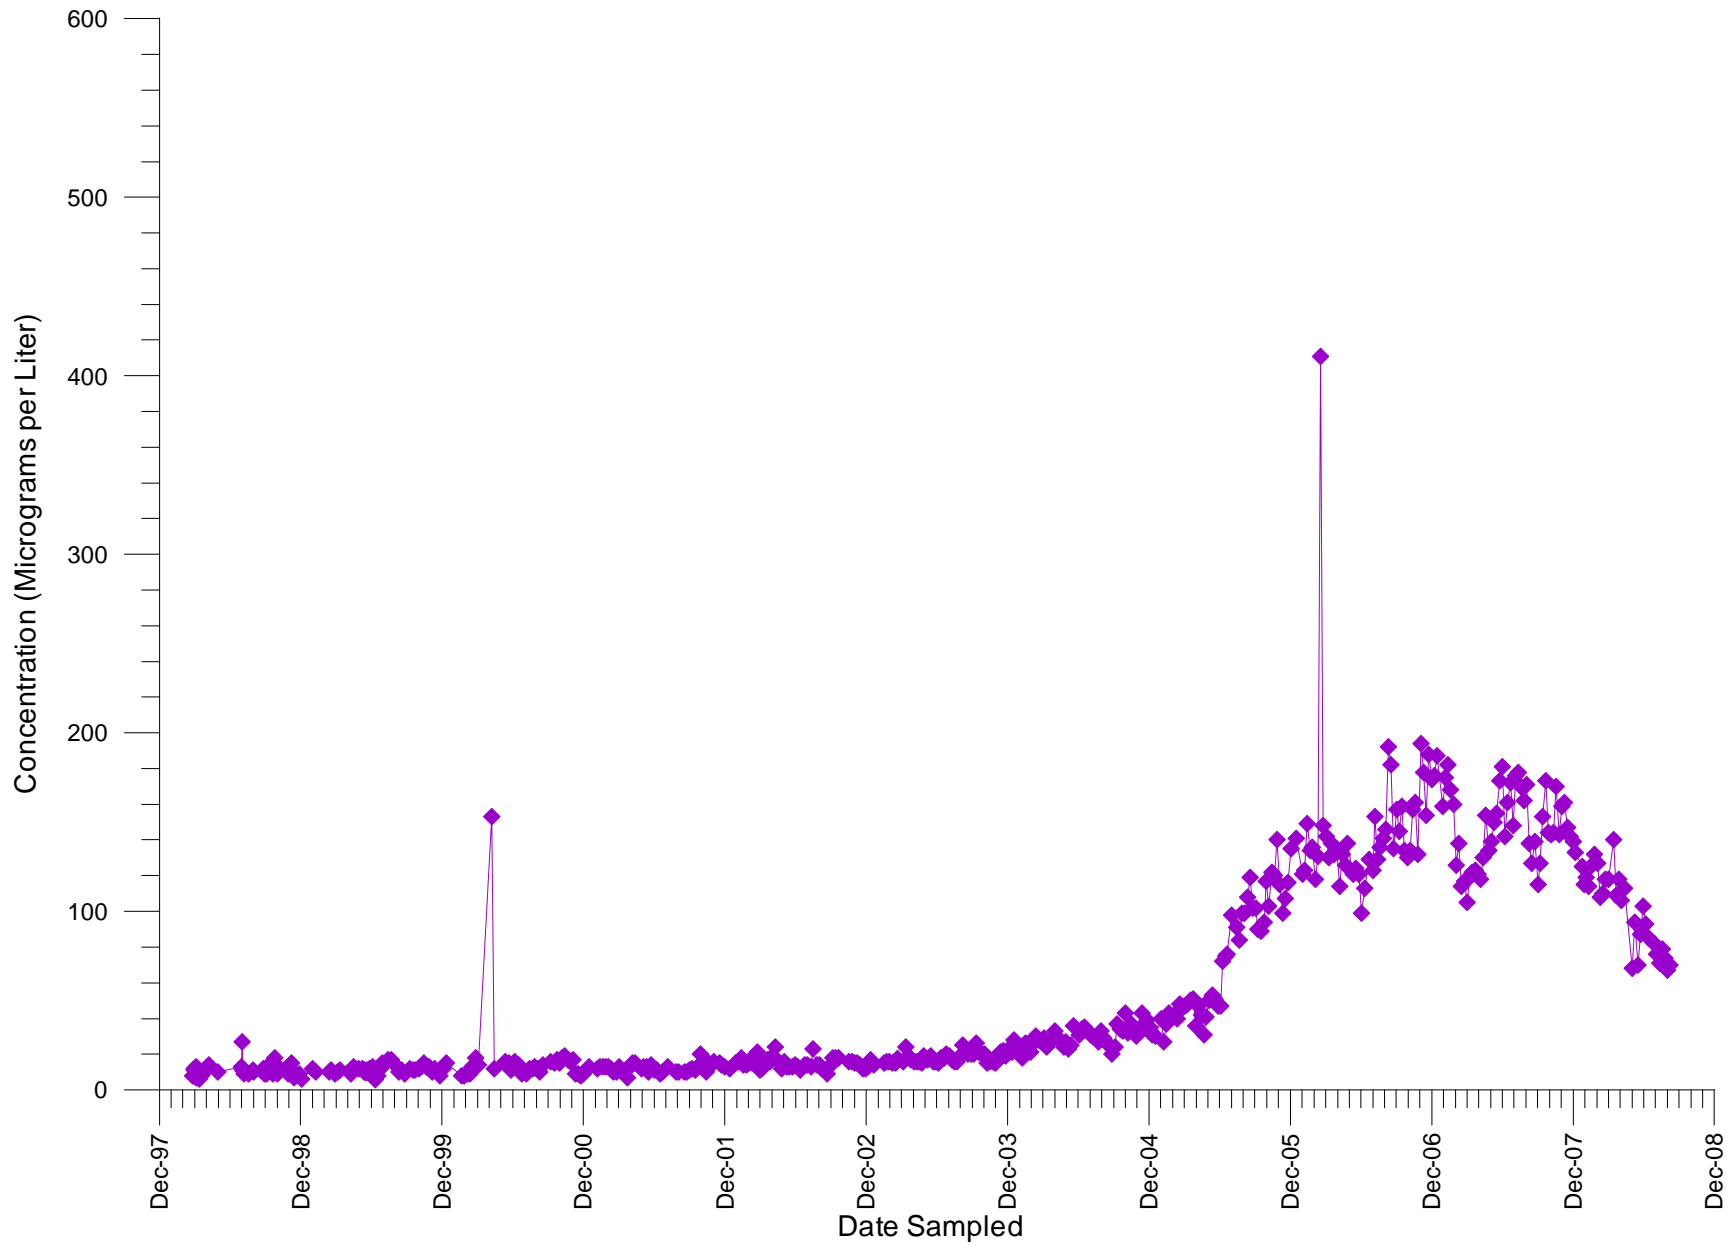
**FIGURE**  
**5**

Trichloroethene Concentration in Remedial Well ONCT-3  
Northrop Grumman Corporation, Bethpage, New York
