ACTIVE INDUSTRIAL UNIFORM SITE GROUNDWATER EXTRACTION AND TREATMENT SYSTEM

REPORT TITLE

Site Management Quarterly Report No. 31

July 1, 2012 through September 30, 2012

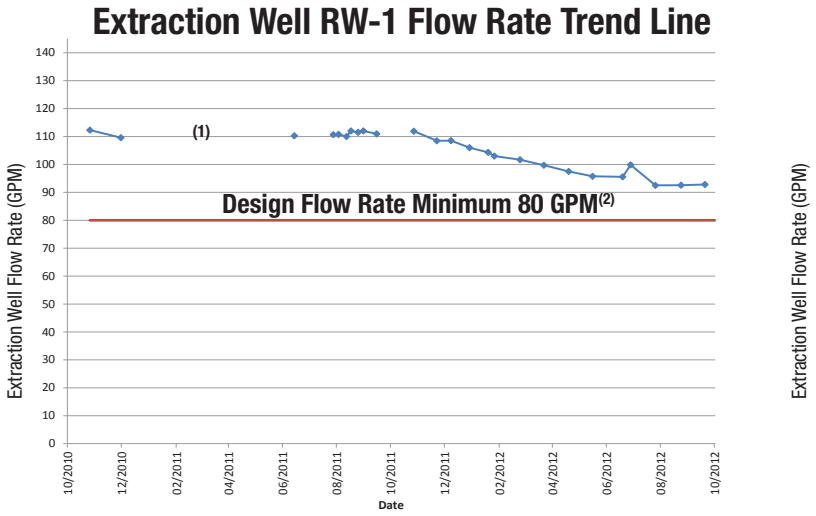
1. The GWE&TS did not operate the majority of the time from December 2010 through July 2011 and September 2011 through October 2011 due to a carbon vessel bed screen failure and residential neighbor complaints pertaining to a loud noise being emitted by the GWE&TS exhaust piping.
2. Based on design information presented in the Active Industrial design documents, containment of the Active Industrial chlorinated plume could be achieved with on-site extraction well RW-1 operating at a minimum of 80% of the design flow rate of 100 GPM (80 GPM).

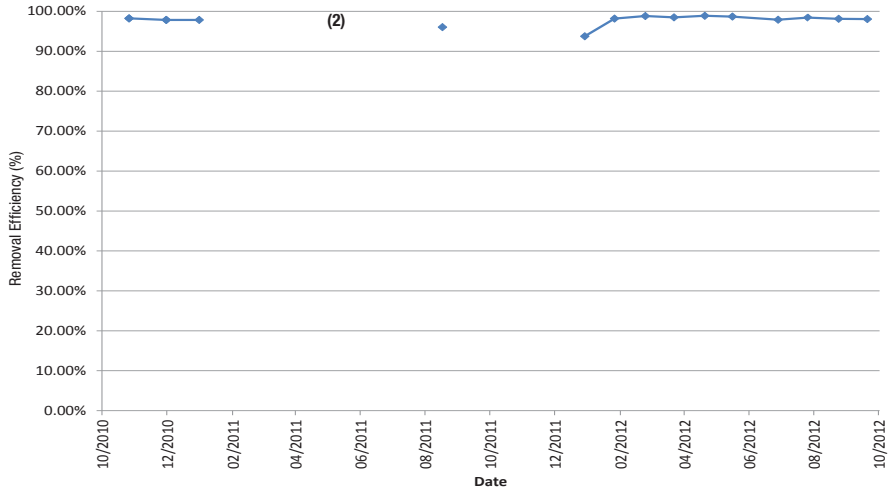
Air Stripper VOC Removal Efficiency [1]

1. The packed-tower air strippers have operated at an approximate efficiency ranging from 92.65% to 99.47% since D&B assumed O&M duties in February 2005.
2. The GWE&TS did not operate the majority of the time from December 2010 through July 2011 and September 2011 through October 2011 due to a shut down related to a carbon vessel bed screen failure and residential neighbor complaints pertaining to a loud noise being emitted by the GWE&TS exhaust piping.
3. The VOC removal costs include monthly utility charges, maintenance costs and engineering costs. Capital construction costs and NYSDEC project management effort are not included in this evaluation.
4. Average calculated from when D&B assumed O&M duties in February 2005 through this reporting period.

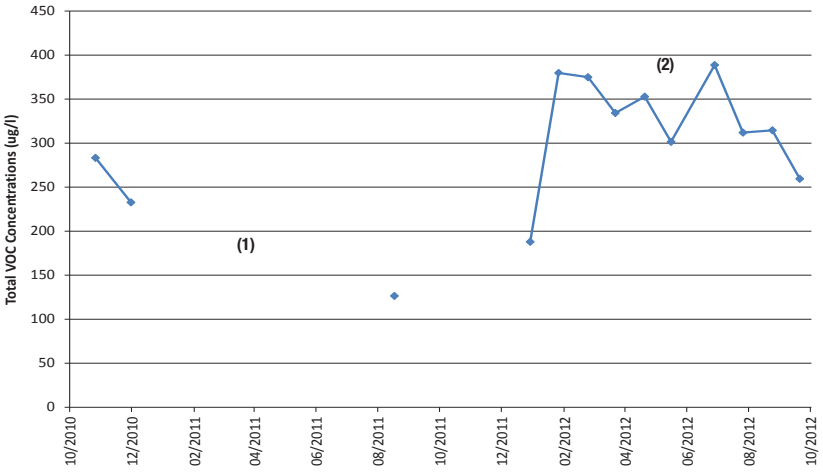
Extraction Well RW-1 Total VOC Concentration Trend Line

1. The GWE&TS did not operate during the majority of the time from December 2010 through July 2011 and September 2011 through October 2011 due to a carbon vessel bed screen failure and a continuous loud noise emitted by the GWE&TS exhaust piping.
2. This increase in total VOC concentration in extraction well RW-1 influent may be attributable to a lagging effect of the disturbance of the subsurface and contaminants during the latest soil removal IRM completed in June and July 2011.
