Monthly Report of the Operations & Maintenance Activities

Claremont Polychemical Operable Unit 5 Groundwater Treatment System

Old Bethpage, New York
October 2020

NYSDEC Standby Engineering Contract Work Assignment #D0076025-28

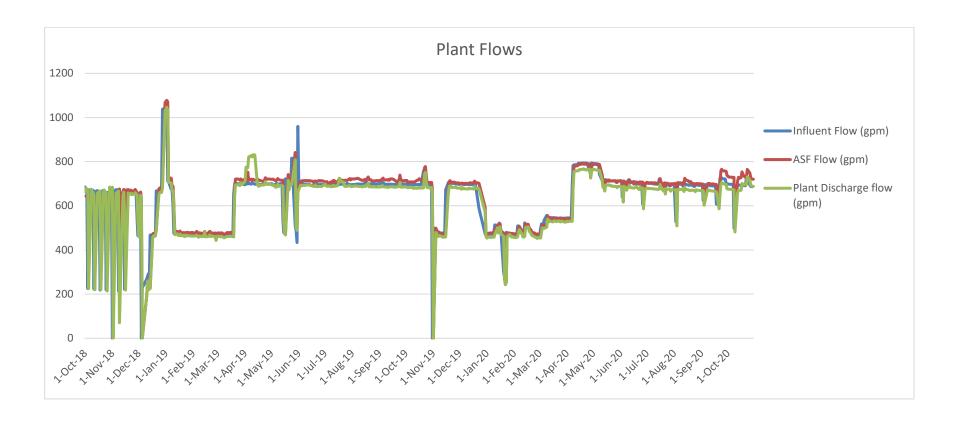
Figure 1 – Plant Discharge Daily Flow

A graphic representation of the system's daily plant discharge output is provided in **Figure 1** and the daily plant totalizer readings for October are provided in **Table 4**, both following the text of this report.
