**PROPOSED REMEDIAL ACTION PLAN
RCA - ROCKY POINT**

**Operable Unit No. 02
Town of Brookhaven, Suffolk County
New York
Site No. 152011**

August 2006

Division of Environmental Remediation
New York State Department of Environmental Conservation

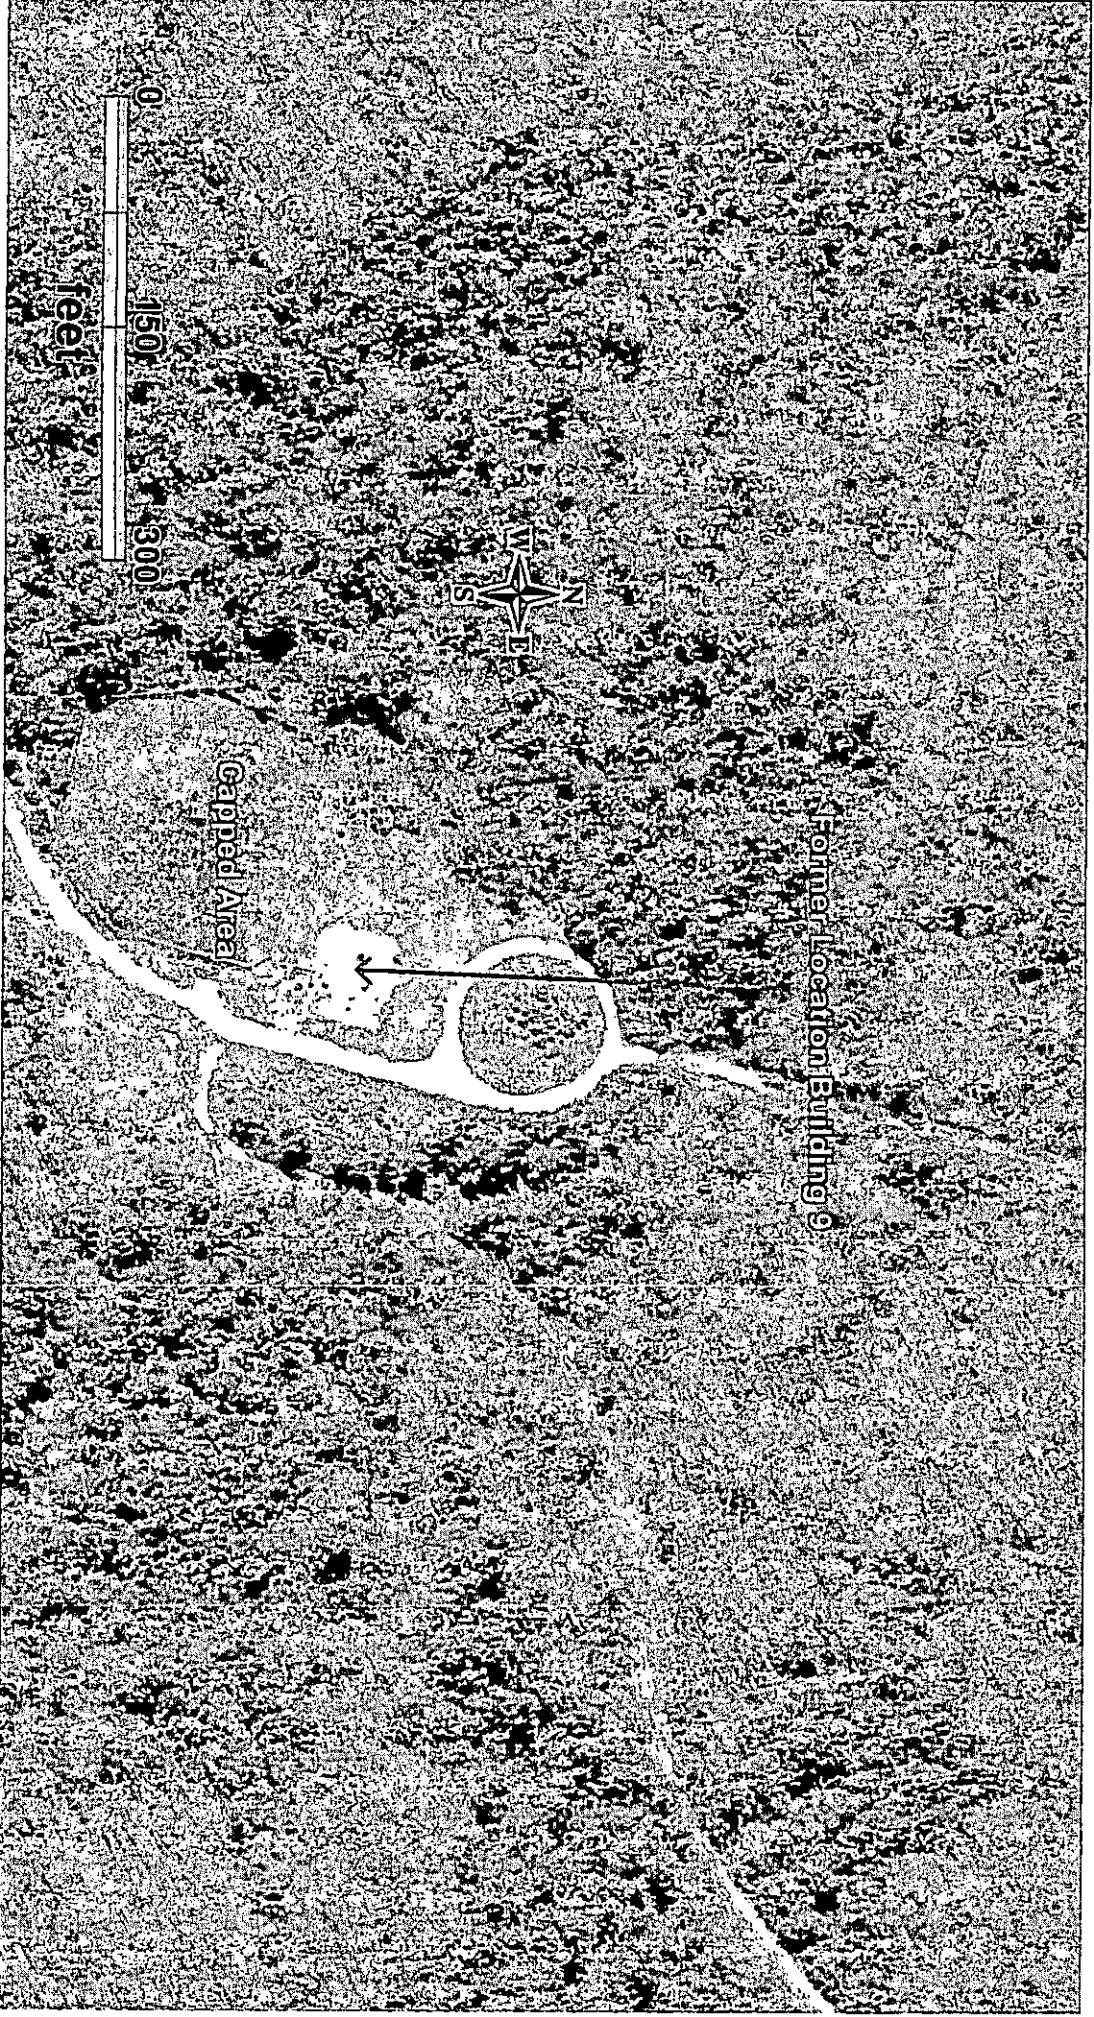
LOCATION OF SITE (CAPPED AREA) IN AERIAL MAP
